INAC – CARD Gordon Lake Remediation Project

**RE: Water Licence MV2016L8-0006 – Gordon Lake Project – Inspection**

## WATER LICENCE ENVIRONMENTAL INSPECTION REPORT

Licensee:	INAC - CARD	Inspection Date – March 1 <sup>st</sup> 2018
-----------	-------------	--

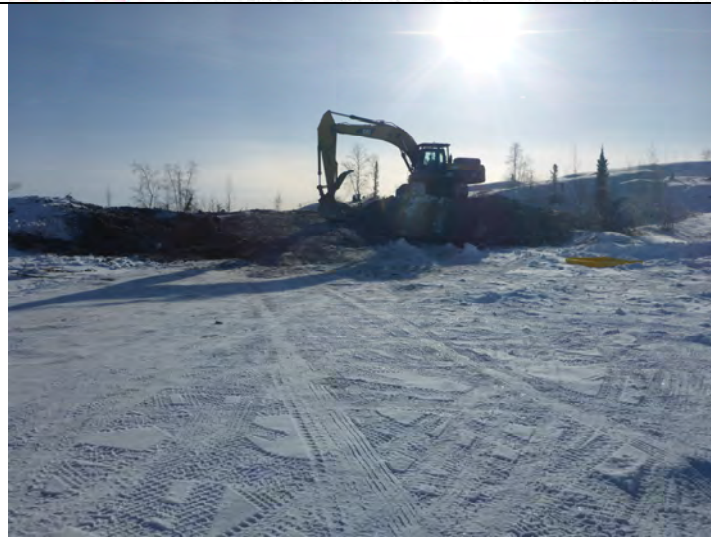
Excavation of waste rock on Zenith Island and Camlaren was being completed at the time of the inspection (Photo #1, #4, and #5). Site representatives inquired into the approval to excavate waste rock from the immediate lake bed around the islands. The Inspector approved the excavation based on the fact that they would not be excavating in the water and only in land fast ice areas. The Inspector also explained that they must stop this excavation if they encounter any water. The Inspector also requested that any sediment on the ice as a result of the excavations is removed prior the spring shutdown.

**Photo #1: Overview of the excavation of material within 100 meters of the OHWM on Zenith Island.**

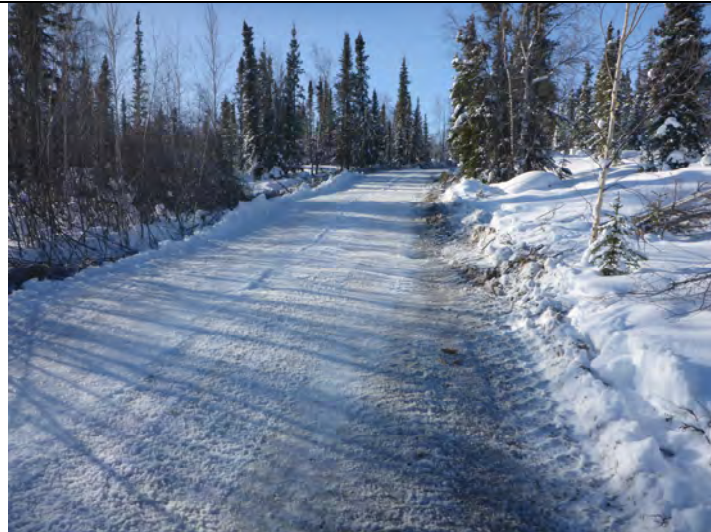
The Inspector noted no concerns with any of the portages or ice roads built to support the project. All of the portages appeared to have at least 10 cm's of ice/snow pack and there were no signs of rutting at the time of the inspection (Photo #2). There was a large area of tailing covered with sand at Burnt Island (Photo #3). The Inspector explained that this area needs to be recontoured in order to avoid water ponding during snow free conditions.

**Photo #2: Portage on Burnt Island accessing the tailings cover.**

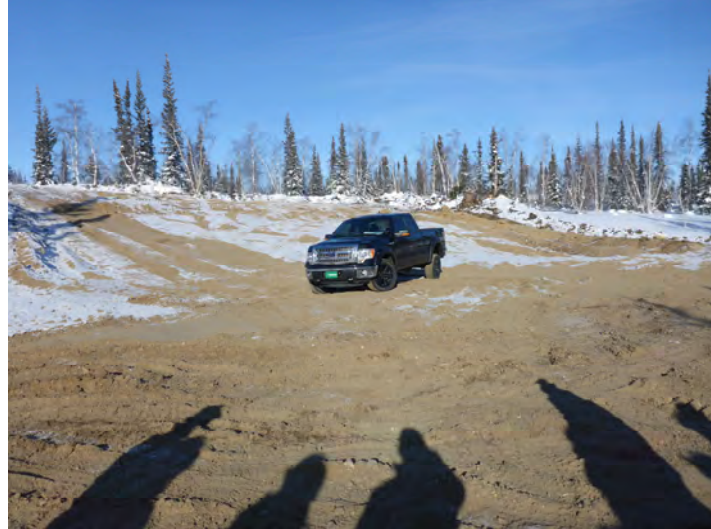
**Photo #3: Overview of the tailings cover on Burnt Island. Note that this will need to be regraded to ensure that ponding does not occur.**

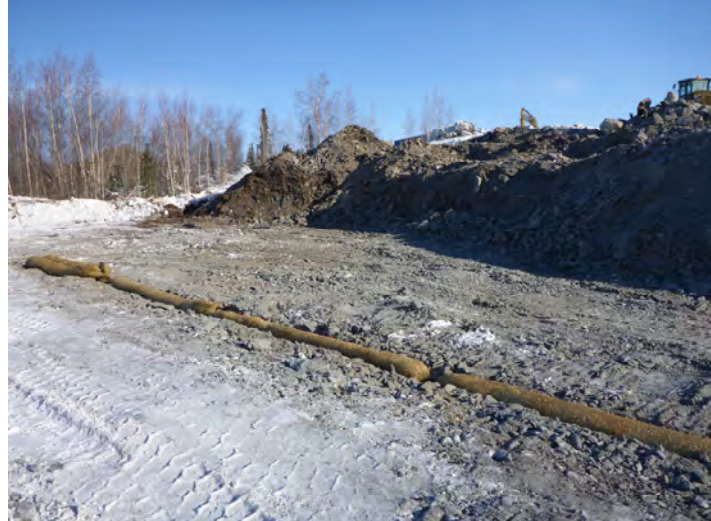
**Photo #4: Overview of the excavation of waste rock at Camlaren.**

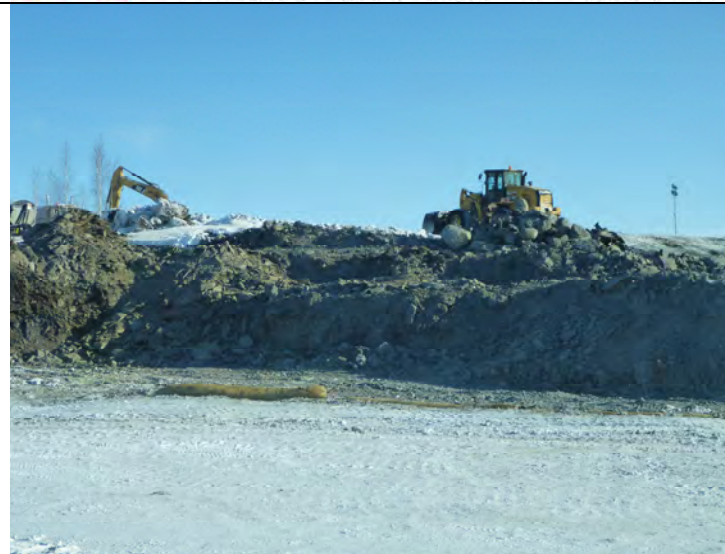
**Photo #5: Overview of the excavation of waste rock at Camlaren.**

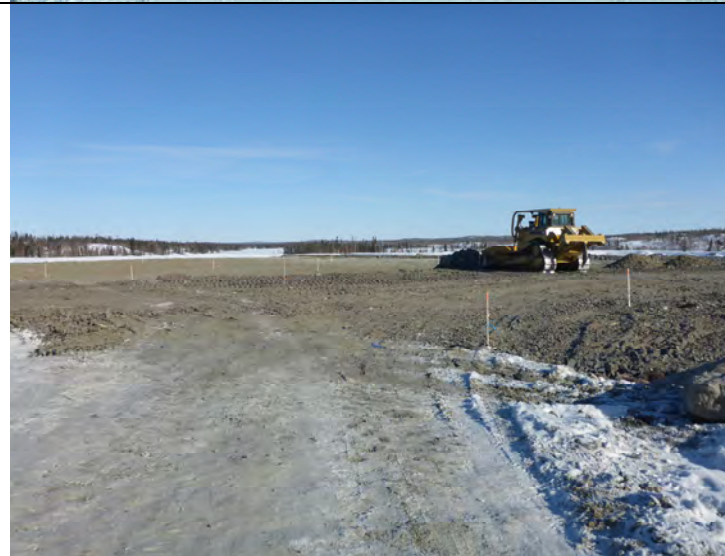
**Photo #6: Overview of the tailings cap on Camlaren.**

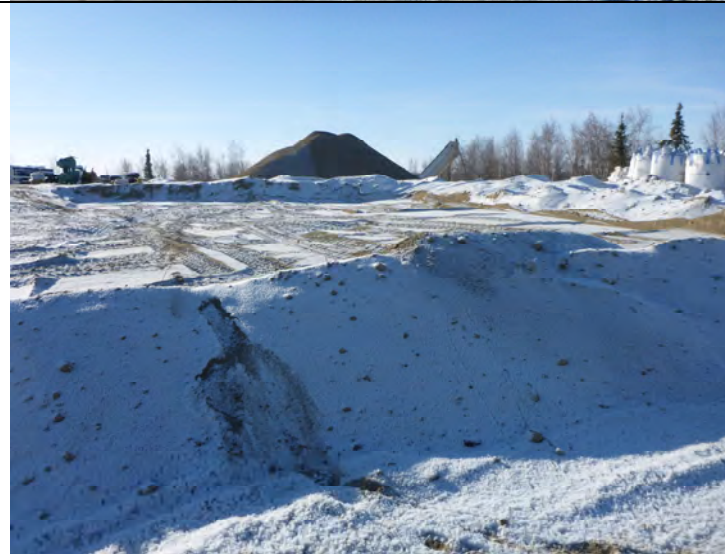
The Inspector noted that the bermed area for the fuel tank farm was lined and appeared to be well constructed (Photo #7). Site representatives requested that the Inspector approve the practice of creating stockpiles of quarried material that is higher than two meters. The Inspector agreed with this practice as it will minimize the footprint of the project on the Camlaren site.

**Photo #7: Overview of the fuel tank secondary containment constructed on Camlaren.**

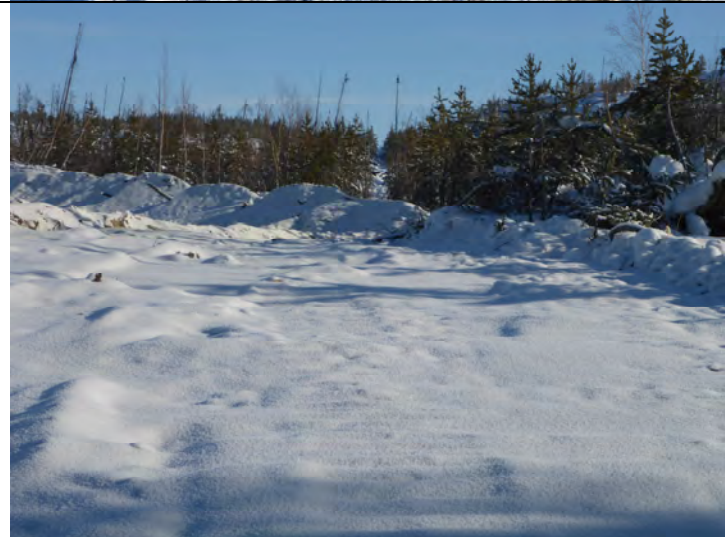
**Photo #8: The boundary between Federal and GNWT lands at the Westbay quarry.**

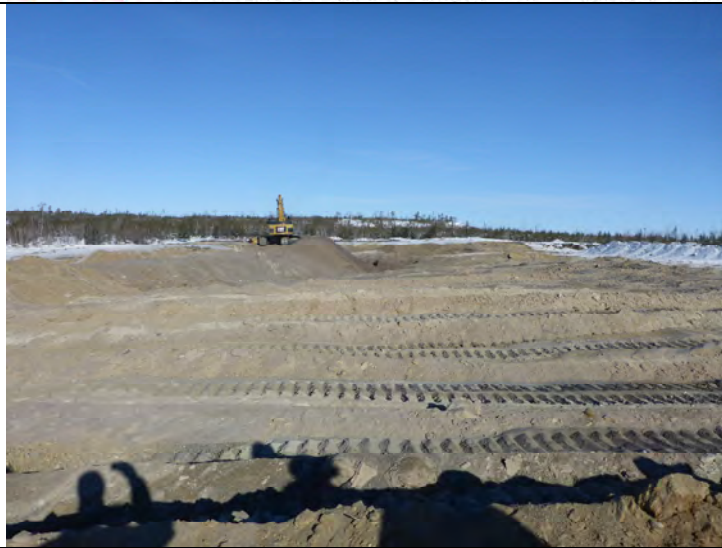
There were no concerns noted with the quarrying activities at the Westbay site (Photo #9). Onsite representatives explained that the quarrying was easier than expected and that there was plenty of material present within the quarry area. The Inspector explained that care should be taken to not over quarry onto GNWT lands without letting the GNWT Inspector know ahead of time.

**Photo #9: Overview of quarrying activities at the Westbay quarry.**

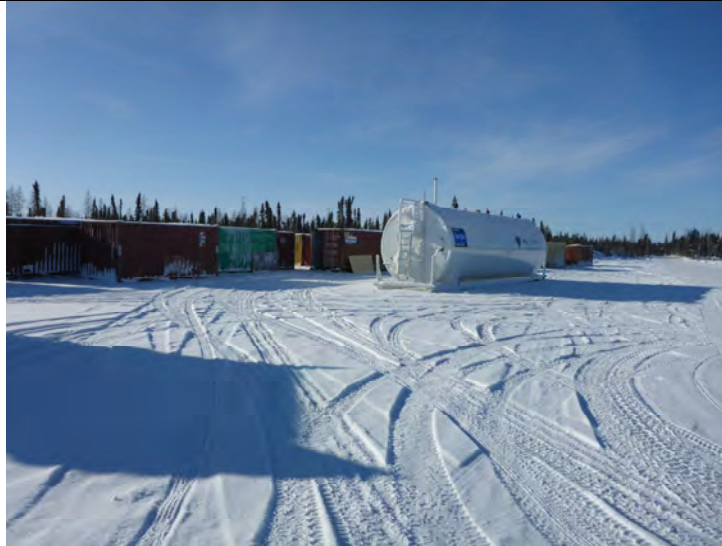
There were multiple seacans, trailers, and fuel tanks placed on the ice near Kidney Pond (Photo #10). The Inspector explained that all of this equipment must be removed prior to spring break up and the area be scrapped to ensure there is no deposit of material into Gordon Lake during freshet.

**Photo #10: Overview of the equipment staged on the ice near Kidney Pond.**

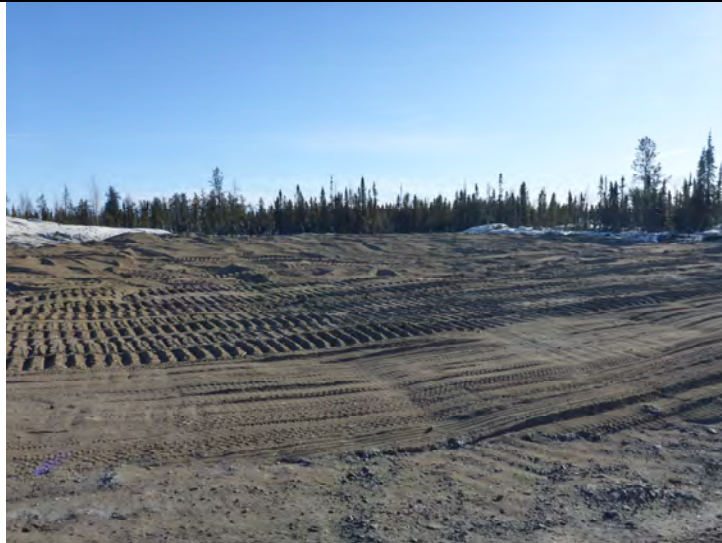
**Photo #11: Excavated waste rock and contaminated soil area located at Kidney Pond.**

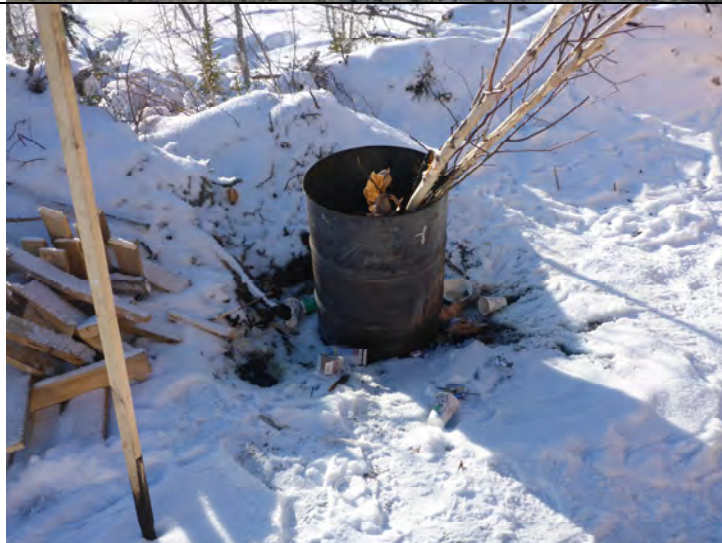
The camp at Zenith Island appeared to be well maintained and operated. The Inspector discovered that plastic was being burnt in a barrel behind the camp (Photo #12). This practice is not acceptable and all plastic must be removed from site and disposed of in accordance with the approved waste management plan.

**Photo #12: Burn barrel located behind Zenith Island Camp. Note that there was non-burnable material in the barrel at the time of the inspection.**

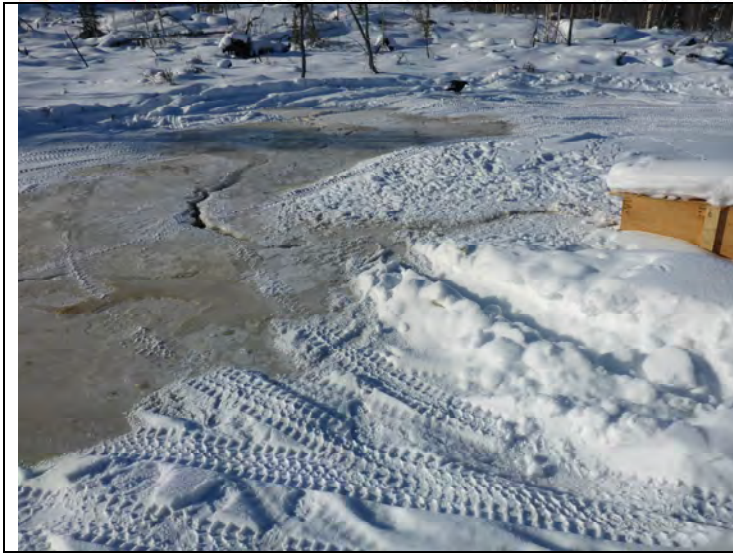
**Photo #13: Grey water discharge located south of the Zenith Camp.**
