INAC – CARD Gordon Lake Remediation Project

**RE: Water Licence MV2016L8-0006 – Gordon Lake Project – Inspection**

## WATER LICENCE ENVIRONMENTAL INSPECTION REPORT

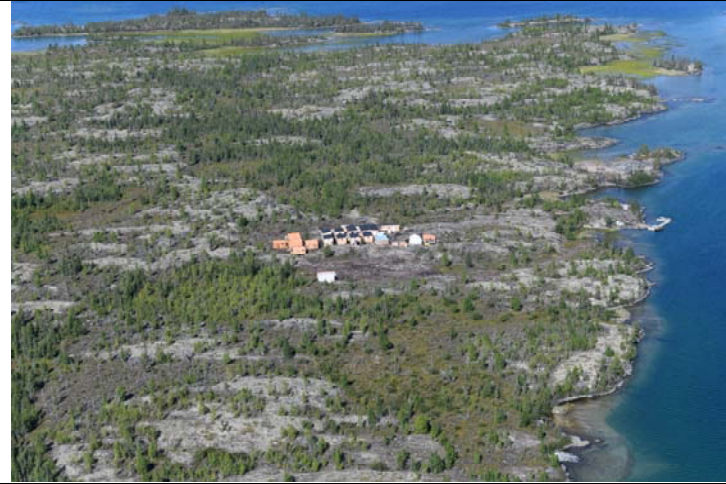
The camp was active at the time of the inspection and appeared to be well run and organized (Photo #1). The sewage and grey water discharge was contained within the sump and remained over 100 meters from the OHWM of Gordon Lake (Photo #2). The Inspectors had no concerns with the fuel management at the camp and it appeared that all camp activities were in compliance with the approved management plans.

**Photo #1: Overview of the camp on Zenith Island.**

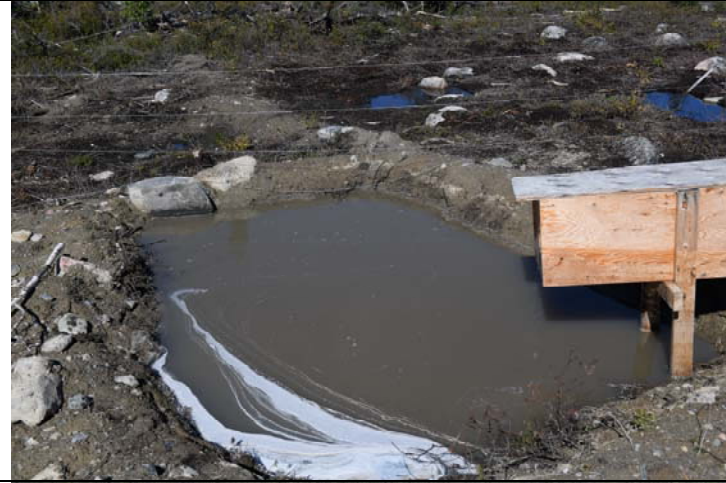
**Photo #2: Grey water discharge at Zenith Island camp.**

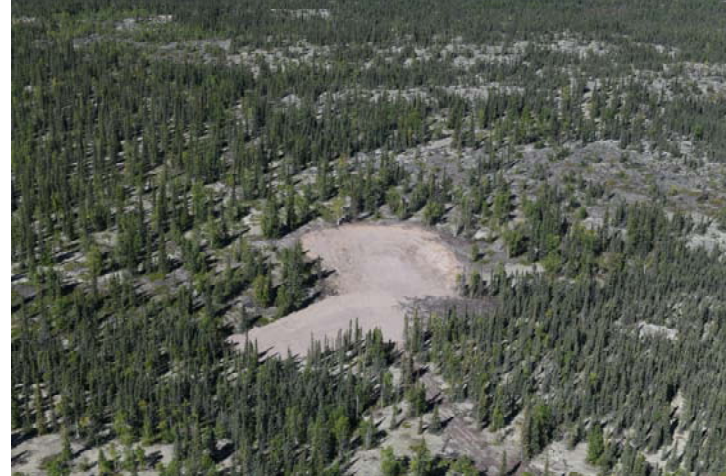
The tailings cover located on Burnt Island appeared to have held up well over the spring freshet as there were no noticeable areas of slumping or concern (Photo #3). The large pile of sand located next to the shaft on Burnt Island will need to be spread out and distributed around the surrounding area prior to the final demobilization from the site (Photo #8).

**Photo #3: Overview of the tailings cover on Burnt Island.**

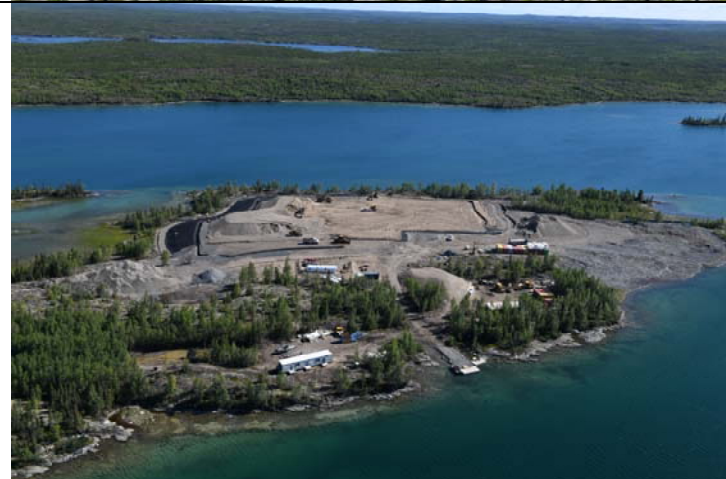
**Photo #4: Overview of the land use activities on Camlaren Island.**

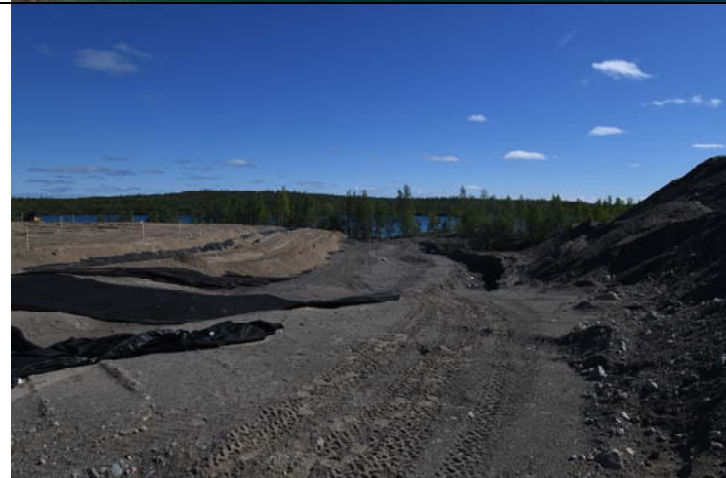
**Photo #5: Overview of the excavation of waste rock at Camlaren.**

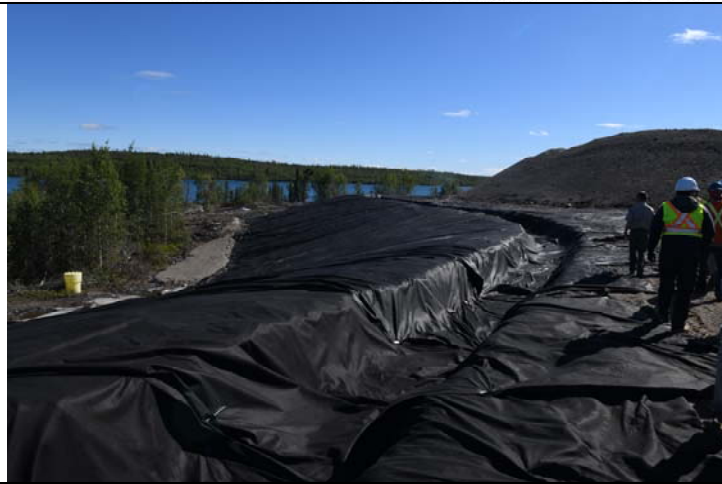
The Inspectors were present during the laying of the geotextile liner and the construction of the ditches and trenches along the perimeter of the tailings and waste rock area on Camlaren Island. The geotextile extended over the diversion ditch and down towards the toe drain that is located between the waste rock and shoreline. The Inspectors were pleased with the attention to detail during the construction as the slope and ditch construction appeared to be done according to the approved 'Tailings and Waste Rock Cover Design Plan'. The next stage of construction will be to complete the ditches/trenches, place another layer quarried material down with a bituminous liner placed on top followed by 0.5 meters of cover.

**Photo #6: Overview of the geotextile liner placed over the diversion trench and down the slope of the cap to the toe drain.**

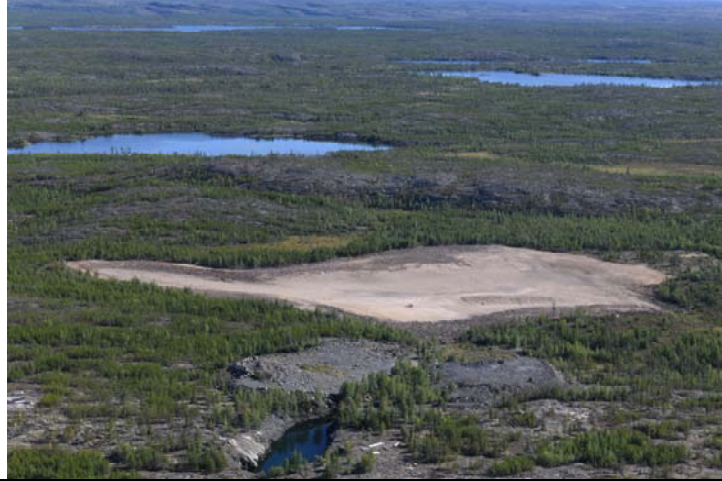
**Photo #7: Overview of the remediated quarry at Westbay Mine site.**

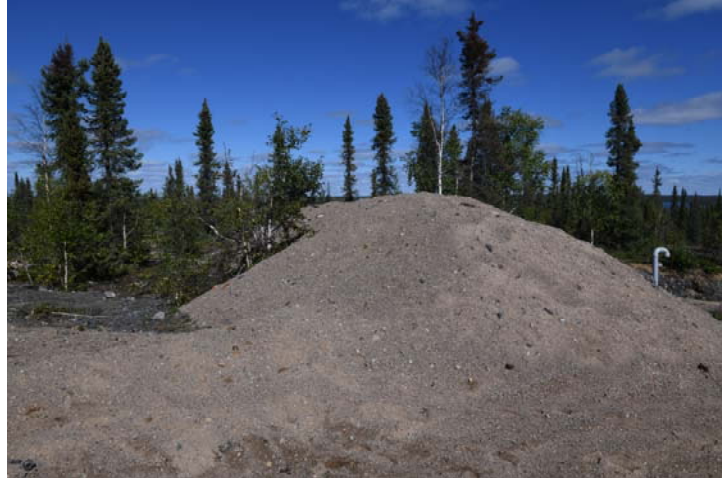
**Photo #8: Remaining stockpile of quarried material near the shaft on Burnt Island.**
