March 21st 2018

INAC – CARD Gordon Lake Remediation Project

RE: Water Licence MV2016L8-0006 – Gordon Lake Project – Inspection

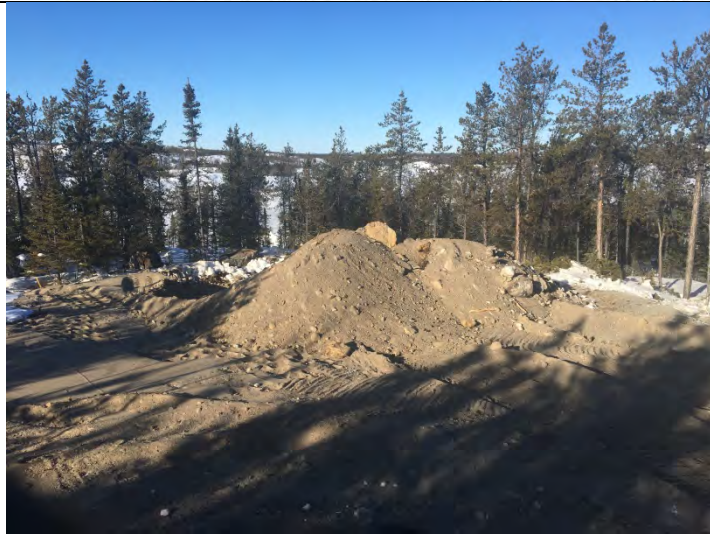
The inspector noted that there were several stockpiles of clay, rock and organics on site. These piles will have to be spread out and displaced evenly ensuring the contour does not allow any ponding of water. (Photo 1 and 2). The inspector noted no concerns with any of the portages or ice roads built to support the project. However, several areas had clay and sediment on the ice on approach to the shore. This material will have to be scraped and removed from the ice. (Photo 3). Contractor had straw rolls to place in the ground close to the shore to catch any sediment that may run towards the lake during freshet. These rolls were not installed at the time of inspection.

Photo #1: Stockpile of clay and rock at Kidney Pond.

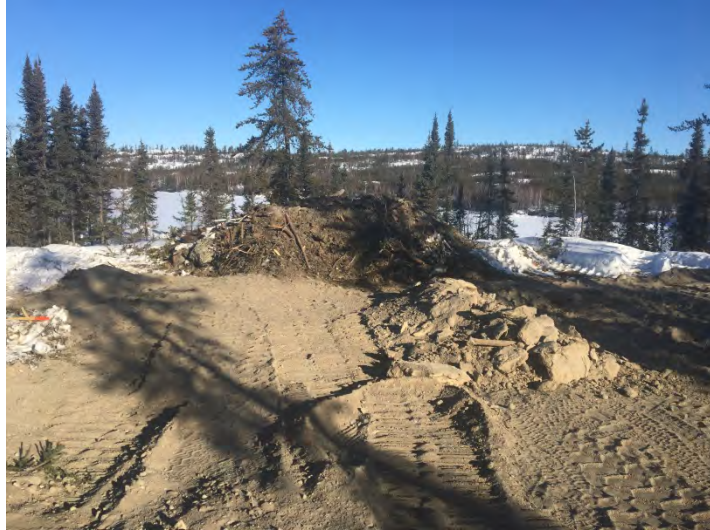
Photo #2: Pile of organic material at Kidney Pond

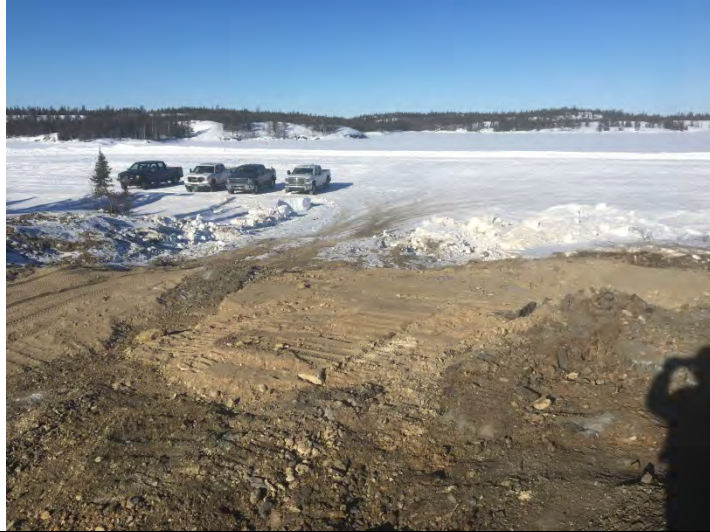
Photo #3: Overview of shoreline approach at Kidney pond.

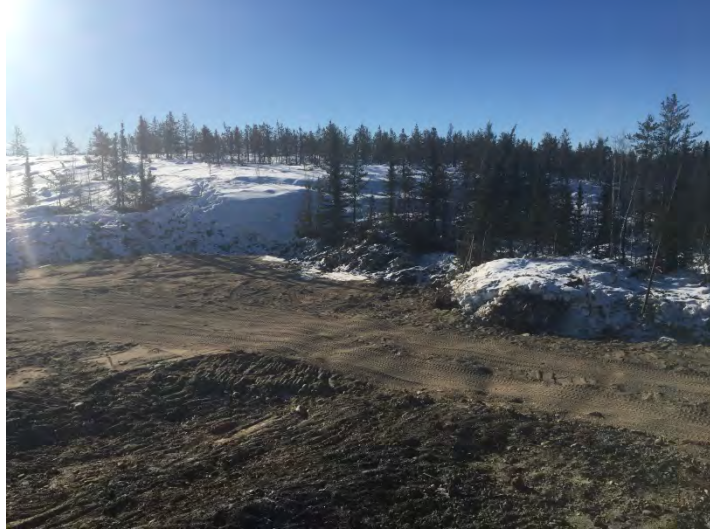
Photo #4: Overview of Treacy and excavation.

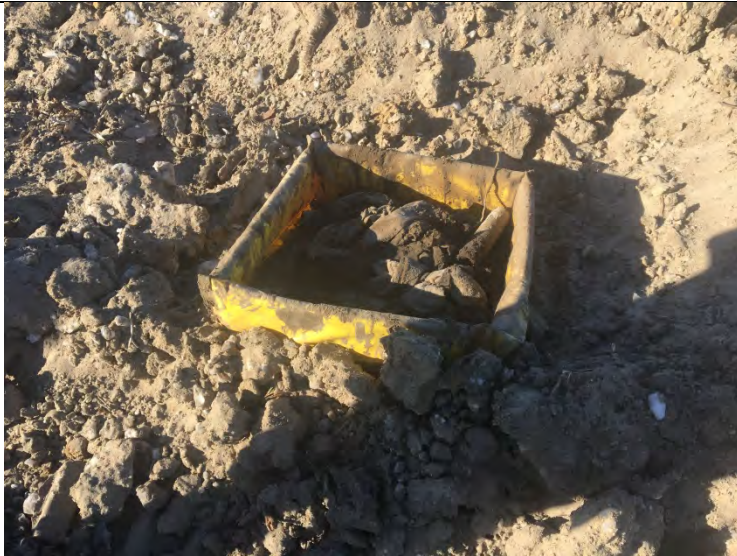
Photo #5: Spill pad at West Bay with contaminants sitting between two pieces of equipment with no drip tray.

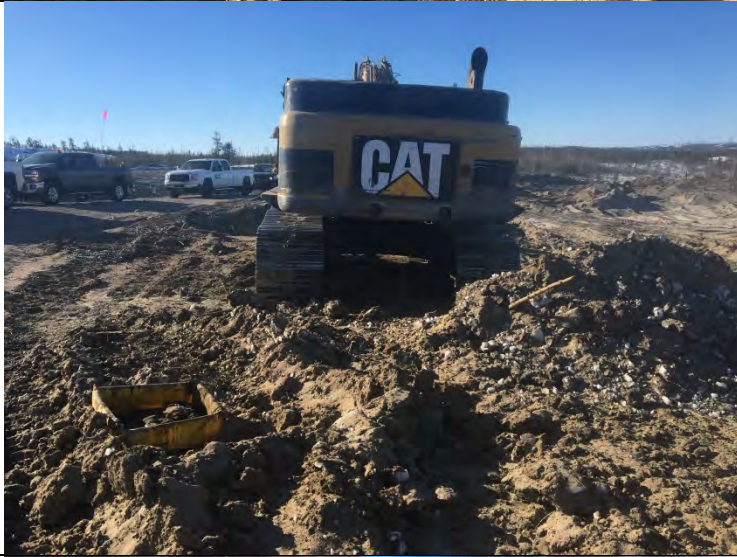
The Inspector noted some concerns with the heavy equipment parked at est bay. There were two CATs parked without drip trays and one of them had leaked Hydraulic oil over the ground. This Material was scraped up and taken to the TCA at Camlaren.(Photo's 6&7)

Photo #6: CAT with no Drip tray underneath.

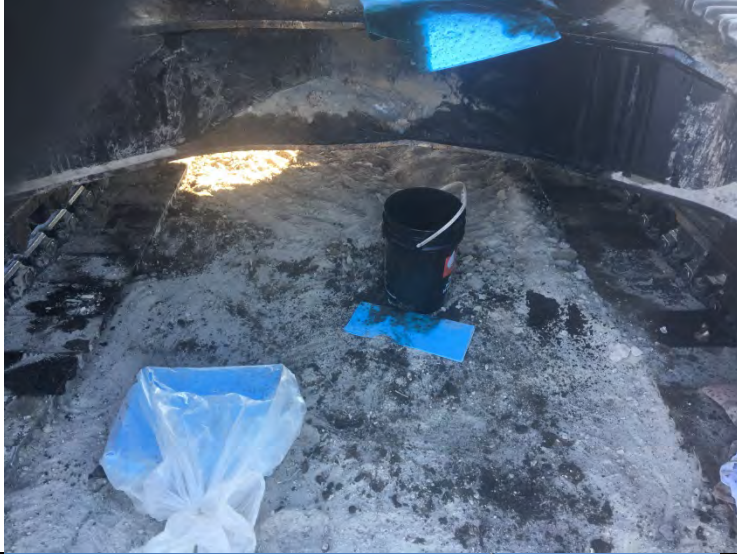
Photo #7: Spill of Hydraulic oil leaking on the ground and around the CAT at Westbay.

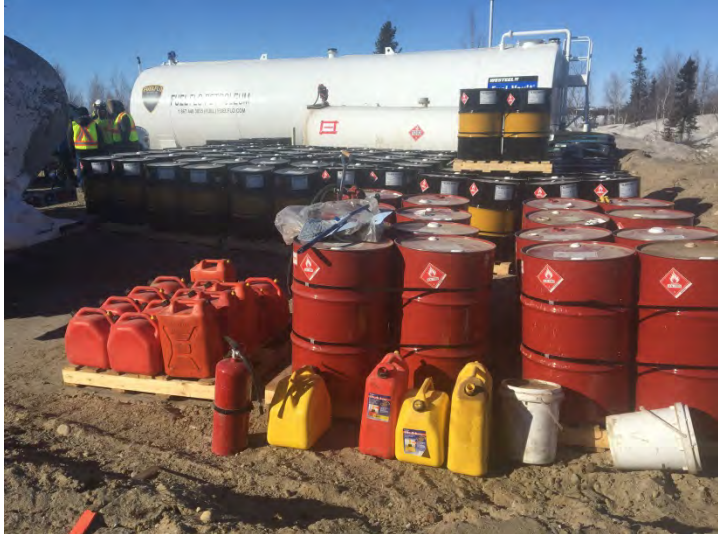
The fuel at Camlaren was all stored within the bermed area (Photo 8). There were 50 drums of premium gasoline 16 drums of regular gasoline and 108 drums of Jet A fuel, for their helicopter work in the summer. The Fuel was stored standing up and site representatives requested that the Inspector approve the fuel to remain standing on the pallets that they were transported on. The Inspector agreed with this provided the fuel remains in the secondary containment area. The inspector noted that the fuel truck had a small leak on the underside. Some staining was present under the truck.(Photo 10). The inspector requested that this leak be fixed prior to this truck being used to transport fuel.

Photo #8: Fuel Berm at Camlaren mine containing 50 drums of premium gasoline. 16 drums of regular gasoline. 108 drums of Jet A fuel, for helicopter work in the summer

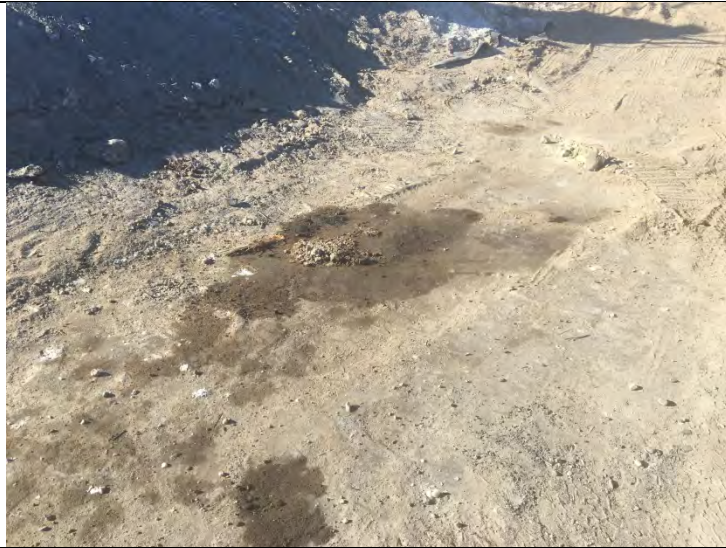
Some stains were noted behind the fuel berm where equipment maintenance was being done. (Photo 9). The inspector requested that the contaminated soil be scraped and placed in the TCA.

Photo #9: Fuel stains behind the fuel berm at Camlaren.

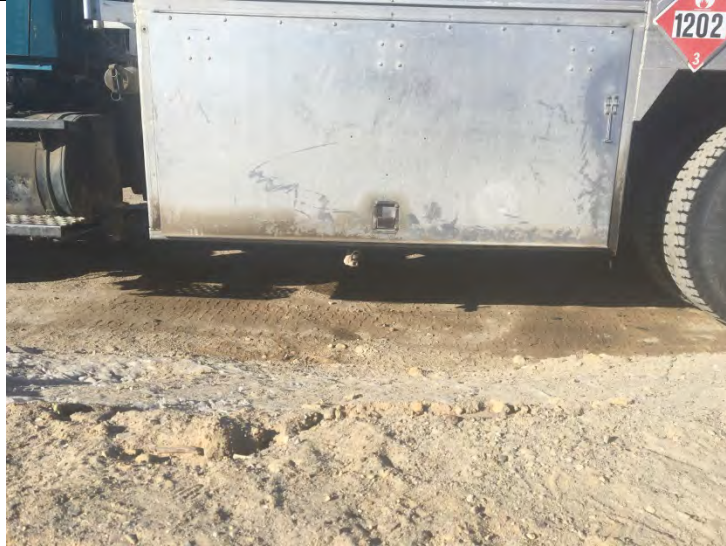
Photo #10: Fuel Truck with a small leak resulting in staining of coil underneath.
