**Re: Land Use Permit MV2016X0011
Miscellaneous
Tundra Mine Site, NT**

ENVIRONMENTAL INSPECTION REPORT

Permittee:	DIAND – CARD	Inspection Date – February 7 th , 2017
------------	--------------	---

Location(s) Inspected:	Winter Road.
------------------------	--------------

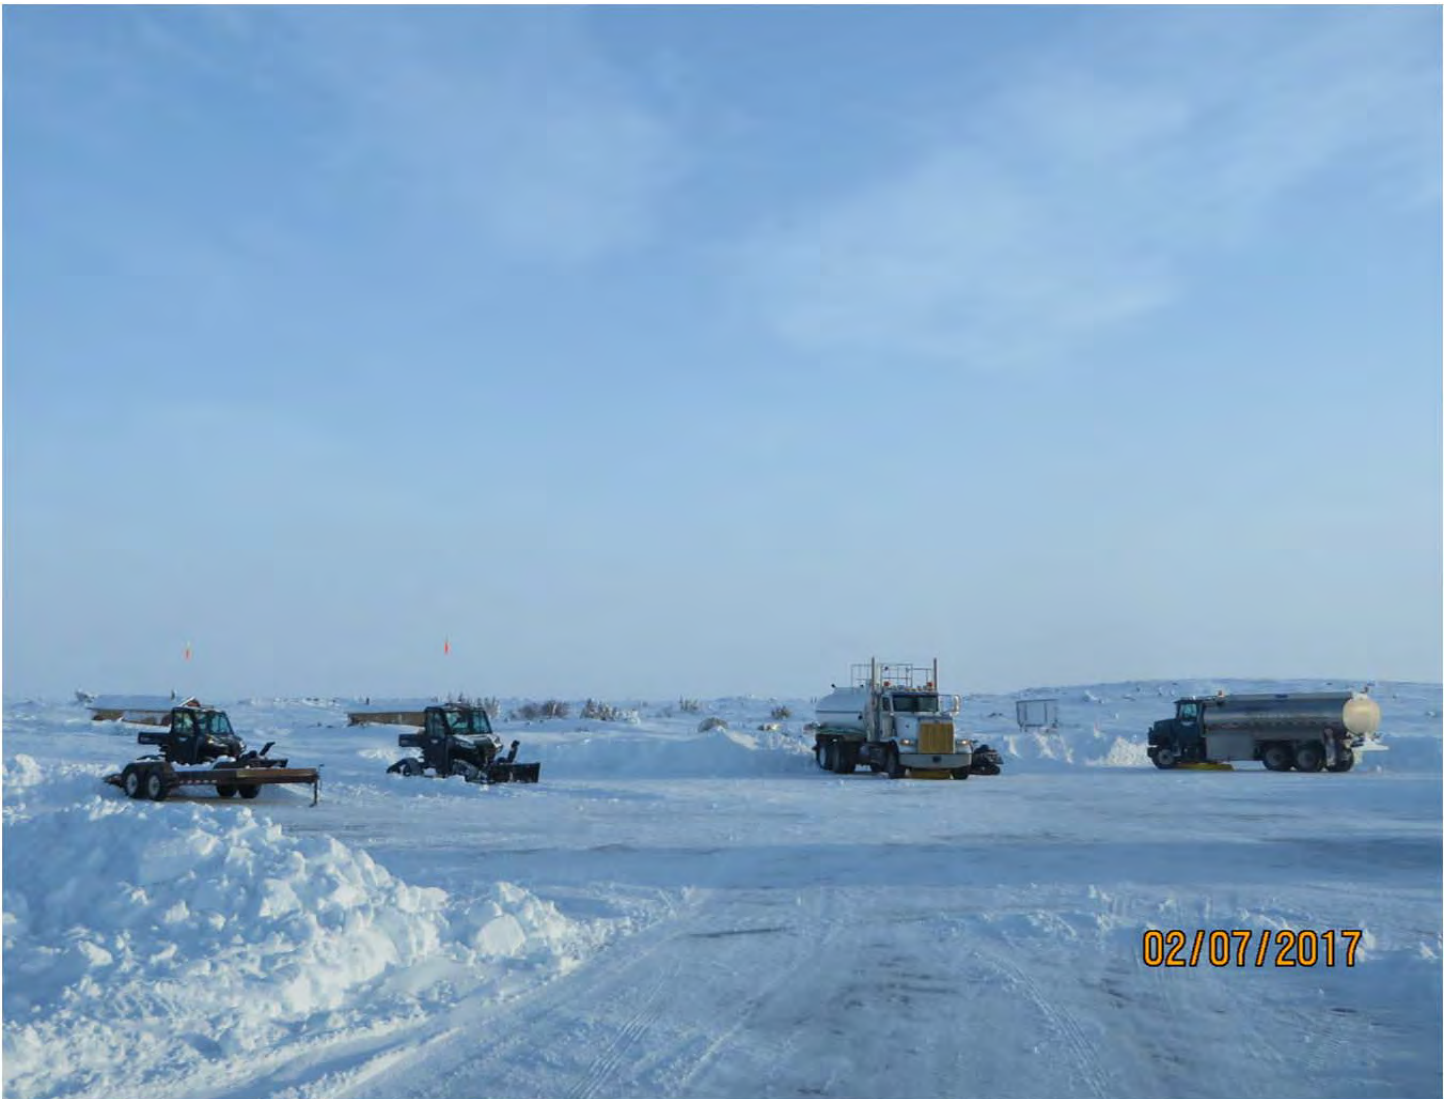
Photo #1 - MV2016X0011 - INAC-CARD - Tundra
Equipment staged on the east side of Mackay Lake for the construction of the winter road to Tundra Mine.

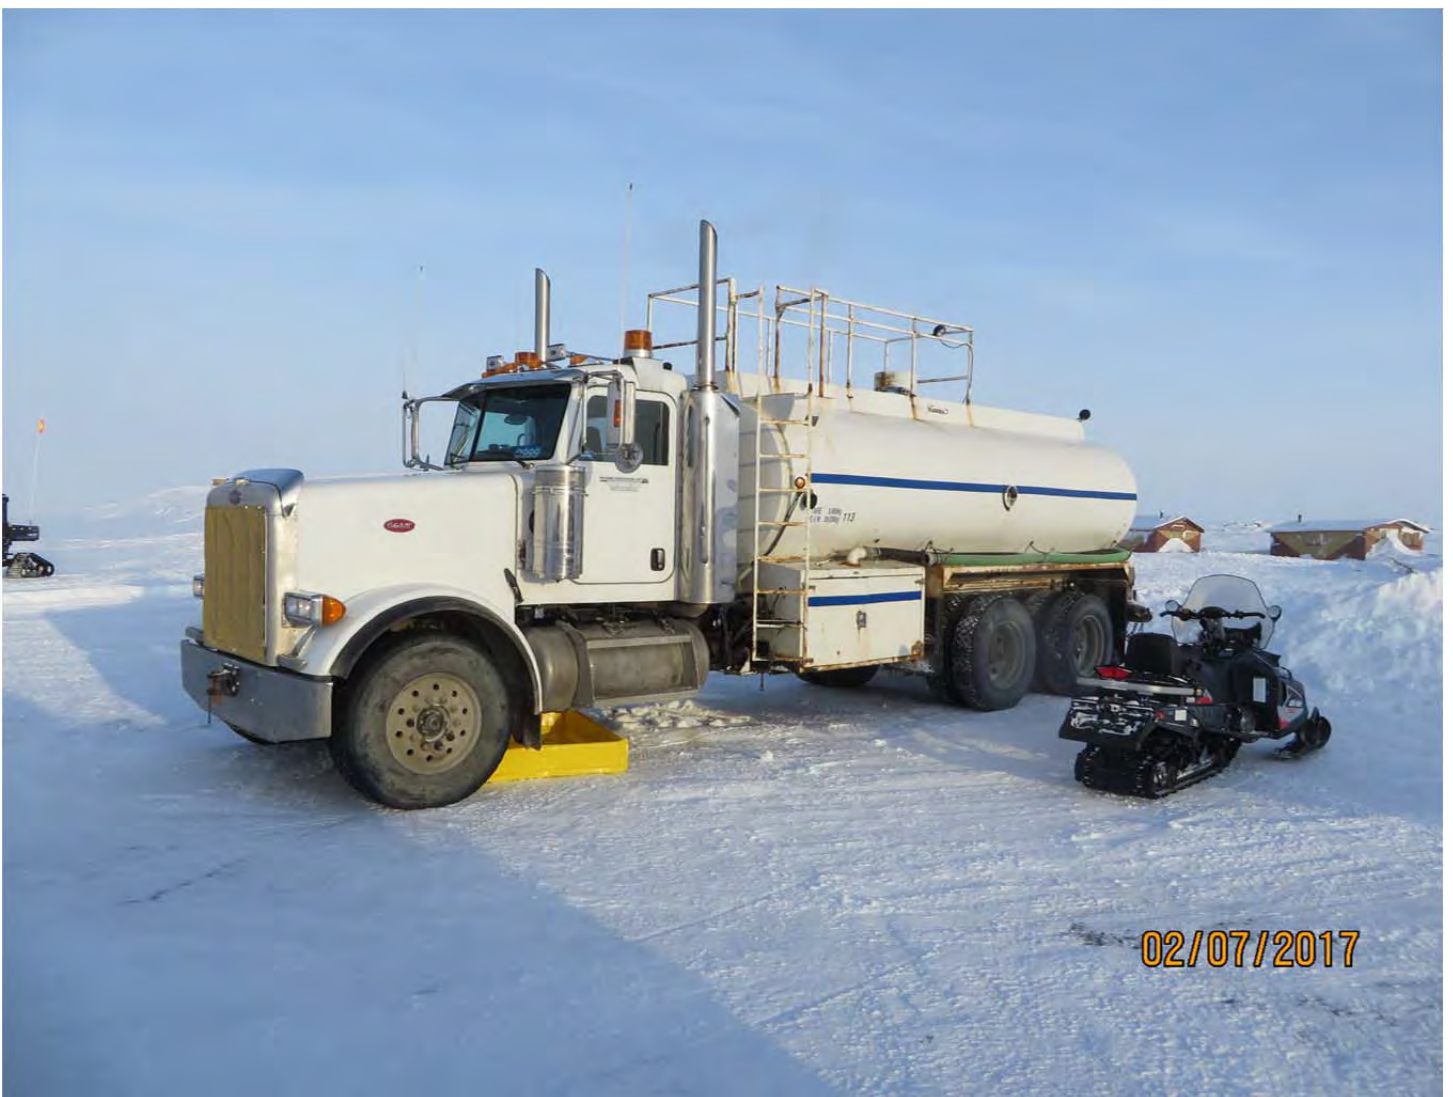
Photo #2 - MV2016X0011 - INAC-CARD - Tundra
Parked water truck with secondary containment below it.

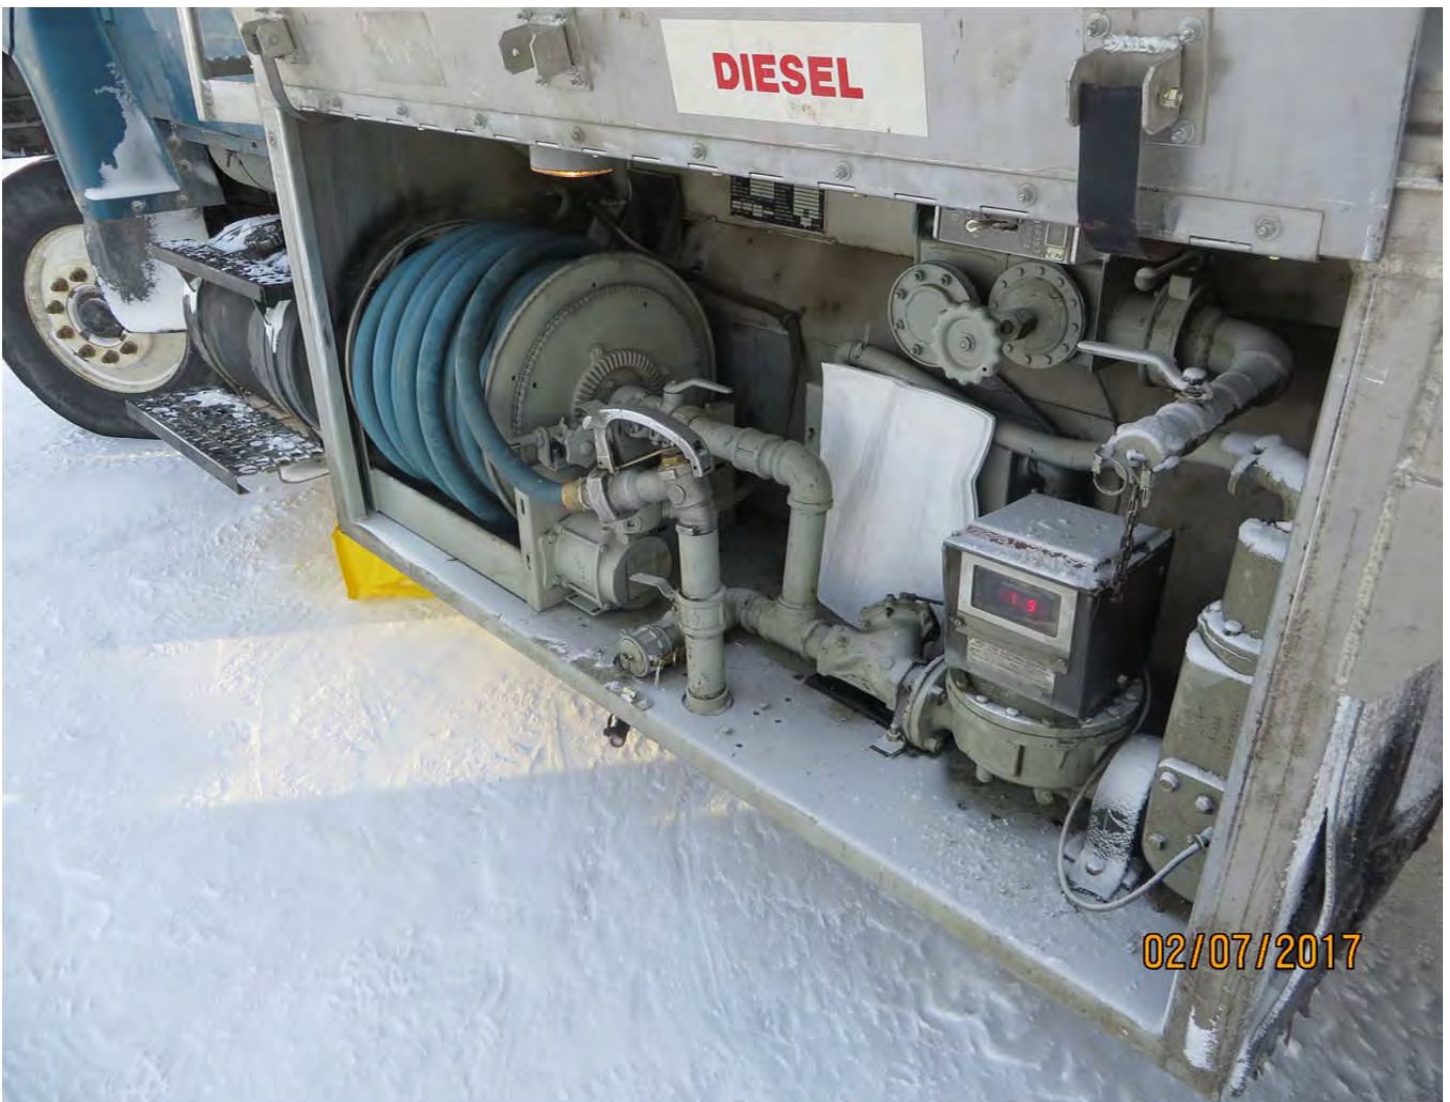
Photo #3 - MV2016X0011 - INAC-CARD - Tundra
No obvious hydrocarbon leaks or spills were observed in the dispensing compartment of the fuel truck.

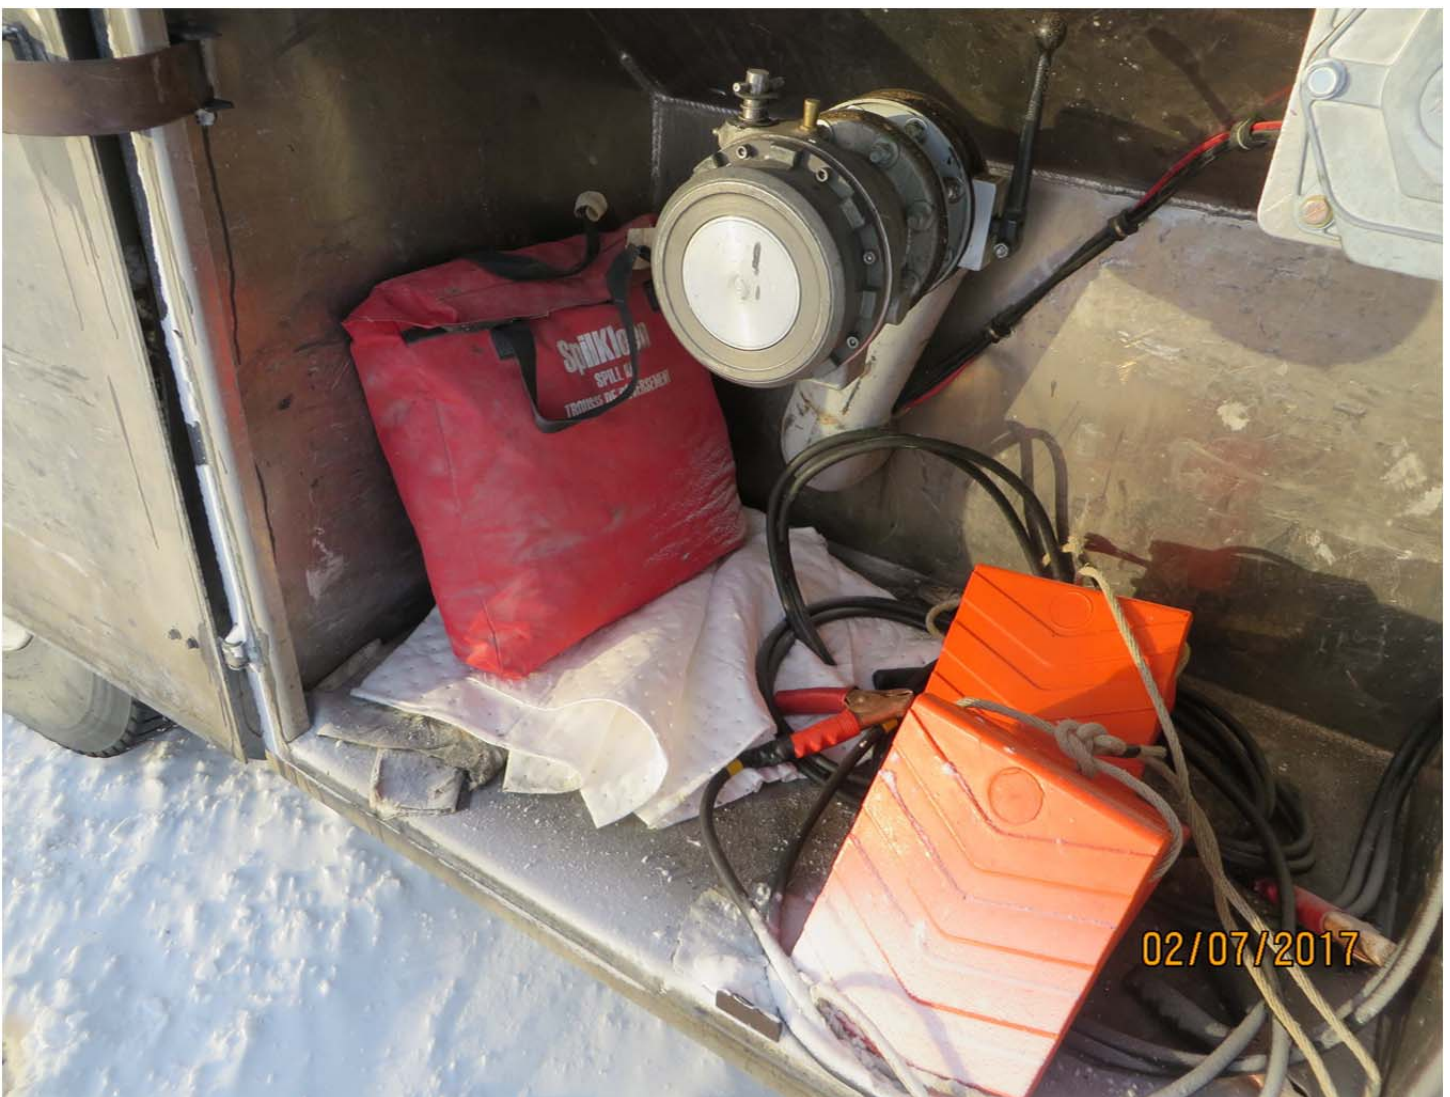
Photo #4 - MV2016X0011 - INAC-CARD - Tundra
Small spill kit was present in one of the compartments of the fuel truck.
