**Re: Land Use Permit MV2016X0011  
Miscellaneous  
Tundra Mine Site, NT**

## ENVIRONMENTAL INSPECTION REPORT

Location(s) Inspected:	The winter road from Mackay Lake to Tundra Mine.
------------------------	--

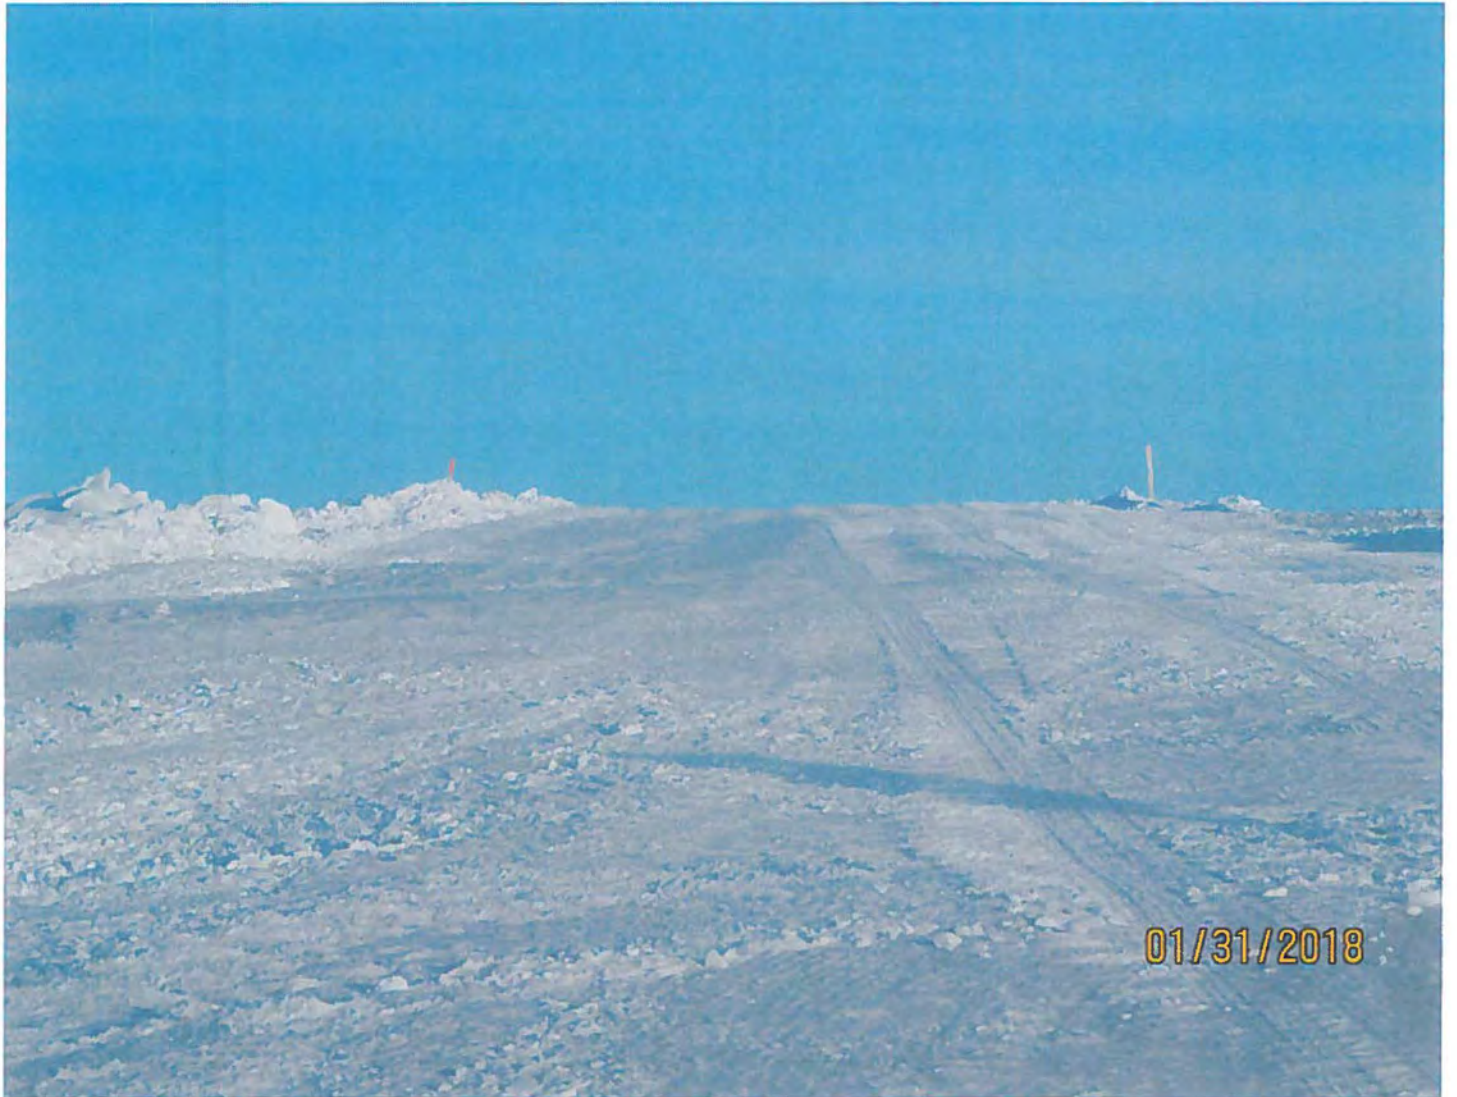
Photo #1 - MV2016X0011 - INAC-CARD - Tundra Mine  
Looking north at the first portage off of Mackay Lake.

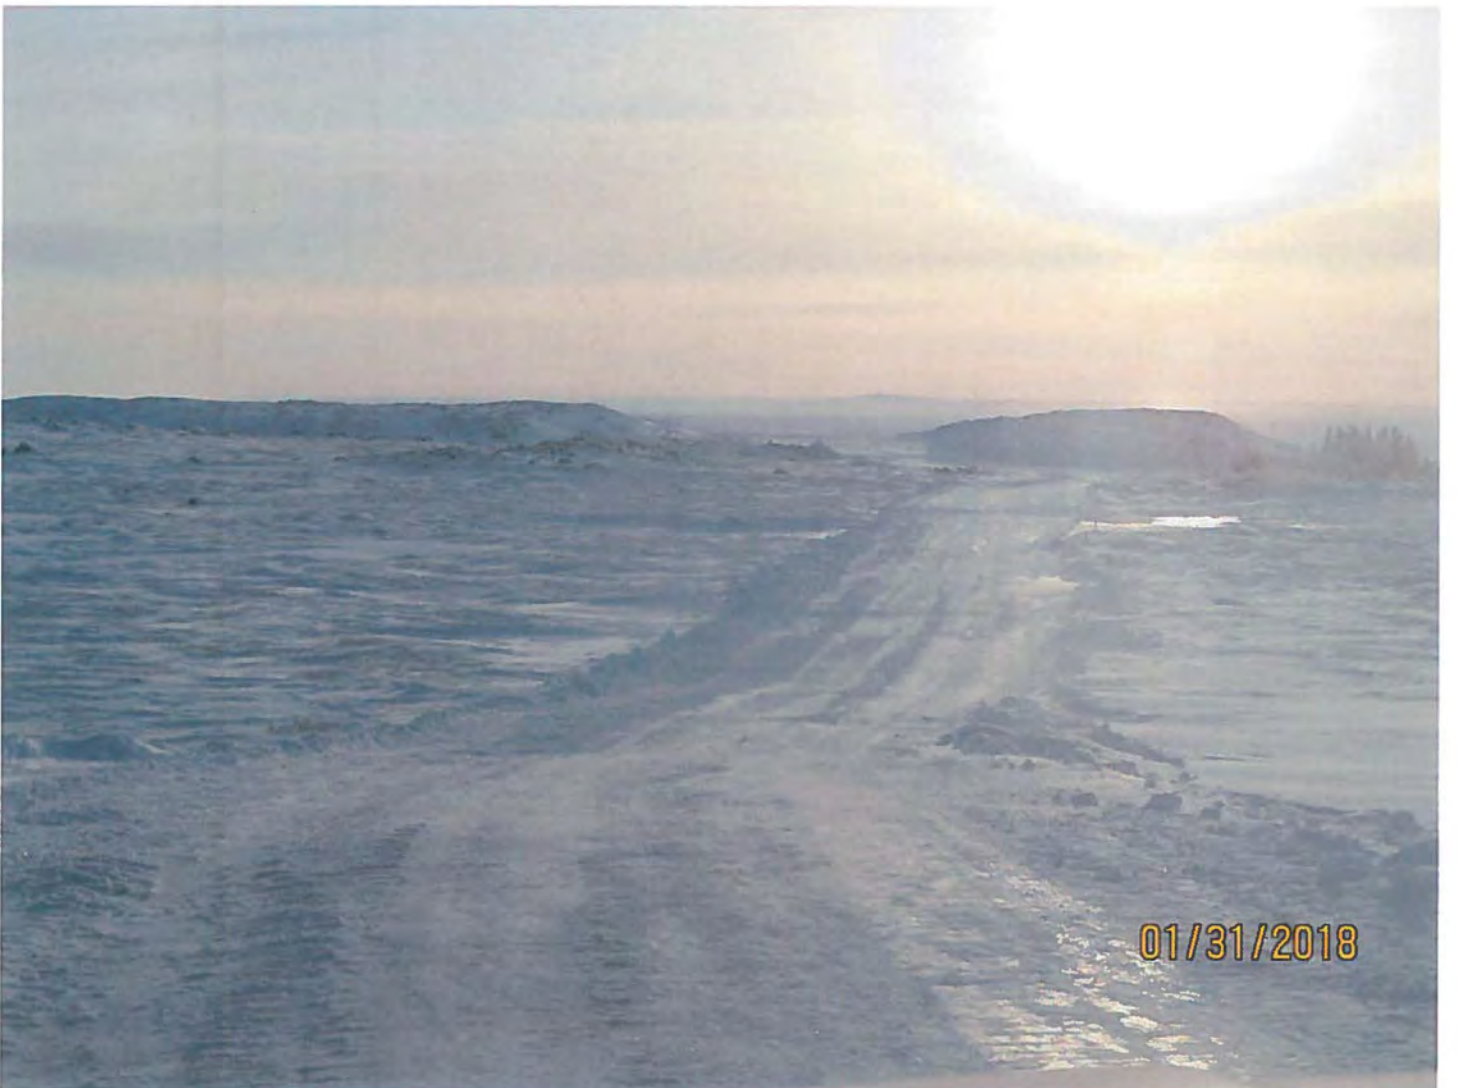
Photo #2 - MV2016X0011 - INAC-CARD - Tundra Mine  
Looking south at the first portage with Mackay Lake in the background.

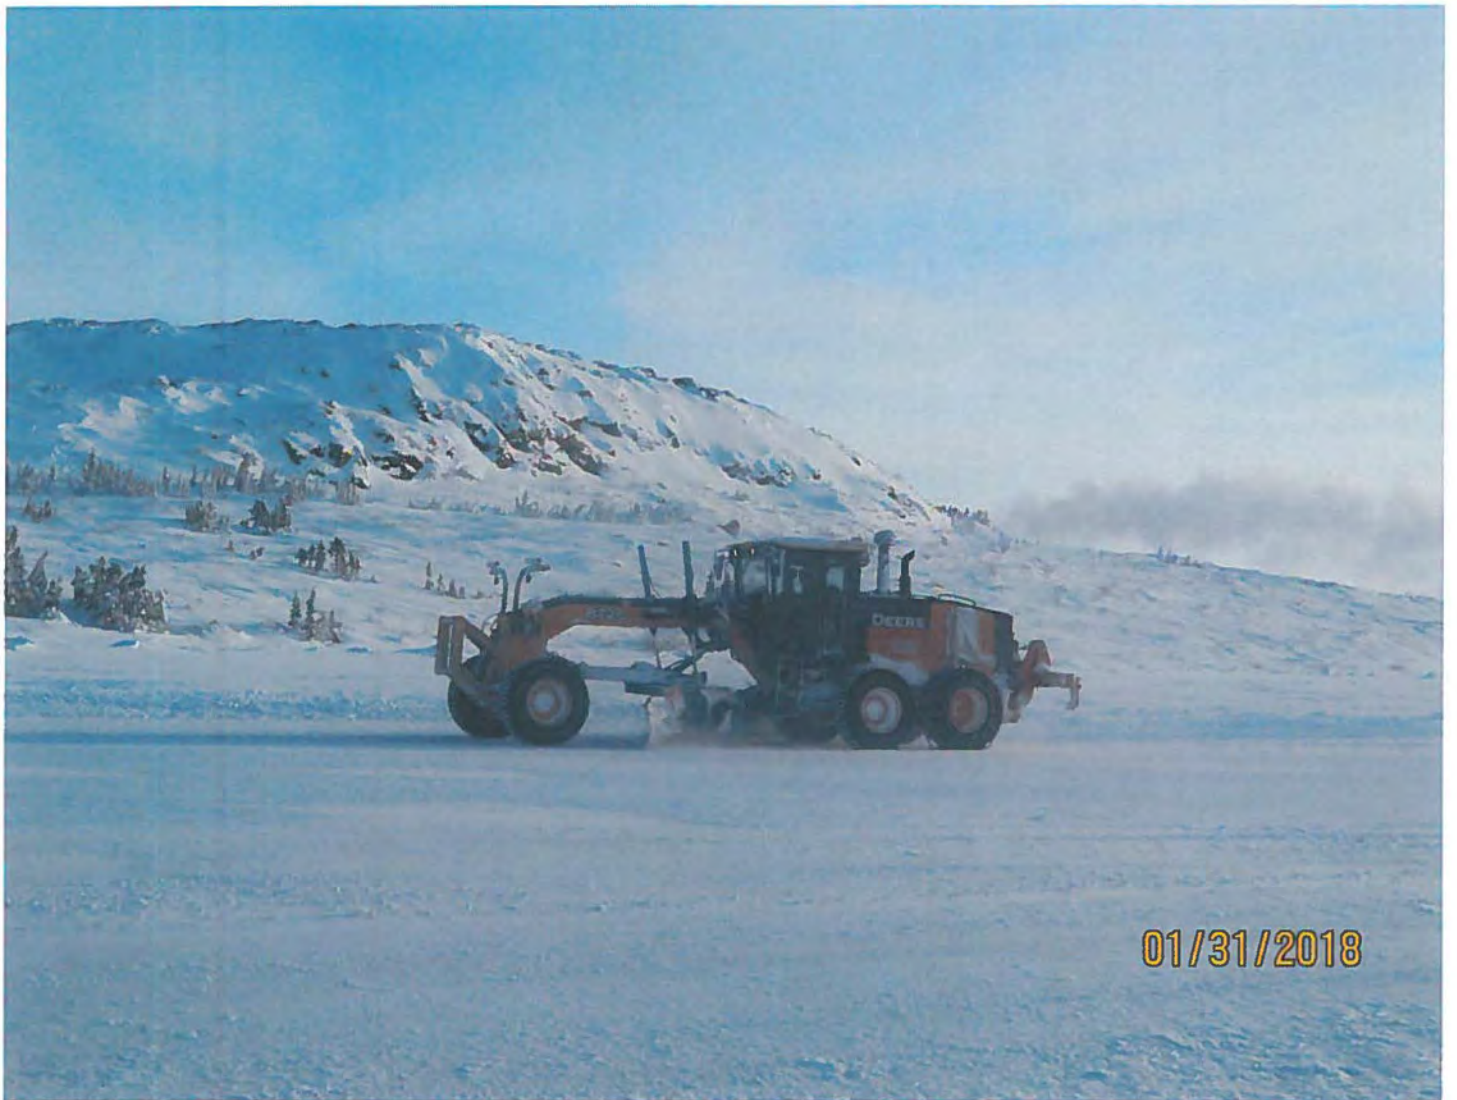
Photo #3 - MV2016X0011 - INAC-CARD - Tundra Mine  
Grader working on the ice surface of Mackay Lake.

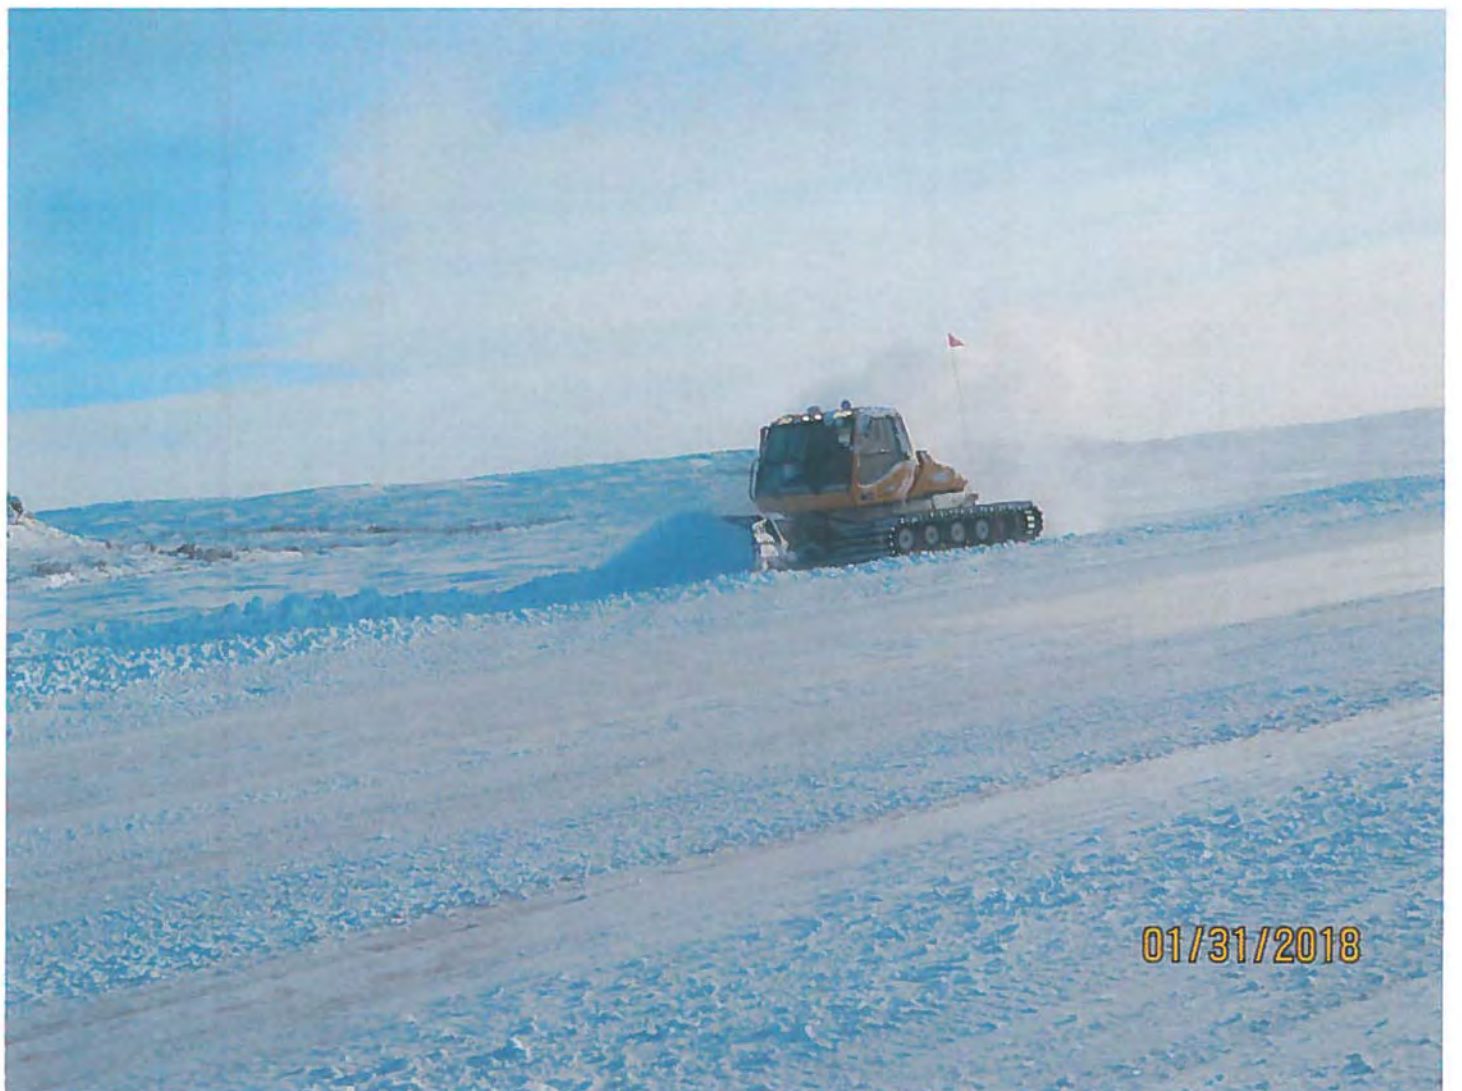
Photo #4 - MV2016X0011 - INAC-CARD - Tundra Mine  
Snowcat actively knocking down the windrows on the ice surface of Mackay Lake.
