**RE: Land Use Permit MV2016X0011 – Tundra Mine Remediation Project – Inspection**

**ENVIRONMENTAL INSPECTION REPORT (MV2016X0011)**

Land Use Permit No.	MV2016X0011		
Quarrying Permit No.	2016QP0005		
Contractor:	Nahanni Construction /Delta Engineering	Subcontractor:

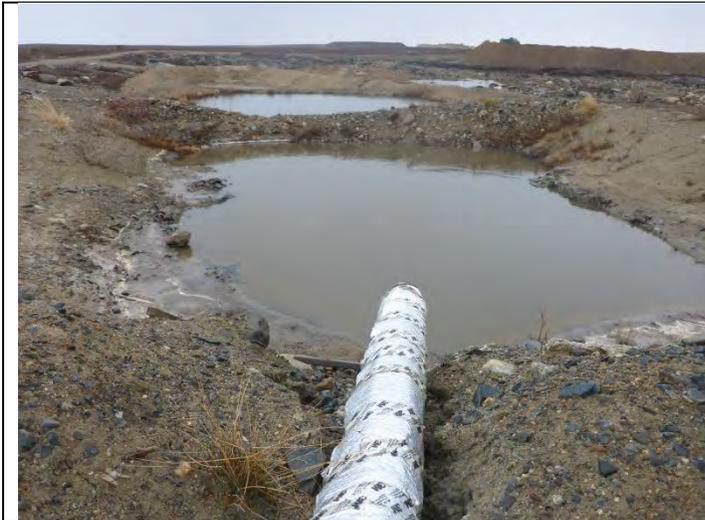
**Photo #1: Overview of the three cell sewage system.**

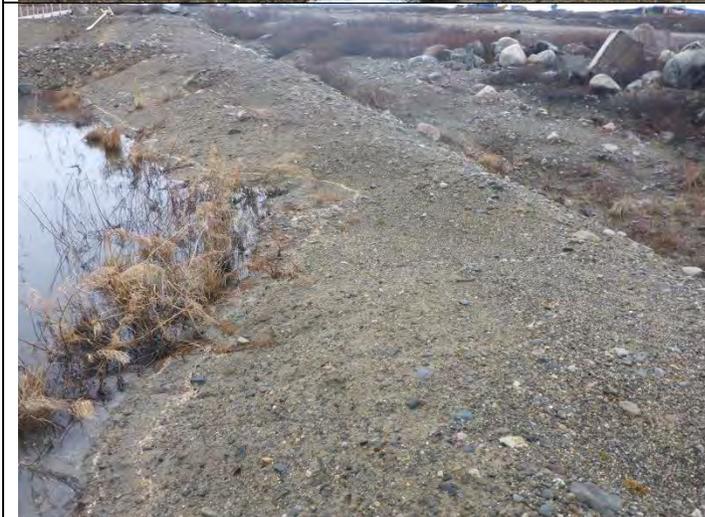
The remediation project was fully operational at the time of the inspection. There were an estimated 40-45 people onsite and multiple activities taking place such as active quarrying, water treatment plant setup, road maintenance, surveying, and water sampling. The Inspector noted that the three cell sewage system had a significant amount of water within all three cells (Photo #1). The amount of water within the cells was caused by the recent freshet and precipitation in the area. The Inspector noted that the levels in each cell were decreasing and did not have any concerns with the amount of freeboard remaining in the cells.

**Photo #2: Close up of the second cell of the sewage system. Note that the level in the cell was dropping at the time of the inspection.**

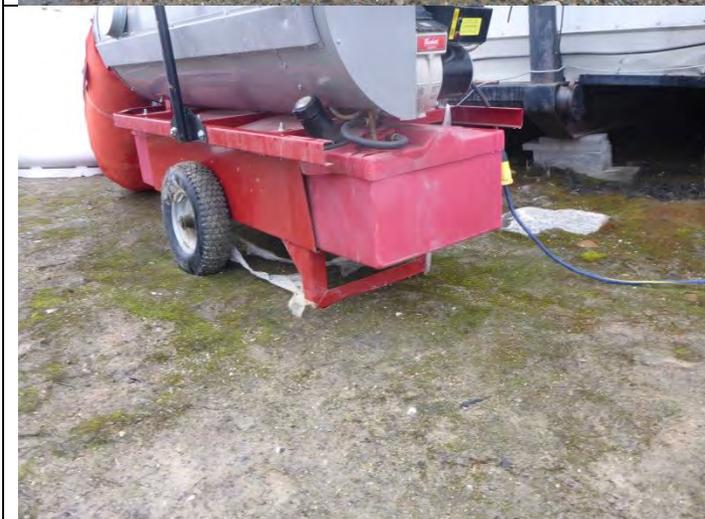
The majority of the equipment around the site that was sitting for at least two hours had drip trays placed under them as required by condition #54 of the land use permit. There were however a few pieces of equipment that did not have any drip trays under them (Photo #3). Site personnel should place drip trays under the remaining equipment to ensure that no hydrocarbon spills occur from the equipment. The staining identified during the February 23<sup>rd</sup> 2017 inspection on the fuel tank that is connected to the camp facilities had been cleaned up and no other concerns were noted with the tank (Photo #4).

**Photo #3: Frost fighter located onsite without a drip tray.**

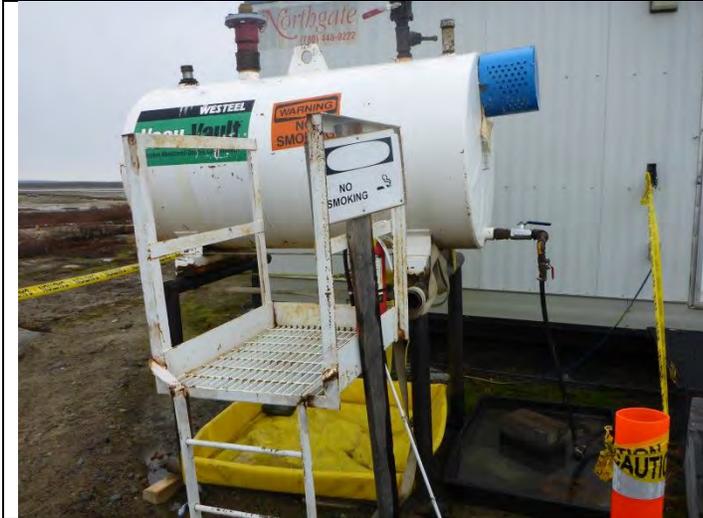
Photo #4: Camp fuel tank, no issues noted.

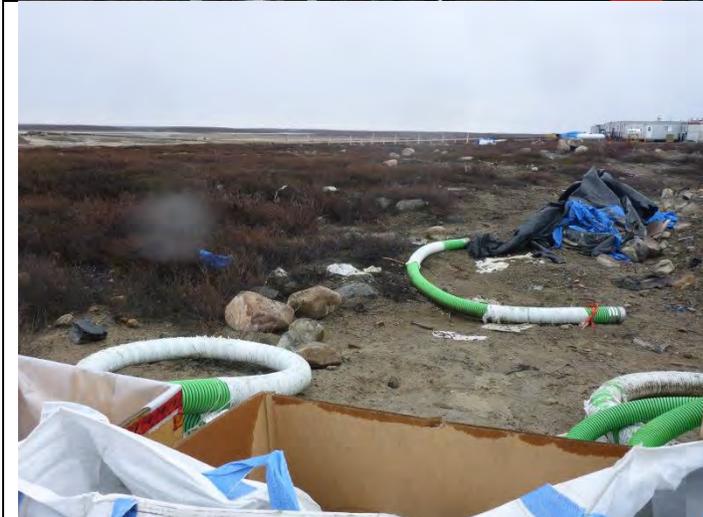
The Inspector noted that there was a large amount of refuse and garbage near the camp that was not stored properly as required by condition #40 of the land use permit (Photo #5). This garbage must be removed and placed within proper containment until it can be dealt with in accordance with the approved waste management plan.

Note #5: Garbage and other debris blowing out onto the tundra.

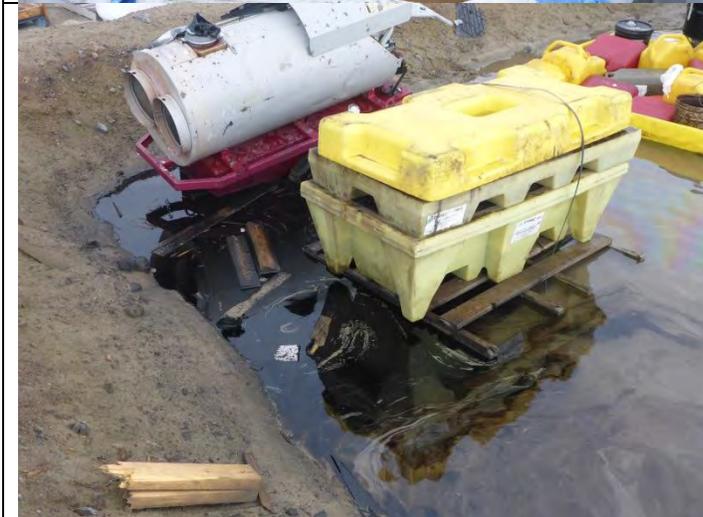
The standing water within the hazardous waste storage area appeared to have a very thick layer of hydrocarbons on top of the standing water (Photo #6). This water will need to be treated and removed from the hazardous waste storage area and the source of the spill identified and repaired. No further access by vehicles in this area should take place until the water is removed. This will avoid spreading the hydrocarbons to the surrounding environment around the storage area. The Inspector noted that there were some larger hydrocarbon stains located near the equipment laydown yard (Photo #7). This contaminated material will need to be removed and disposed of in accordance with the waste management plan.

Photo #6: Thick hydrocarbons floating on the water within the hazardous waste laydown area.

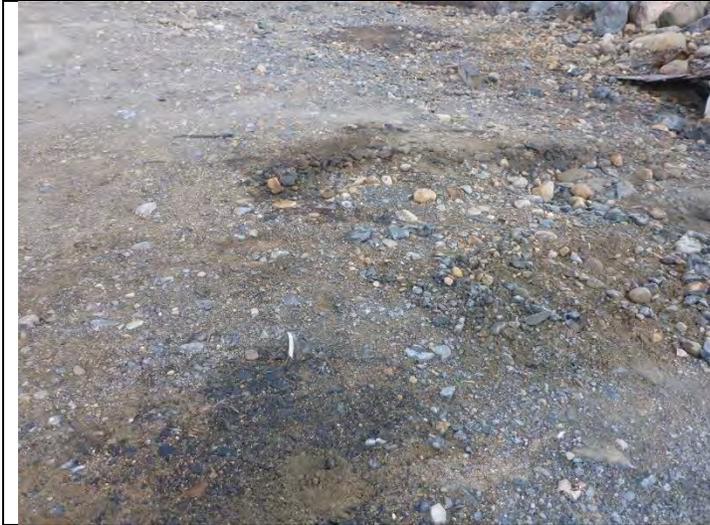
**Photo #7: Hydrocarbon staining around the equipment staging and laydown area.**

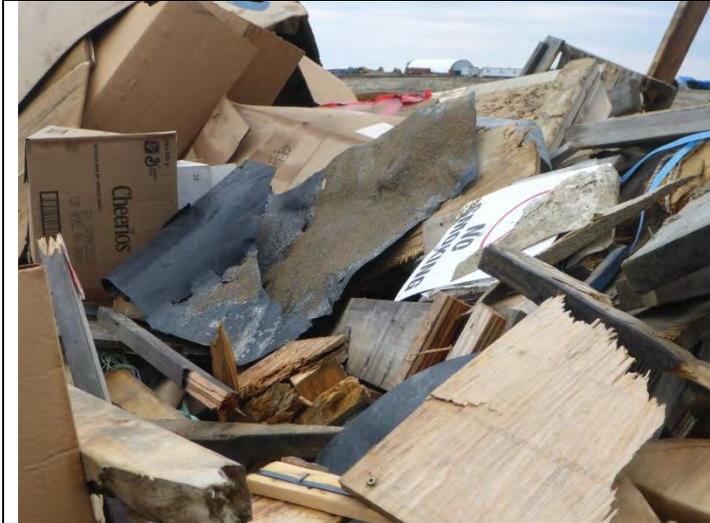
There was a large pile of material that was being prepped for opening burning (Photo #8). The Inspector discovered some non-burnable materials within the pile such as liner, plastic, and what appeared to be Teflon runners. These materials will need to be removed before the material can be incinerated.

**Photo #8: Non burnable refuse placed within the burning pile.**

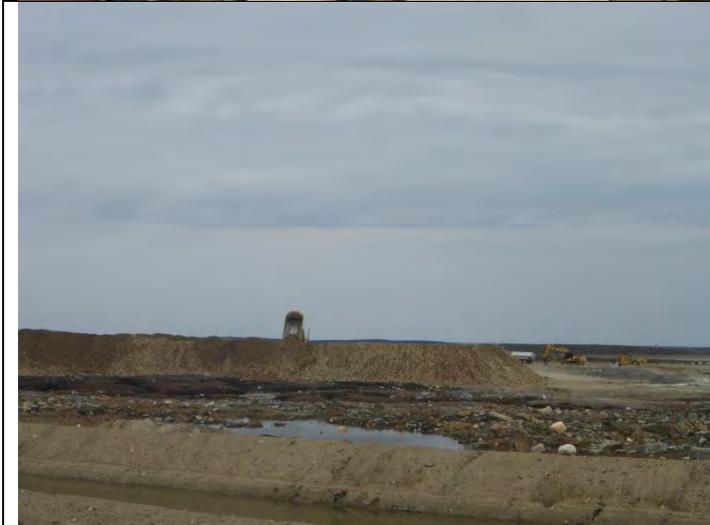
**Photo #9: Overview of the stock piling of quarried material located north of the camp facilities.**

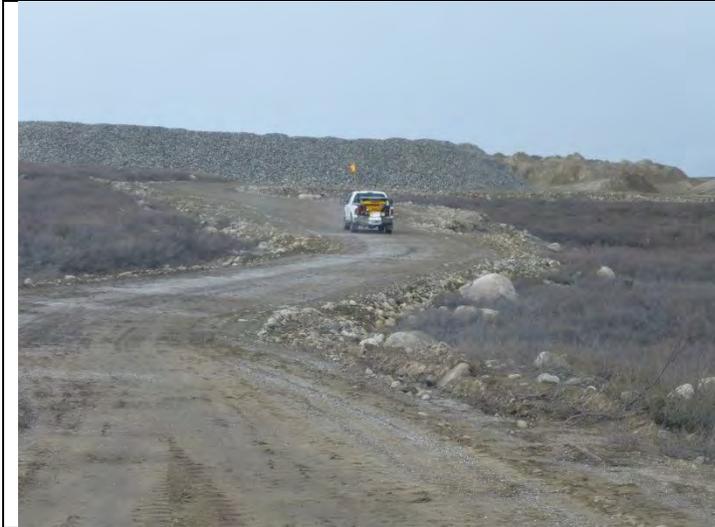
**Photo #10: Site personnel spreading sodium chloride to help control dust around the site.**

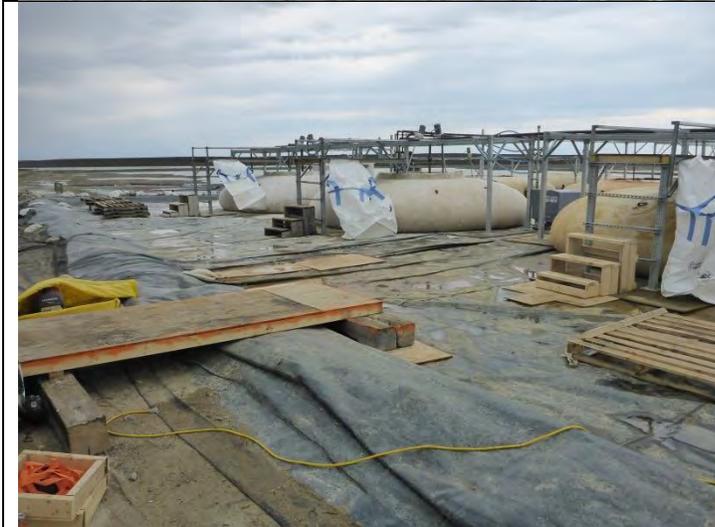
The water treatment plant was setup onsite however it was not operational or discharging at the time of the inspection (Photo #11). The Inspector was informed that site personnel were waiting for some replacement parts and results from the recent water samples to be received before they can commission the plant. The water level in the lower pond was lower than previous years and site personnel estimate that it will take between 10 to 14 days to complete the treatment and discharge. The Inspector requests that the pre-sample results are submitted to the Inspector at least 48 hours prior to discharge.

**Photo #11: Overview of the water treatment plant. Note that the plant was not operational at the time of the inspection.**

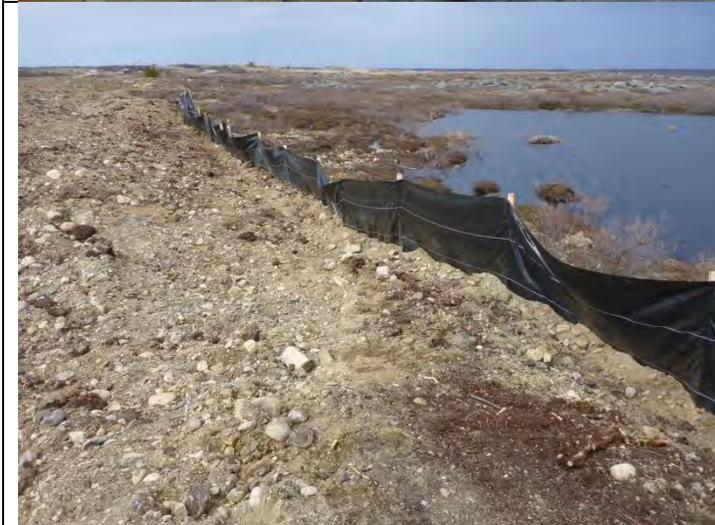
The Inspector discovered that the A3 pit had been quarried to an estimated 3 meters from the OHWM of an unnamed waterbody (Photo #12). This distance was not authorized by the Inspector and is in contravention of condition #4 of the land use permit. The A3 quarry appeared to already have been remediated and all organics have been pulled back over the area. No further quarrying can take place within the A3 quarry until a proper survey is conducted to ensure that no further encroachments into the authorized buffer takes place.

**Photo #12: Overview of the A3 quarry and its proximity to the nearby waterbody.**

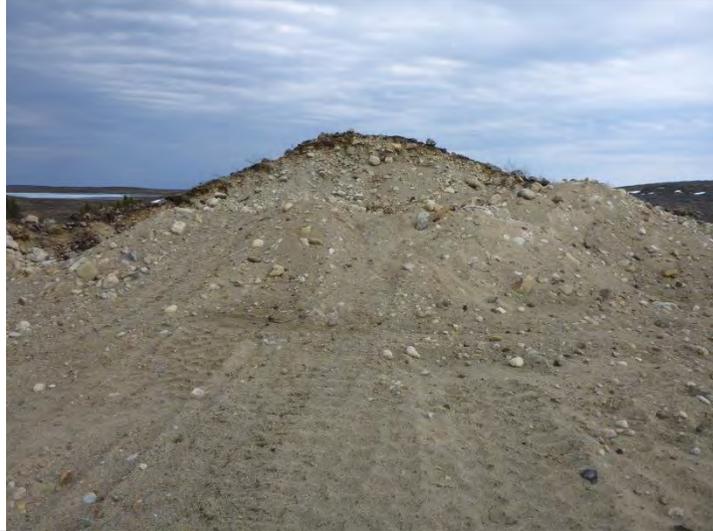
**Photo #13: Overview of the A1 esker quarry.**

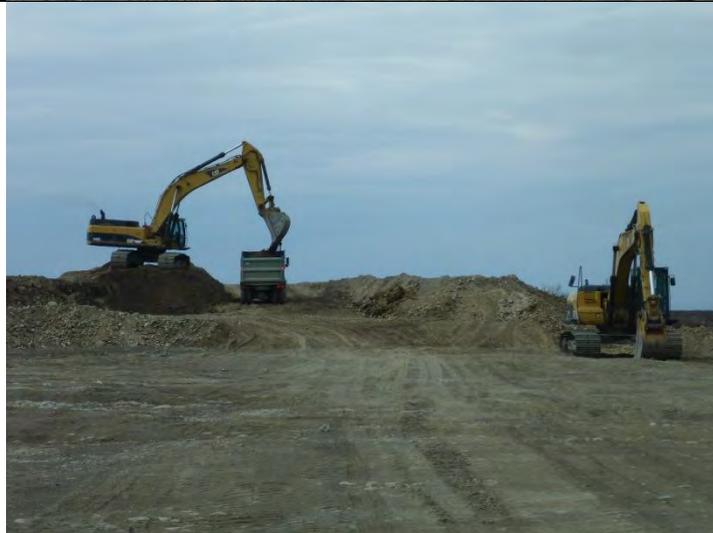
A large scale quarrying operation was taking place at the time of the inspection. There was a large stock pile of material located north of the camp (Photo #9) which was being removed from the A2 quarry (Photo #14). There were no concerns noted with the operations at the West Lower Pond or A2 quarries as they appeared to be well managed and within the approved areas. The Inspector recommends that a survey be completed at the A1 quarry located to the southeast of the airstrip to ensure the operation does not encroach into the authorized setback or cross into GNWT lands.

**Photo #14: Overview of the quarrying operation at the A2 quarry near the airstrip.**
