RE: Land Use Permit MV2016X0011 – Tundra Mine Remediation Project – Inspection

INSPECTION DATE – February 23rd 2017

ENVIRONMENTAL INSPECTION REPORT (MV2016X0011)

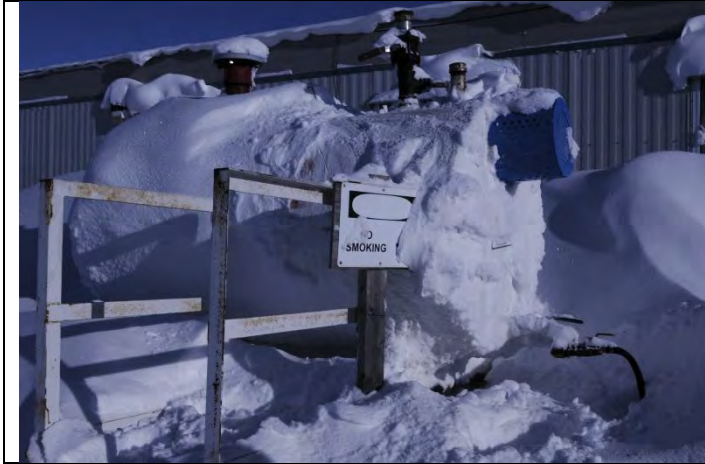
Photo #1: Photo of Fuel tank for camp with fuel stains on the side of the tank and on the bottom. This snow must be removed and placed in proper containment.

The Inspectors expect that all hydrocarbon spills are immediately addressed and that the contaminated snow/soil be removed and stored according to the approved management plans. The Inspectors also want to stress the importance of ensuring that there are a minimum of 10 cm's of firm ice/snow pack as required in condition #12 of the land use permit which is designed to protect the tundra and vegetation below the cover.

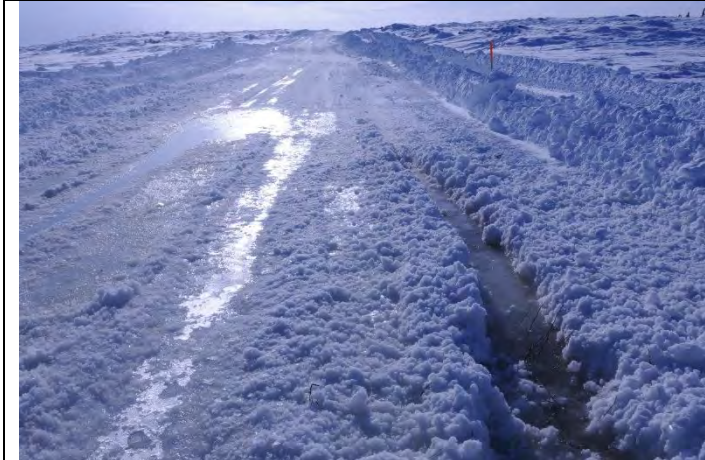
At the time of the inspection Nahanni Construction / Delta Engineering was constructing the road that connects the Tundra Project to the JV winter road. The federal portion of the winter road started at Portage #3 (Photo #2). The Inspectors noted that both portages on federal lands were very soft on the shoulders and appeared to not have the required 10 cm of ice/snow thickness required by condition #12 of the land use permit (Photos #2, 3, 4, & 5). The Inspectors did note that the center of the portages did in fact have the required snow/ice cover and were not as soft as the shoulders. The Inspectors expressed their concern with the state of the road and that they thought that rutting may occur in contravention of conditions #20 & #21 of the land use permit. The Inspectors explained their concerns with Mr. Brostschi and stated that no heavy loads should pass over these two portages until they freeze and firm up.

Photo #2: A view of portage 3 showing soft shoulders.

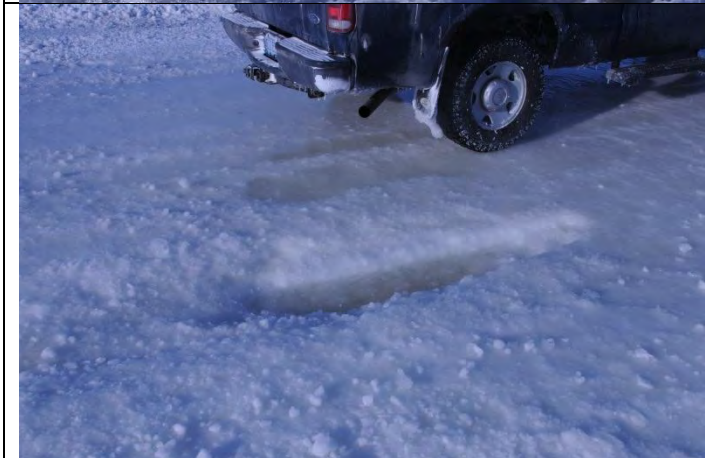
Photo #3: Portage #2 showing large deep holes.

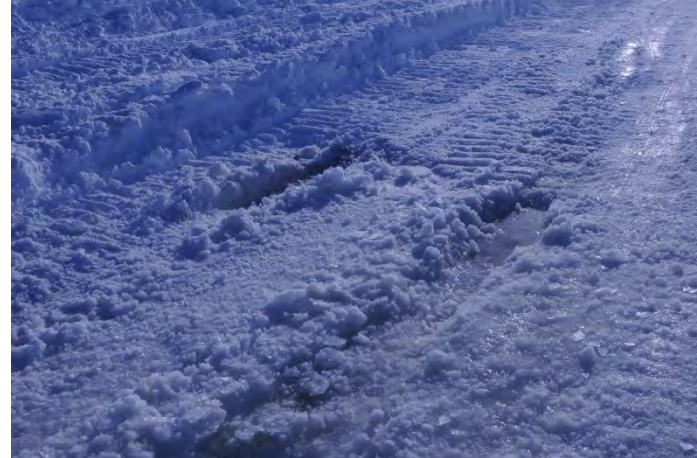
Photo #4: Portage #2 showing very soft shoulders.

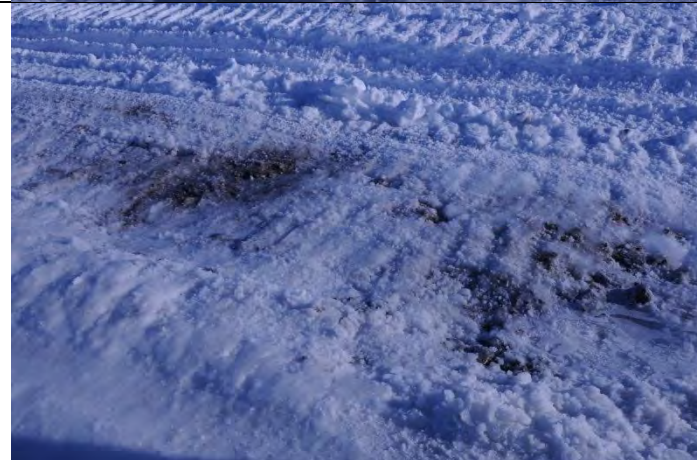
Note #5: Portage #1 showing limited snow cover on the ice road.

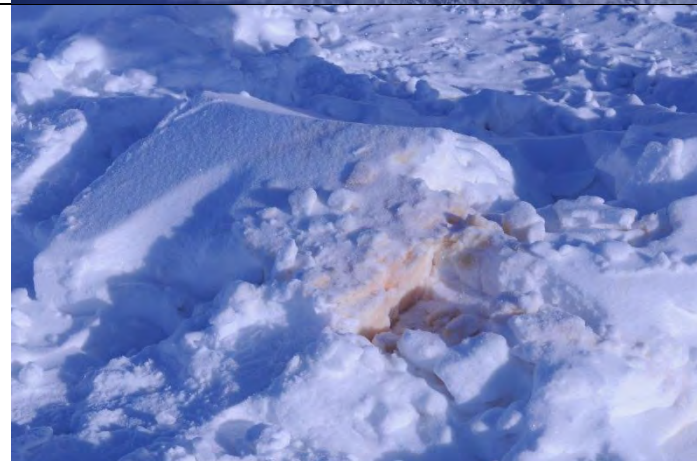
The majority of the site personnel were focused on opening camp, construction of the ice road, and the preparation of equipment for the loading and unloading of the haul trucks. It was estimated that approximately the Tundra project will receive 120 and back haul out 60 loads. A small hydrocarbon spill was discovered near one of the equipment laydown areas (Photo #6). The Inspectors explained that the contaminated snow must be removed and placed within proper containment until it can be disposed of according to the approved waste management plan. The small fuel tank used to run the camp (photo #1) appeared to have signs of overfilling/spills on the top and sides of the tank. The Inspectors expect that proper care be taken in the future filling of all tanks and equipment onsite and that the contaminated snow be removed from this area. There were multiple pieces of equipment staged around the site that did not have a drip tray placed under them to catch and leaks that may occur (Photo #9). The Inspectors expect that drip trays are used in the future to ensure compliance with condition #54 of the land use permit.

Photo #6: A small hydrocarbon spill in the equipment lay down area.

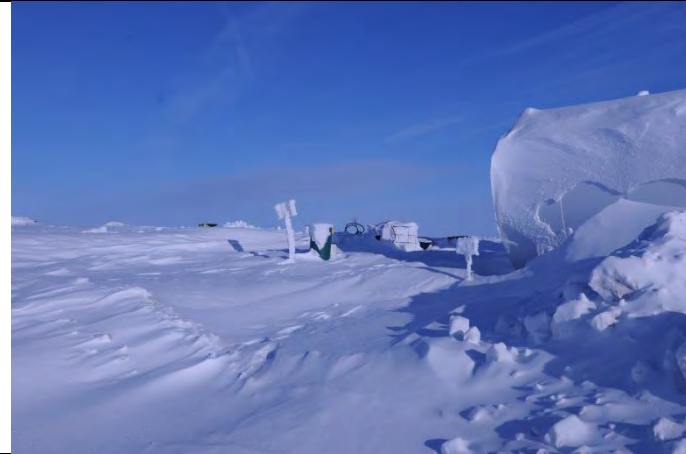
Photo #7: Fuel tanks and view of the Hazardous waste area.

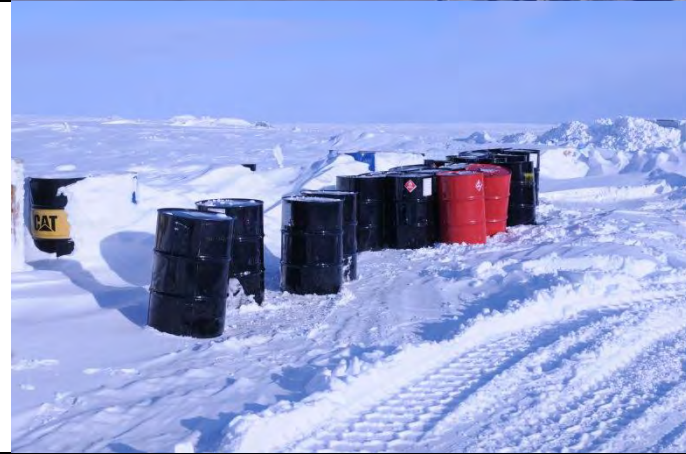
No other concerns were noted with the site as all waste stored in the hazardous waste laydown area was properly stored and sealed. All concerns noted during the inspection were discussed with Mr. Brostschi and other site personnel.

Photo #8: Overview of the hazardous waste laydown area.

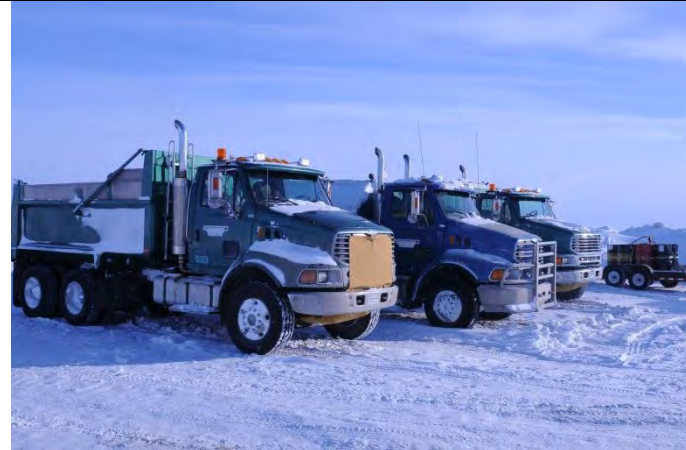
Photo #9: Example of equipment parked without drip trays.

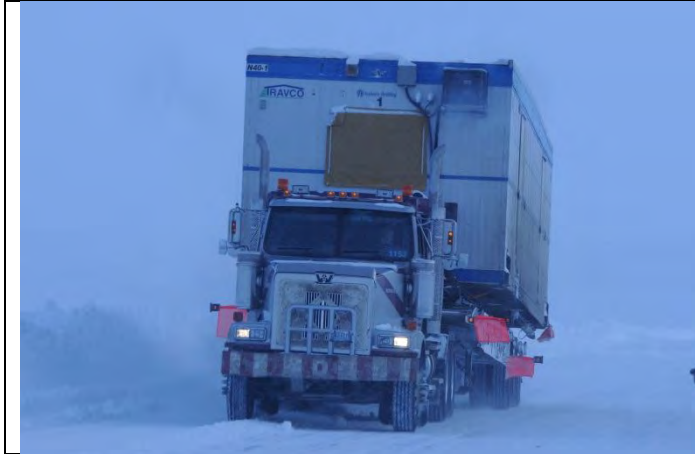
While leaving site the Inspectors noted that the portages were firming up and appeared to be ready for minimal heavy traffic. The Inspectors were met by a convoy of three large haul trucks waiting to access the Tundra site. Mr. Bob Johnson explained a fully loaded water truck would first drive over the portages to ensure that they are able to sustain the weight of the haul trucks. Mr. Johnson then told the Inspectors that the trucks will be piloted to ensure that they stay in the middle of the portages where the ice/snow cover is able to sustain the loads. The Inspectors agreed based on the fact that Mr. Johnson understood that travel over the portages must cease immediately if rutting was observed.

Photo #10: One of the three trucks that were going to travel over the soft portages.
