RE: Land Use Permit MV2016X0011 & Water Licence MV2016L8-0003– Tundra Mine Remediation Project – Inspection

INSPECTION DATE – September 20th, 2017

ENVIRONMENTAL INSPECTION REPORT (MV2016X0011)

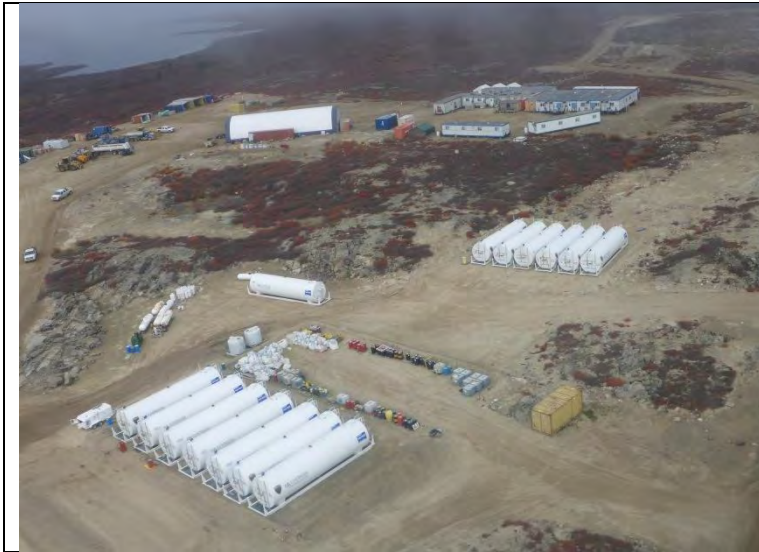
Photo #1: Overview of the Tundra camp and surrounding area.

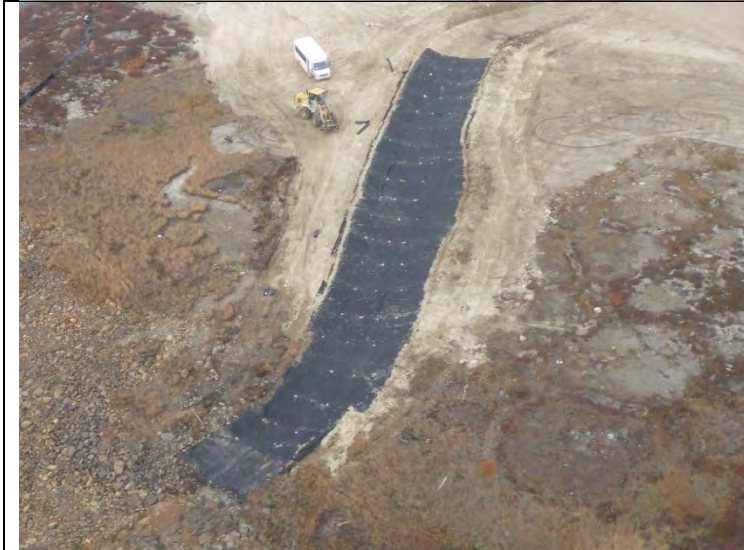
Photo #2: Mill Pond outflow construction.

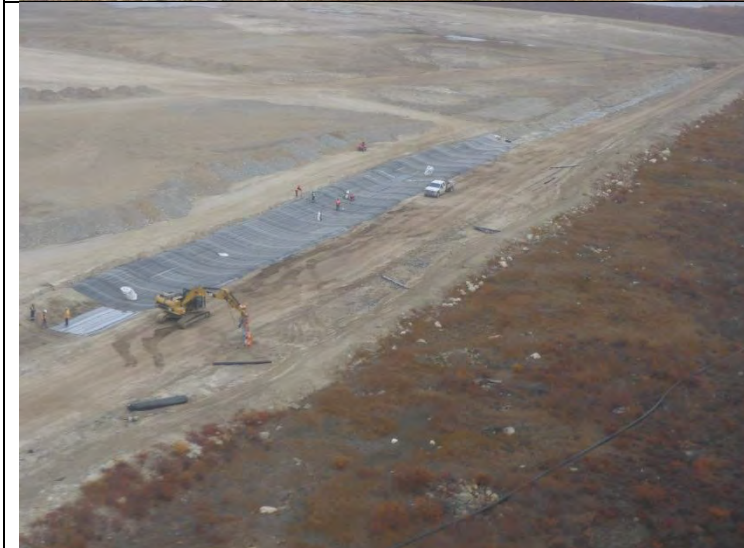
Workers were placing the liner in the drainage channel connecting Mill Pond to Lower Pond (Photo 3 & 11). The liner was being welded at the seams to insure no leakage underneath (Photo 12). Personnel were also working on the tailings contaminated area. The entire tailings have been covered with a liner. (Photo 14) and workers were placing Type A material on the top of the liner with an excavator (Photo 15).

Photo #3: Tailings contaminated area diversion ditch construction.

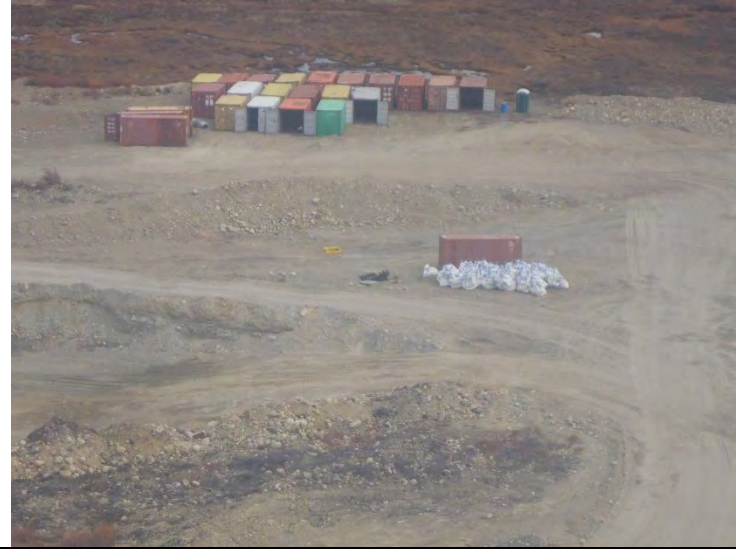
During the last inspection, site personnel notified the Inspectors that an old landfill containing machinery and refuse had been unearthed during quarrying near the airstrip. Partially filled drums had been buried and leaked into the surrounding soil. Samples of this soil were taken and tested positive for hydrocarbon contamination. The impacted soil was placed under the tailings cap and the metal debris was placed in mega bags and stored on the southeast side of the runway. (Photo # 4 and 8) This material will be backhauled out on the winter road and disposed of at a designated facility.

Photo #4: South east end of the runway where they have stored the debris found during quarrying.

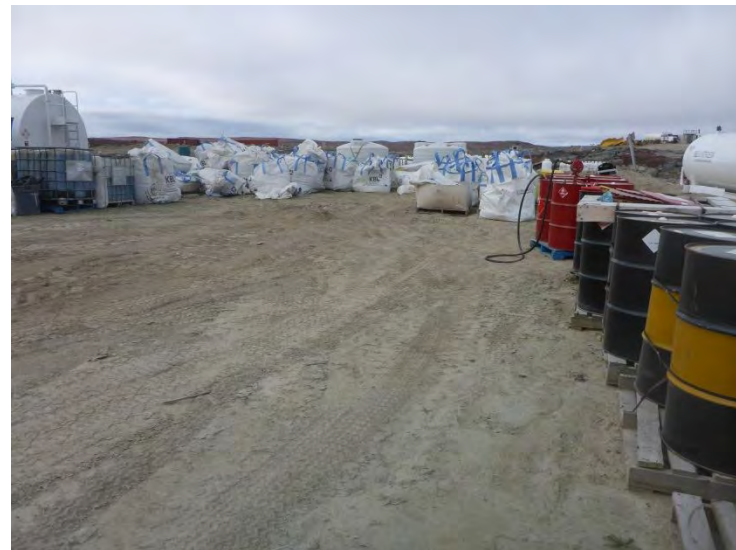
Photo #5: Hazardous waste area.

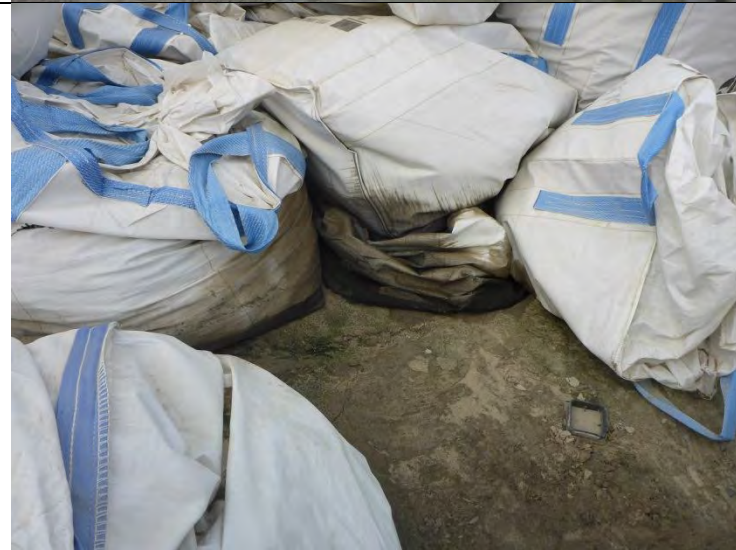
There was no standing water within the hazardous waste storage area at the time of inspection however there was hydrocarbon stains on the mega bags that are stored inside the hazardous waste area (Photo # 6).

Photo #6: Stains on the bags in the Hazardous lay down area from a previous spill.

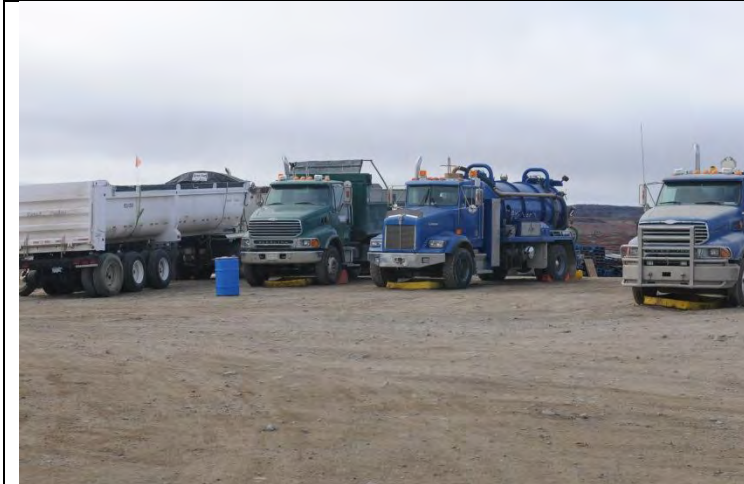
All equipment around the site that was sitting for at least two hours had drip trays placed under them as required by condition #54 of the land use permit. (Photo #7) Both of the hydrocarbon spills that had been detected during the previous inspection had been cleaned up and the impacted soil was removed and contained in accordance with the waste management plan.

Photo #7: Drip trays placed under vehicles that were parked for over 2 hours.

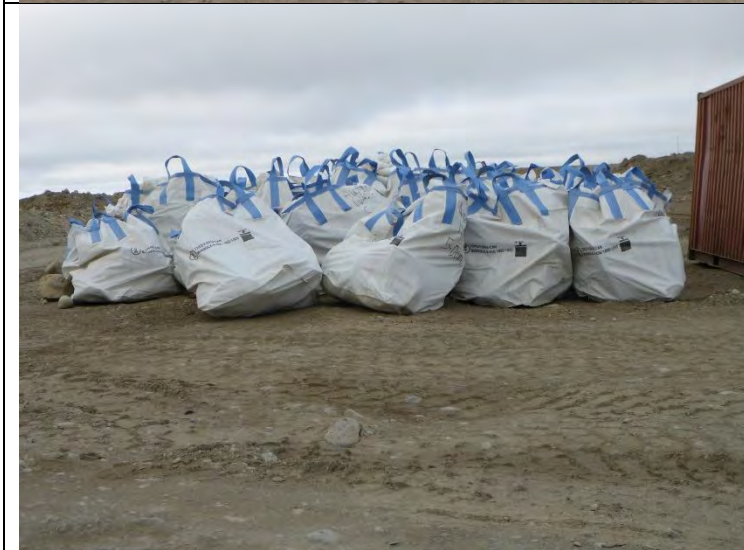
Photo #8: Airport waste neatly packed into bags that will be transported out over the winter road.

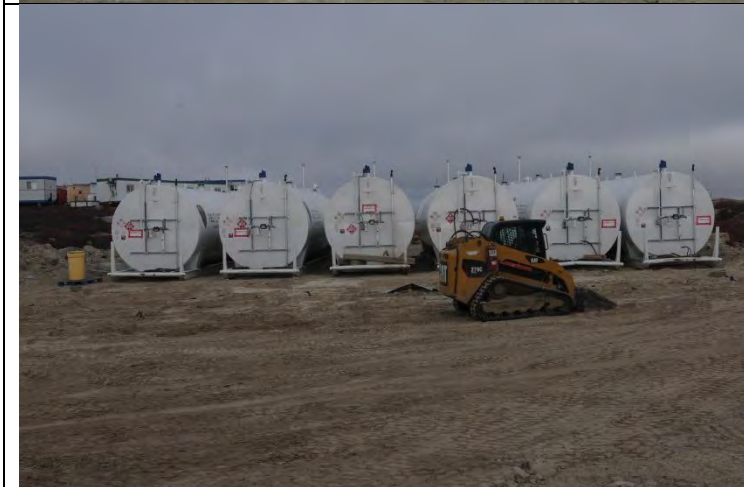
Photo #9: New tank farm berm with new empty tanks placed inside.

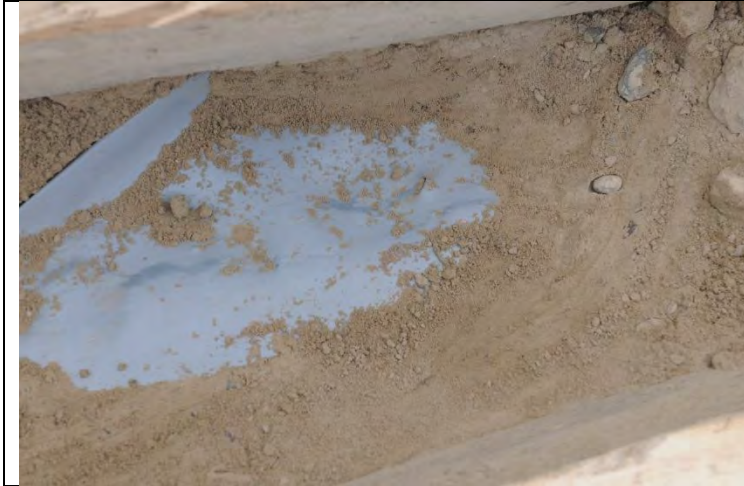
The new tank farm was inspected and multiple problems were noted. The berm liner has multiple holes from the installation of the tanks (Photo 10.) The liner is supposed to be completely sealed over the entire perimeter of the berm. The liner should extend to the top of the dyke wall and currently the liner does not. There are places in the berm where the liner has folded back over itself and does not extend up the berm at all (Photo 19). This berm will have to be reconstructed in order to meet the requirements in the submitted management plans.

Photo #10: One of several holes found in the impermeable membrane during the inspection of the berm.

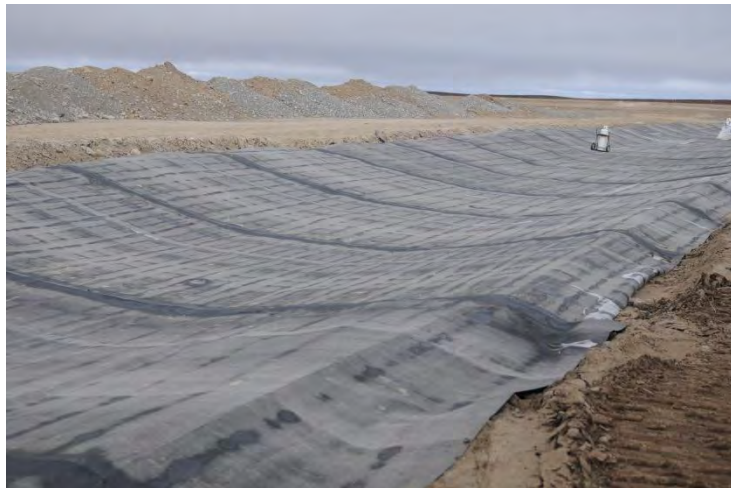
Photo #11: Liner being placed in the drainage channel connecting Mill Pond to Lower Pond.

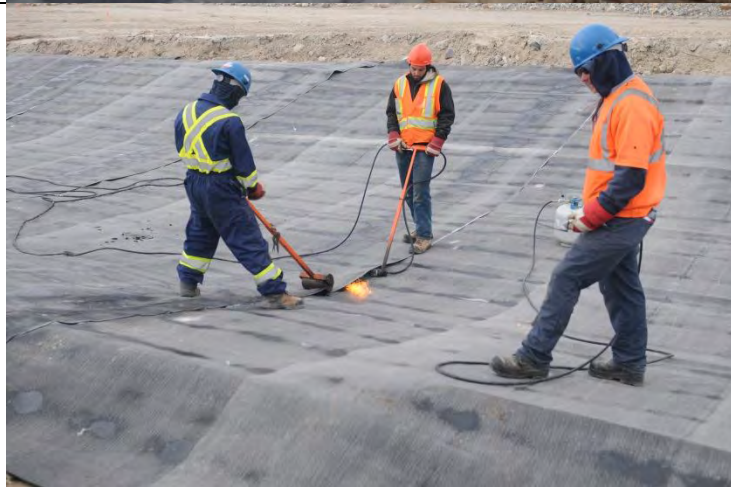
Photo #12: Seams of the liner being welded together.

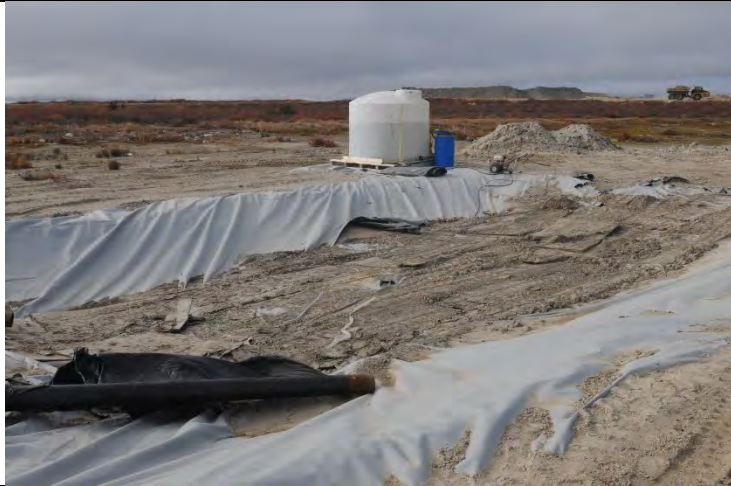
Photo #13: Wash berm which was used to rinse vehicles coming out of the tailings area has been ripped and no longer usable.

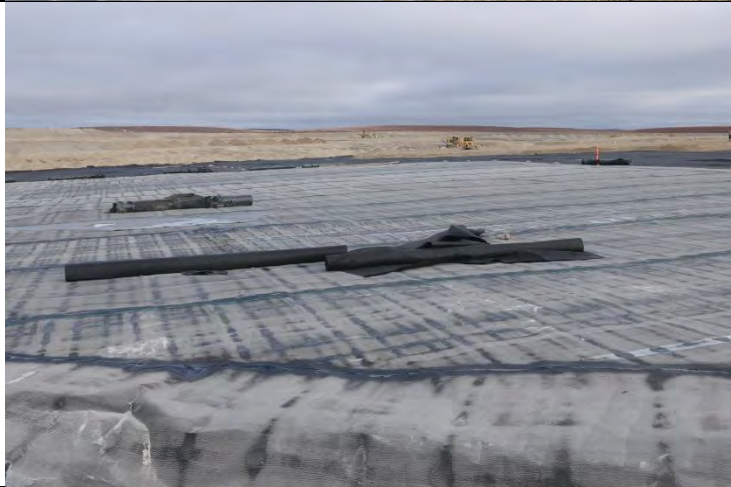
Photo #14: Tailings contaminated area, before its covered with material.

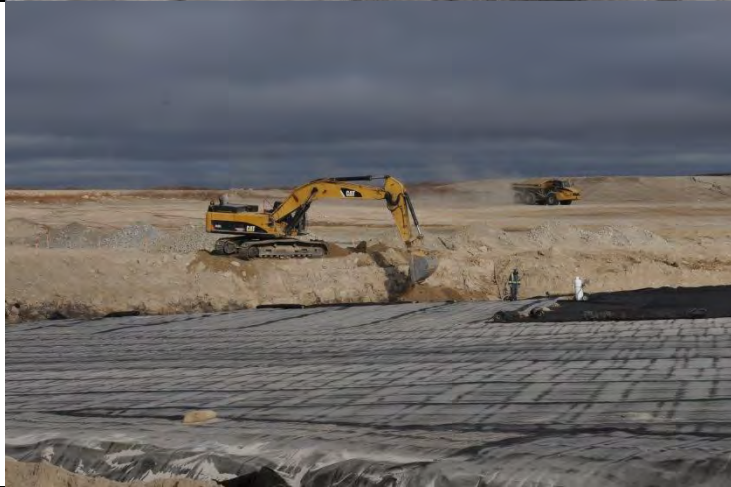
Photo #15: Dirt being placed on top of the tailings cap membrane.

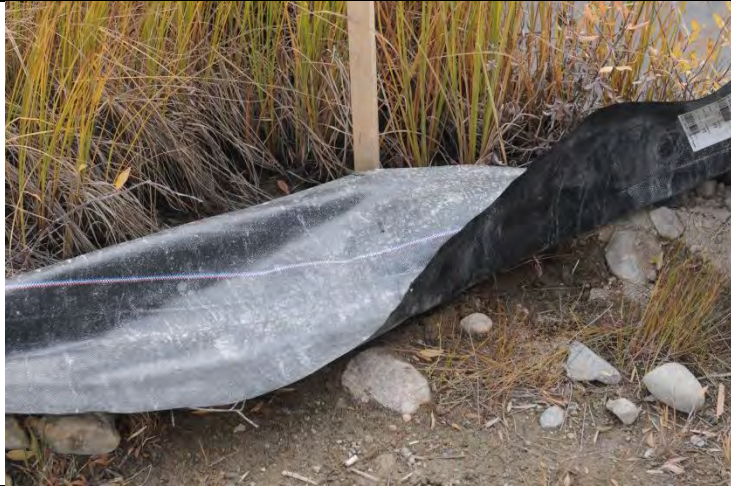
During the inspection, inspectors noted that the silt fencing installed around the airstrip road bridge was not properly installed. In order for a silt fence to be an effective filter for sediment-laden runoff they need to be installed properly. The silt fence must be properly affixed to the support posts to prevent it from folding down onto itself (Photo 16). For ditch installations, the filter fabric dam should be appropriately embedded in the ditch bottom and sides (eg, 10cm minimum) to prevent the movement of fines under or around the dam (Photo 17).

Photo #16: Silt fence around the bridge near the airstrip not installed properly. The top of the silt screen should be affixed to the posts to ensure it can't fold down.

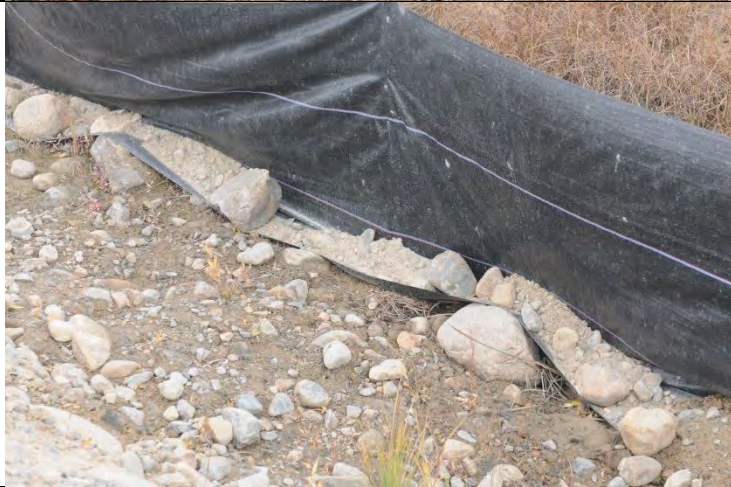
Photo #17: Improper installation of silt screen. The filter fabric dam should be appropriately embedded in the ditch bottom and sides (e.g. 100 mm minimum) to prevent the movement of fines under or around the dam.

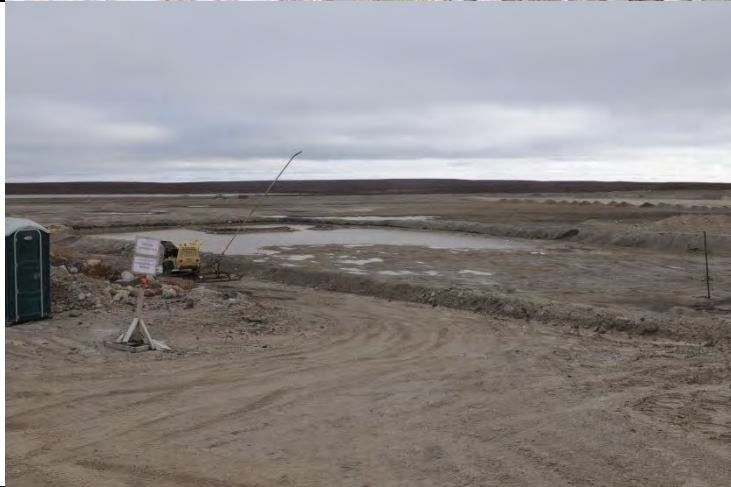
The water treatment plant was no longer in use. It had been taken apart and stored on site for removal. Some untreated water remained within the water treatment berm (Photo # 13). This water will have to be treated to meet the discharge criteria outlined in the water licence prior to discharge. Inspectors request that a plan be submitted outlining how this water will be treated and a copy of the sample results verifying proper treatment prior to discharge.

Photo #18: Standing water located in the water treatment area that has not been treated.

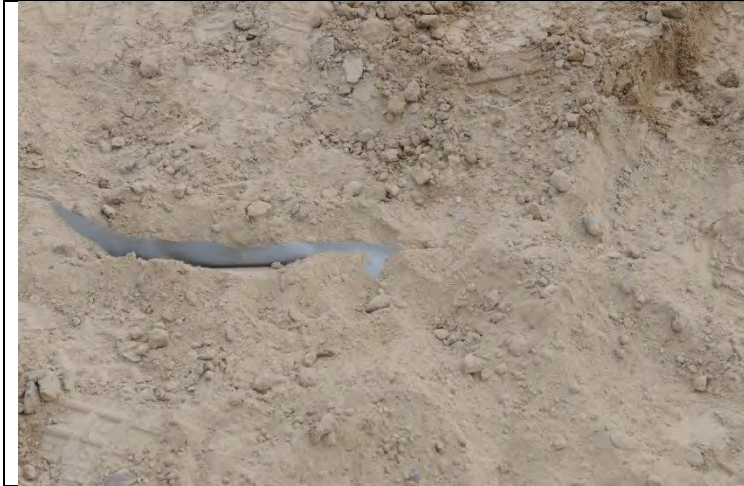
Photo #19: Liner on the berm edge.
