RE: Land Use Permit MV2016X0011 & Water Licence MV2016L8-0003– Tundra Mine Remediation Project – Inspection

INSPECTION DATE – February 27th 2018

ENVIRONMENTAL INSPECTION REPORT (MV2016X0011)

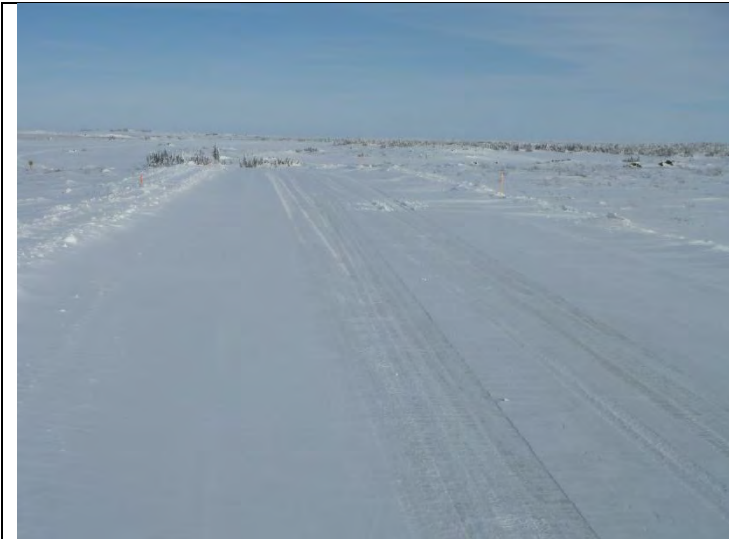
All of the portages within the federal area appeared to have the minimum of 10 cm’s of snow/ice cover as required by condition #12 of the land use permit (Photo #1). There were no signs of rutting or any other concerns with any aspects of the ice roads and ice airstrip (Photo #11).

Photo #1: Overview of the Tundra ice road access portage.

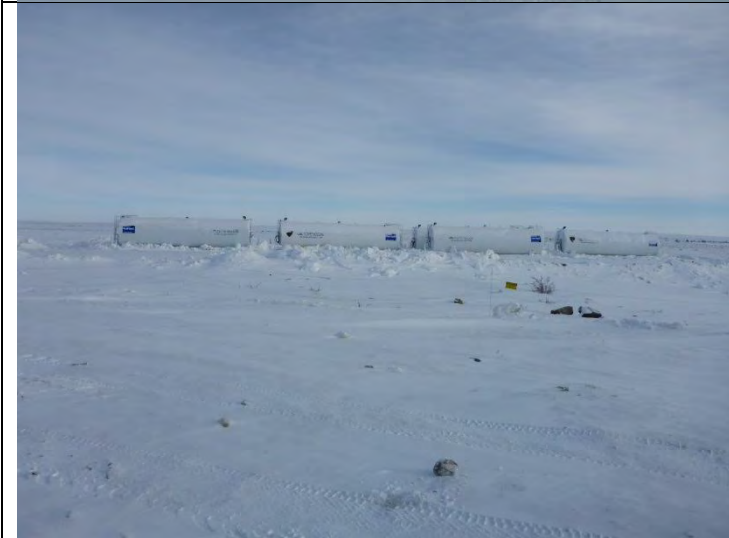
The contractor was in the process of finalizing the season’s demobilization from site (Photo #9). There were a number of large 100,000 liter tanks staged and ready for transport (Photo #2). Mr. Osborne stated that two tanks will be left onsite and filled to 90% capacity in order to provide fuel during freshet monitoring and for repair/maintenance activities during the 2018 season (Photo #8). These two tanks were placed within secondary containment and there appear to me no leaks or spills in the nearby area.

Photo #2: Overview of large tanks ready for demobilization from site.

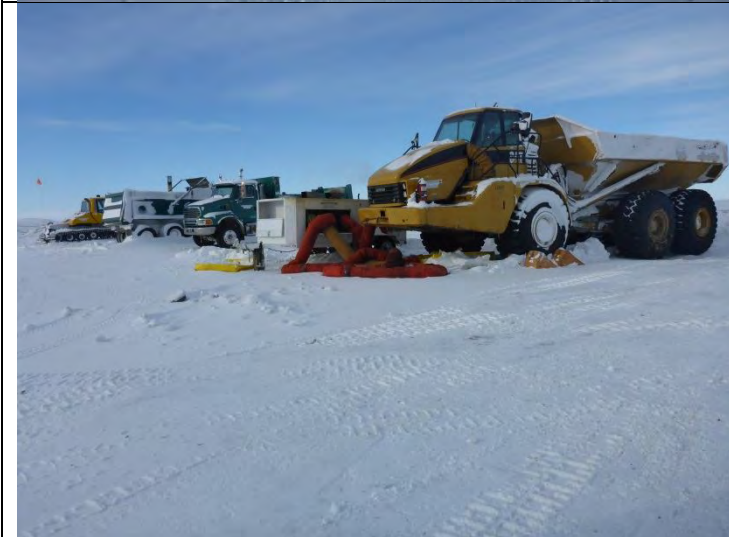
Photo #3: Heavy equipment laydown area.

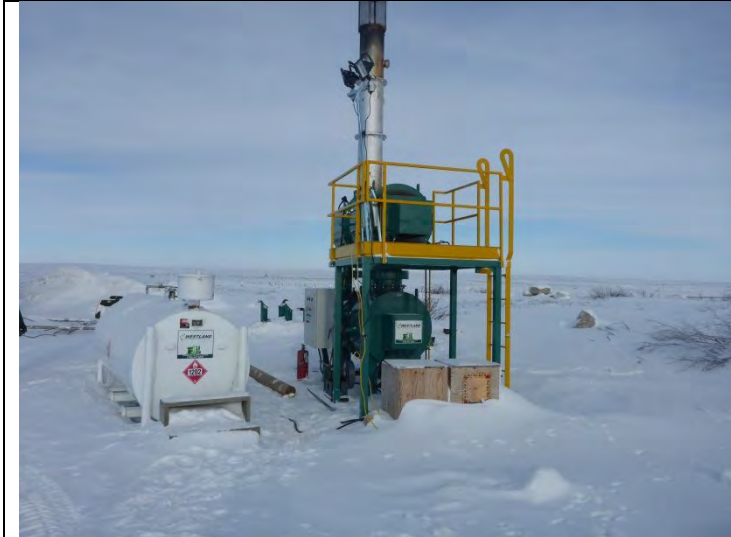
Photo #4: Overview of the incinerator.

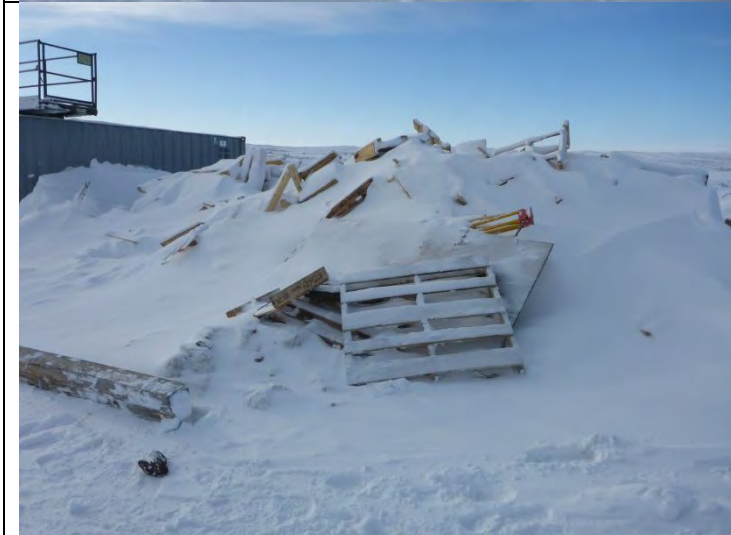
Mr. Osborne stated that the pile of debris located near the incinerator was intended to be disposed of by open burning (Photo #5). The Inspector noted that there appeared to be some items mixed within the pile that were not permitted to be burnt and must be removed prior to disposal.

Photo #5: Combustible waste pile.

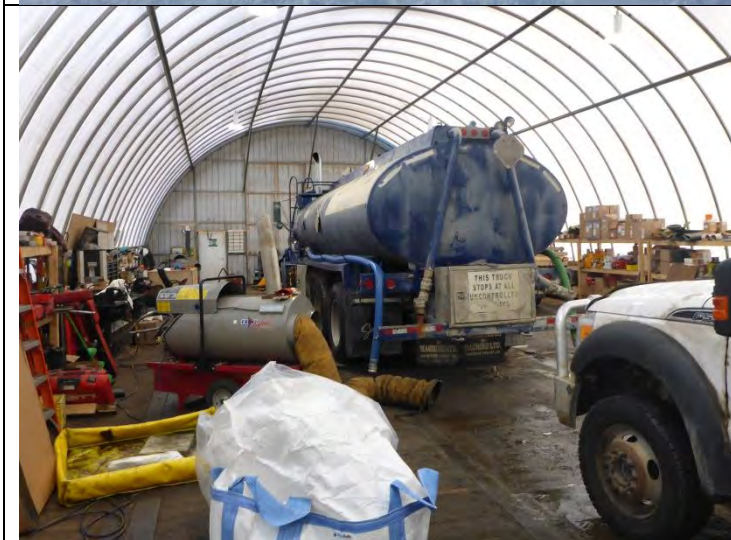
Photo #6: Overview of coverall shop area.

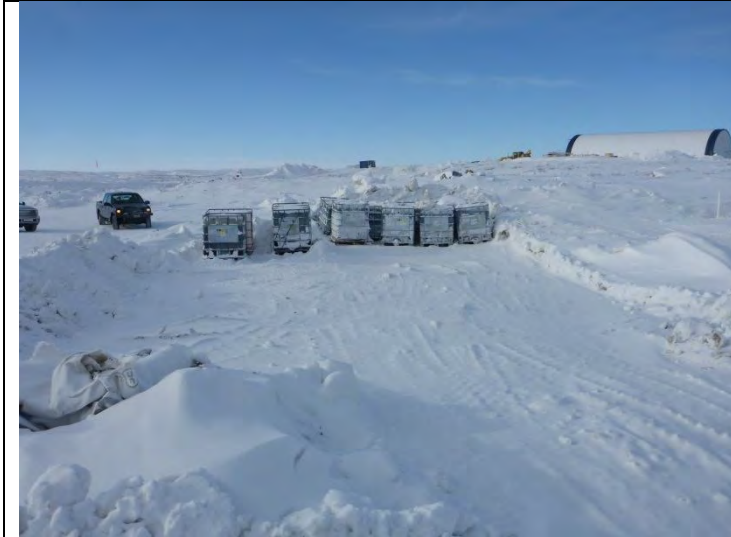
Photo #7: Remaining hazardous waste within lined area.

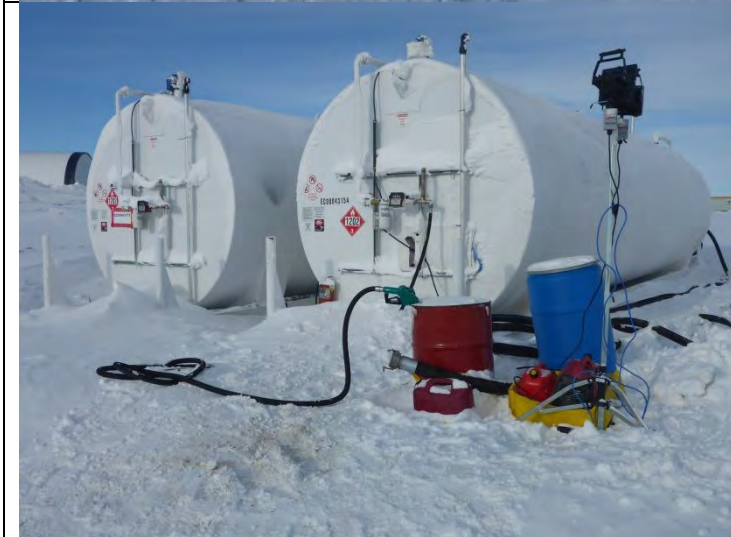
Photo #8: The two 100,000 liter tanks remaining onsite.

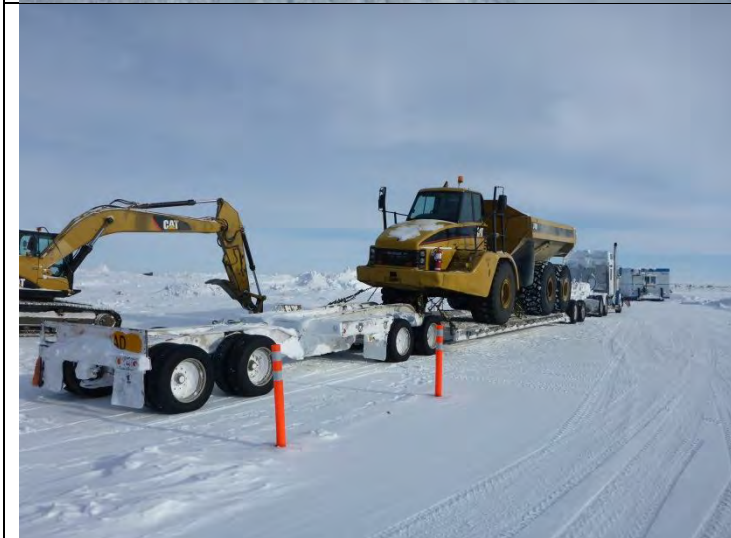
Photo #9: Rock truck staged for demobilization.

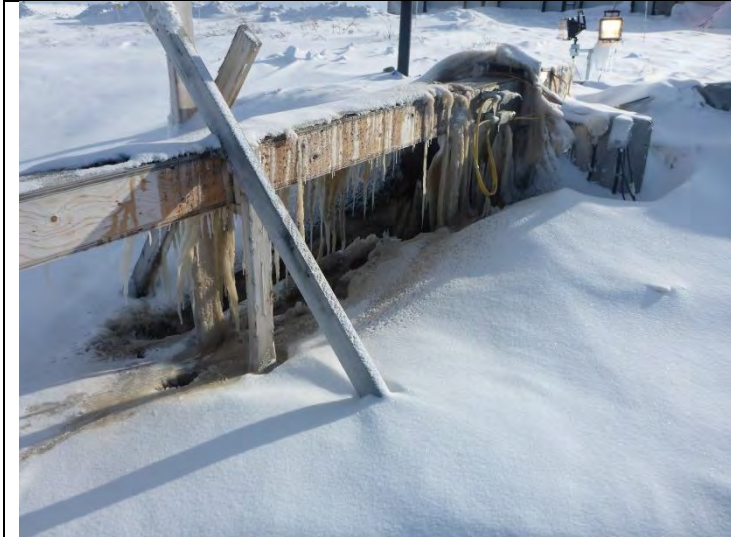
The Inspector noted that the sewage discharge line had been disconnected from the tank which resulted in an unauthorized discharge of sewage to the tundra (Photo #10) contrary to condition #36 of the land use permit and Part F condition #25 of the water licence. The Inspector noted that it did not appear that the sewage line had been inspected in the last few days and that the entire wooden utilidor that houses the sewage line was full of sewage. The Inspector explained that all of the sewage must be cleaned up prior to the demobilization from site and the contaminated wooden utilidor be removed and placed within the first cell of the sewage lagoon. Site personnel were heading out to assess the situation and start the cleanup while the Inspector was still onsite. The Inspector also explained that all sewage spills must be reported under the NT/NU spills agreement and must be done immediately. Site personnel reported the spill immediately (NT/NU Spill #18-061).

**Photo #10: NT/NU Spill 18-061.
Unauthorized sewage discharge from tank to lagoon.**

The Inspector has received photos showing that the cleanup of NT/NU Spill #18-061 has been partially completed and no further risk to the environment is present. The cleanup will be finalized once the contractor heads back into site in mid-April.

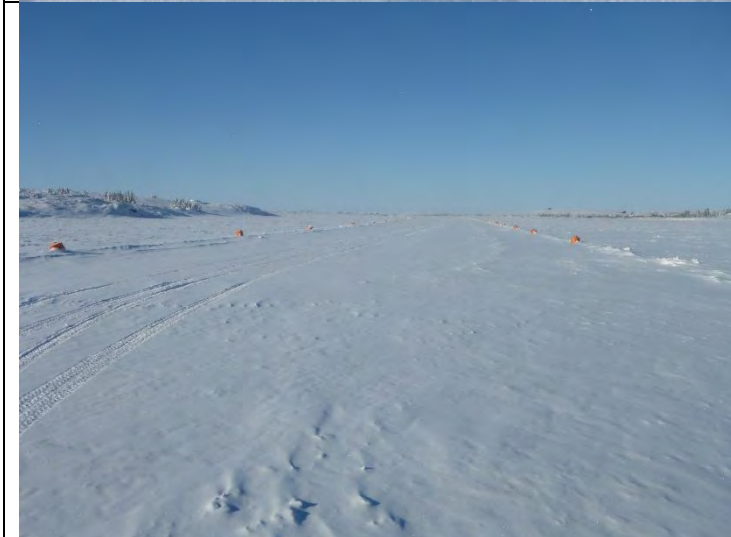
**Photo #11: Overview of ice runway located
on Bulldog Lake.**
