April 13, 2018

<b>File Number</b>	<b>MV2017C0024</b>
<b>Type of Operation</b>	<b>MINERAL EXP - drilling</b>
<b>Location</b>	Medic truck staging area, active drill area EM-18-PP- 103 to 108, water source O28, completed drill sites since last inspection: EM-18-PP-090-102, Hinge zone marsh, L65-18-PP-001, 002, 003, 004, 005, 006, 007, 008, 009, 010, 012.

An inspection of the above noted operation was conducted on April 06, 2018 by Manager, Resource Management Mike Vassal and Resource Management Officer Jayda Robillard.

## ENVIRONMENTAL INSPECTION REPORT

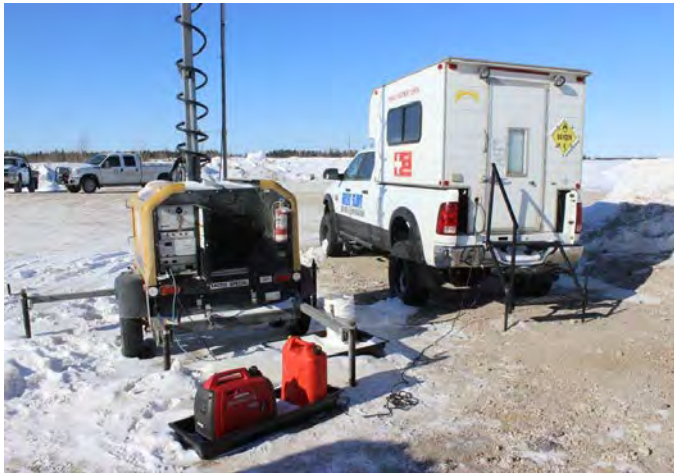
**Figure 1**  
**Medic truck staging**

The site was clean and no environmental issues were observed (Figure 1 and 2). The outhouse was nearly full.

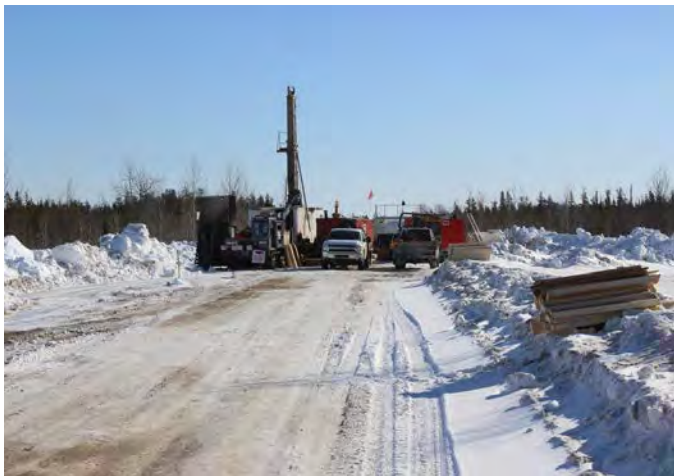
**Figure 3**  
**Foraco drill on access road at EM-18-PP-105**

Drilling was taking place on the main Pine Point access road (Figure 3). Foraco was depositing drill mud and cuttings on the road. Mitch Burtnick from Foraco said there was no way to capture these wastes (Figure 4). Inspectors will check these sites in the spring.

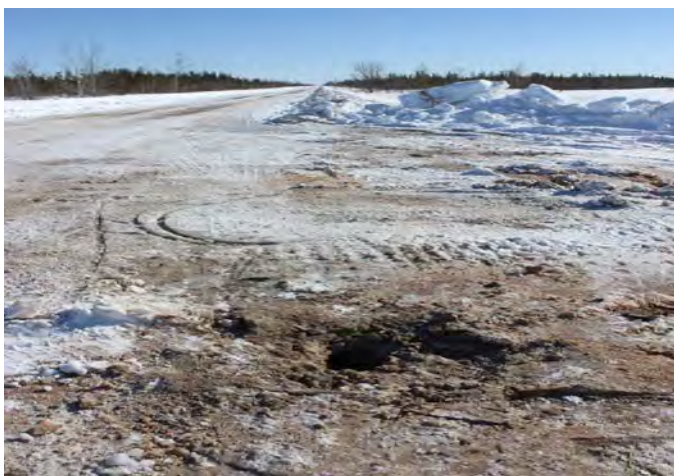
**Figure 5**  
**EM-18-PP-103 is along the edge of the access road**

Figure 5 shows hole number EM-18-PP-103 that is along the edge of the access road. The holes have concrete plugs that are set at 12 m deep. Holes in the access road need to be filled with gravel immediately in order to allow vehicles to safely use the road. Once filled, the gravel will need to be tamped down (compacted) to prevent erosion of the road when conditions are wet. It is recommended that marking caps not be used, but if marking caps are used they will have to be buried to a depth that will prevent road graders from exposing the cap and vehicles from hitting them.

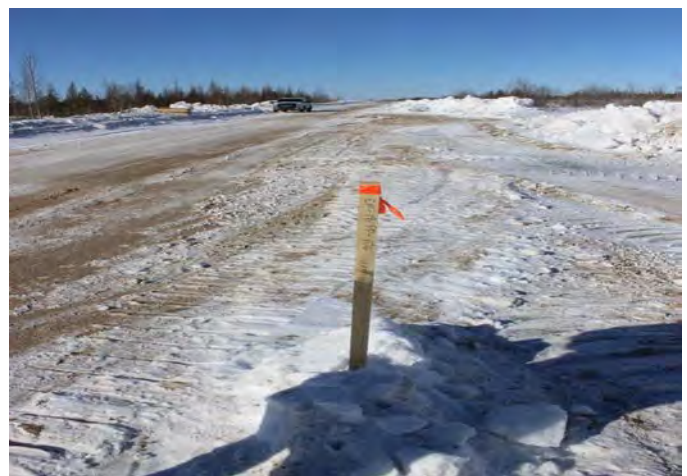
**Figure 6**  
**EM-18-PP-106. This is the next hole to be drilled on access road. Note that these holes are on the road surface and need to filled to prevent any public safety issues.**

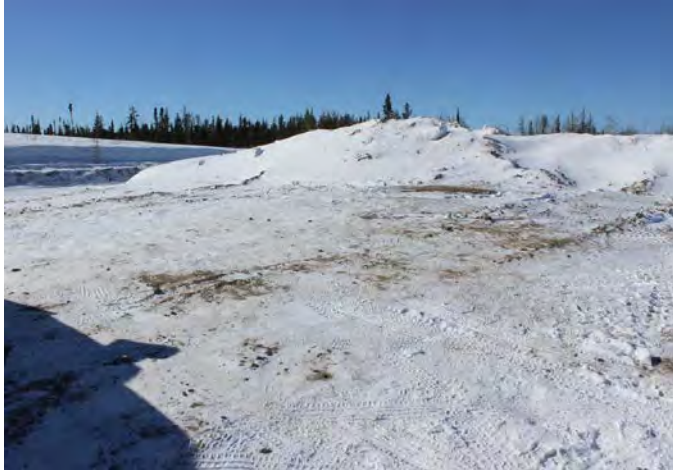
An inspection of the winter drilling program near Pine Point NT was conducted on April 6, 2018 by Manager, Resource Management Mike Vassal and Resource Management Officer Jayda Robillard. The inspectors looked at water sources, staging areas, previously drilled sites and the active drilling area. Snow continues to obscure some of the issues that were raised in previous inspections. The inspectors could not evaluate the drill cuttings at the Hinge zone marsh (Figure 17), nor the spill site at Great Slave Drilling and Explorations staging area (Figure 7). These sites will be inspected once the snow melts.

**Figure 7**  
Great Slave staging area. Snow cover obscured the spills.

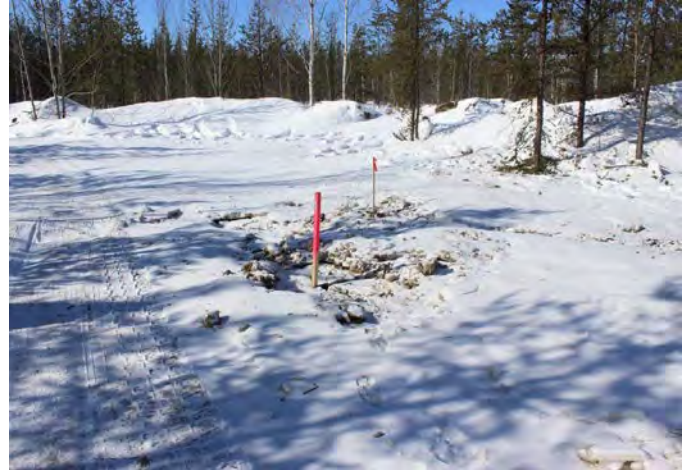
The inspectors looked at all the sites that had been drilled since the last inspection on March 26, 2018. This included holes at EM-18-PP-090 to 102 and L65-18-PP-001 to 012. A number of holes need to be filled and leveled when conditions permit. This has been documented in previous reports. Figure 8 shows holes 90 and 91 as examples of holes in the EM 90 to 102 area that need to be filled

**Figure 8**  
EM-18-PP-090, 091. Example of drill holes that need to be filled in when conditions permit.

and leveled when conditions permit.

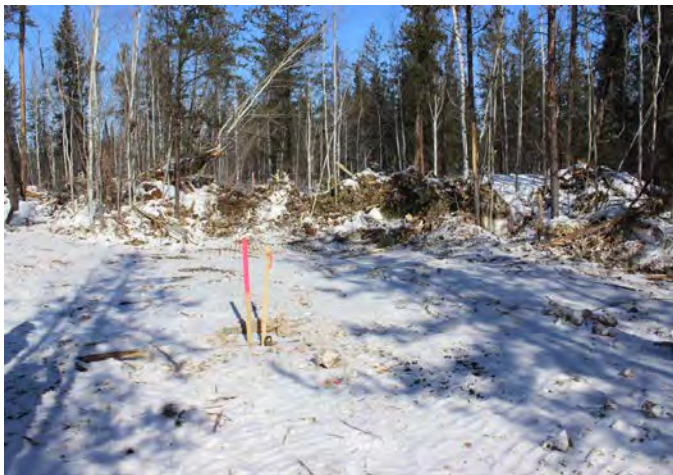
**Figure 9**  
EM-18-PP-093. Woody debris needs to be mulched and both woody debris and soil need to be spread over the site when conditions permit

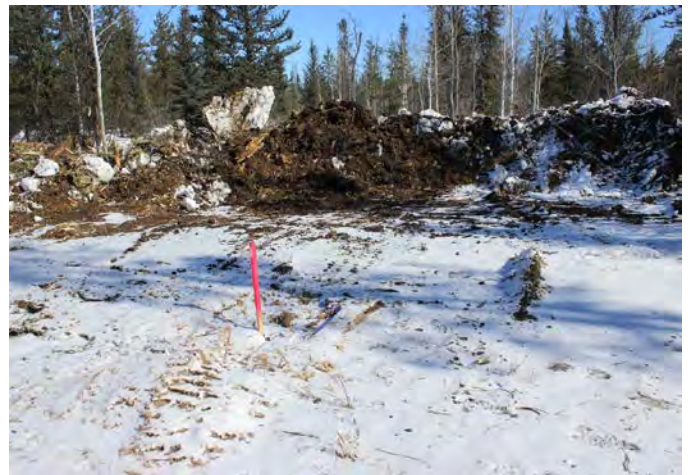
**Figure 10**  
EM-18-PP-097. Pile of snow, soil and woody debris. To be spread back over site when conditions permit

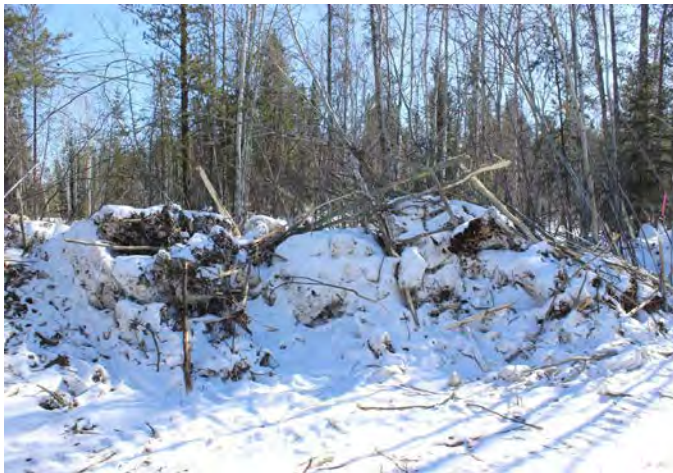
**Figure 11**  
EM-18-PP-092. Broken trees to be mulched and spread over site.

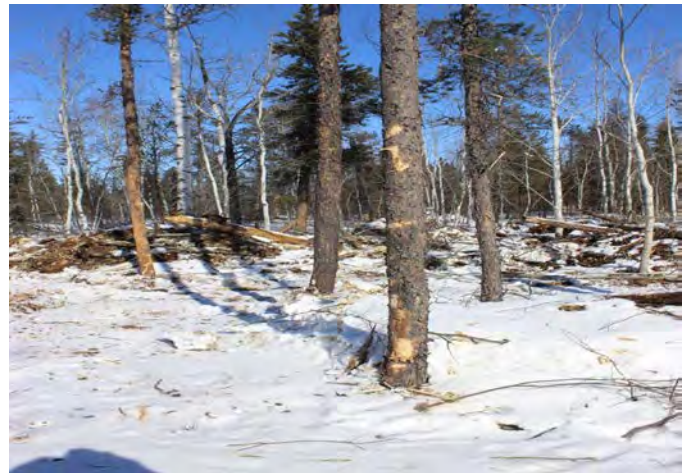
**Figure 12**  
Scarred tree

Access roads were in good condition with adequate snow cover. Pine Point Mining is using access roads that were cut by Cominco. A number of trees were scarred in the recent clearing activity (Figure 12).

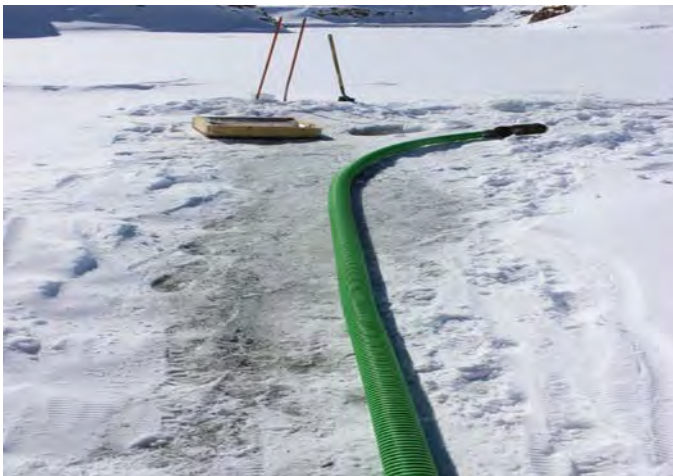
**Figure 15**

Figure 15 shows the water source at O28. Salt is being used for traction on the ice. It is preferred that natural local material such as sand or gravel be used instead.

**O28 water source. Salt is being used for traction on the ice.**

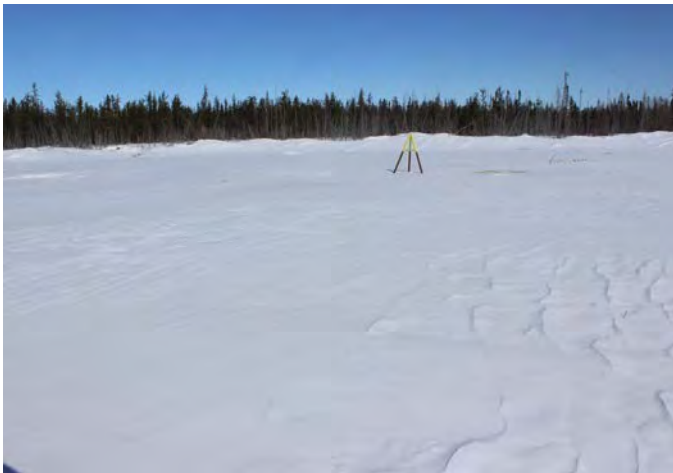
**Figure 17**

Because of the snow cover the inspectors were not able to evaluate the hydrocarbon stained area at Great Slave Drilling staging area, and were also not able to view the drill waste in the marsh at the Hinge Zone. These areas are to be checked in the spring.

**Hinge zone marsh. Snow cover obscured view of drill cuttings in the ice**

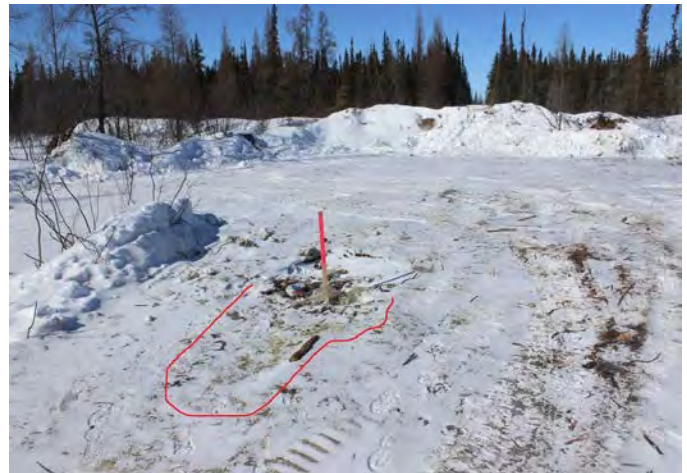
**Figure 18**

There is an oil spill by the hole at L65-18-PP-009. LUP Condition #78  
Coordinates are: 60° 48' 34.3" N 114° 38' 01.2" W. Please see Figure 18.

**Spill at L65-18-PP-009. Spill is outlined in red beside the hole**

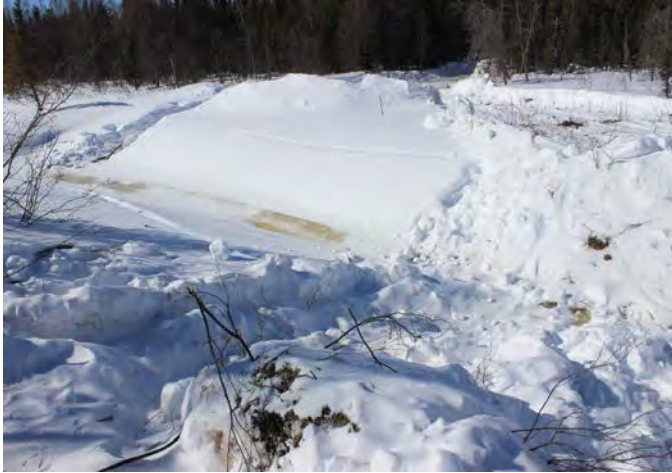
**Figure 19**

No issues were observed at the L65 water source (Figure 19).
