File Number MV2017C0024
Type of Operation MINERAL EXP - drilling
Location SCS staging, First aid station, M48 drilling, camp set-up, X65 drilling, Foraco staging

An inspection of the above noted operation was conducted on December 12, 2018 by Manager, Resource Management Mike Vassal and Manager, Resource Management Rob Walker.

ENVIRONMENTAL INSPECTION REPORT

Permittee:	Pine Point Mining Limited	Permit Expiry Date:	July 19, 2022
Land Use Permit No.	MV2017C0024	Previous Inspection:	October 04, 2018
Quarrying Permit No.		Inspection Date:	December 12, 2018
Contractor:		Subcontractor:	
Location(s) Inspected:	First aid station, camp set-up, X65 drilling		
Current Stage of Operation:	One drill in operation. Camp is being set-up		
Program Modifications Approved:

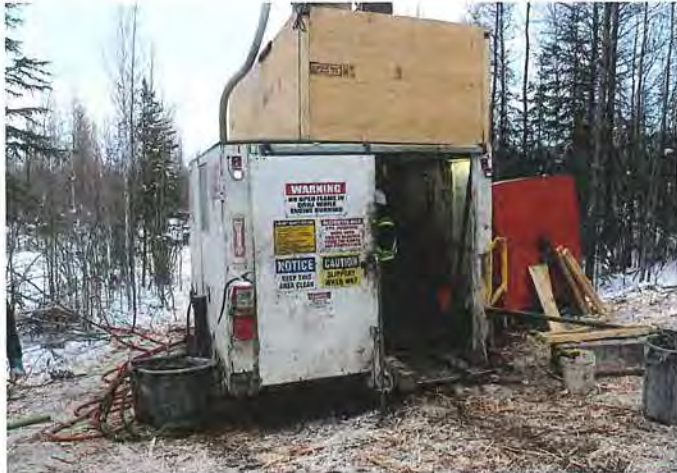
Foraco was drilling in the X65 area on the X65-PP-023 site, 60° 51' 54.1" N 114° 37' 49.6" W .

Figure 1
Foraco drilling at X65-18-PP-023

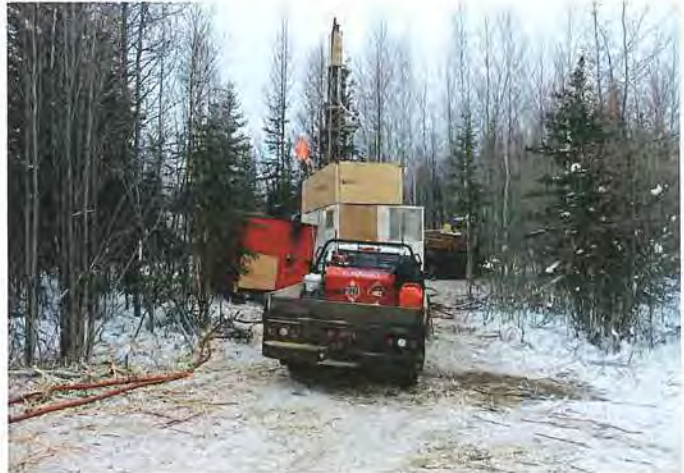
Figure 2
Foraco drilling X-65 023 site

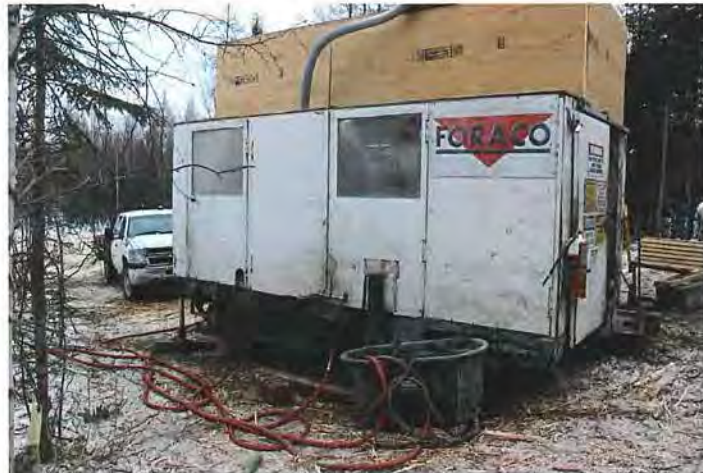
Figure 3
Foraco drilling X65-023

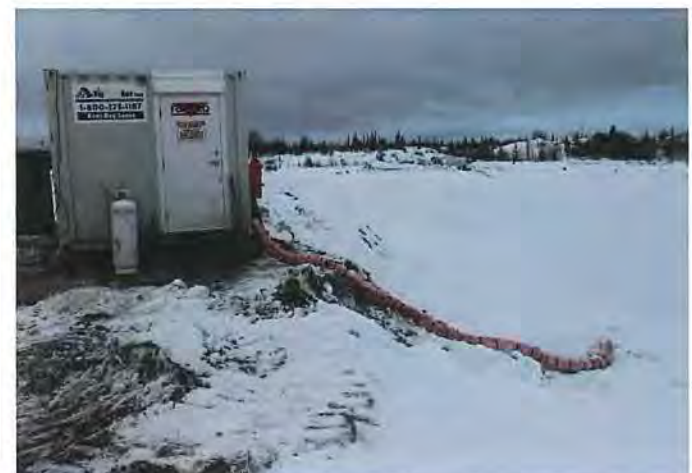
was approximately 10 meters by 8 Meters. Water seen outside the pit was fresh water that was pumped through system when not drilling.

Figure 4
Foraco water source

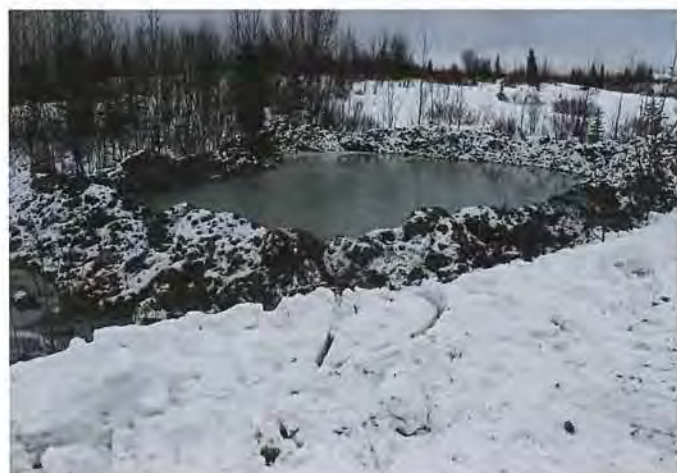
Foraco staging area was at 60° 51' 50.6" N 114° 37' 40.7" W, set up next to the old X-64 pit. The sump being used for the X65 holes was located at 60° 51' 51.1" N 114° 37' 32.1" W and

Figure 5
X65 sump

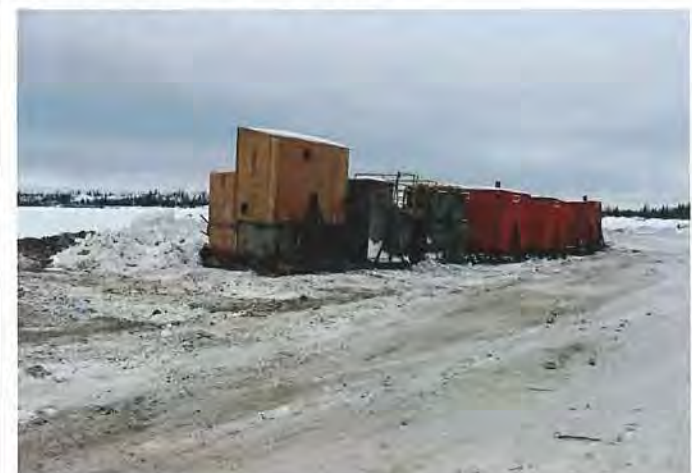
Figure 6
Foraco staging area at X65

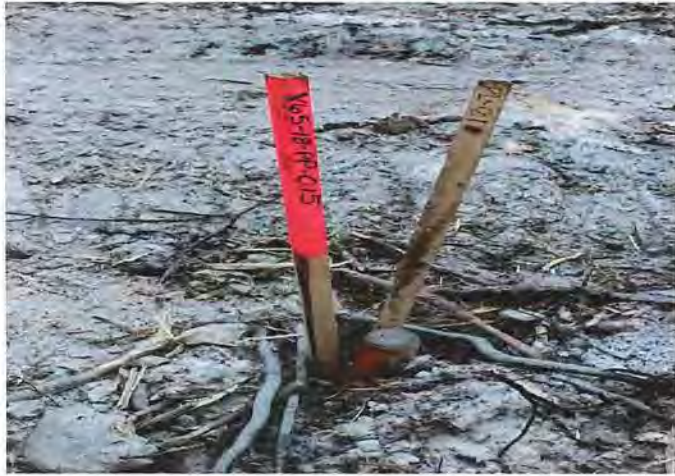
Inspected previously drilled holes at **X65-15:** 60° 51' 56.8" N 114° 37' 37.6" W, **X65-16:** 60° 51' 54.6" N 114° 37' 38.0" W and **X65-22:** 60° 51' 54.8" N 114° 37' 47.1" W

Figure 7
X-65 015 drill hole

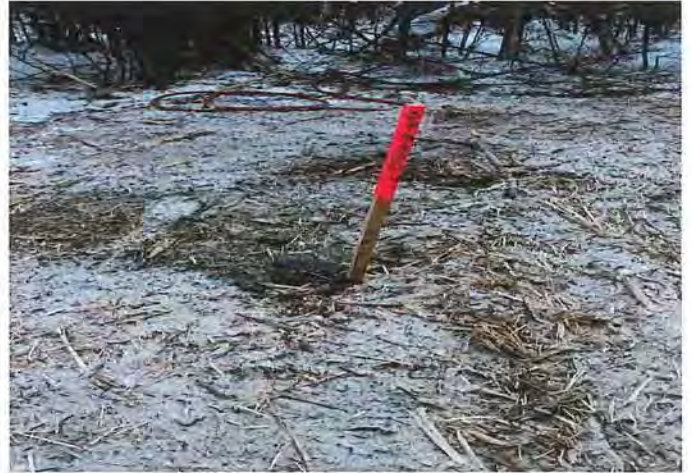
Figure 8
X-65 017 drill hole

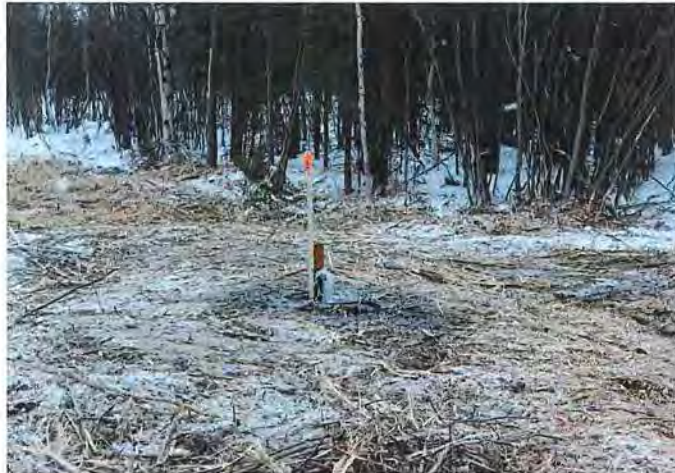
3 artesian wells were encountered in the X65 area and were all capped on Thursday Dec 13, including X65-021 at 60° 51' 57.2" N 114° 37' 46.5" W which was previously plugged but had started flowing again. The area being drilled is quite swampy hence the increase in artesian wells being encountered.

Figure 9
Closer view of X65 -021 artesian well

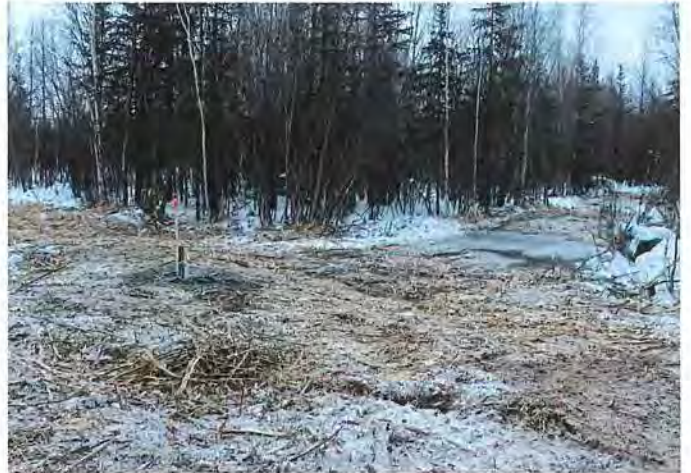
Figure 10
Flowing artesian well, X65-18-PP-021

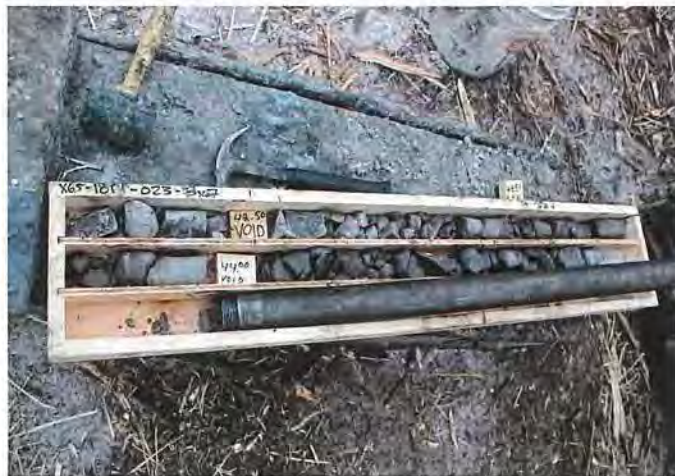
Figure 11
Core from X-65 hole, end of hole near 45 M.

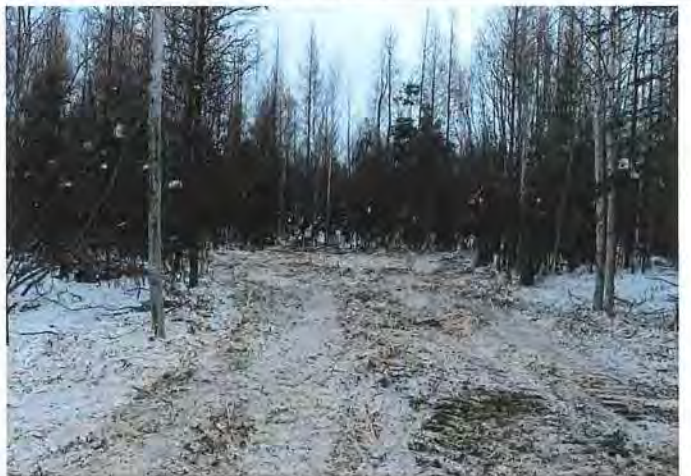
Figure 12
View of X65-017 drill site

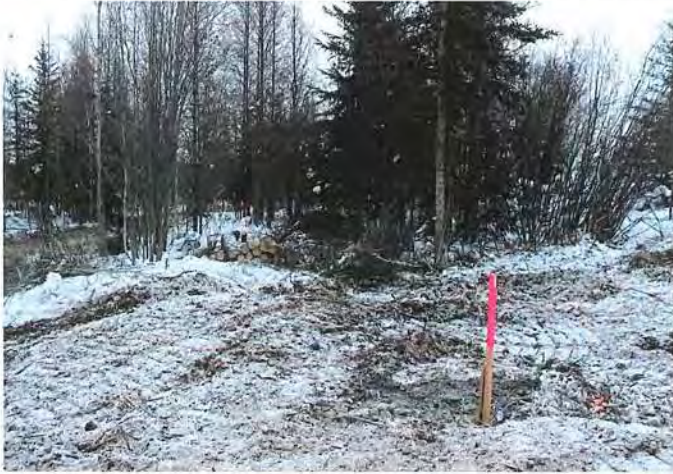
Figure 13
Completed hole X65-016 with stacked wood

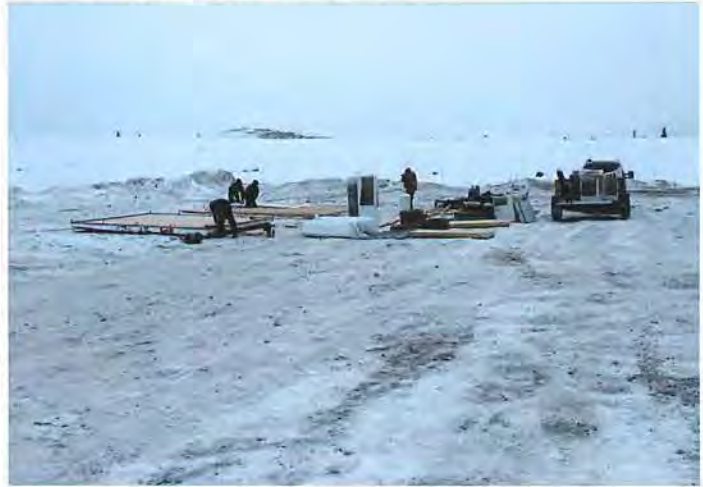
Work had just started that morning on the tent camp located on the top of the old I-46 waste rock pile at 60° 51' 32.5" N 114° 27' 51.0" W. Discovery Mining was setting up the camp with just a couple tent floors built at the time of inspection.

Figure 14
PPM camp being set up

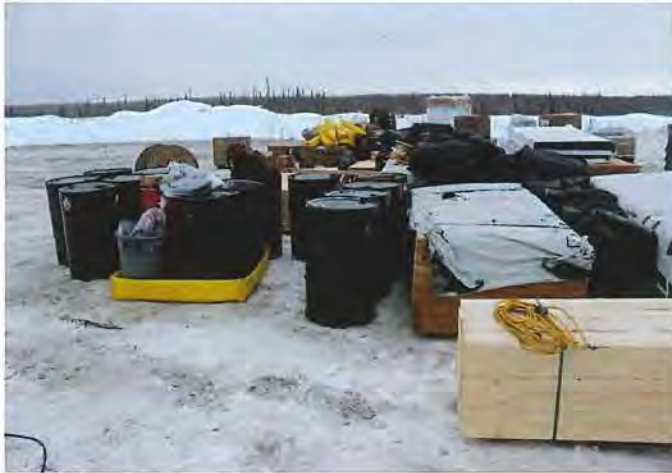
Figure 15
PPM camp. Black diesel drums are empty

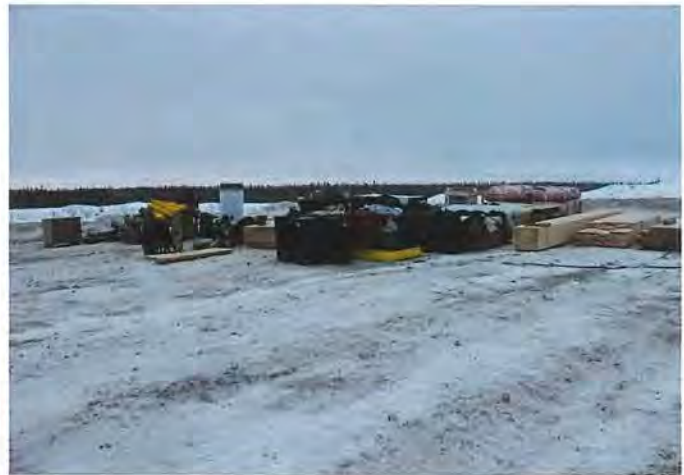
Figure 16
PPM camp lay down area

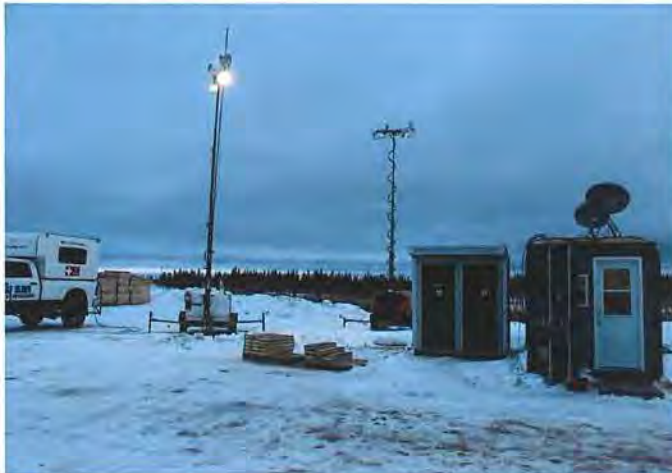
First Aid truck and office area was located at 60° 52' 01.3" N 114° 25' 13.5" W at the intersection of two major haul roads.

Figure 17
First aid and office site.
