**File Number** MV2017C0024  
**Type of Operation** MINERAL EXP - drilling  
**Location** W-85 sites and access into the site

## ENVIRONMENTAL INSPECTION REPORT

<b>Permittee:</b>	Pine Point Mining Limited	<b>Permit Expiry Date:</b>	July 19, 2022
<b>Land Use Permit No.</b>	MV2017C0024	<b>Previous Inspection:</b>	Sept. 7, 2018
<b>Quarrying Permit No.</b>		<b>Inspection Date:</b>	October 04, 2018
<b>Contractor:</b>	Procore	<b>Subcontractor:</b>	
<b>Location(s) Inspected:</b>	W-85 sites and access into the site		
<b>Current Stage of Operation:</b>	Drill was not in operation , core being hauled out.		
<b>Program Modifications Approved:</b>

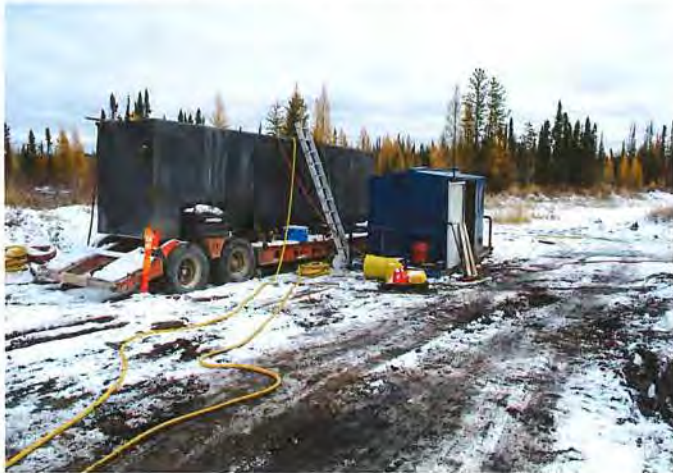
**Figure 1**  
Water Supply and drill waste tanks.

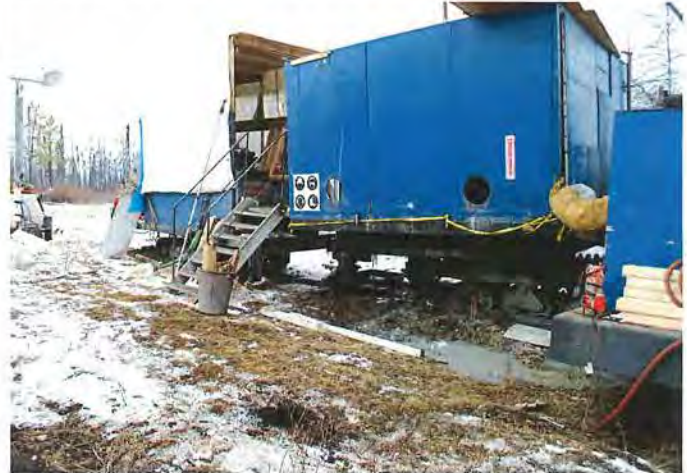
**Figure 2**  
Drill rig on hole W 85 18 PP 004.

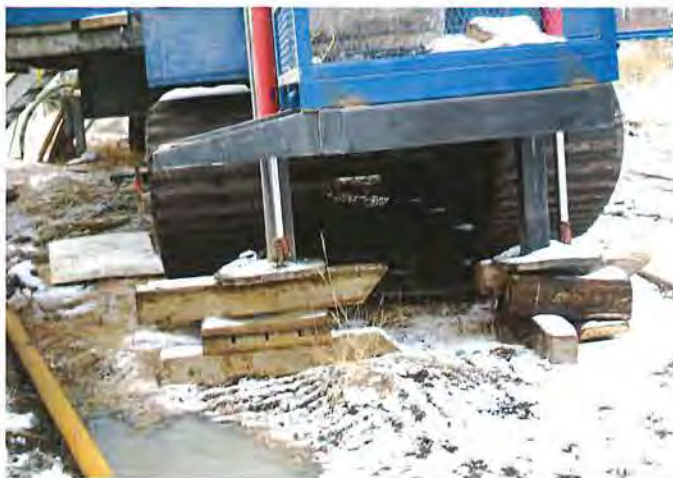
**Figure 3**  
Drill with drip tray under it.

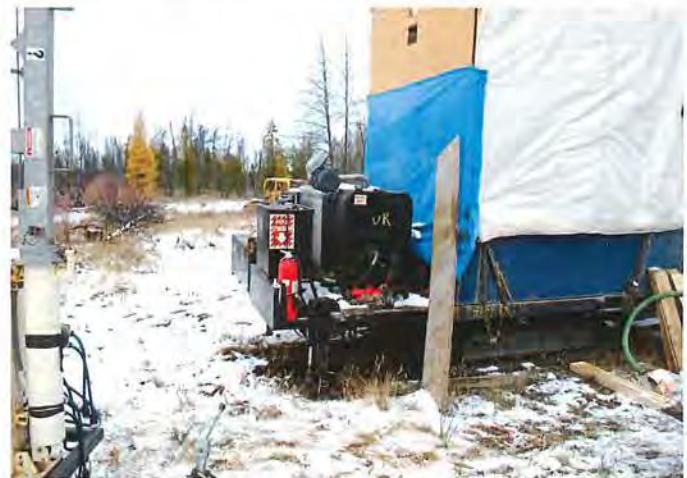
Artesian well flowing hole. Secondary containment on tanks on drill rig. Access route.

**Figure 4**  
Tanks on drill unit no secondary containment.

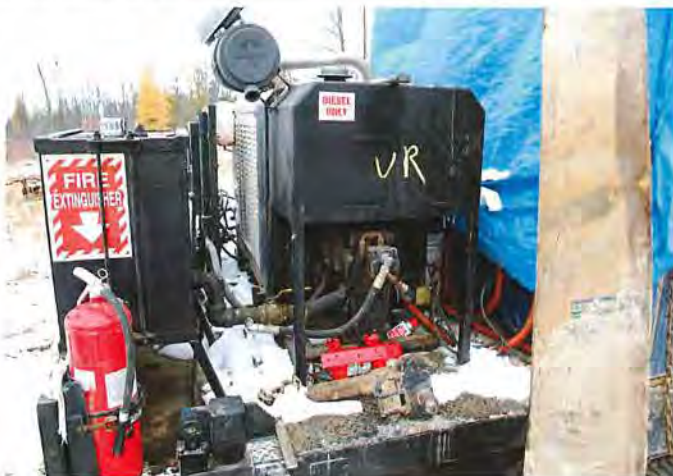
**Figure 5**  
Close up of hydraulic tank on left and diesel tank on right.

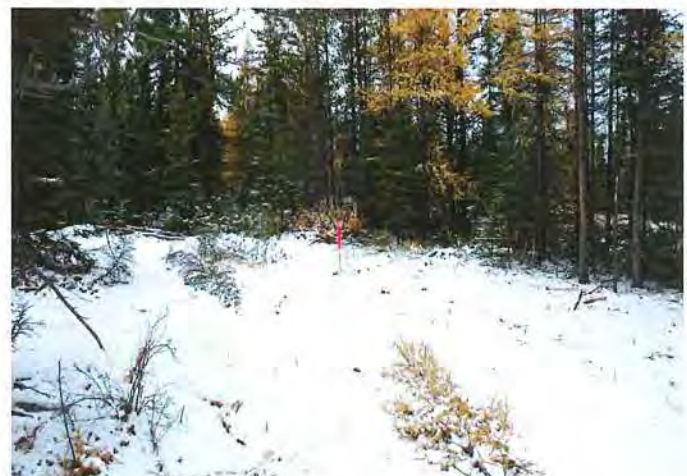
**Figure 6**  
View of finished hole W85 18 PP 002.

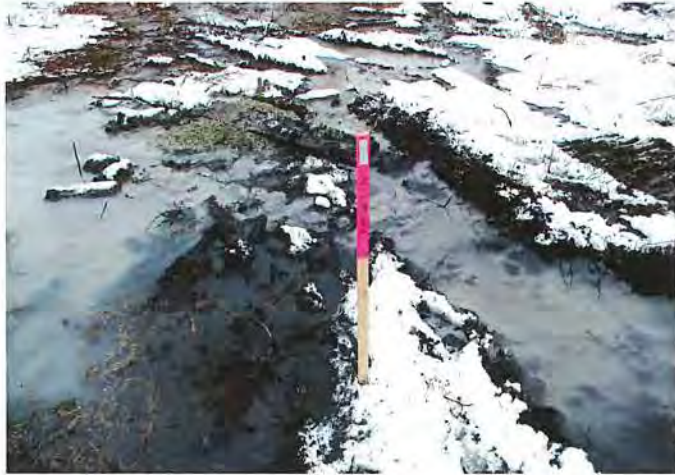
Condition # 27 ( Picture # ) Site that is being drilled, W8518PP004, looked good, using a tank to collect drill cuttings and recirculate the water. Its then hauled back to sump near old haul road. Four holes have been drilled in the area with W-85 18 PP-003 (N60 50 06.7 W114 47 27.9) having water flowing out of the hole with a strong sulfur smell in the area. Talking to staff an attempt was made to plug it but it continues to flow. Inspectors were contacted to inform them of the artesian well and plans to plug it. A reminder that under condition # 24 as well as stopping the flow the Board should be advised of this as

**Figure 7**  
View of flowing water at drill hole 003.

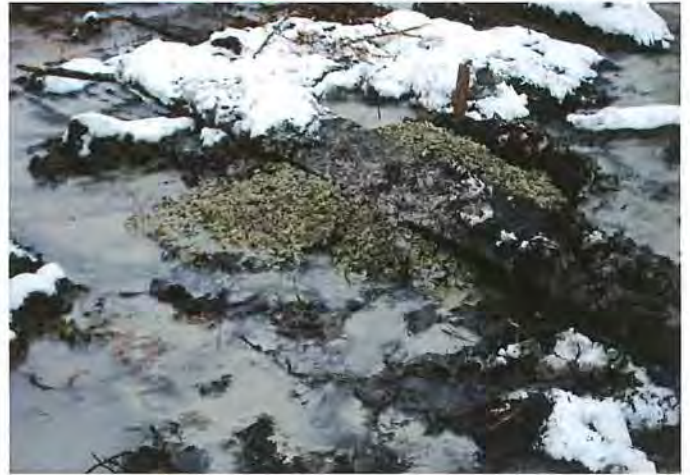
well. H2S gas was high enough from the hole to trigger the detector on the drill rig. Water is supplied via a water truck from the old pit N 81. Three pumps are located close to the shoreline and should be pulled back and in containment similar to what the fuel and oil on site are in. (Picture #15) Around the drill rig and area was pipe, hose and other drilling materials laying on the ground. With the snowfalls that have occurred it is recommended that these outlying items be more consolidated so are not forgotten at site. As mentioned in the last two reports for the 2018 permit, this drill rig is out of compliance as the diesel and hydraulic tanks that are not in secondary containment. (pictures # 4 & 5) This rig should not be used until such time that there is secondary containment under these tanks or tanks changed to double walled. It was noted that all equipment parked on site had drip trays under them.

**Figure 8**  
W 85 18 PP 003 flowing water from drill hole.

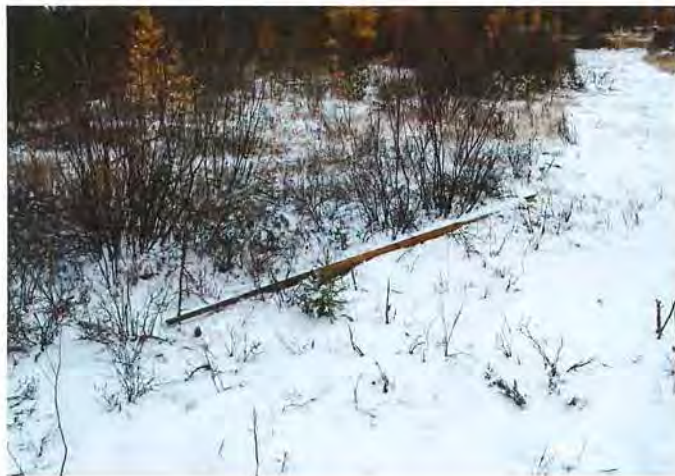
**Figure 9**  
Pipe and metal rod near drill sites.

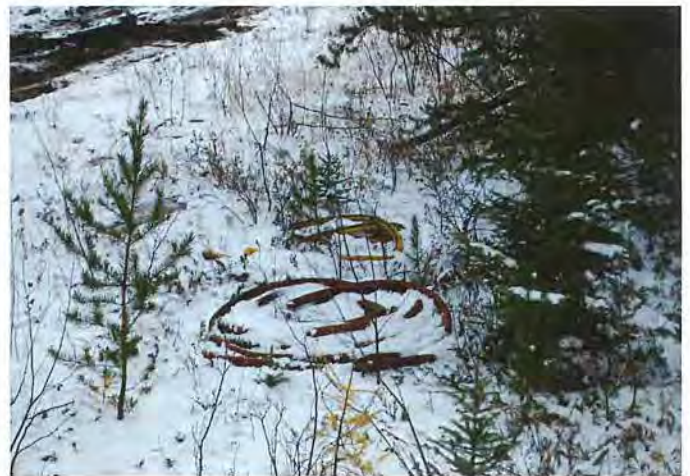
**Figure 10**  
Hose near drillsites being covered.

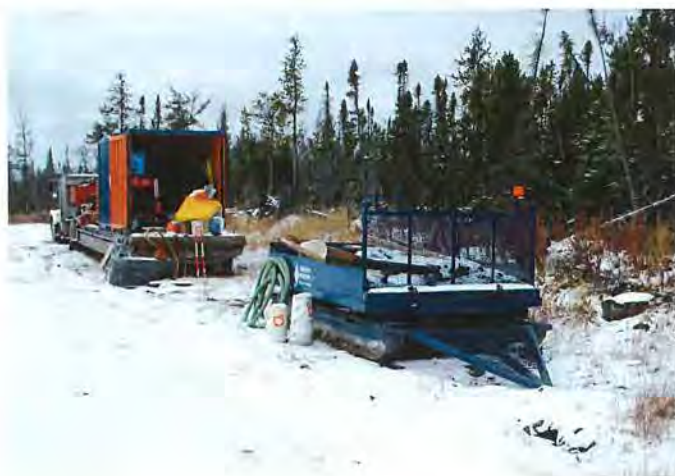
**Figure 11**  
Staging area near W 85 drill.

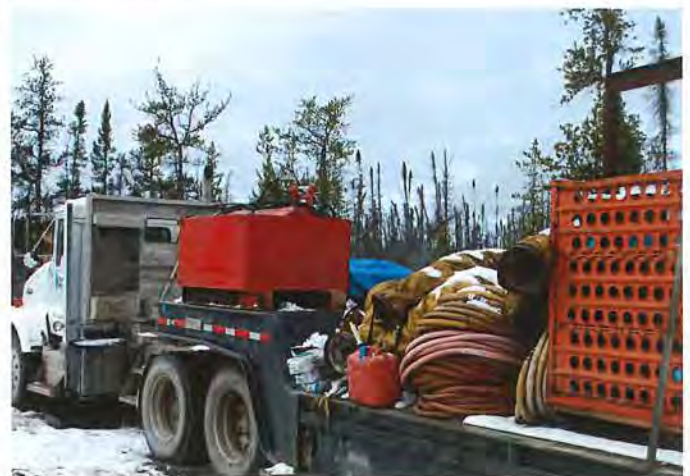
**Figure 12**  
Jerry can sitting precariously on edge of low boy.

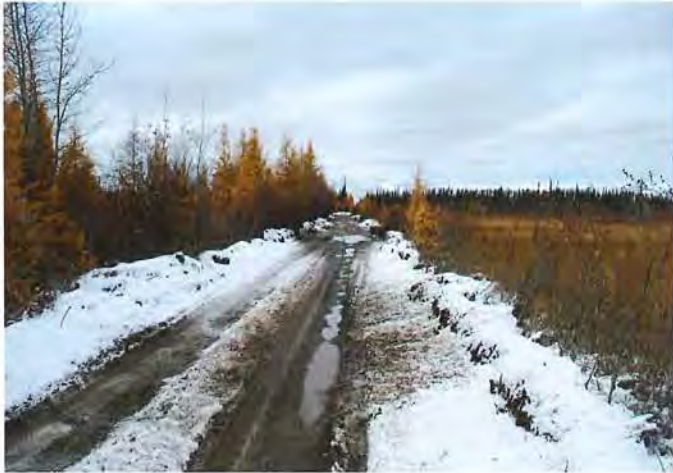
**Figure 13**

Access into the W85 sites is about a 10 km overland drive from end of existing mine road and then utilizes existing cutlines and access. Site is in a recent burn area and partially in soft swampy ground. Access in to the site goes thru swampy areas and is starting to show signs of rutting, recommend that work be suspended and wait for the ground to fully freeze.

Soft area showing signs of rutting on access into W-85.

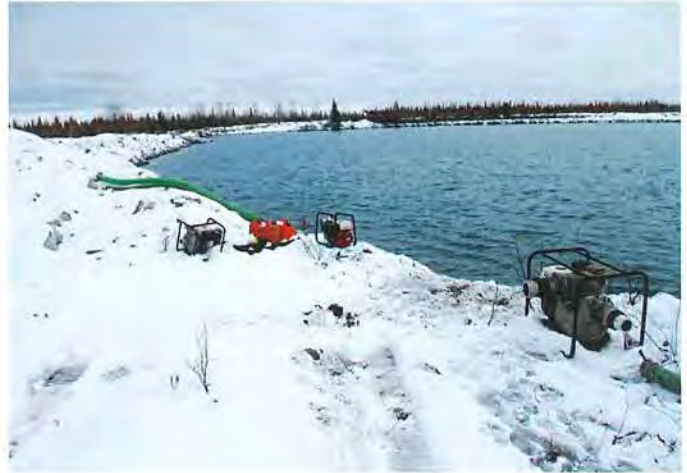
**Figure 14**

Pumps on edge of bank.

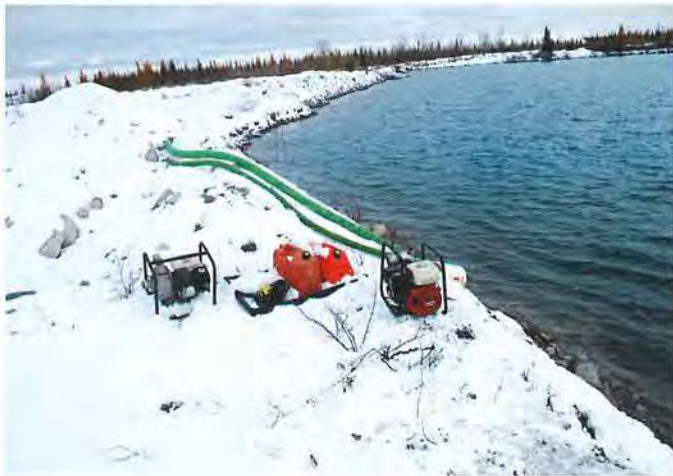
**Figure 15**

Water pumps on edge of shoreline.
