File Number MV2017C0024
Type of Operation MINERAL EXP - drilling
Location Camp , X-65 Area , access into W-85

An inspection of the above noted operation was conducted on February 28, 2019 by Manager, Resource Management Rob Walker.

ENVIRONMENTAL INSPECTION REPORT

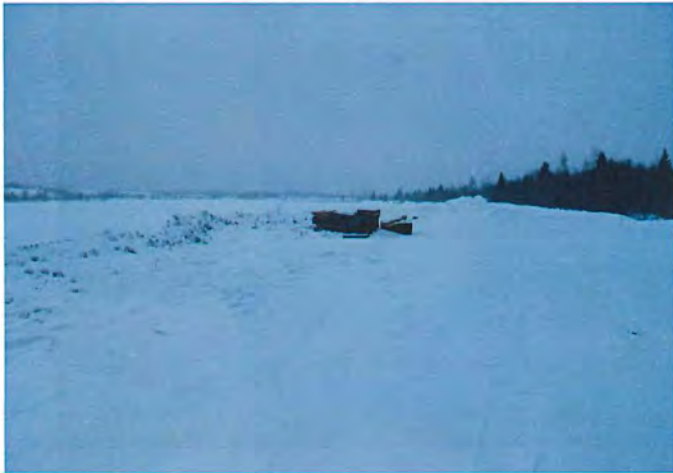
Figure 1

Inspected X-65 sites where both Foraco and Great Slave drilling had been before pulling out. Everything looked good, did observe at the staging area Foraco had been using that there was still a pile of pallets and a large tire drag left there. On top of the Z-64 waste rock pile(60 51 17.2 N 114 37 35.3 W) discovered 9 bags of frozen drill waste that need to be dealt with. Along the access back to the campsite just near the turnoff near the camp another staging area with empty coreboxes and two metal buildings and a c can was stored.

Old Foraco staging area with pallets and tire drag.

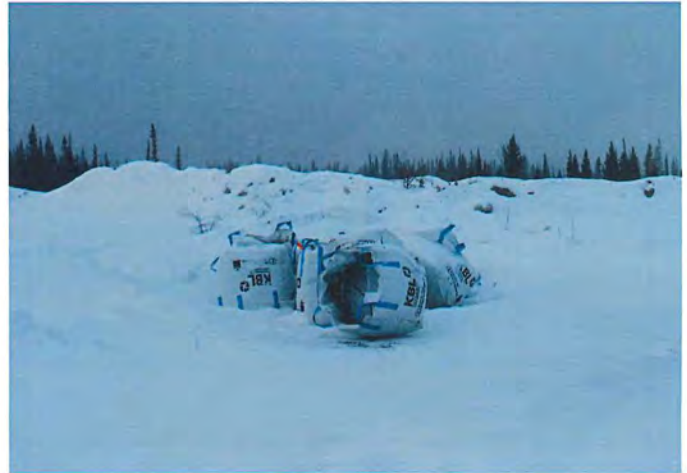
Figure 2

9 Bags of drill waste on top of Z64 waste rock pile.

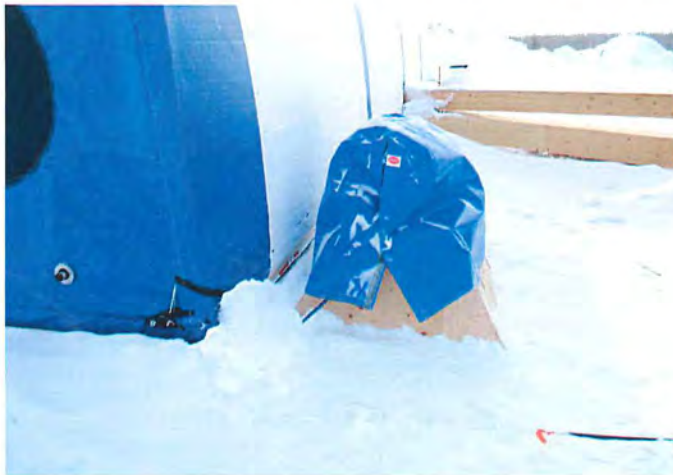
Figure 3

Cover on top of tent fuel drum and spill tray.

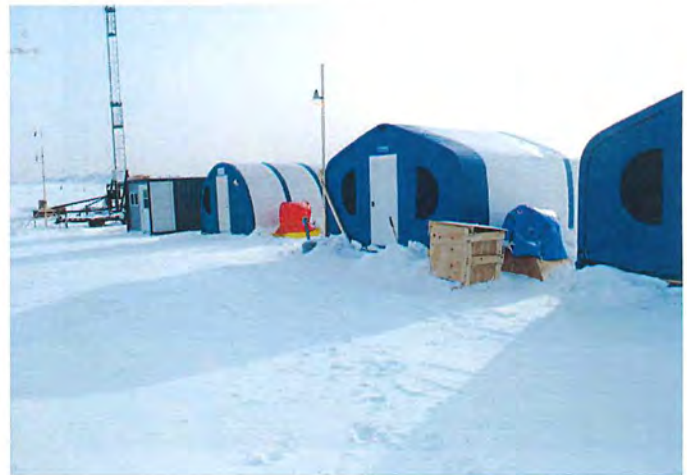
Figure 4

View of main camp buildings.

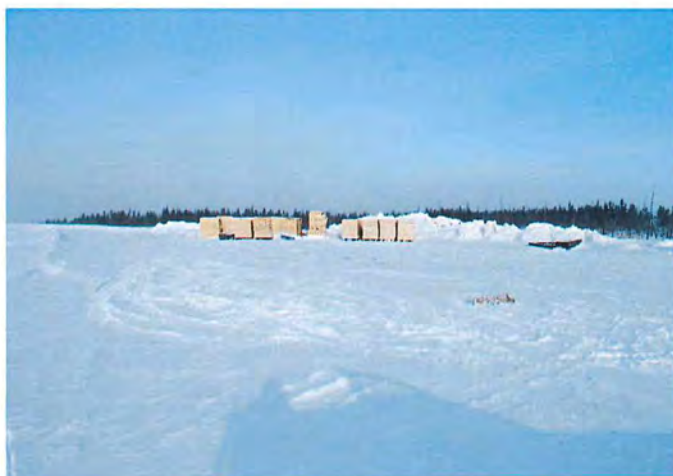
Figure 5

Staging area along main haul road with empty core boxes.

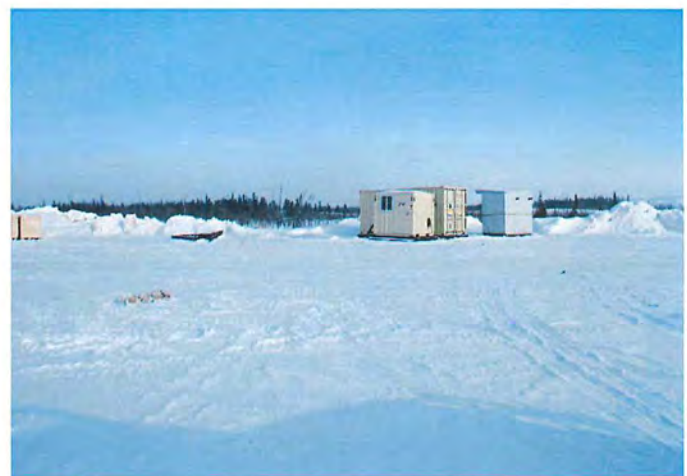
Figure 6

Buildings next to empty core boxes.

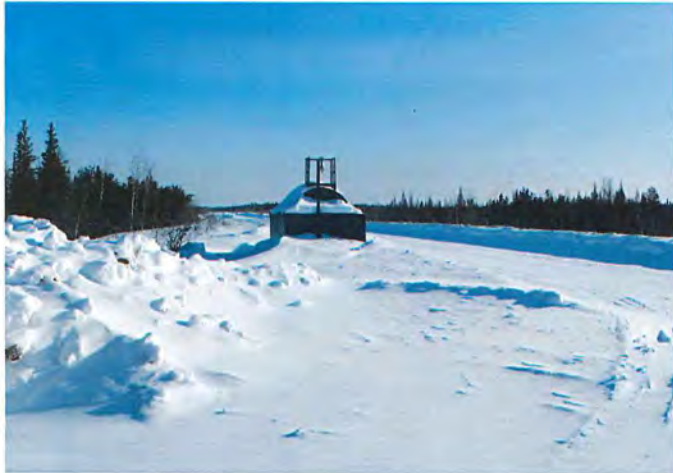
Figure 7

Great Slaves large tank next to haul road.

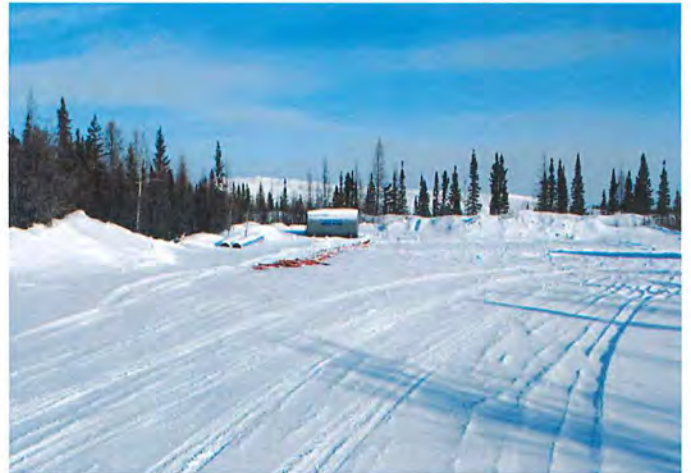
Figure 8

Checked out Great Slave Drilling staging area close to the camp still had the following items, 2 smaller tanks for water, couple of lengths of culvert, lots of hose laying out or rolled up, Quonset with building materials and equipment inside and finally one large water tank parked next to the main haul road.

Great Slave staging area with tanks, culverts and hoses.

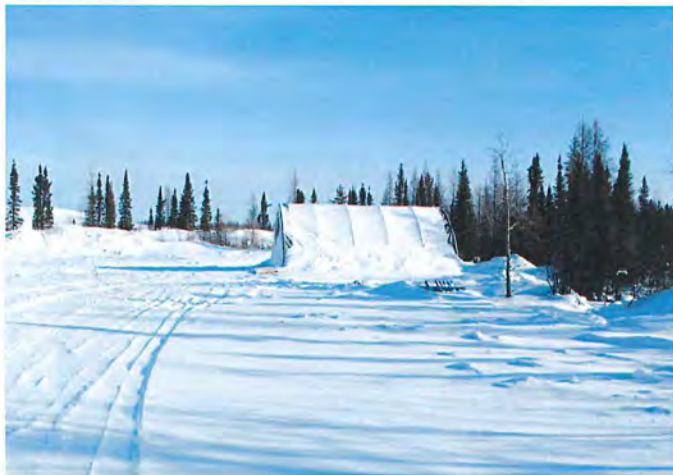
Figure 9

G S staging area with Quonset structure.
