**Re: Land Use Permit MV2017X0005  
Bluefish Lake Hydro Facility  
Bluefish Lake, NT**

## ENVIRONMENTAL INSPECTION REPORT

Location(s) Inspected:	Winter road.
------------------------	--------------

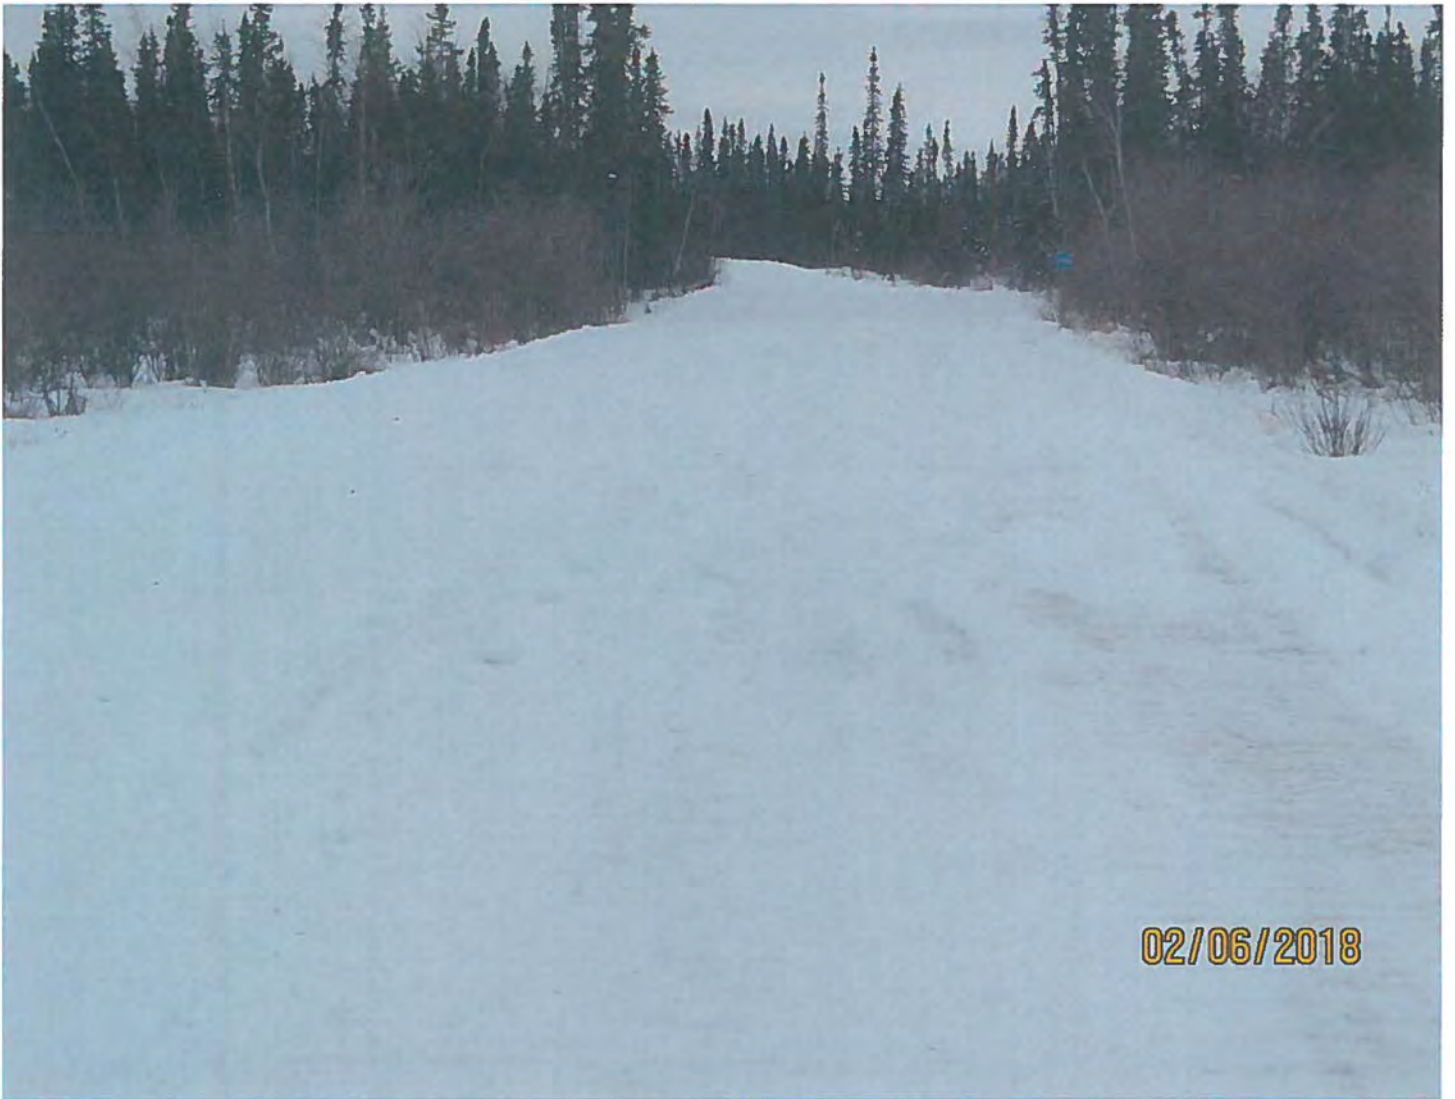
At the time of the inspection, work on the first portage (Photo #1 & #2) was underway with personnel icing the ramps onto portages with pumps. Also, a Pisten Bully (Photo #3) was gathering snow from the ice surface of McMeekan Bay and Prosperous Lake for snow fills and construction of portages to achieve compliance with Condition #11 of the permit.

Photo #1 - MV2017X0005 - NTPC - Bluefish Winter Road  
Looking south at the first portage (P70). Snowcat is pushing snow from the lake into the portage.

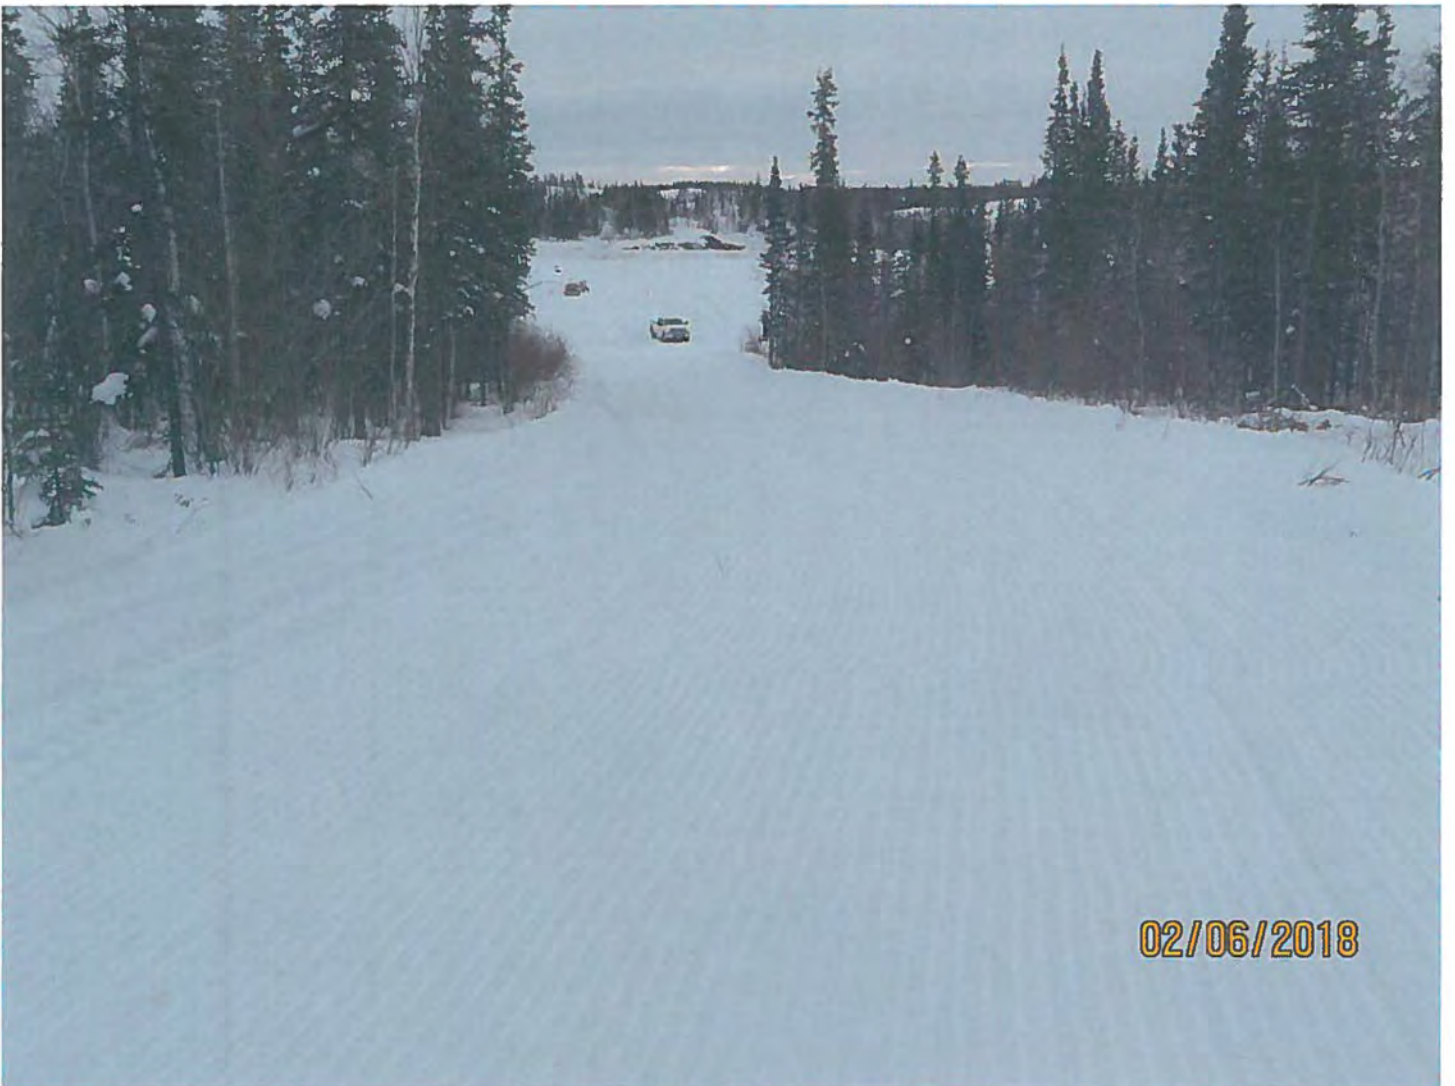
The Inspector was informed by Mr. Rocher that a water truck will be mobilized into the land use area on February 7<sup>th</sup>, 2018 and will begin icing in the first portage. Once complete, it will then be used on the second portage of the winter road which is located at the north end of Prosperous Lake.

Photo #2 - MV2017X0005 - NTPC - Bluefish Winter Road  
Southern ramp onto the first portage is being iced by hand and a water truck will be mobilized on Feb 7, 18.

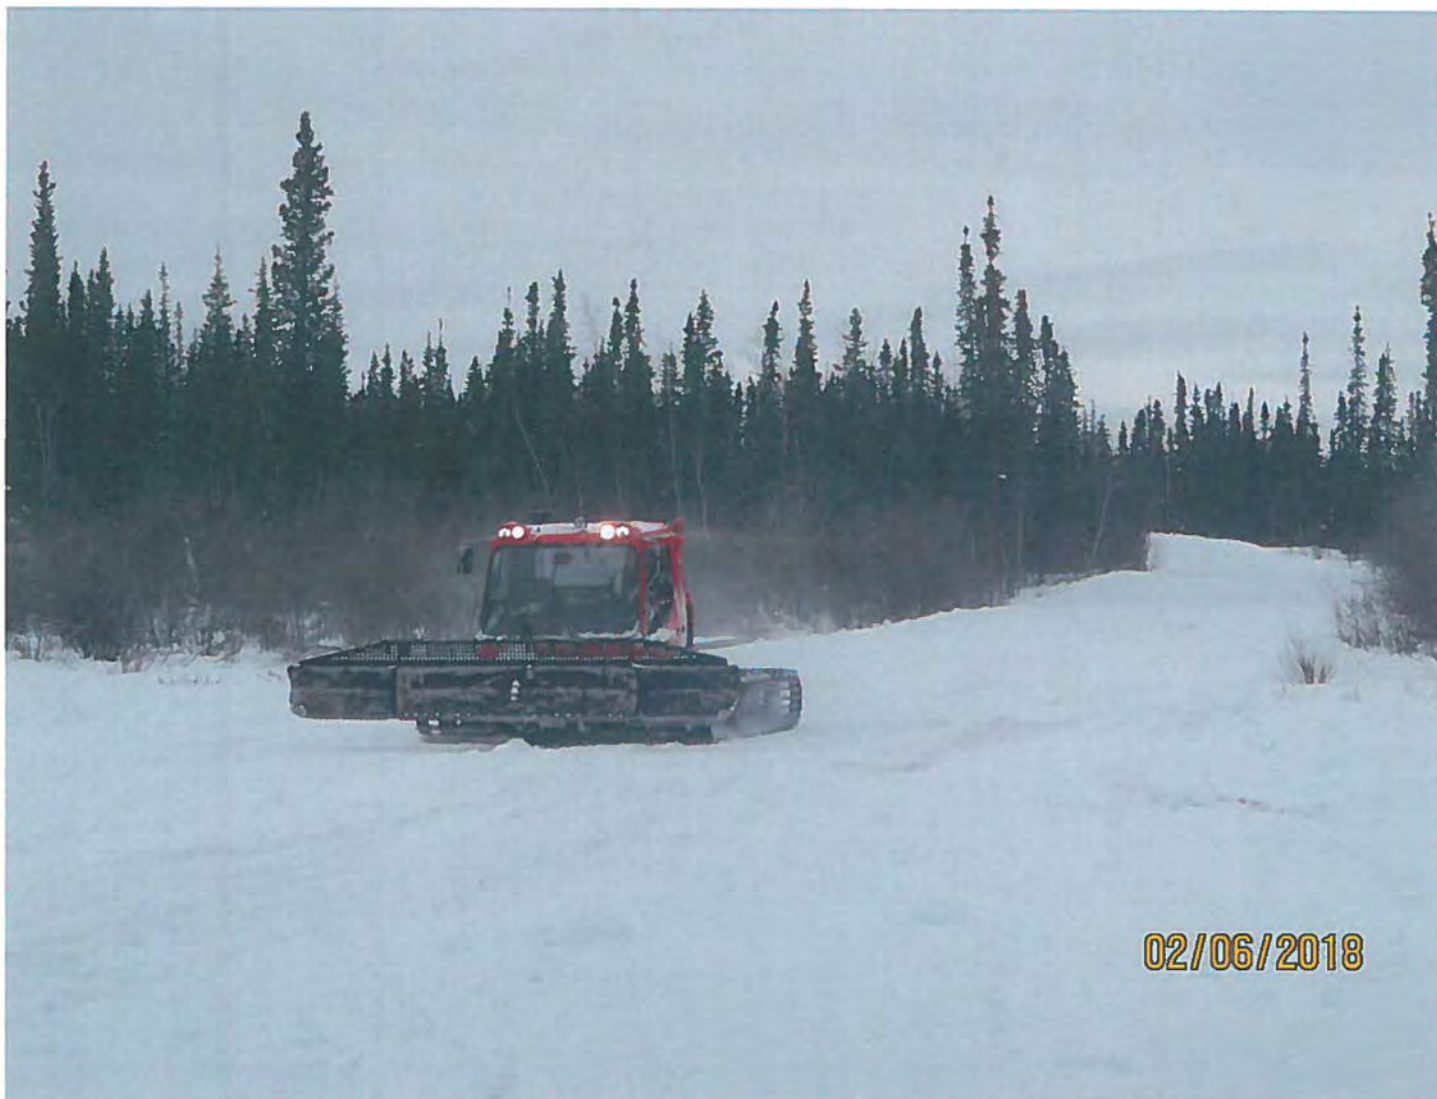
Photo #3 - MV2017X0005 - NTPC - Bluefish Winter Road  
Pisten Bully actively working on the first portage (P70).

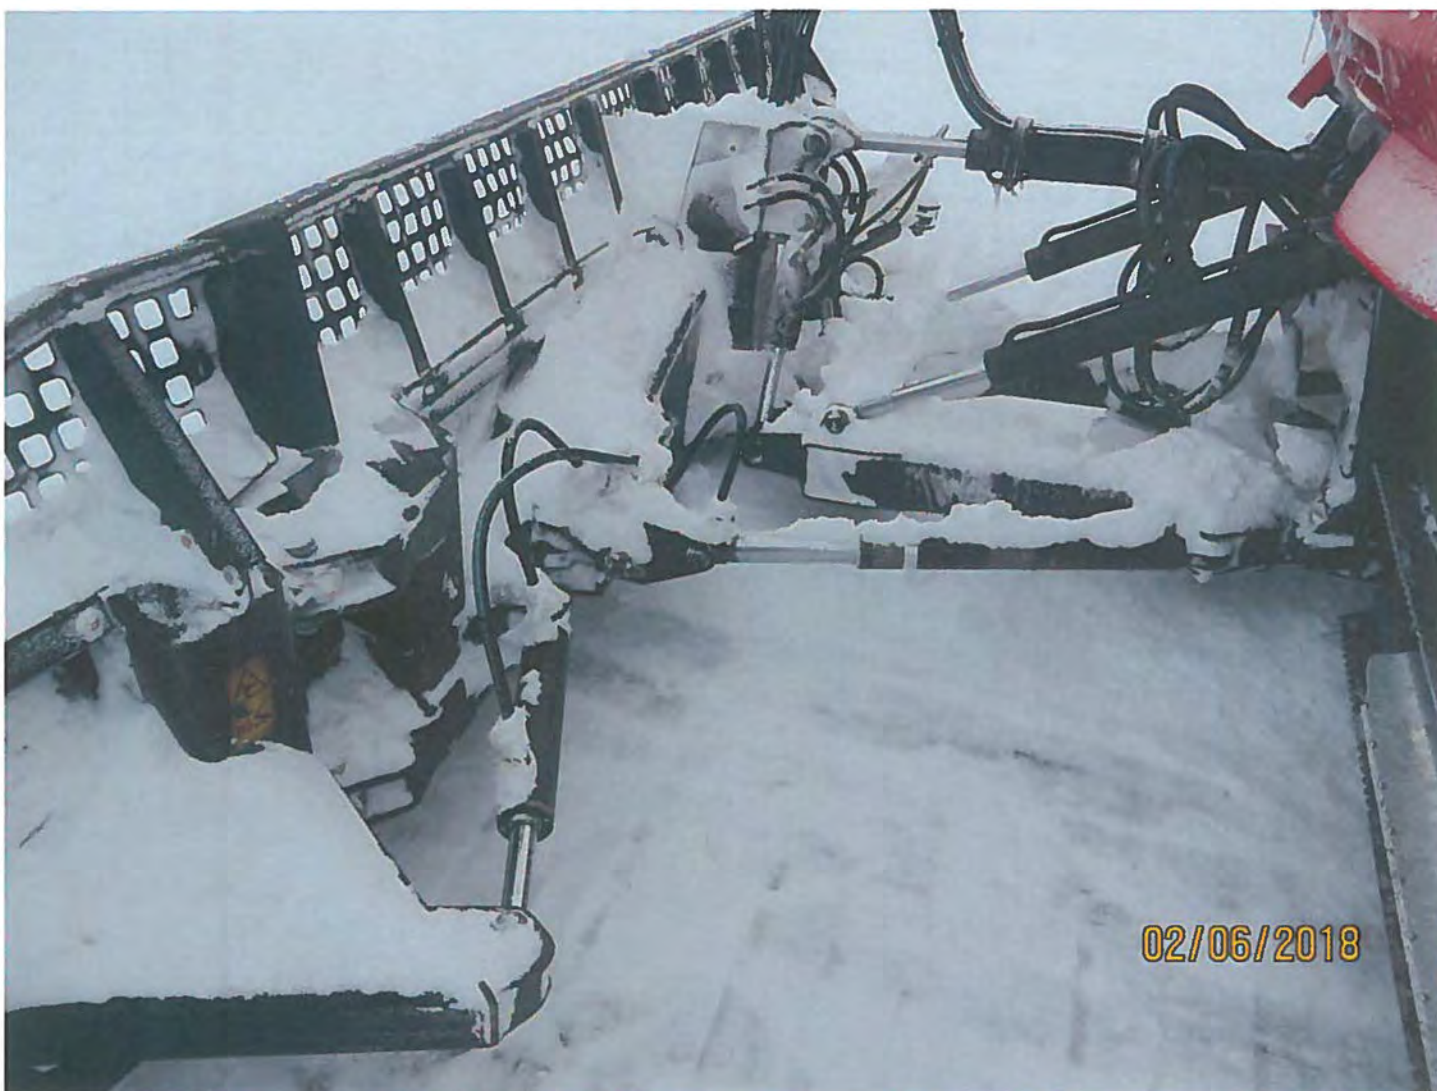
No concerns were noted during the inspection since the Pisten Bully appeared to be operating cleanly as no major hydrocarbon leaks/spills were observed, the fittings on this piece of equipment were wrapped with hydrocarbon absorbent matting when possible (Photo #4), no displaced organics were observed on the first portage, drip trays for placement under parked equipment were on hand, and adequate spill response materials were readily available in the crew pickup located on McMeekan Bay.

Photo #4 - MV2017X0005 - NTPC - Bluefish Winter Road  
No hydrocarbon leaks of concern were noted on the blade of the snowcat. When possible, fittings are wrapped with absorbent matting.
