File Number	MV2017X0007
Type of Operation	Miscellaneous
Location	The three quarry sites and camp at KM 36.3 on Highway 6

ENVIRONMENTAL INSPECTION REPORT

Permittee:	GNWT - Department of Infrastructure	Permit Expiry Date:	March 15, 2022
Land Use Permit No.	MV2017X0007	Previous Inspection:	September 11, 2017
Quarrying Permit No.	2017QP0013	Inspection Date:	October 24, 2017
Contractor:	Rowes Construction	Subcontractor:	
Location(s) Inspected:	The three quarry sites and camp at KM 36.3 on Highway 6		
Current Stage of Operation:	Active crushing of material		
Program Modifications Approved:

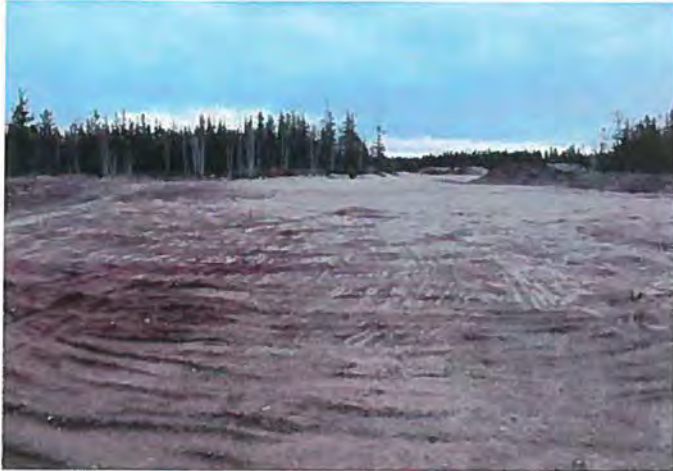
Figure 1

Site 1: Over view of site

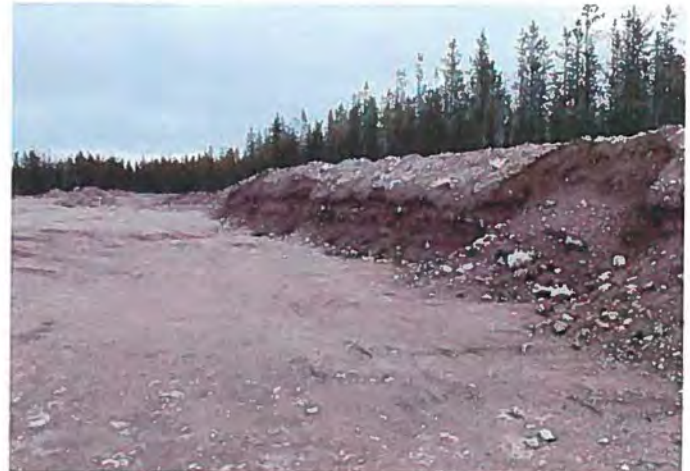
Figure 2

34. The Permittee shall slope the sides of waste material piles, excavations and embankments – except in solid rock- to a minimum ration of 2:1 vertical, unless otherwise authorized in writing by an inspector.

There are slopes that are too steep as shown in Figure 2.

Site 1: Steep edges

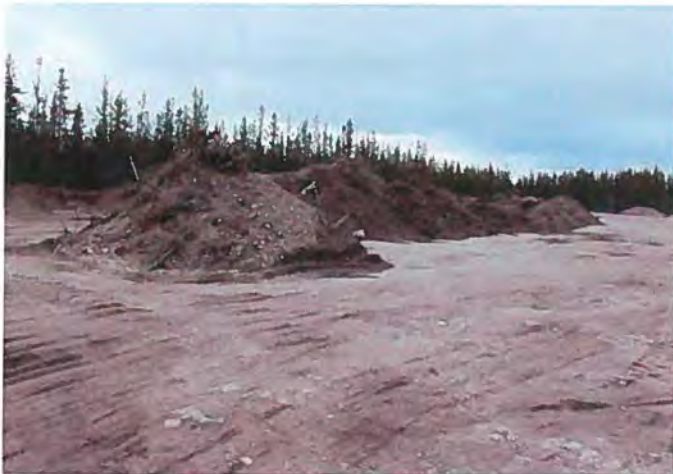
Figure 3

Site 1: Overburden

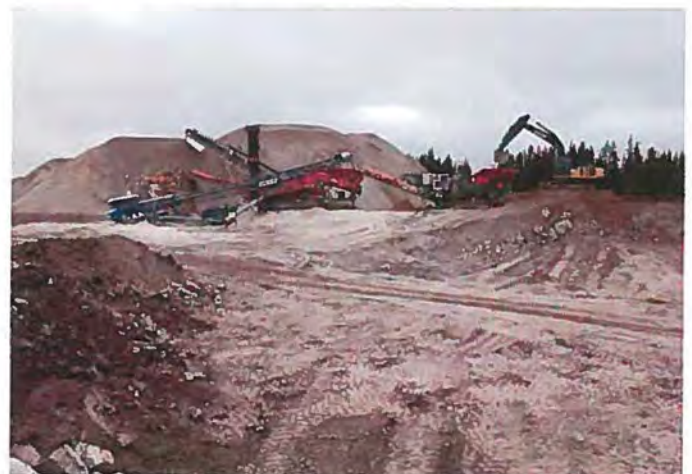
Figure 4

Site 2: Crushers, sorters, and excavator

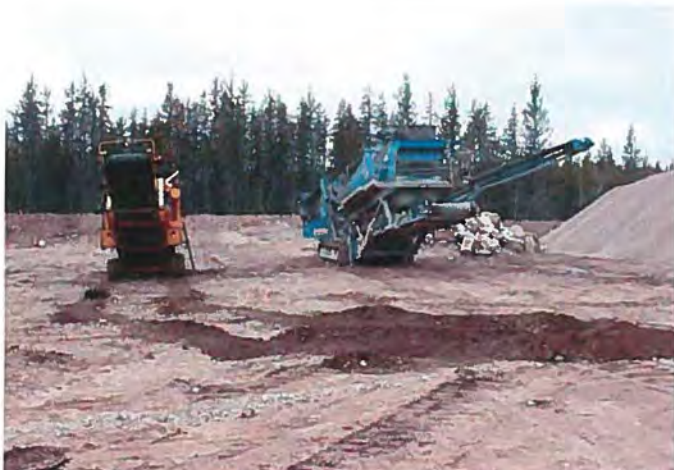
Figure 5

72. All equipment that may be parked for two hours or more, shall have hazmat/drip tray under it or be sufficiently diapered. Leaky equipment shall be repaired immediately.

The crushers not being used did not have drip trays. If equipment is parked greater than two hours then secondary containment is needed.

Site 2: Crushers not being used

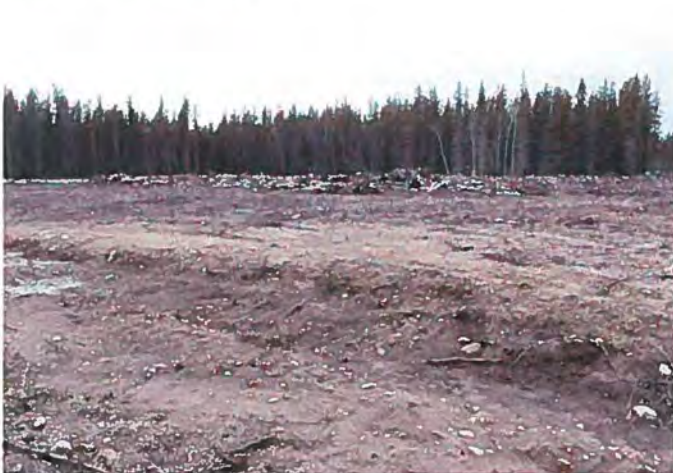
Figure 9

83. The permittee shall carry out progressive reclamation of disturbed areas as soon as it is practical to do so.

Site 3: Brush debris

Since Site 3 will not be used the site should be reclaimed as soon as practical. This would include spreading and crushing the brush debris with heavy machinery.

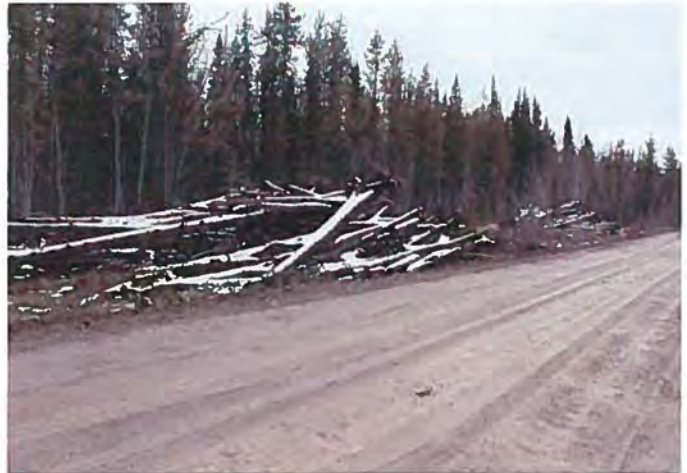
Figure 10

There are piles of trees that are to be used by Timberworks.

Site 3: Trees to be used by Timberworks

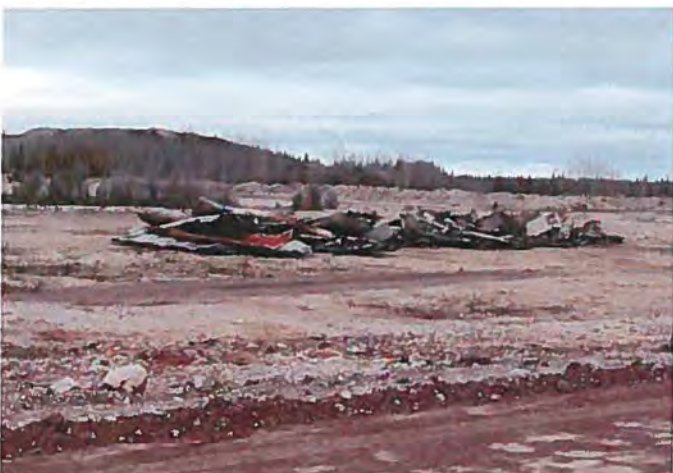
Figure 11

The heavy equipment and fuel containers have been removed. What remains is a pile of used culverts. They need to be removed to an approved facility.

Staging Area: Culverts
