November 23, 2018

<b>File Number</b>	<b>MV2017X0007</b>
<b>Type of Operation</b>	<b>MISC.</b>
<b>Location</b>	Pine Point access road. Access from Km 38.3, Hwy 6

An inspection of the above noted operation was conducted on October 01, 2018 by Manager, Resource Management Mike Vassal.

## ENVIRONMENTAL INSPECTION REPORT

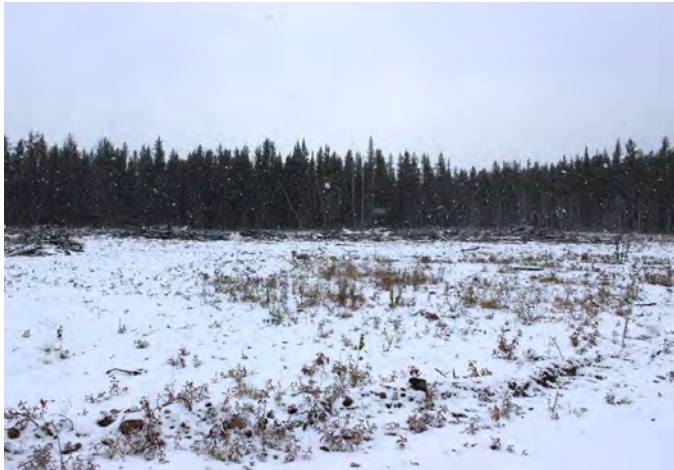
**Figure 1**

Site 3 is the cleared area that was not developed (Figure 1) .

**Undeveloped Site 3. Downed vegetation at back of site needs to be dealt with**

The brush on site needs to be dealt with as per Land Use Permit (LUP) condition 74. It can be

spread over the site and walked down by heavy equipment.

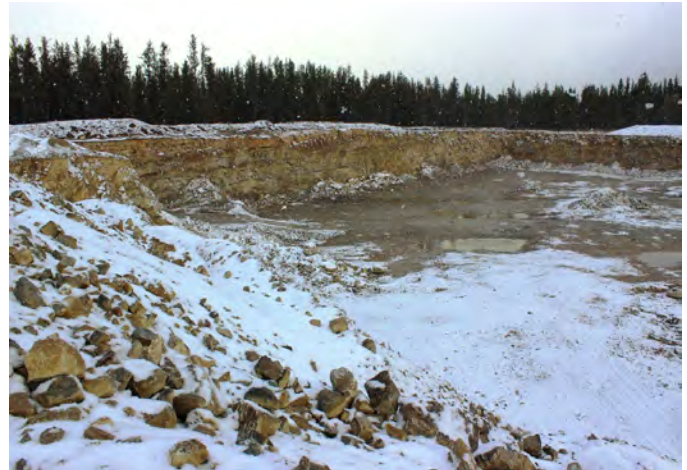
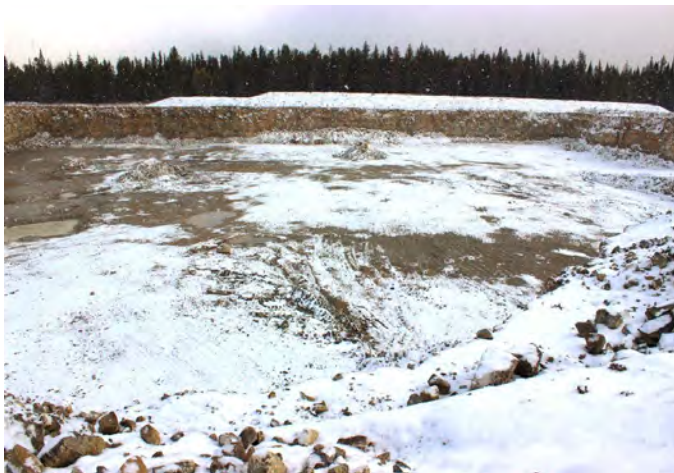
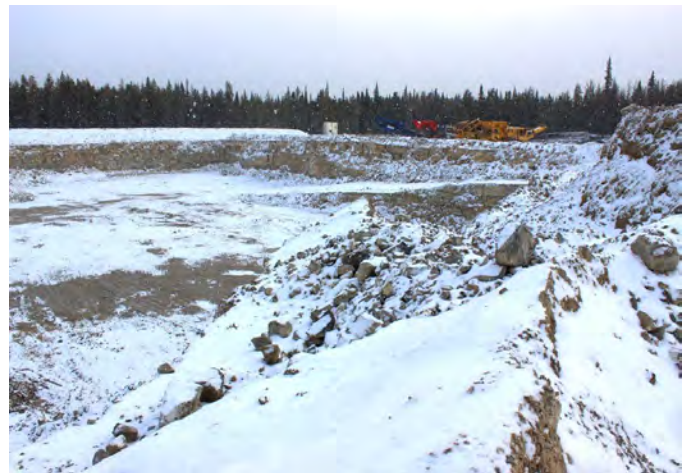
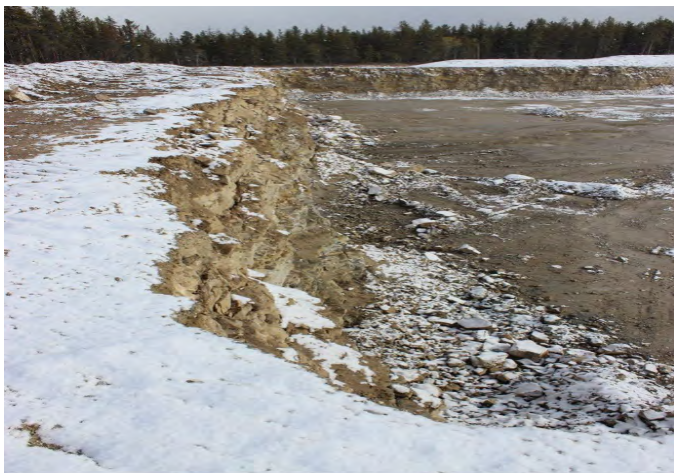
Site 2 is the quarry site (Figures 2 to 5). There is a safety berm around this steep-sided quarry. There are a few areas where there is no berm. For safety reasons the berm needs to be extended so that it is continuous around the quarry, except for the access road into the quarry.

**Site 2 quarry and berm**

**Site 2 quarry**

**Site 2 quarry wall**

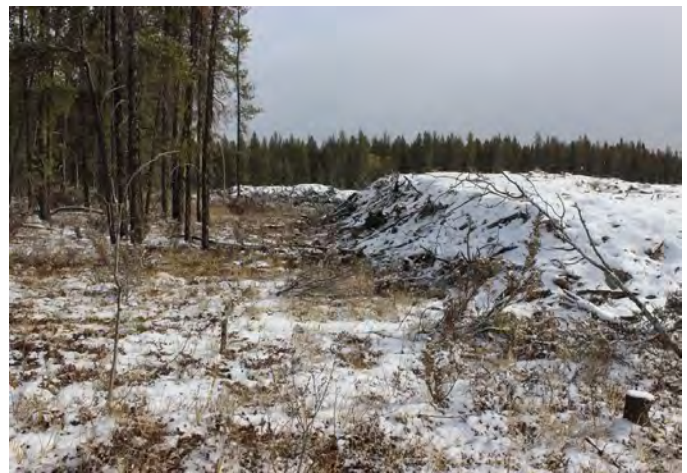
**Figure 6**

**Site 2 berm and buffer strip**

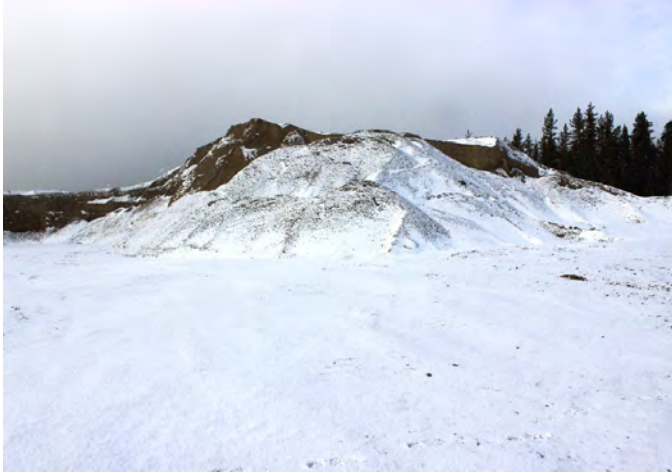
**Figure 7**  
**Site 2 material pile**

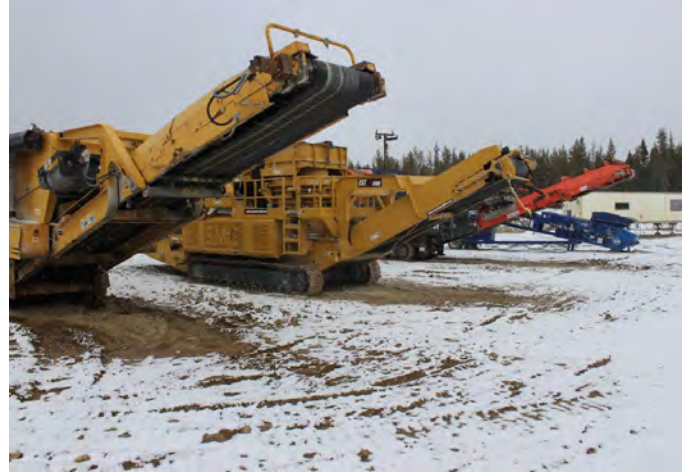
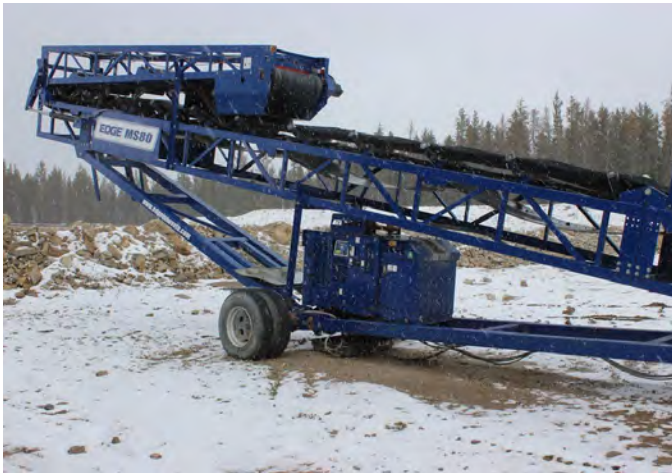
Most of the equipment remaining at the quarry site had drip trays (Figures 8 and 9). Please ensure that all parked machinery has some form of secondary containment.

**Figure 8**  
**Site 2 equipment**

**Figure 9**  
**Site 2 equipment**

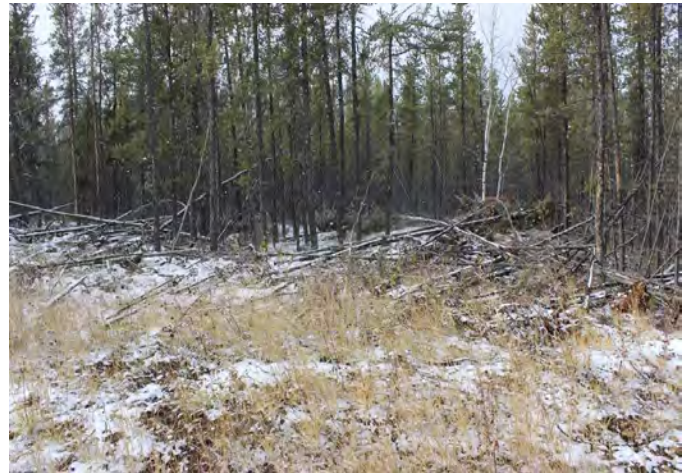
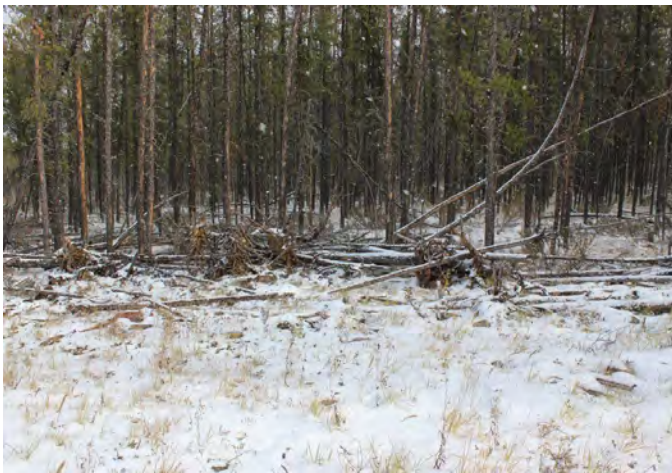
The group walked the exploratory trails behind the Site 2 quarry. Some areas had been cleared and the trees were pushed into the forest. The trees and roots need to be pulled out of the forest and compacted on these sites (Figures 10 and 11). The trees in this area are larger and should have been salvaged, as per LUP condition 76. The test pits need to be filled in, as per LUP condition 14 (Figure 12).

**Figure 10**  
**Trail behind Site 2: trees pushed over**

**Figure 11**  
**Trail behind Site 2: trees pushed into forest**

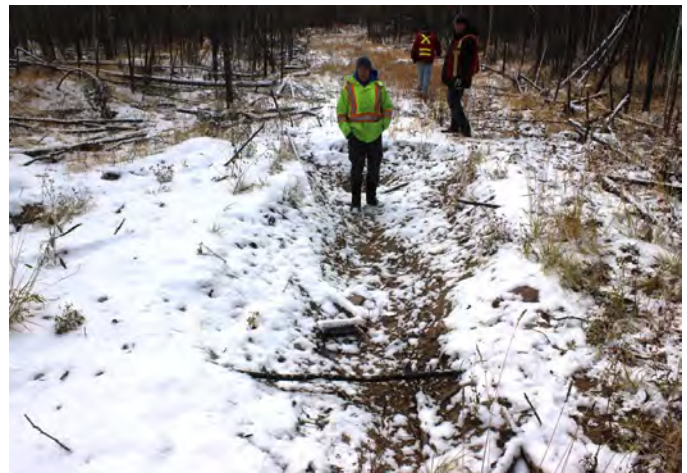
**Figure 12**  
**Test pit on trail behind Site 2**

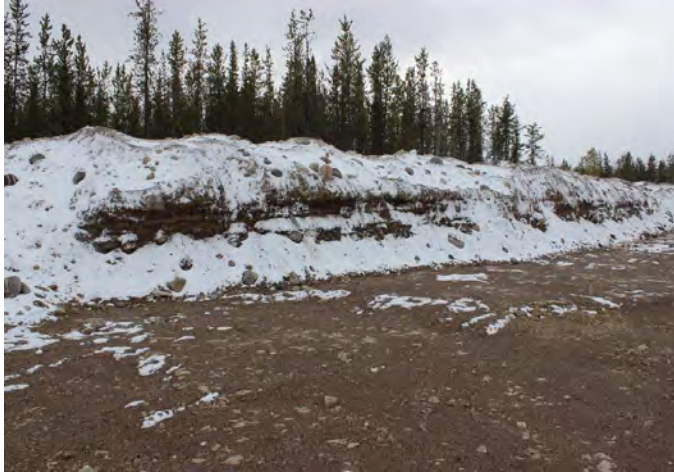
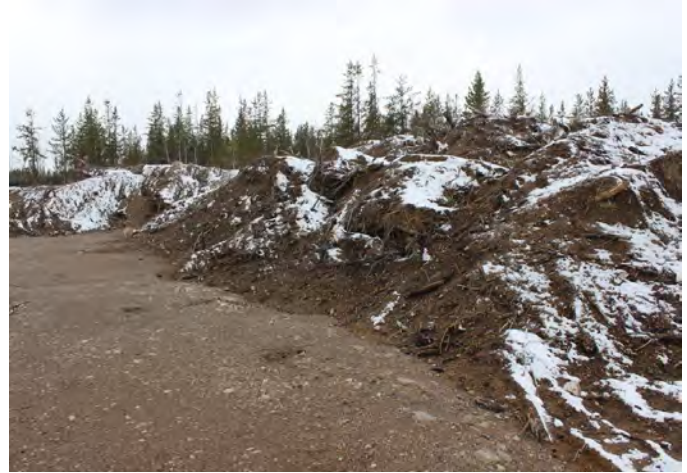
Site 1 was not active. There were trees mixed with rocks and overburden in large piles (Figures 13 and 14). If there are no plans to continue to work at this site, the piles need to be spread out over the site as per LUP condition 79. If work will continue at this site, the piles need to be graded to a minimum of 2:1 as per LUP condition 34.

**Site 1 overburden**
