**File Number** MV2017X0018  
**Type of Operation** HWY MAINTENANCE & OPERATIONS  
**Location** Buffalo River Bridge, NWT Highway No. 5

## ENVIRONMENTAL INSPECTION REPORT

An inspection was conducted of the Buffalo River Bridge site near Km 55, NWT Highway No. 5 by Resource Management Officers Norman McCowan and Jayda Robillard on June 22 and 25, 2018. The inspection was conducted to ensure compliance with the terms and conditions annexed to Land Use Permit MV2017X0018.

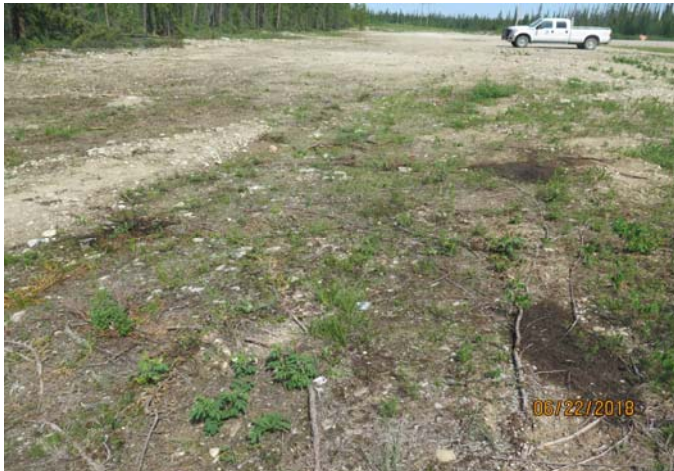
**Figure 1**

Several hydrocarbon stains were observed near the cement plant site and truck staging area on the northwest side of the Buffalo River Bridge. The spills on the west side as seen in Figure 1 were cleaned up satisfactorily on the weekend of June 23-24, 2018 as confirmed during the June 25, 2018

06/22/18 – Hydrocarbon spills at Site #1.

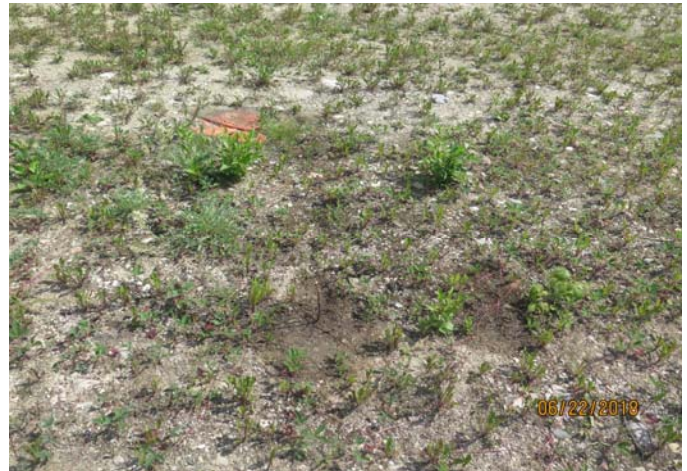
**Figure 2**

06/22/18 – Hydrocarbon spills at Site #1.

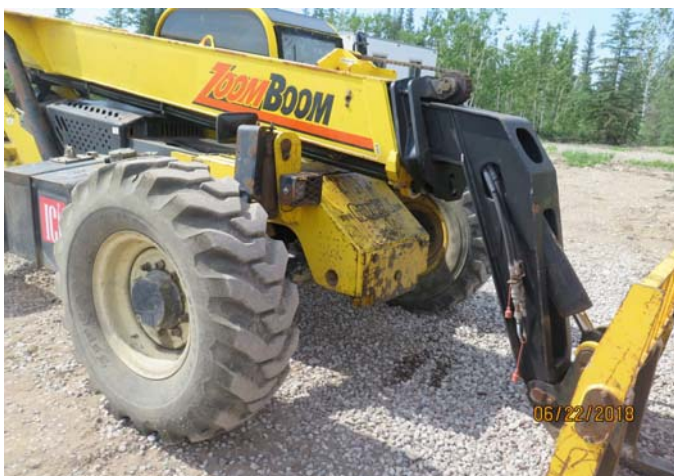
**Figure 3**

The northeast side of the bridge was used for vehicle and equipment parking, office trailers and storage during the bridge project. Numerous spills were located throughout this project area. A loader parked on June 22, 2018 was leaking hydraulic oil as seen in Figures 3-4.

06/22/18 – Contractors loader leaking hydraulic oil at Site #2.

- The Permittee is required to clean-up all hydrocarbon spills and haul the contaminated material to an authorized disposal site in accordance with Permit Condition #76.

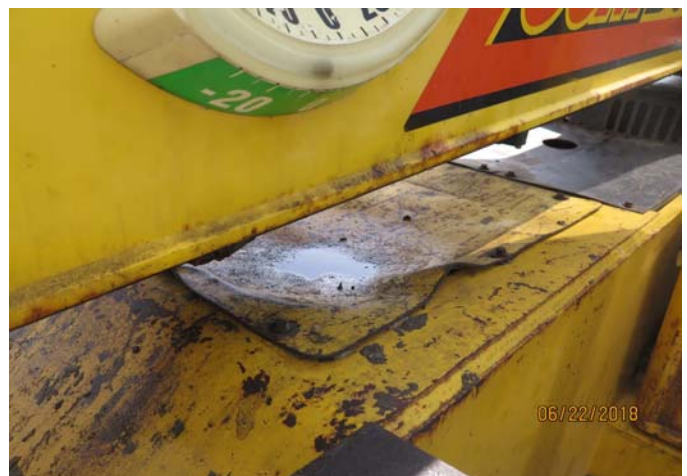
**Figure 4**

06/22/18 – Contractors loader leaking hydraulic oil at Site #2.

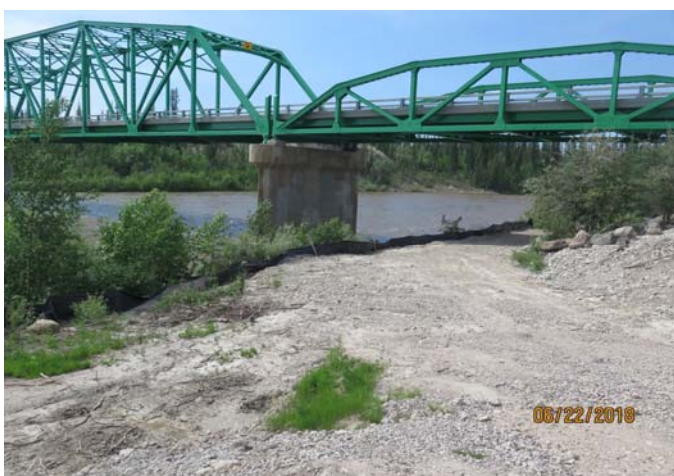
**Figure 5**

Silt fencing installed for sedimentation control next to the Buffalo River at the commencement of the bridge project has not been removed. This was discussed with Peter Praetzel who stated that the silt fencing would be left in for another season. The silt fencing has been reinforced and the Inspectors have no objection to the fencing being left.

Silt fencing located on the east side of the Buffalo River.

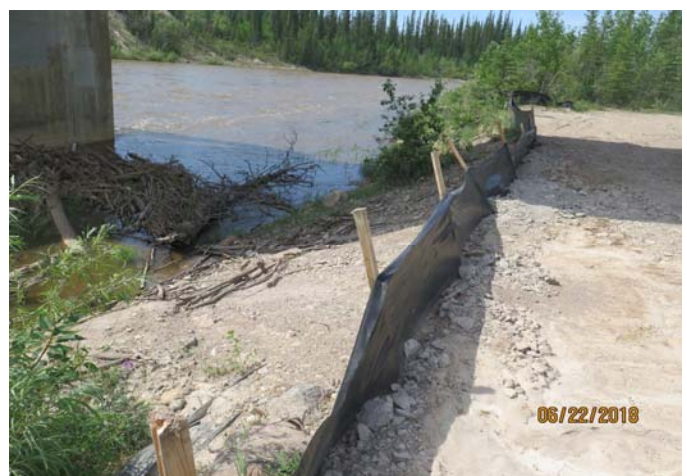
**Figure 6**

Silt fencing has been reinforced and will be left in for another season.

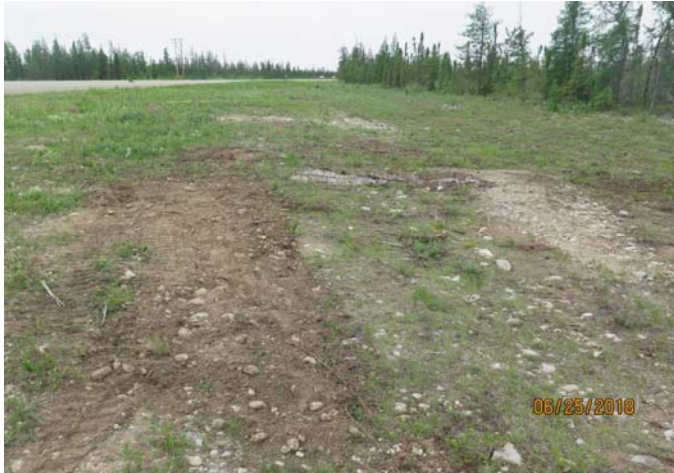
**Figure 7**

inspection. Cleanup of the spills is seen in Figure 7.

Clean-up of the hydrocarbon spill at Site #1 appeared satisfactory.

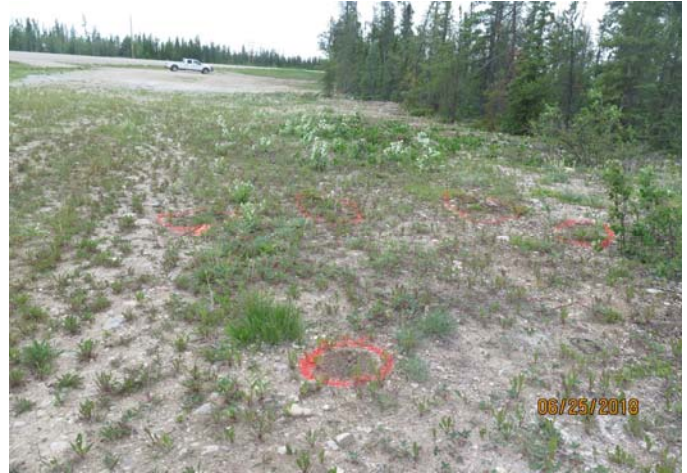
**Figure 8**

However additional spills located on the east side of Site #1 where the cement trucks were parked had not been cleaned up in accordance with Permit Condition #76 which states *“The Permittee shall clean up all leaks, spills and contaminated material”*.

The perimeter of all hydrocarbon spills on the east side of Site #1 were spray painted on the later inspection date to assist the Permittee in locating the spills requiring clean-up (Figures 8-9).

The perimeter of additional hydrocarbon spills at Site #1 were spray painted to assist the Permittee in locating the spills requiring clean-up.

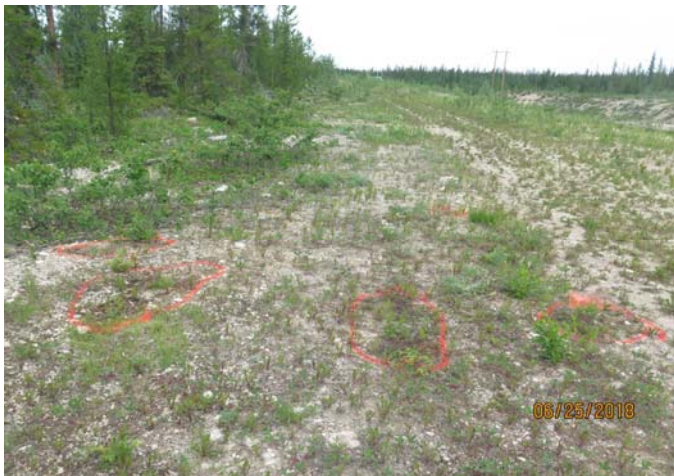
**Figure 9**

Hydrocarbon spills at Site #1 requiring clean-up.

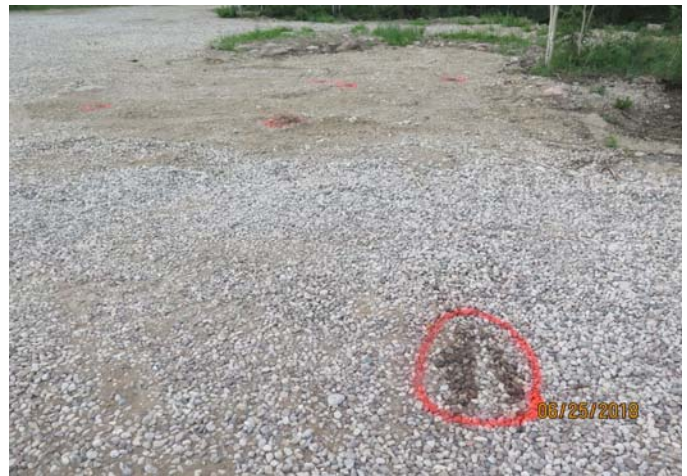
**Figure 10**

The perimeter of all hydrocarbon spills at Site #2 were spray painted on the later inspection date to assist the Permittee in locating the spills requiring clean-up (Figures 10-14).

The perimeter of hydrocarbon spills at Site #2 were spray painted to assist the Permittee in locating the spills requiring clean-up.

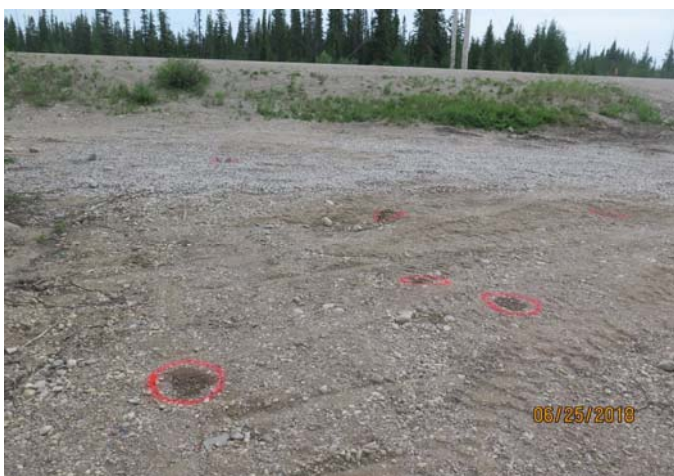
**Figure 11**

Hydrocarbon spills at Site #2 requiring clean-up.

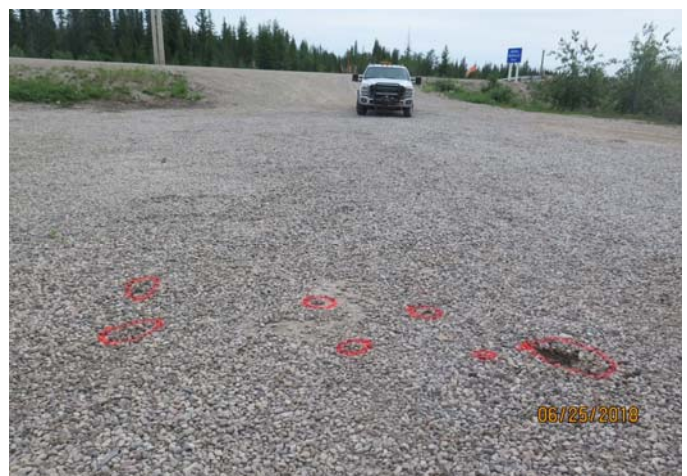
**Figure 12**

Hydrocarbon spills at Site #2 requiring clean-up.

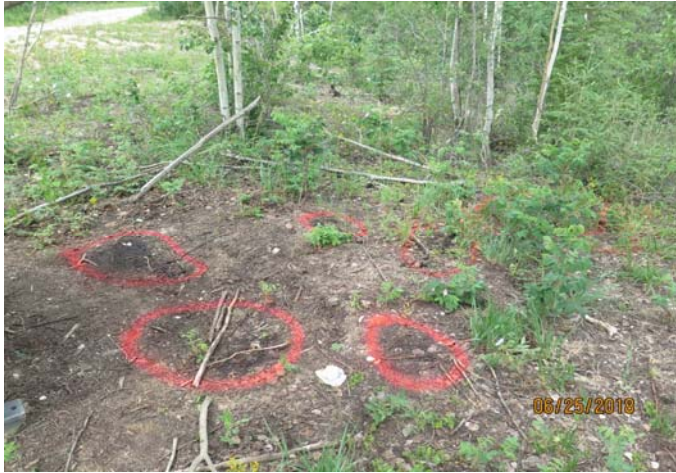
**Figure 13**

Hydrocarbon spills at Site #2 requiring clean-up.

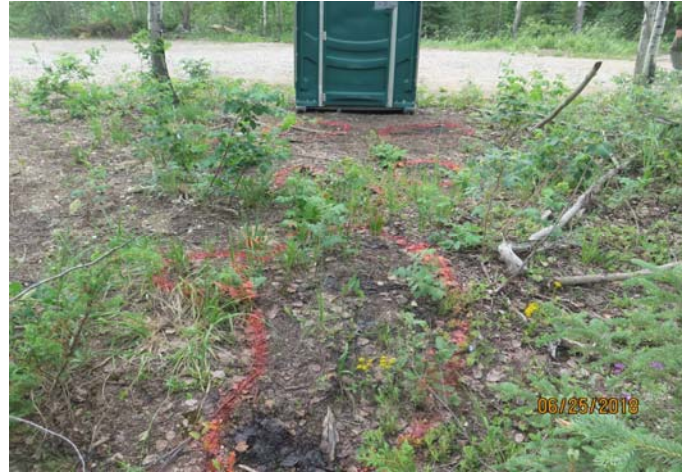
**Figure 14**

Hydrocarbon spills at Site #2 requiring clean-up.
