File Number	MV2017X0018
Type of Operation	HWY MAINTENANCE & OPERATIONS
Location	Hwy 5, Km 84 L

ENVIRONMENTAL INSPECTION REPORT

Permittee:	GNWT - Department of Infrastructure	Permit Expiry Date:	May 14, 2022
Land Use Permit No.	MV2017X0018	Previous Inspection:	September 04, 2018
Quarrying Permit No.	18/0014	Inspection Date:	October 01, 2018
Contractor:	Tetra Tech	Subcontractor:	
Location(s) Inspected:	Hwy 5, Km 84 L		
Current Stage of Operation:	No recent activity		
Program Modifications Approved:

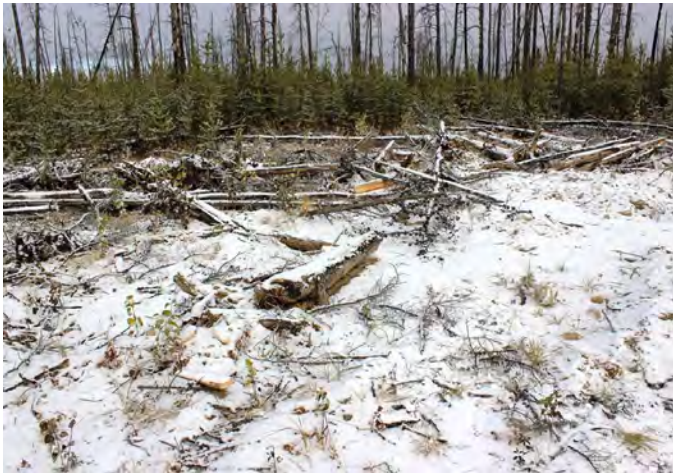
Figure 1

Test Pit #128

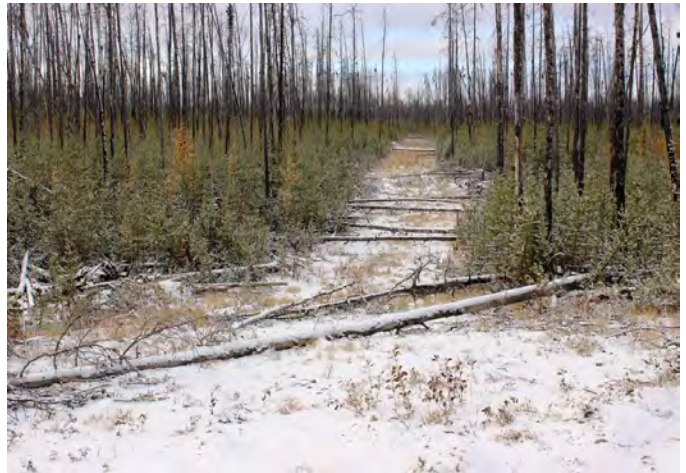
Figure 2

Access trail

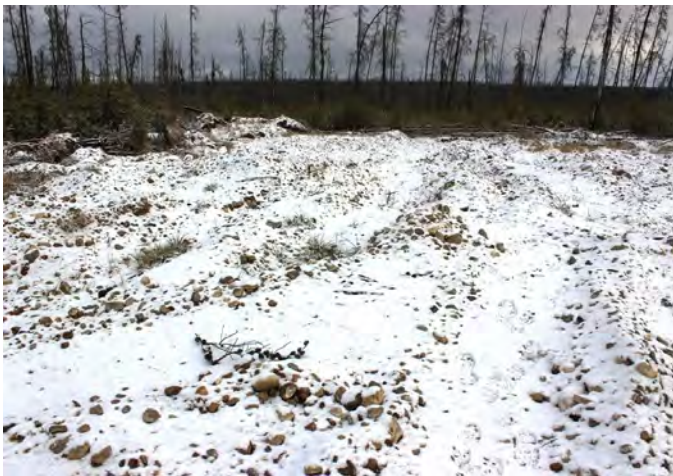
Figure 3

Test pit #124

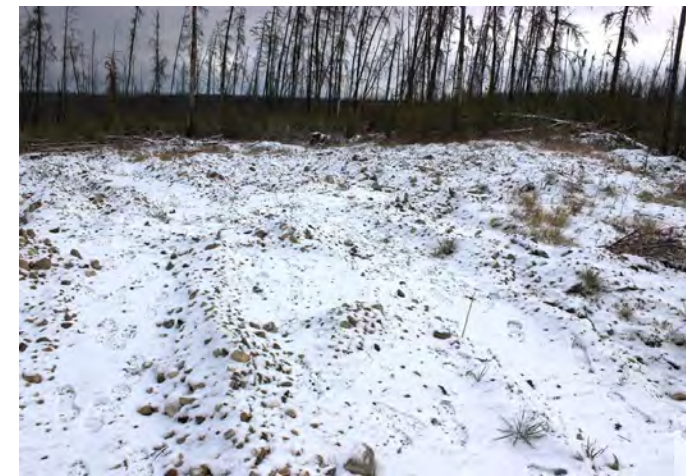
Figure 4

Test Pit #124

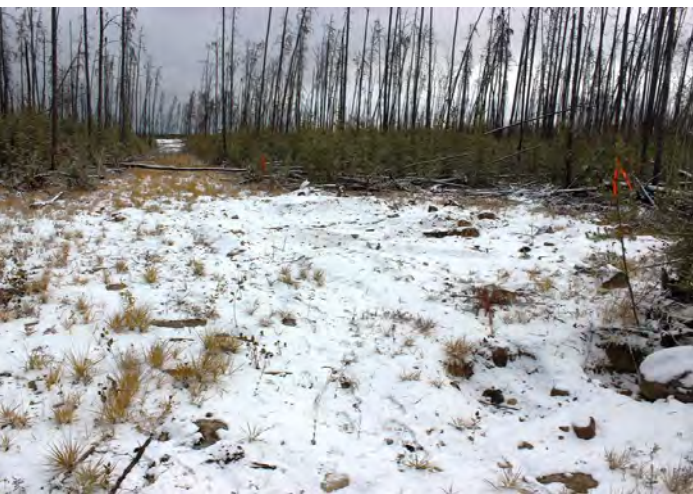
Figure 5

Test Pit #127

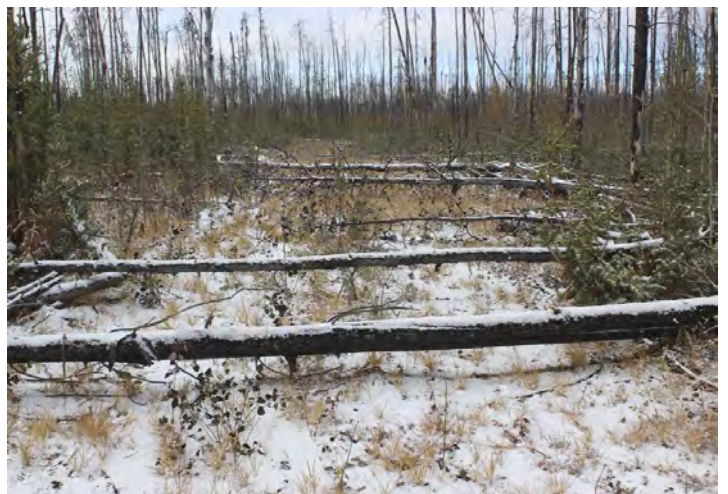
Figure 6

Km 84 L is on the east side of Hwy. 5. This inspection occurred on October 1, 2018. The inspector was accompanied by Sandy Murray, on contract to the Department of Infrastructure and Rob Girvan and Ed Hoeve from Tetra Tech. The group had planned to inspect both 84 L and the work at 84 L 3200. There was a large number of trees that had come down so the inspectors were not able to access the 3200m site.

Trees across access trail

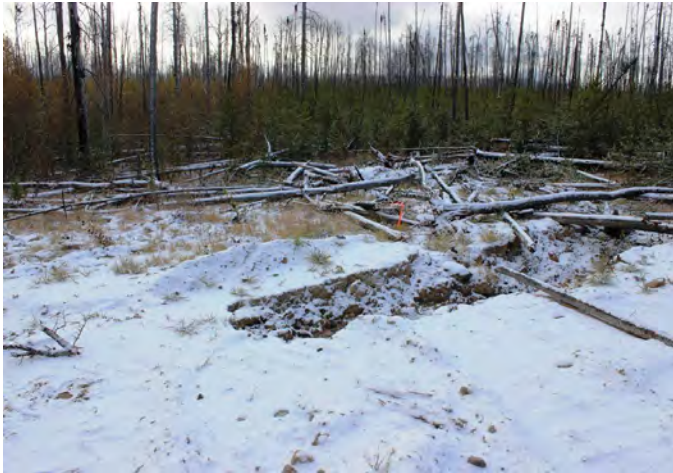
Figure 7

Test Pit #126
