<b>File Number</b>	<b>MV2017X0018</b>
<b>Type of Operation</b>	<b>HWY MAINTENANCE &amp; OPERATIONS</b>
<b>Location</b>	<b>Hwy 5 Km 232</b>

## ENVIRONMENTAL INSPECTION REPORT

<b>Permittee:</b>	GNWT - Department of Infrastructure	<b>Permit Expiry Date:</b>	May 14, 2022
<b>Land Use Permit No.</b>	MV2017X0018	<b>Previous Inspection:</b>	October 01, 2018
<b>Quarrying Permit No.</b>	18/0014	<b>Inspection Date:</b>	September 24, 2018
<b>Contractor:</b>	Carter Industries	<b>Subcontractor:</b>	
<b>Location(s) Inspected:</b>	Hwy 5 Km 232		
<b>Current Stage of Operation:</b>	Active crushing and separating of blast material		
<b>Program Modifications Approved:</b>

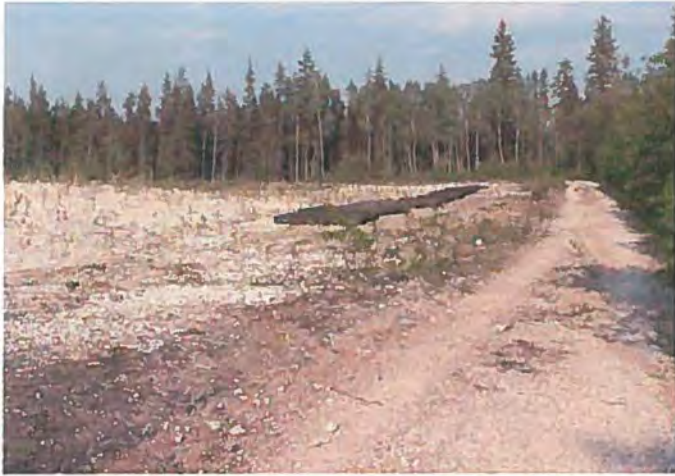
**Figure 1**

Blasting at the Department of Infrastructure quarry at Km 232 on Highway 5 occurred on August 8, 2018. The inspector was notified about the blasting and observed the blast (See Figures 1 to 3). No concerns were noted at the time of the blasting.

**Km 232 SE corner set-up for blasting August 8, 2018**

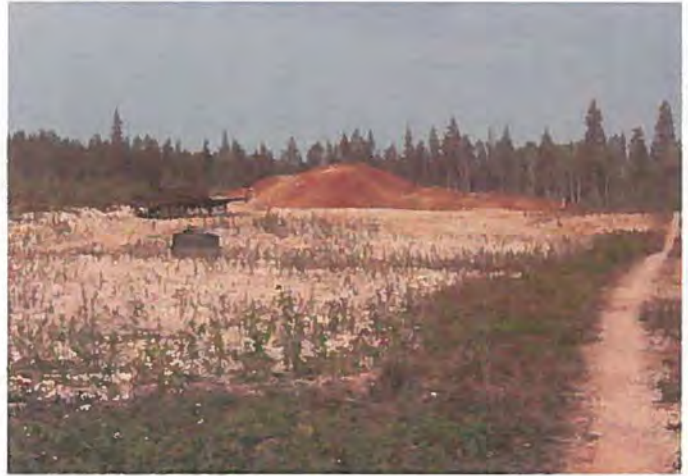
**Figure 2**

**View of site immediately after blasting August 8, 2018**

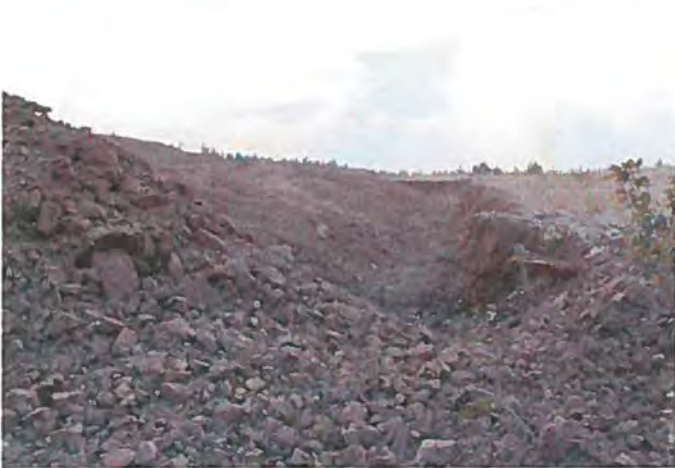
**Figure 3**

**Closer view of material created after blasting August 8, 2018**

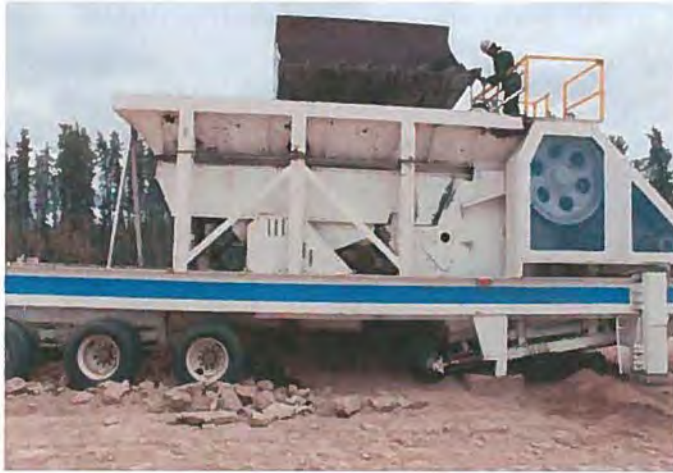
**Figure 7**  
**Crusher**

The inspectors met with the site foreman, Brad and discussed the operation. A leak was observed in the crusher (Figure 7 and 8). Brad said that it would be fixed immediately. Some of the machinery did have drip trays, but their use was inconsistent.

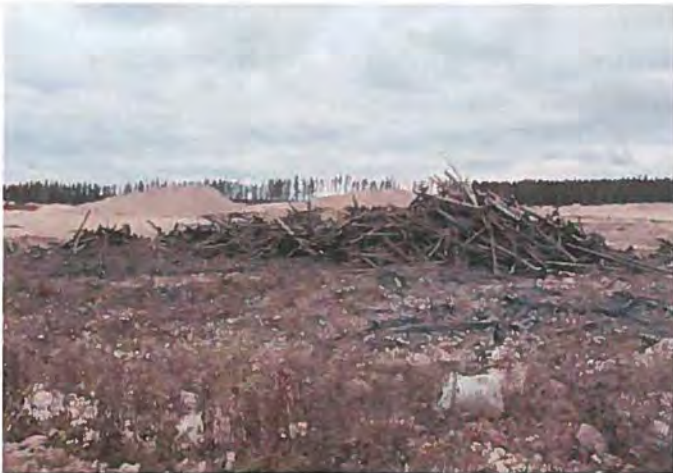
**Figure 9**  
**Cleared wood**

There is a pile of downed trees on this site (Figure 9). Trees with a diameter greater than 13 cm(5") in diameter should be salvaged and made available for use, as per LUP condition #79. These trees are likely not salvageable. They can be burned or spread out and knocked down by heavy equipment when conditions permit.

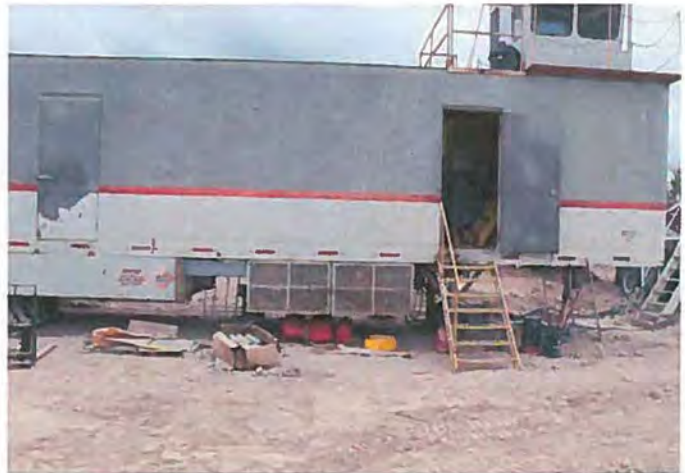
**Figure 10**  
**Jerry cans under trailer**

Leaks and spills need to be cleaned up, as per LUP condition #76. The jerry cans under the trailer should have secondary containment (Figure 10).

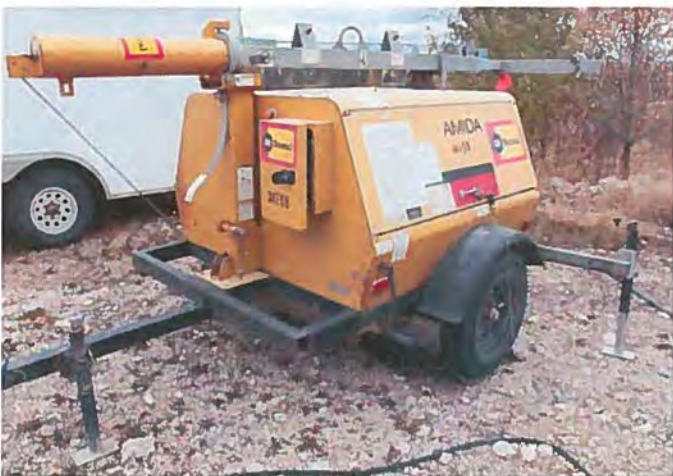
**Figure 11**  
**Light generator**

The inspectors observed a leak in the light generator that was in the camping area (Figure 11 and 12). This leak did not get reported to the foreman. Drip trays should be used under all equipment that is parked for more than 2 hours, as per Land Use Permit (LUP) condition #75.
