File Number MV2017X0019
Type of Operation HWY MAINTENANCE & OPERATIONS
Location NWT Highway No. 1, Km 242.6, Km 241.5 and Km 204.9

ENVIRONMENTAL INSPECTION REPORT

Permittee:	GNWT - Department of Infrastructure	Permit Expiry Date:	May 14, 2022
Land Use Permit No.	MV2017X0019	Previous Inspection:	October 23, 2017
Quarrying Permit No.	16/08, 17/22,17/23,17/31,18/02, 18/12,18/13,18/15	Inspection Date:	May 02, 2018
Contractor:	Carmacks Enterprises Ltd	Subcontractor:	RBee Aggregate Consulting Ltd, McCaw North Drilling & Blasting, Patterson Sawmill
Location(s) Inspected:	NWT Highway No. 1, Km 242.6, Km 241.5 and Km 204.9		
Current Stage of Operation:	<p>Km 242.6 - Access road built into the quarry, quarry site is being cleared in preparation for the quarrying and crushing operation taking place in the summer.</p> <p>Km 241.5 - Small camp set up in existing quarry.</p> <p>Km 204.9 - Access road and quarry site has been logged.</p>		
Program Modifications Approved:

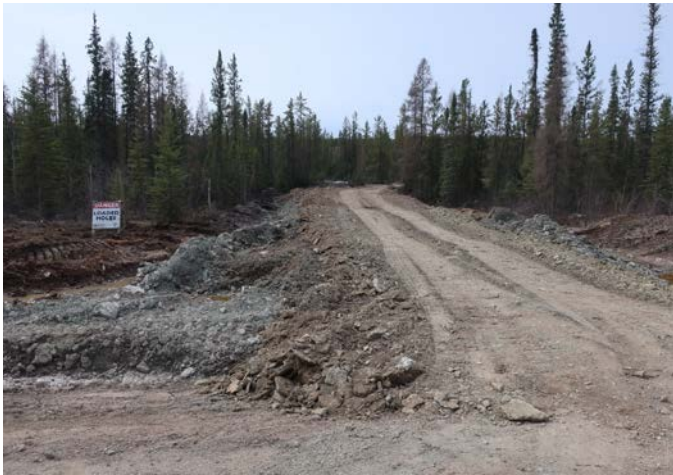
Figure 1

Km 242.6 - Access Road from Hwy 1 Km 242.6

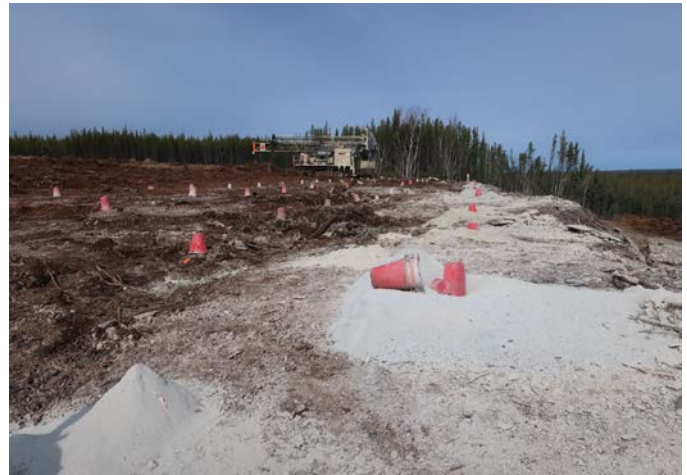
Figure 2

At the time of inspection, a mulcher owned by RBee Aggregate Consulting Ltd was mulching in the planned quarry area. Once this is completed, the mulch and overburden will be stripped and windrowed on the east side of the quarry. A test blast pattern is being drilled on the north face of the bedrock. Drilling and blasting is being conducted by McCaw North Drilling and Blasting. The test pattern is expected to be blasted in the next couple of days. The cleared quarry area measures approximately 208m x 122m.

Km 242.6 -Test blast holes being drilled on north face of the bank.

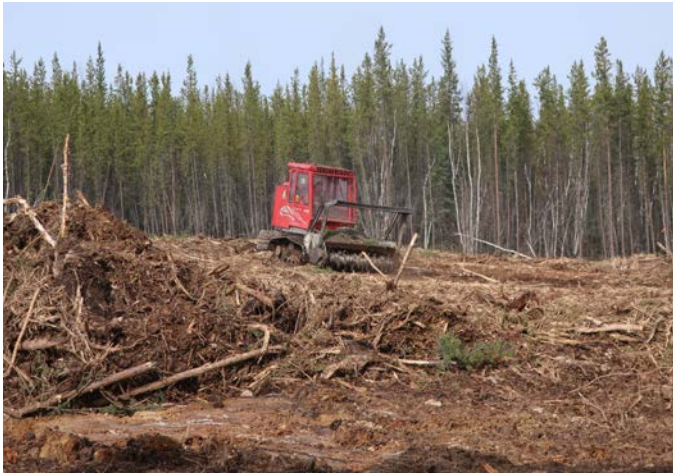
Figure 3

Km 242.6 -Mulcher working in the area to be quarried.

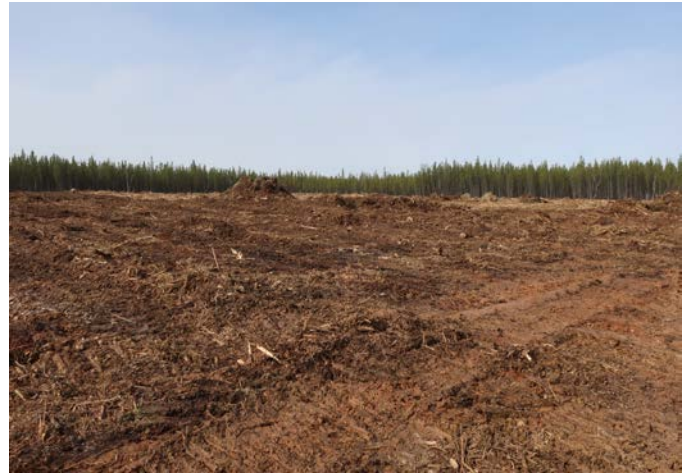
Figure 4

Facing southwest, the quarry area has been logged and mulched.

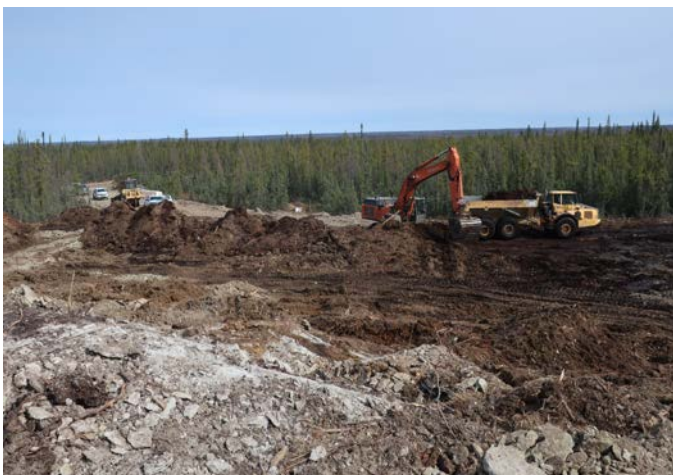
Figure 5

The clearing was logged by Patterson Sawmill and salvageable timber has been decked into four piles on the north side of the area where it will be accessible by the public. A pad for the crusher/stockpile area is being constructed on the north side of the quarry. Overburden in the crusher/stockpile area is being windrowed on the east side of the clearing. Once the pit is depleted and the stockpile area is no longer required, the overburden will be spread back over the site to help foster revegetation.

Km 242.6 -Overburden is being stripped from the area that the crusher/stockpile pad will be constructed.

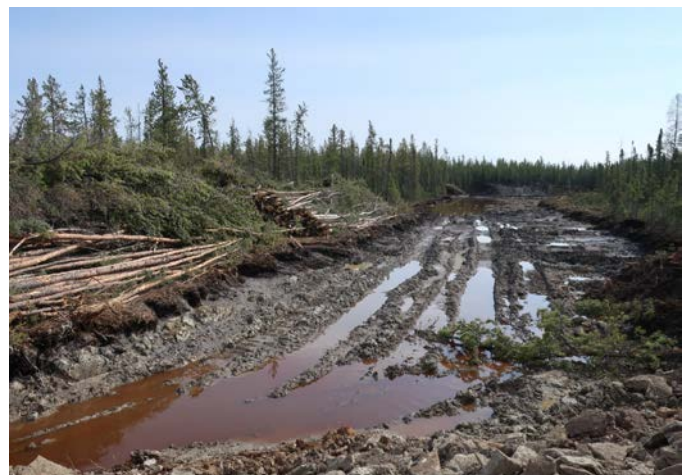
Figure 6

Km 242.6 -Salvaged timber has been decked along the north side of the clearing. Overburden is being windrowed along the east side.

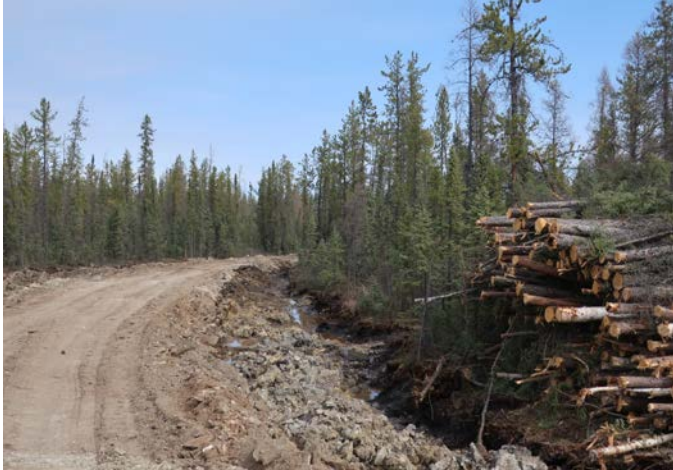
A new quarry site is being developed at Hwy 1, Km 242.6. Notification of commencement of the operation was provided by Amanda Vavrek with Carmacks Enterprises Ltd, the contractor running the project. At the time of inspection, the access road has been built into the quarry site. The Inspectors were pleased to see that the road has been doglegged in accordance with Condition 15 of the land use permit. More work is planned to improve the access road and drainage alongside it.

Figure 7
Km 242.6 - Access road and drainage to be improved.

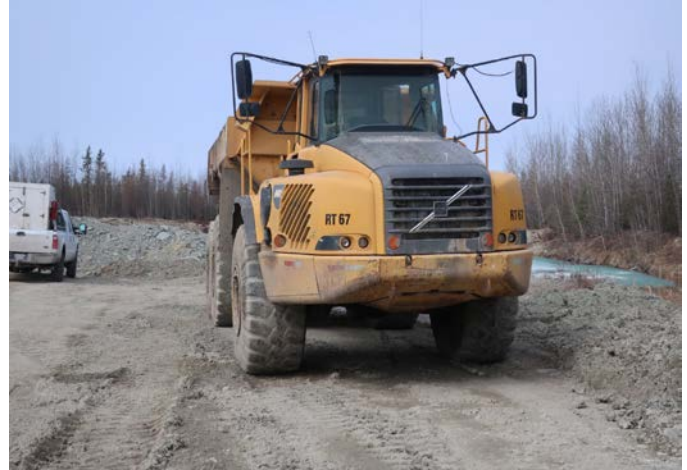
Figure 8
Km 241.5 - Dump truck

A D6 dozer and a dump truck were also parked at the camp area. Note that Condition 75 requires that "All equipment that may be parked for two hours or more, shall have a haz-mat/drip tray under it or be sufficiently diapered. Leaky equipment shall be repaired immediately." Please ensure that drip trays are being used at both the quarry and the camp site.

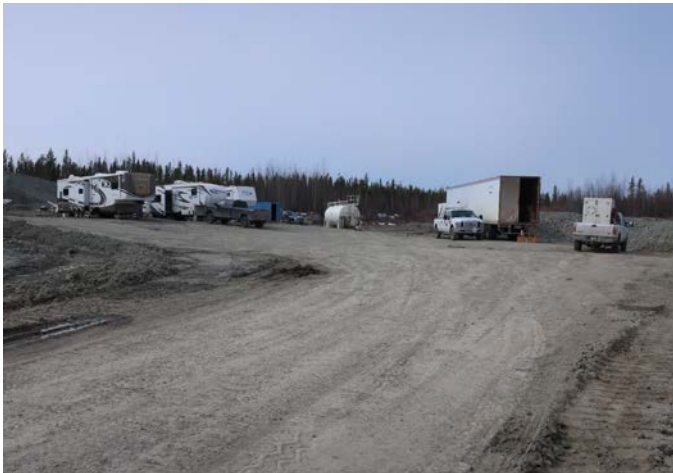
A small camp consisting of three self contained RV's, one storage trailer and a 34,000L double walled fuel tank has been set up in an old DOI quarry at Km 241.5. Camp area was clean and organized. The Inspectors did not observe a spill kit on site. Condition 74 requires that spill response equipment is in place to respond to any potential spills. Please ensure that a spill kit is on site. The fuel nozzle for the double walled tank requires some type of containment to prevent fuel from dripping onto the ground.

Figure 9
Km 241.5 - Camp set up in old quarry.

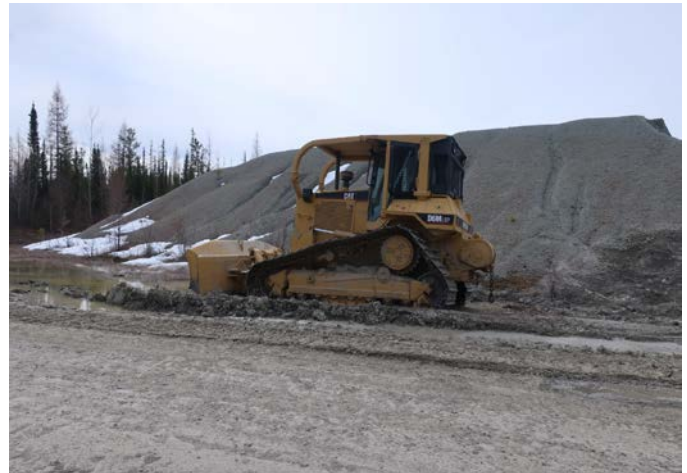
Figure 10
Km 241.5 - D6 Cat

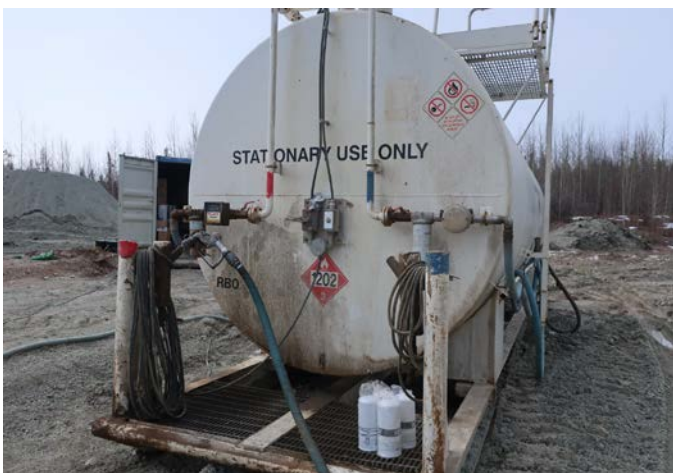
Figure 11
Km 241.5 - 34,000L Double walled fuel tank.

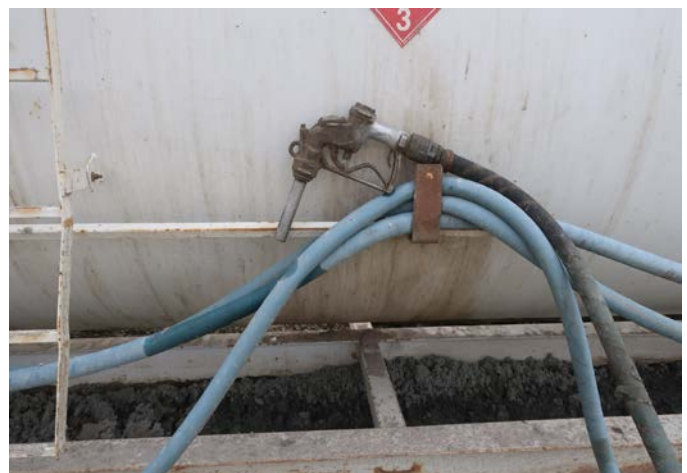
Figure 12
Km 241.5 - Refuelling nozzle requires containment.

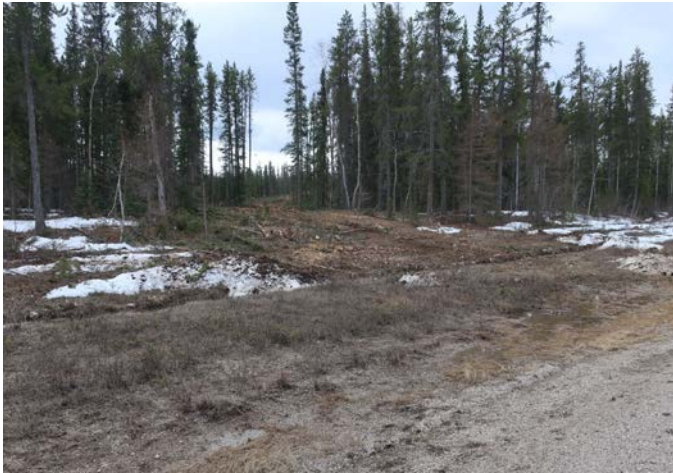
Figure 13

The access road located at 61°08'25.3"N 117°46'19.9"W has a small dogleg and salvageable timber has been decked into 6 piles (5 on the north side, 1 on the south side). There was no equipment in this area at the time of inspection. The Inspectors note that the access road was within 300m of a nearby lease. The Inspector advised Alexander Murray, DOI Permittee representative in an email on November 30th that due to the proximity of the proposed quarry site at Km 204.9 to nearby leases (within 300m), they must contact the MVLWB to determine whether an amendment to the LUP was required. To date the Inspectors have not received any documentation or approvals authorizing the development of the quarry and access road.

Km 204.9 - Access road has been logged.

Prior to the development of the quarry and access road at Hwy 1, Km 204.9 the Permittee must contact the MVLWB to receive authorization as per Condition 1 of the LUP which reads "*The Permittee shall not conduct any part of the land-use operation within 300m of any privately owned or leased land or structure, unless otherwise authorized in writing by the Board*". Please contact

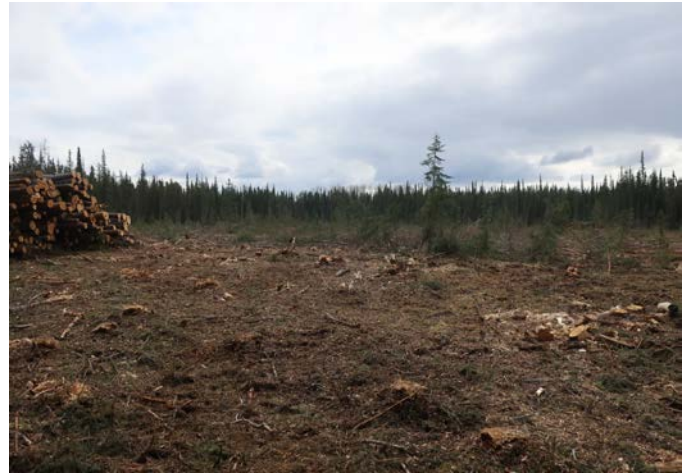
Figure 14

A pre-inspection of this site was not conducted due to the Inspectors being away for training. Access road and the quarry site measuring approximately 220m x 161m has been logged by Patterson Sawmill in preparation for quarry and road development. Removal of overburden from the quarry and access has not occurred to date. The Inspectors understand that this work is scheduled to be done in July 2018.

Km 204.9 - Clearing for the quarry has been logged.

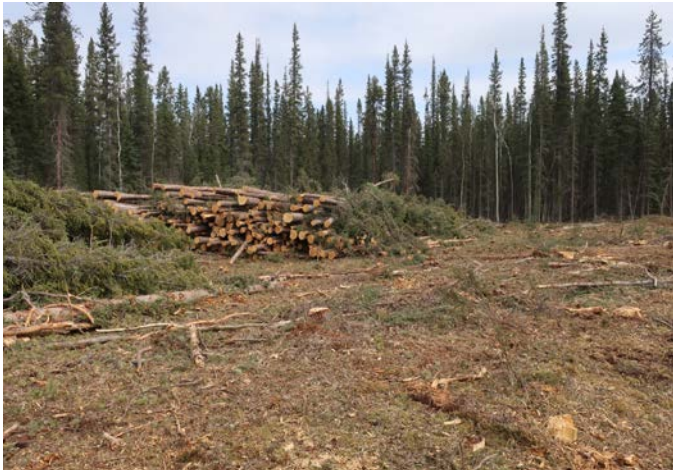
Figure 15

Km 204.9 - Salvageable timber has been decked at the north side of the clearing near the access road.
