December 18, 2018

**File Number** MV2017X0019  
**Type of Operation** HWY MAINTENANCE & OPERATIONS  
**Location** NWT Highway No. 1, Km 242.6, Km 241.and Km 204.9

## ENVIRONMENTAL INSPECTION REPORT

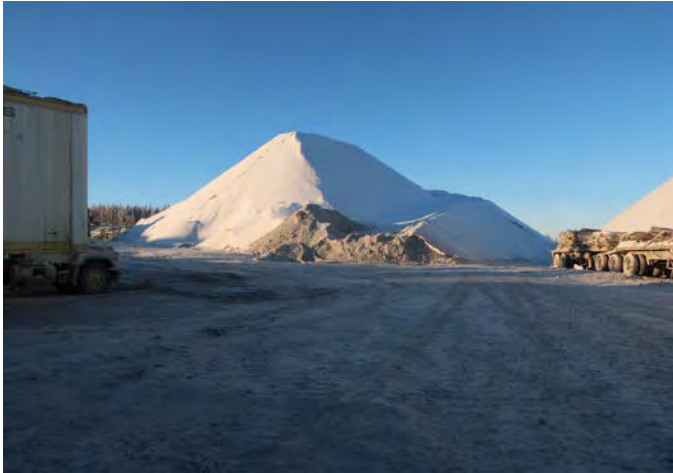
**Figure 1**

- 108,000m<sup>3</sup> - 50mm (Carmax)
- 9250m<sup>3</sup> - 50mm (DOI)
- 12,000m<sup>3</sup> - Airport Chips
- 5000m<sup>3</sup> - Chips (Carmax)
- 35, 200m<sup>3</sup> - 20mm (Carmax)
- 5000m<sup>3</sup> - 20mm (Hwy Maintenance)
- 2 stockpiles of reject material (58% Silt)

**Km 242.6 - 108,000m3 stockpile of processed granular material**

The Inspector recommends that signage be placed in front or on the stockpiles to identify material type.

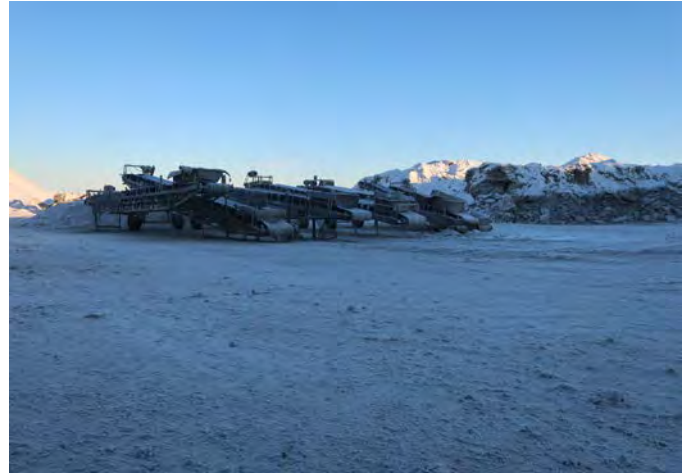
**Figure 2**

Removal of the equipment from the quarry site is expected to start on Saturday Dec 8th. The quarry site appeared to be clean and organized at the time of inspection.

**Km 242.6 - Conveyors from crushing operation prepared for removal from site.**

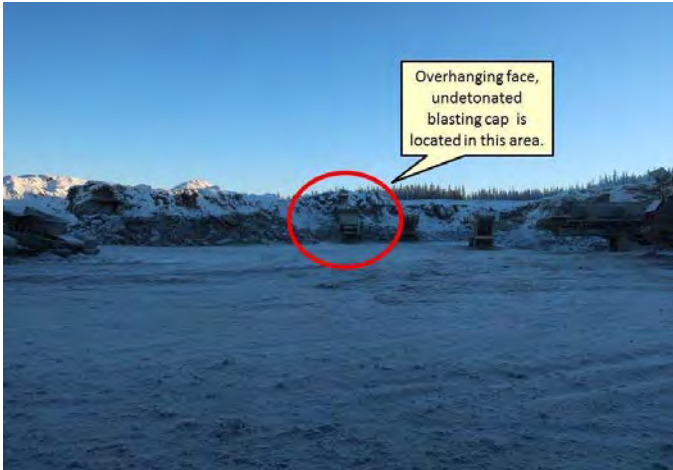
**Figure 3**

During the inspection it was noted that there is overhanging rock on the east wall of the pit. The contractors explained that there is a undetonated blasting cap in the vicinity of the overhang so they kept equipment out of this area for safety reasons. Carmax Enterprises,

the main contractor on the project, is aware of the undetonated blast cap. As the Permit Holder, it is the responsibility of the Department of Infrastructure to ensure that this blast cap is identified and appropriately handled to ensure the safety of any contractors that may work in this pit now and in the future as well as the safety of the general public. No further quarrying will be allowed in the pit until the Department of Infrastructure can provide written confirmation to the Inspectors that the undetonated blast cap has been appropriately dealt with and no longer poses a safety concern.

**Km 242.6 - East side of the quarry where undetonated blasting cap is located.**

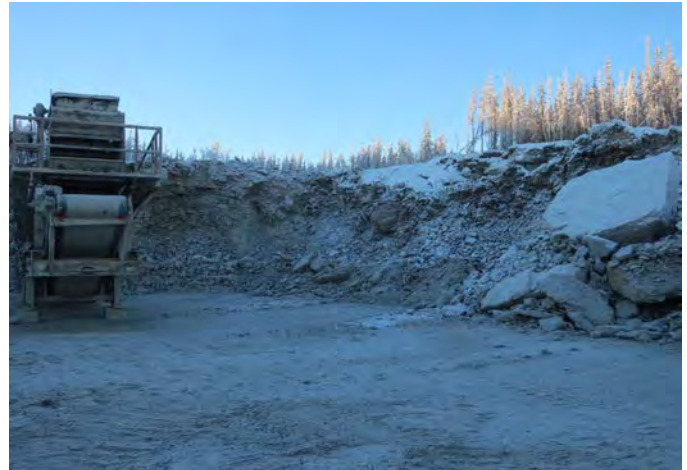
**Figure 4**

**Km 242.6 - Scaling work is required along pit walls to remove loose rock.**

Inspectors met with Glenn from RBee Agreegate Consulting at the Km 242.6 quarry. Crushing operation was complete on Wednesday and the contractor was preparing equipment for removal from site. A rock berm has been placed away from the pit walls to prevent the public from getting close to the rock walls. The Inspectors requested that the rock walls be scaled to knock down any loose rock as a measure of public safety.

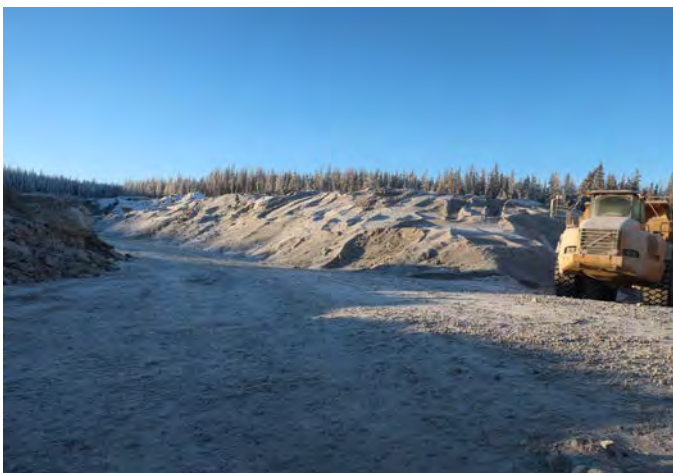
**Figure 5**

**Km 242.6 - Reject material piled near the entrance to the quarry.**

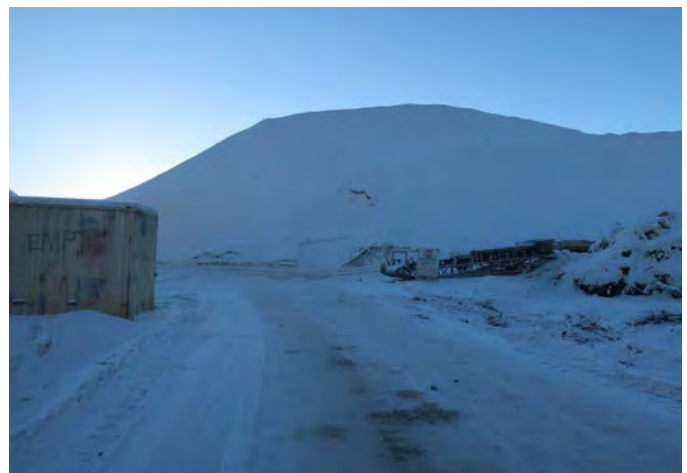
**Figure 6**

**Km 242.6 - Entrance to the stockpile area and quarry site.**

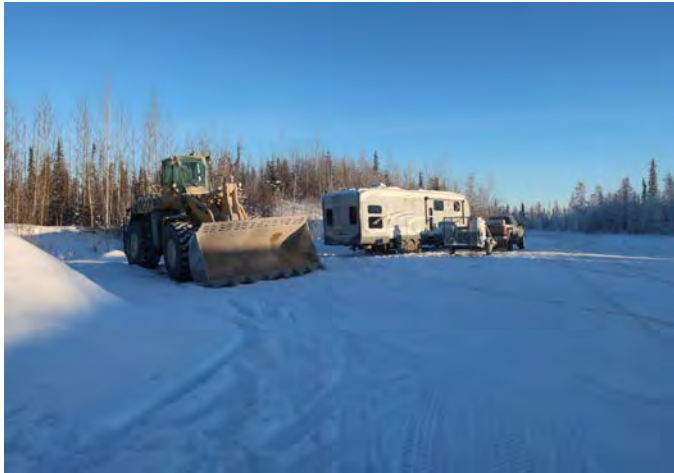
**Figure 7**  
Km 241 - Campers are getting ready to be removed.

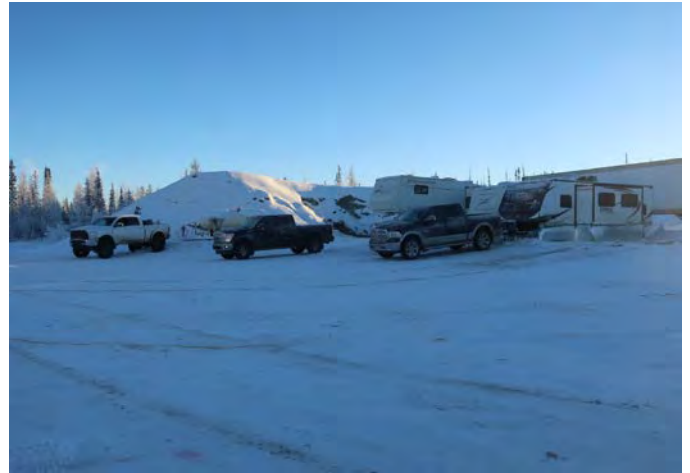
**Figure 8**  
Km 241 - Campers are getting ready to be removed.

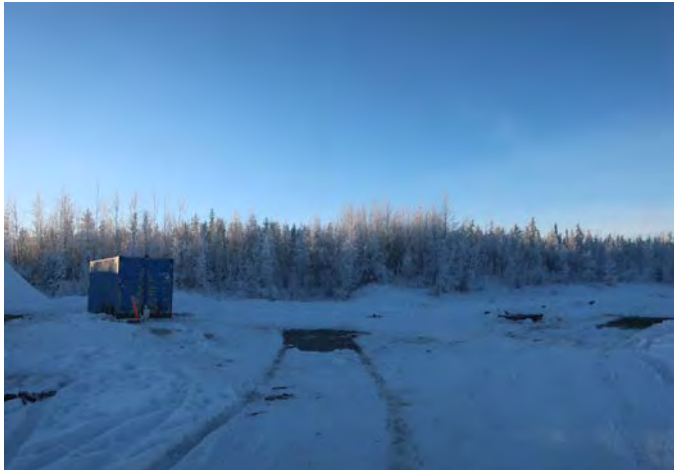
**Figure 9**  
Km 241 - A few campers have been removed from site.

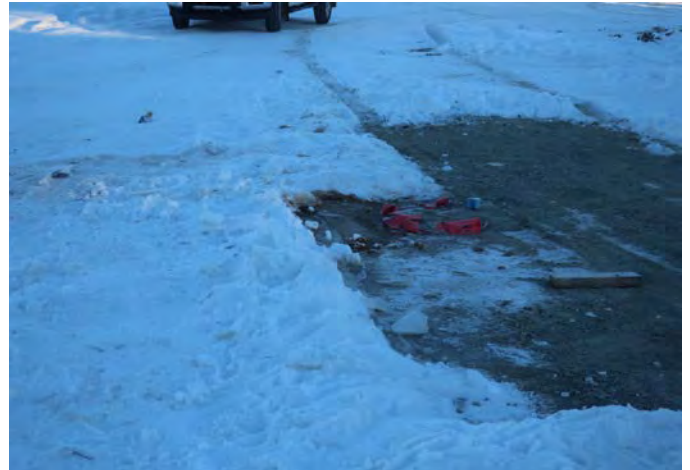
Some of the campers (RVs) have been removed from the clearing. At the time of inspection, crews were preparing to remove the remaining campers and were cleaning up around the site. There was a small amount of household garbage around the site at the time of inspection which should be cleaned up once the campers and equipment has been removed (Condition 18).

**Figure 10**  
Km 241 - A small amount of garbage must be cleaned up after the campers and equipment are removed.

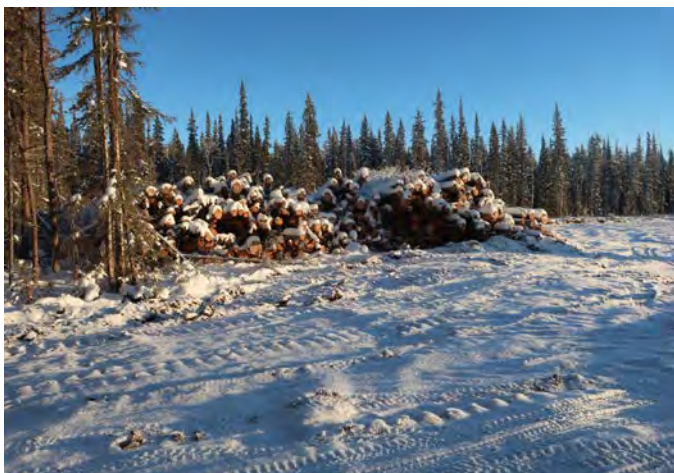
The site has been stripped, overburden has been windrowed on the west side of the clearing one CAT blade width from the standing timber. Piles of salvaged timber remain on the north side of the clearing.

**Figure 11**  
Km 204.9 - Salvaged timber has been piled at the north end of the clearing.

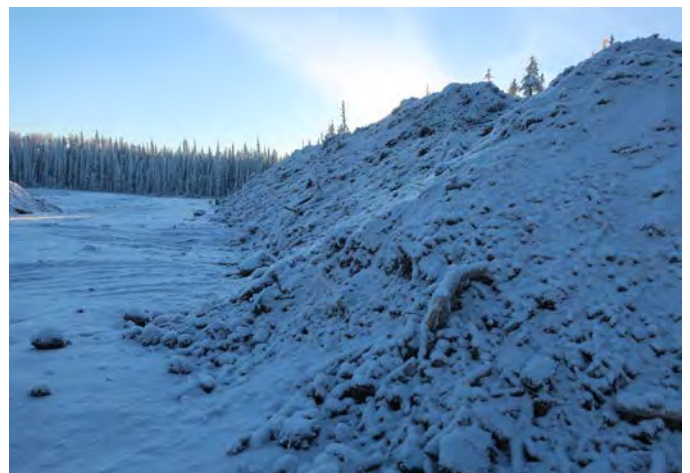
**Figure 12**  
Km 204.9 - Windrowed overburden on the west side of the clearing.

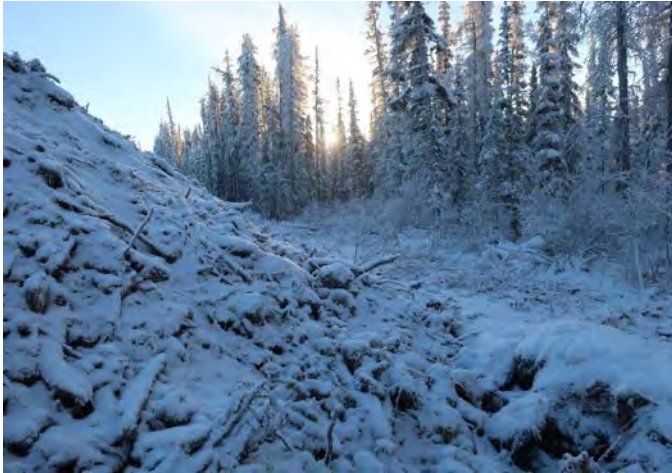
**Figure 13**

**Km 204.9 - One CAT blade width between the windrowed overburden and the standing timber.**
