File Number MV2017X0019
Type of Operation HWY MAINTENANCE & OPERATIONS
Location NWT Highway No. 1, Km 242.6, Km 241.5 and Km 204.9

ENVIRONMENTAL INSPECTION REPORT

Permittee:	GNWT - Department of Infrastructure	Permit Expiry Date:	May 14, 2022
Land Use Permit No.	MV2017X0019	Previous Inspection:	October 23, 2017
Quarrying Permit No.	16/08, 17/22,17/23,17/31,18/02, 18/12,18/13,18/15	Inspection Date:	May 02, 2018
Contractor:	Carmacks Enterprises Ltd	Subcontractor:	RBee Aggregate Consulting Ltd, McCaw North Drilling & Blasting, Patterson Sawmill
Location(s) Inspected:	NWT Highway No. 1, Km 242.6, Km 241.5 and Km 204.9		
Current Stage of Operation:	<p>Km 242.6 - Access road built into the quarry, quarry site is being cleared in preparation for the quarrying and crushing operation taking place in the summer.</p> <p>Km 241.5 - Small camp set up in existing quarry.</p> <p>Km 204.9 - Access road and quarry site has been logged.</p>		
Program Modifications Approved:

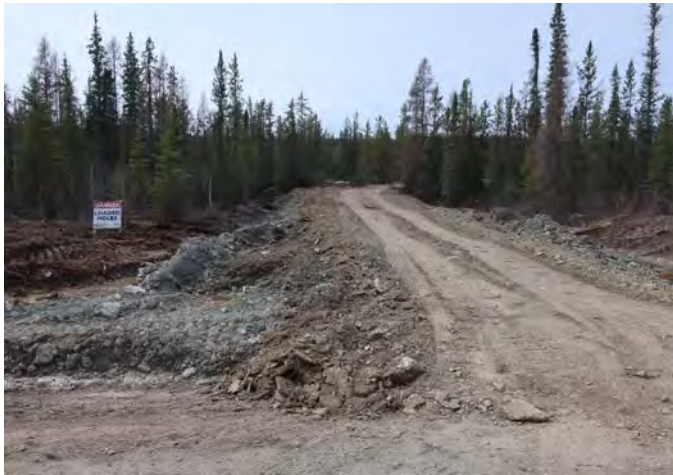
Figure 1

Km 242.6 - Access Road from Hwy 1 Km 242.6

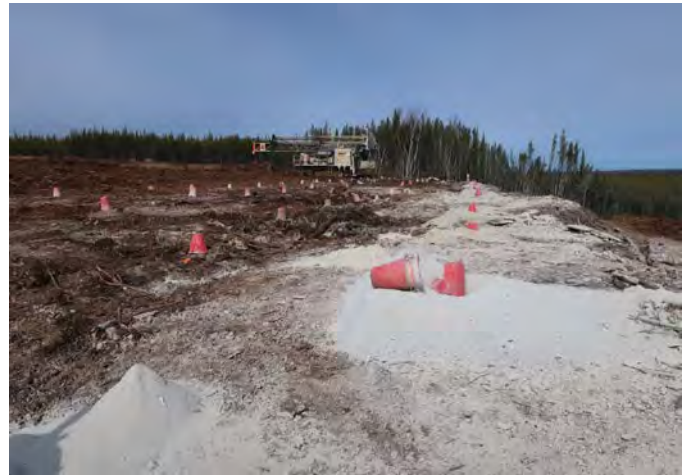
Figure 2

At the time of inspection, a mulcher owned by RBee Aggregate Consulting Ltd was mulching in the planned quarry area. Once this is completed, the mulch and overburden will be stripped and windrowed on the east side of the quarry. A test blast pattern is being drilled on the north face of the bedrock. Drilling and blasting is being conducted by McCaw North Drilling and Blasting. The test pattern is expected to be blasted in the next couple of days. The cleared quarry area measures approximately 208m x 122m.

Km 242.6 -Test blast holes being drilled on north face of the bank.

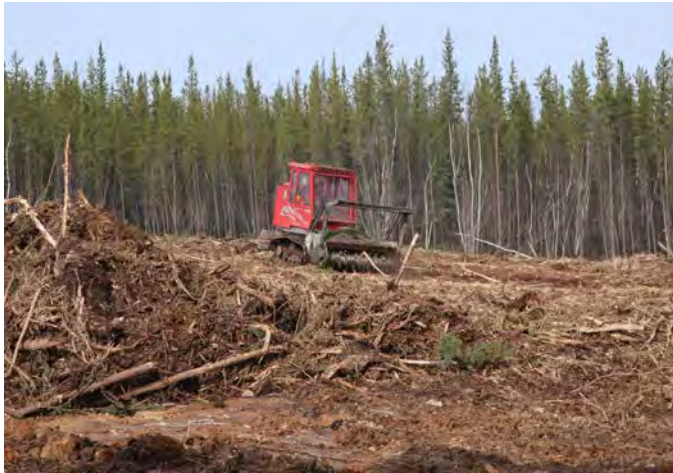
Figure 3

Km 242.6 -Mulcher working in the area to be quarried.

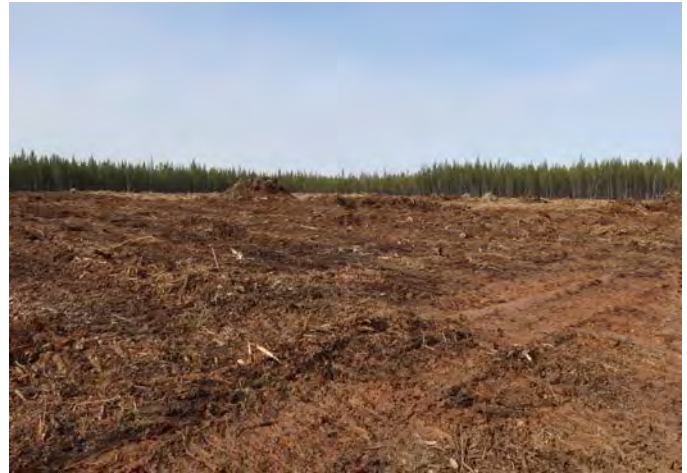
Figure 4

Facing southwest, the quarry area has been logged and mulched.

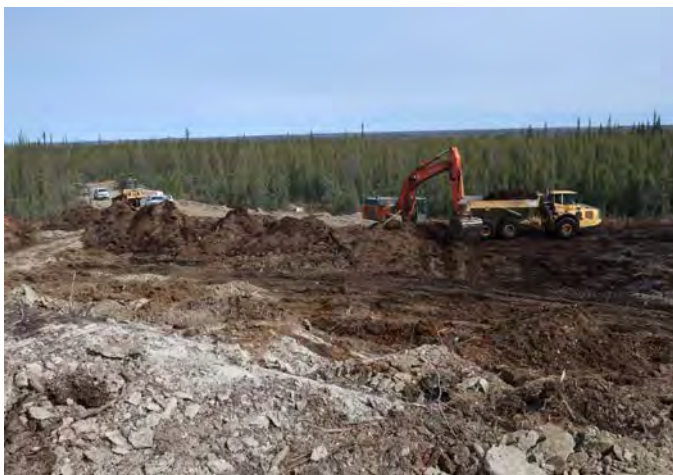
Figure 5

The clearing was logged by Patterson Sawmill and salvageable timber has been decked into four piles on the north side of the area where it will be accessible by the public. A pad for the crusher/stockpile area is being constructed on the north side of the quarry. Overburden in the crusher/stockpile area is being windrowed on the east side of the clearing. Once the pit is depleted and the stockpile area is no longer required, the overburden will be spread back over the site to help foster revegetation.

Km 242.6 -Overburden is being stripped from the area that the crusher/stockpile pad will be constructed.

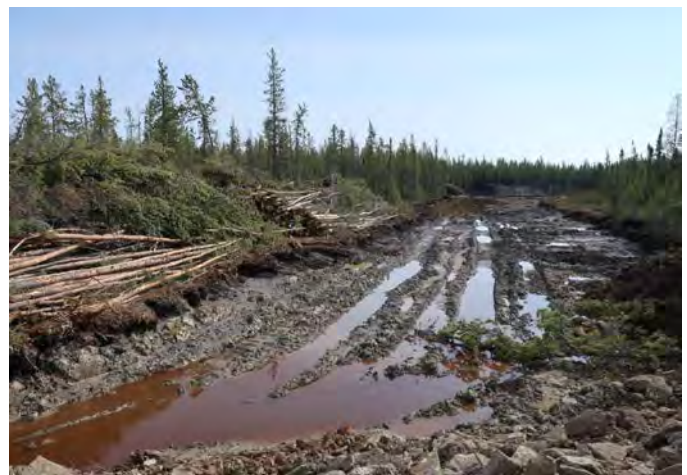
Figure 6

Km 242.6 -Salvaged timber has been decked along the north side of the clearing. Overburden is being windrowed along the east side.

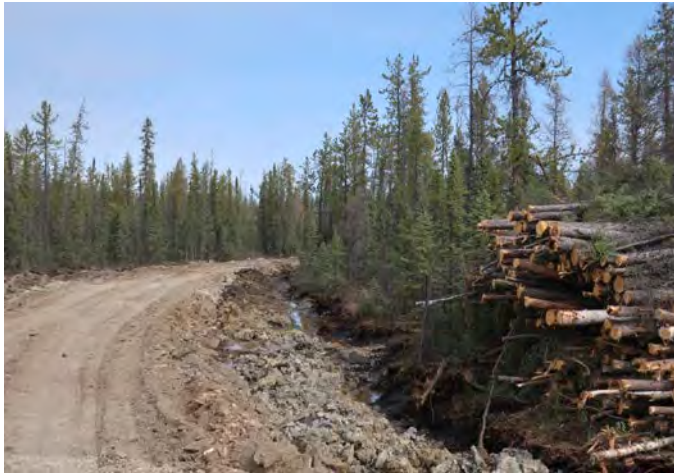
A new quarry site is being developed at Hwy 1, Km 242.6. Notification of commencement of the operation was provided by Amanda Vavrek with Carmacks Enterprises Ltd, the contractor running the project. At the time of inspection, the access road has been built into the quarry site. The Inspectors were pleased to see that the road has been doglegged in accordance with Condition 15 of the land use permit. More work is planned to improve the access road and drainage alongside it.

Figure 7
Km 242.6 - Access road and drainage to be improved.

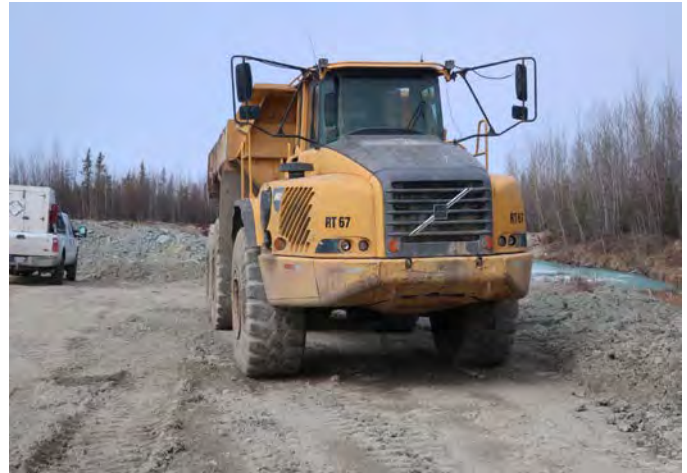
Figure 8
Km 241.5 - Dump truck

A D6 dozer and a dump truck were also parked at the camp area. Note that Condition 75 requires that "All equipment that may be parked for two hours or more, shall have a haz-mat/drip tray under it or be sufficiently diapered. Leaky equipment shall be repaired immediately." Please ensure that drip trays are being used at both the quarry and the camp site.

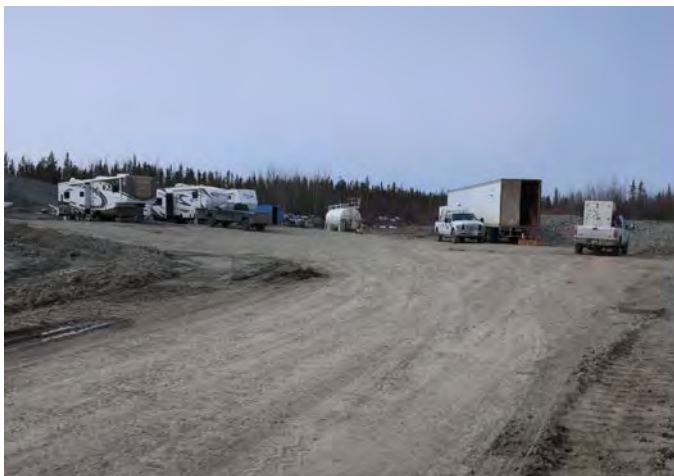
Figure 9
Km 241.5 - Camp set up in old quarry.

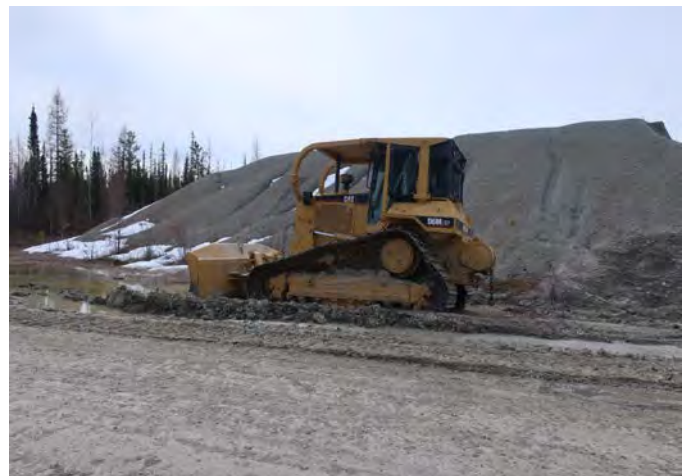
Figure 10
Km 241.5 - D6 Cat

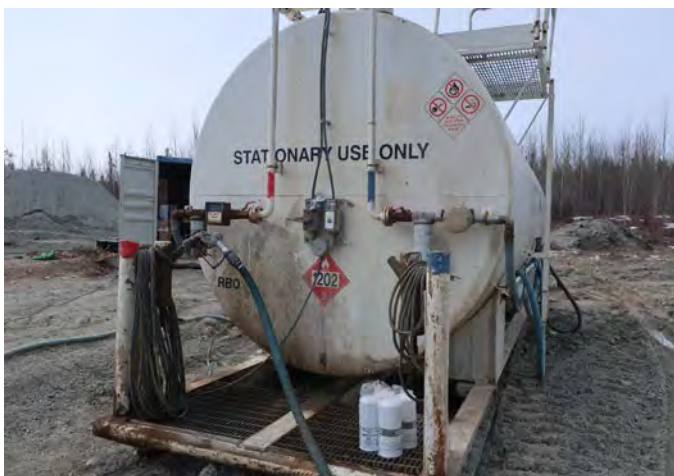
Figure 11
Km 241.5 - 34,000L Double walled fuel tank.

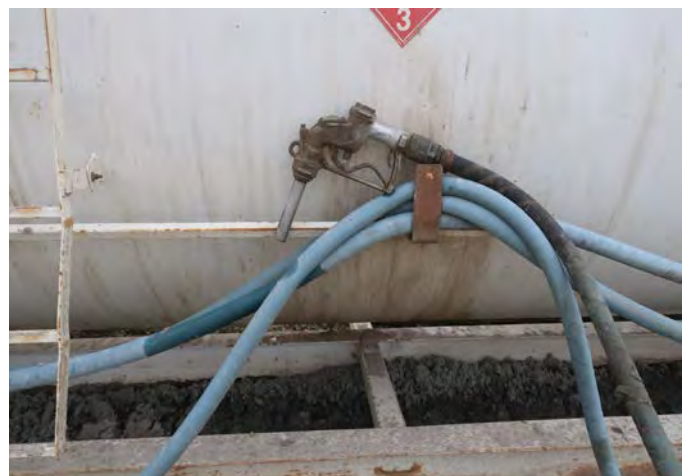
A small camp consisting of three self contained RV's, one storage trailer and a 34,000L double walled fuel tank has been set up in an old DOI quarry at Km 241.5. Camp area was clean and organized. The Inspectors did not observe a spill kit on site. Condition 74 requires that spill response equipment is in place to respond to any potential spills. Please ensure that a spill kit is on site. The fuel nozzle for the double walled tank requires some type of containment to prevent fuel from dripping onto the ground.

Figure 12
Km 241.5 - Refuelling nozzle requires containment.

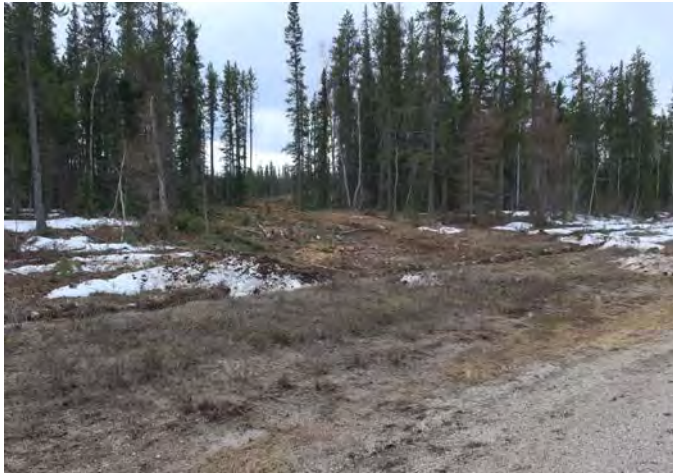
Figure 13

The access road located at 61°08'25.3"N 117°46'19.9"W has a small dogleg and salvageable timber has been decked into 6 piles (5 on the north side, 1 on the south side). There was no equipment in this area at the time of inspection. The Inspectors note that the access road was within 300m of a nearby lease. The Inspector advised Alexander Murray, DOI Permittee representative in an email on November 30th that due to the proximity of the proposed quarry site at Km 204.9 to nearby leases (within 300m), they must contact the MVLWB to determine whether an amendment to the LUP was required. To date the Inspectors have not received any documentation or approvals authorizing the development of the quarry and access road.

Km 204.9 - Access road has been logged.

Prior to the development of the quarry and access road at Hwy 1, Km 204.9 the Permittee must contact the MVLWB to receive authorization as per Condition 1 of the LUP which reads "*The Permittee shall not conduct any part of the land-use operation within 300m of any privately owned or leased land or structure, unless otherwise authorized in writing by the Board*". Please contact

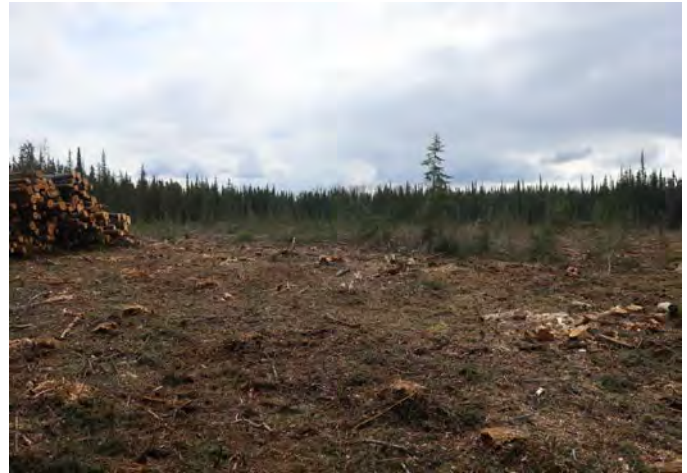
Figure 14

A pre-inspection of this site was not conducted due to the Inspectors being away for training. Access road and the quarry site measuring approximately 220m x 161m has been logged by Patterson Sawmill in preparation for quarry and road development. Removal of overburden from the quarry and access has not occurred to date. The Inspectors understand that this work is scheduled to be done in July 2018.

Km 204.9 - Clearing for the quarry has been logged.

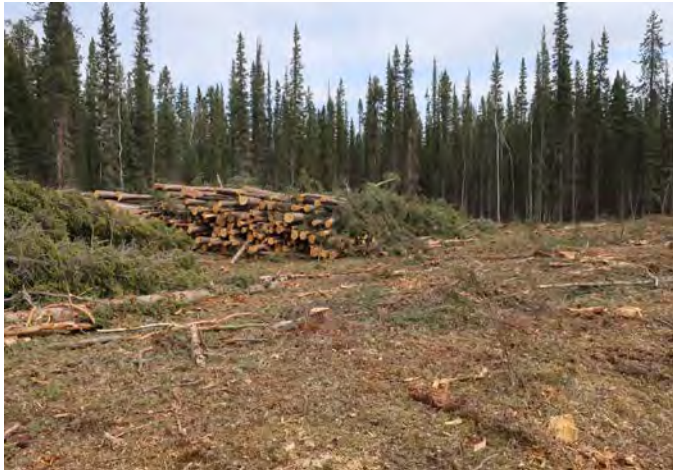
Figure 15

Km 204.9 - Salvageable timber has been decked at the north side of the clearing near the access road.
