**File Number** MV2017X0019  
**Type of Operation** HWY MAINTENANCE & OPERATIONS  
**Location** NWT Highway No. 1, Km 242.6 quarry and Km 241.5 Camp

An inspection of the above noted operation was conducted on September 19, 2018 by Resource Management Officers Norm McCowan and Jayda Robillard.

## ENVIRONMENTAL INSPECTION REPORT

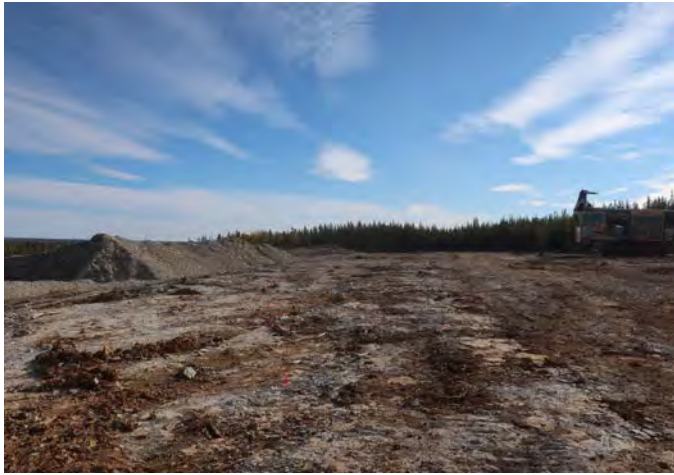
**Figure 1**

Facing east, overburden has been piled on the east side of the clearing. Blasted rock from Block 1 that was unsuitable is seen on the left side of the photo.

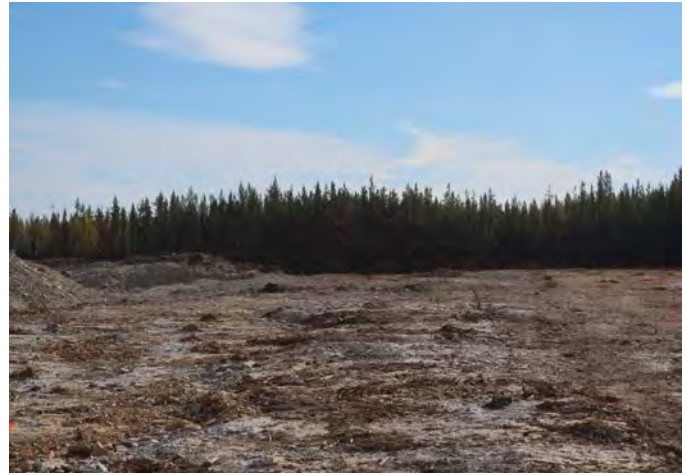
**Figure 2**

Overburden cleared from the top bench (Block 2) will be contoured.

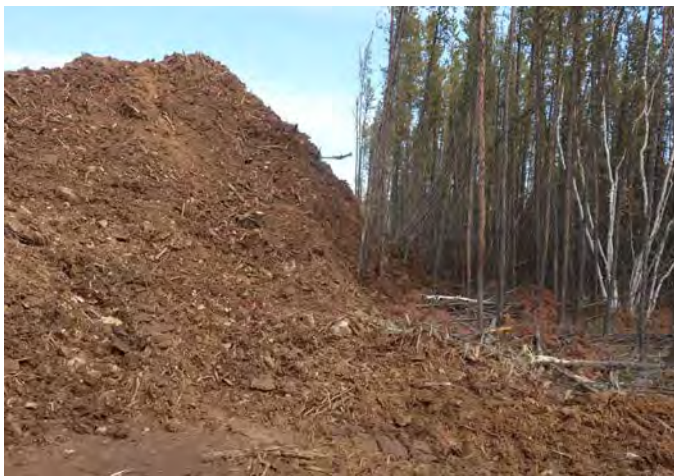
**Figure 3**

Area one CAT blade width between the overburden stockpile and the standing timber will be mulched.

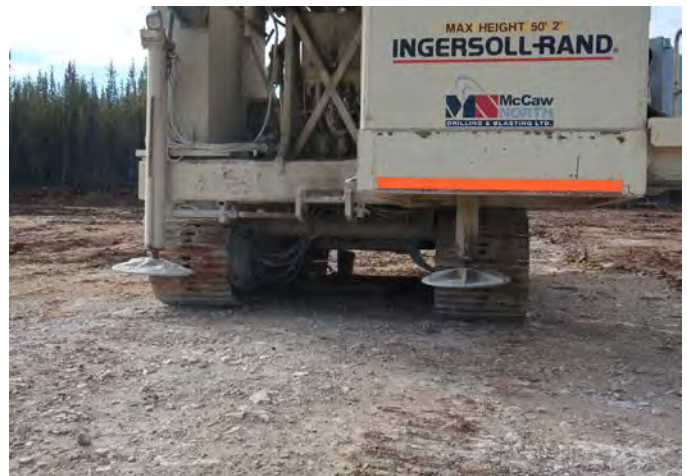
**Figure 4**

Drip tray being used beneath a drill on the top bench.

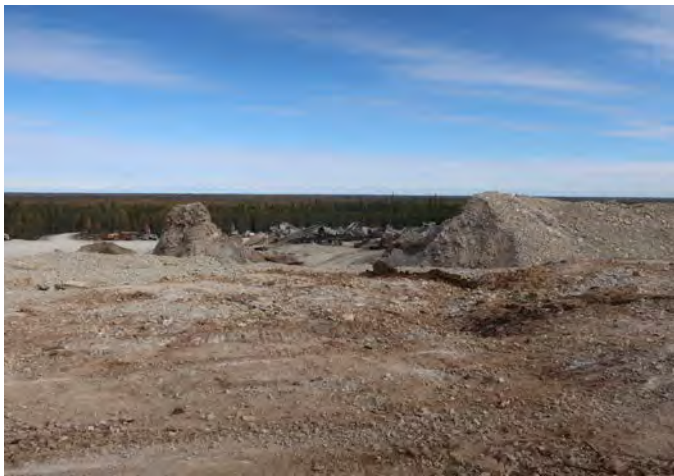
**Figure 5**

Pillar and stockpile of Block 1 material. Crushing operation is in the background.

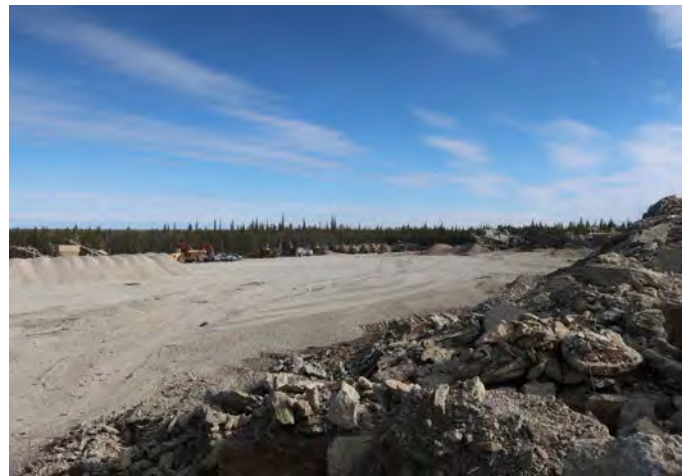
**Figure 6**

Equipment lined up along the north edge of the clearing.

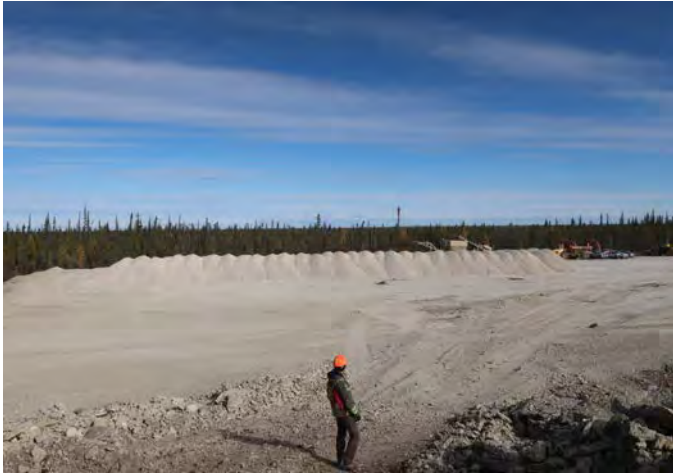
**Figure 7**

Approximately 1000m<sup>3</sup> of test crush is stockpiled on the west side of the clearing. The material will be used for a gravel pad.

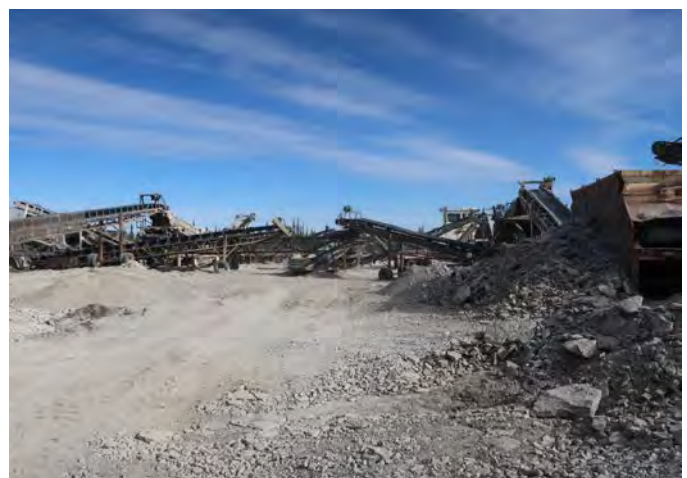
**Figure 12**

Conveyor system being set up for the crushing operation.

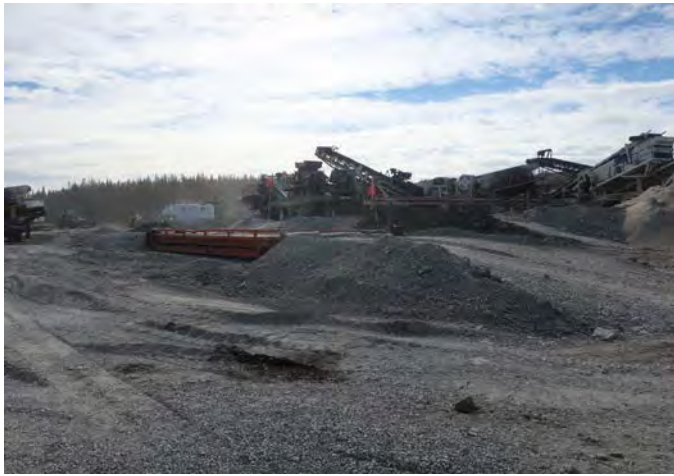
**Figure 13**  
**Weigh scale**

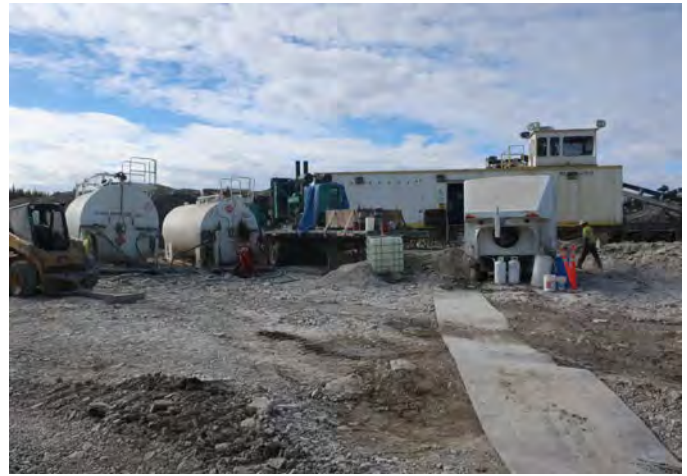
**Figure 14**  
**Fuel tanks, generator, and white lab trailer.**

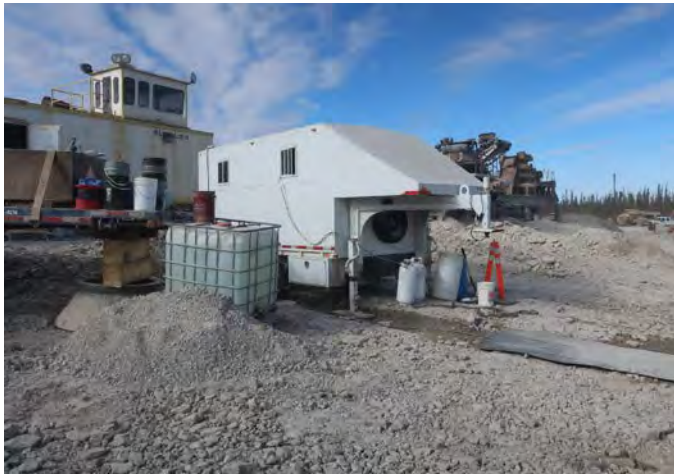
**Figure 15**  
**White trailer is a lab for testing rock and determine specs of processed material. Cube of freshwater is used for lab tests.**

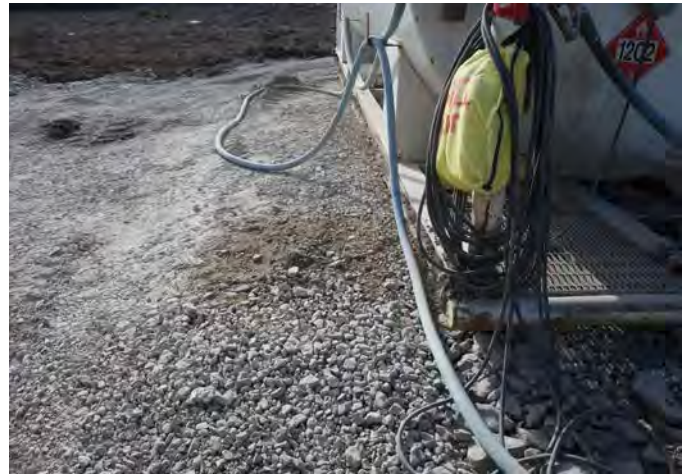
**Figure 16**  
**Small spill next to fuel tank.**

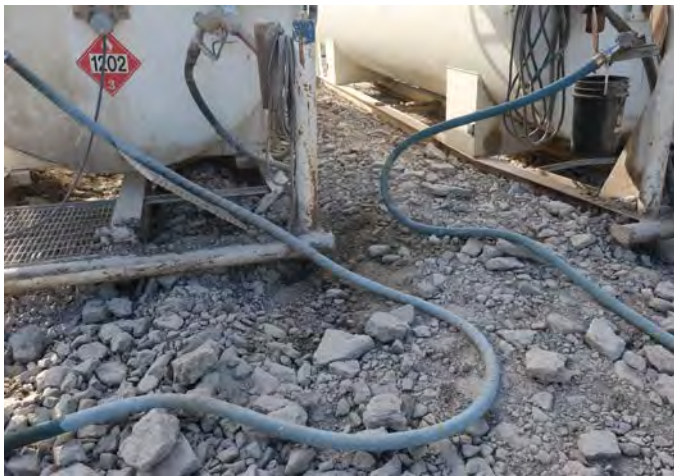
**Figure 17**  
**Small spill next to fuel tank.**

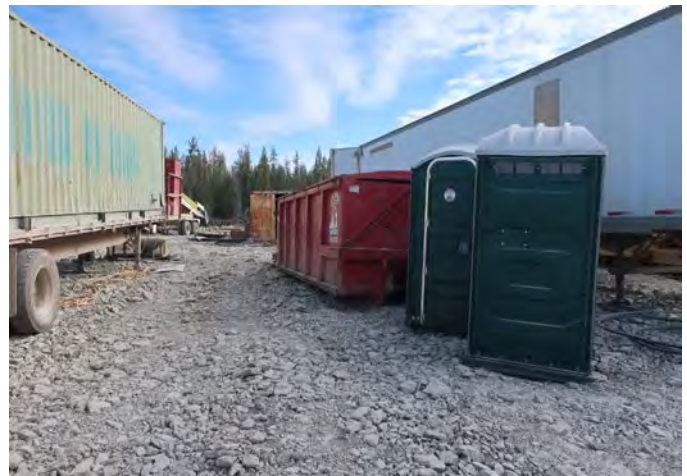
**Figure 18**  
**Garbage bin and porta pottys.**

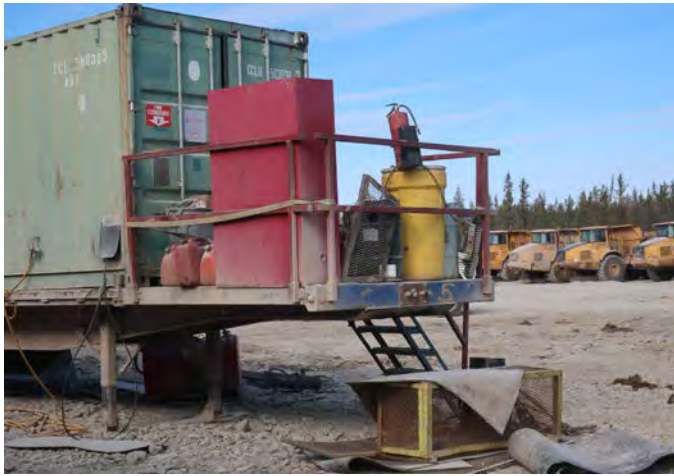
**Figure 19**  
Spill kit in the yellow drum.

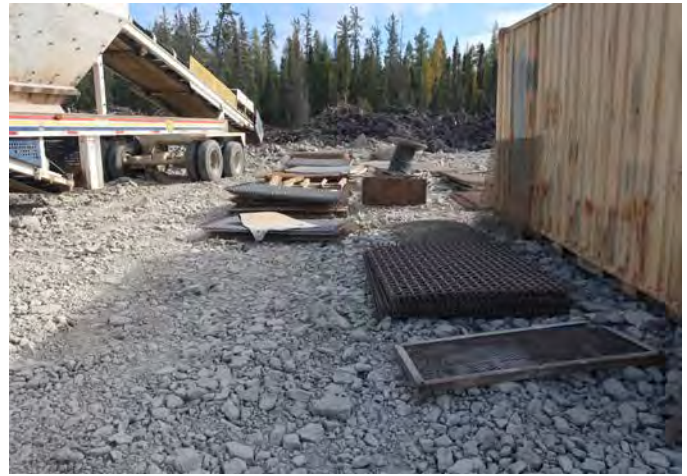
**Figure 20**  
Screens used for crusher system.

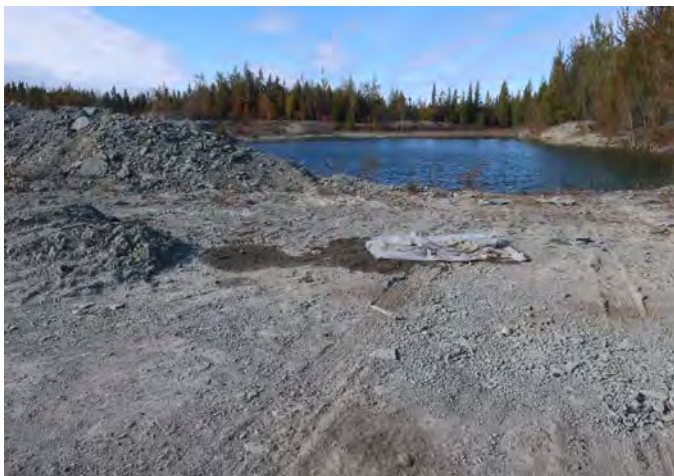
A small spill was observed under the generator and requires cleanup in accordance with **Condition 76**. The spill that was identified in the previous inspection caused by the leaking mulcher has not been cleaned up. All contaminated soil must be removed and taken to an

**Figure 21**  
Camp - Hydraulic oil spill from the mulcher has not been cleaned up.

authorized disposal facility (**Condition 76**). The mulcher along with the scattered drip trays noted in the previous inspection have been removed from the camp area.

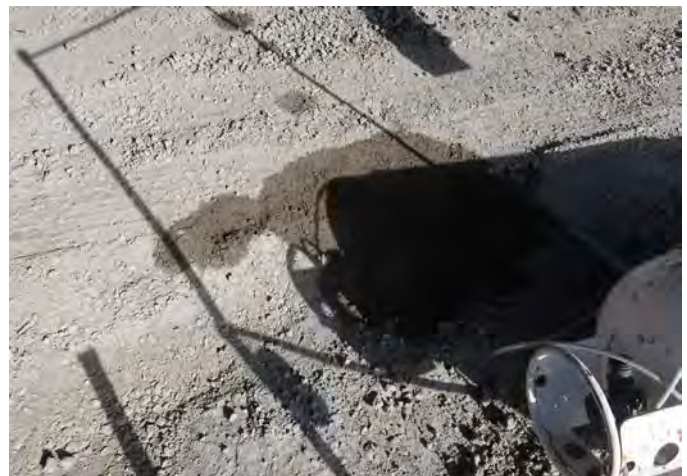
**Figure 22**  
Camp - Spill under the generator trailer must be cleaned up.

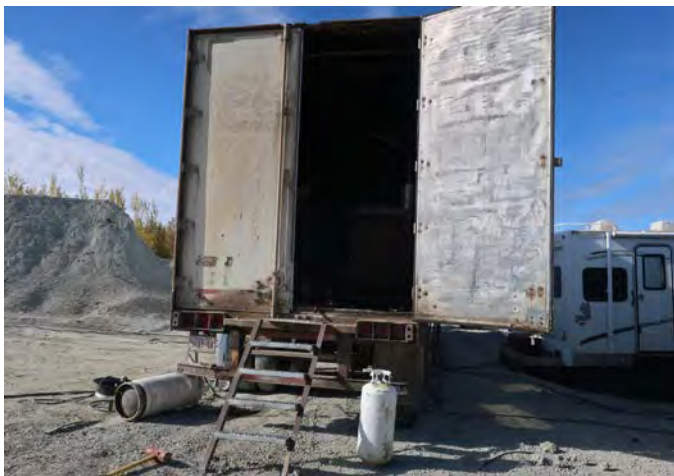
**Figure 23**  
Camp - generator trailer

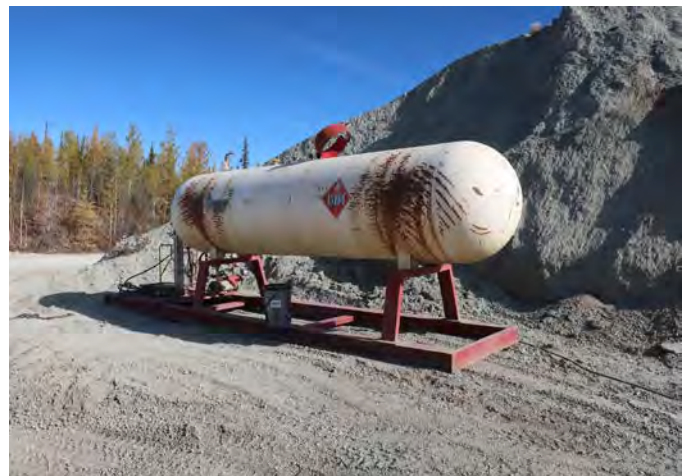
**Figure 24**  
Camp - Propane tank

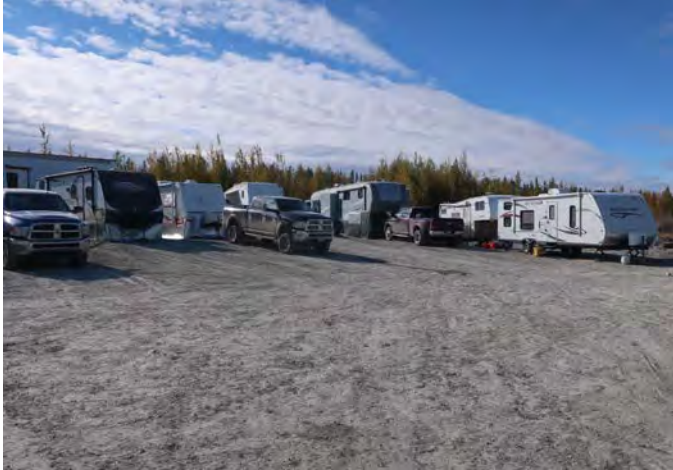
**Figure 25**

**Camp - Travel trailers are being used by the contractors.**
