INAC-CARD Giant Mine UBC Bridge

**RE: Land Use Permit MV2017X0030 –Giant Mine UBC Bridge Project**

**INSPECTION DATE – March 12<sup>th</sup> 2018**

**ENVIRONMENTAL INSPECTION REPORT (MV2017X0030)**

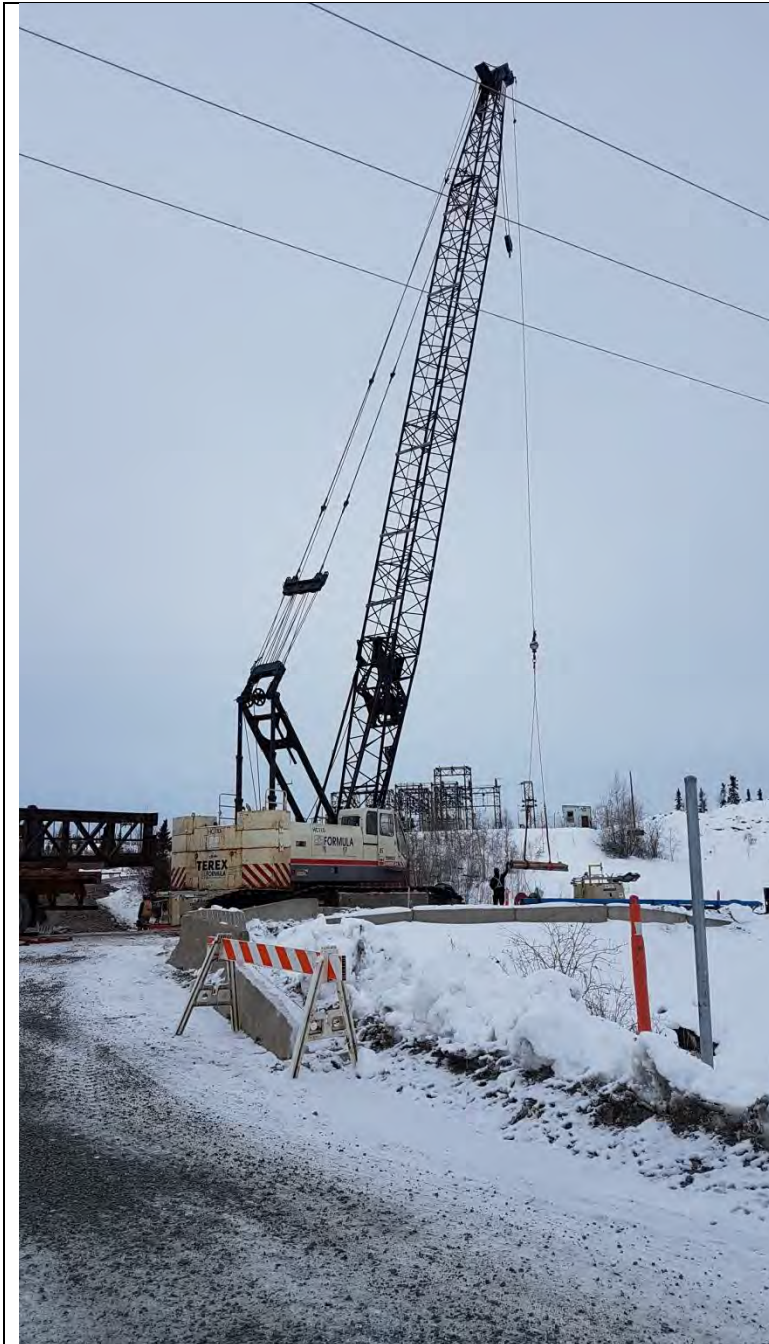
The Inspectors noted at the time of the inspection that site personnel were using a 110 ton crane (Photo #1) to unload construction material (Photo #2) that is required to complete the bridge repairs. The contractor had staged one ATCO trailer and one portable toilet near the work area (Photo #3). The Inspectors had no concerns with the waste management onsite as it appeared to comply with conditions #18 and #19 of the land use permit.

**Photo #1: 110 Ton Crane used in the repair of the bridge**

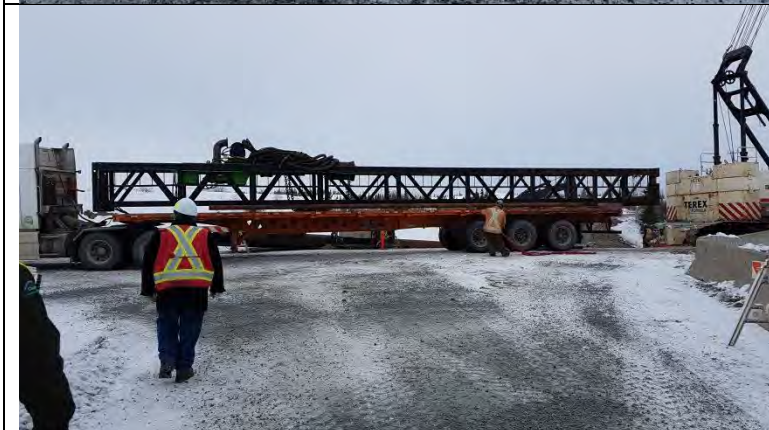
**Photo #2: Overview of a load of material needed for the bridge repair.**

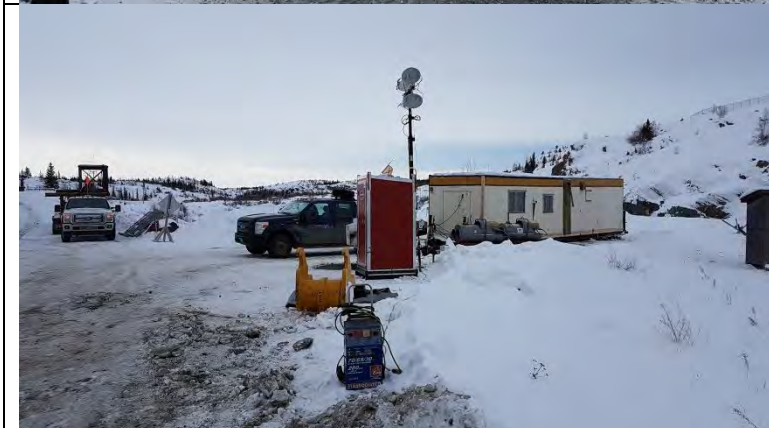
**Photo #3: Overview of the portable trailer and facilities used to facilitate the activities under the land use permit.**

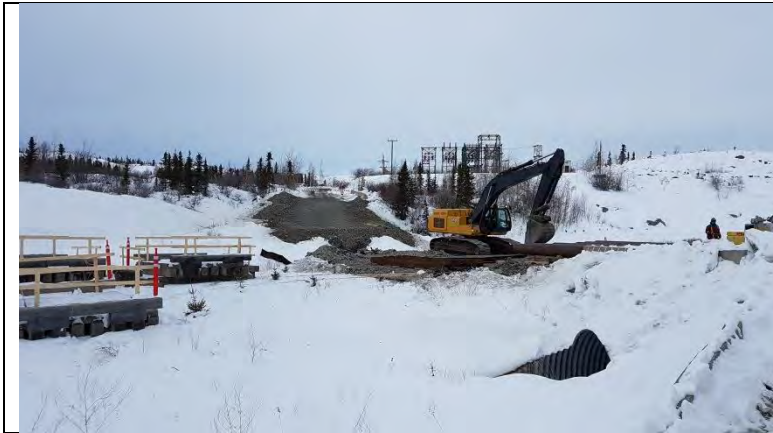
The project requires the contractor to work in very close proximity to Baker Creek (Photos #4 & #6). The Inspectors noted that the Baker Creek ice surface had no visible sediment or rocks on it (Photo #7) which indicated that onsite personnel were using extra precautions while conducting the land use activities near the creek.

**Photo #4: Overview of the bridge area that spans Baker Creek.**

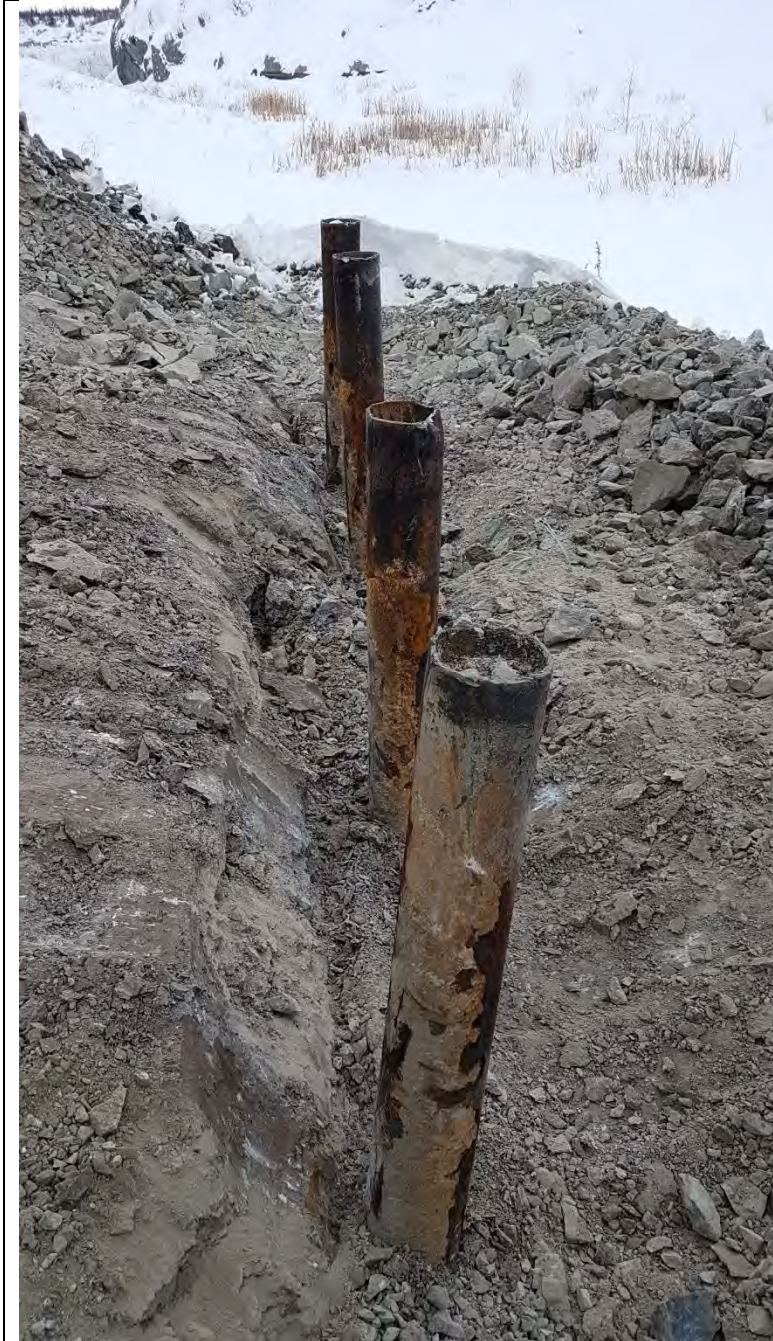
Site personnel explained that the four piles used to support the old bridge were loose and needed to be replaced (Photo #5). Engineers were working on the new pile placement locations and the Inspectors requested that notification be given prior to the drilling of the new piles. The Inspectors also explained that silt fencing should be installed prior to the drilling and that the ice surface be scraped to ensure that no sediment enters Baker Creek during freshet.

**Photo #5: The older piles that will be replaced prior to the replacement of the bridge.**

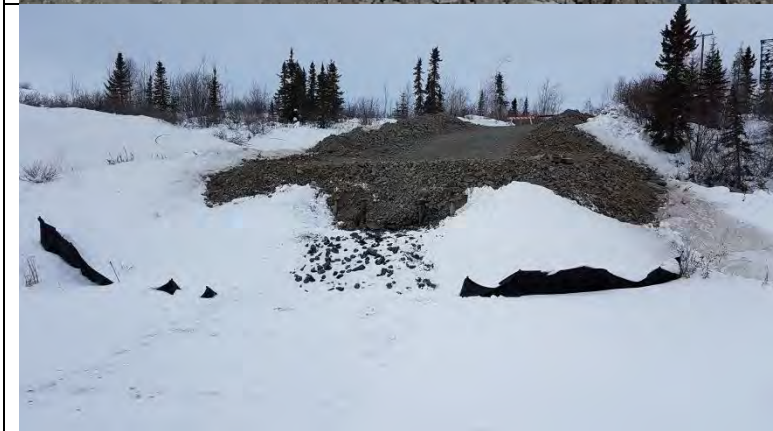
**Photo #6: Overview of the north side of Baker Creek.**

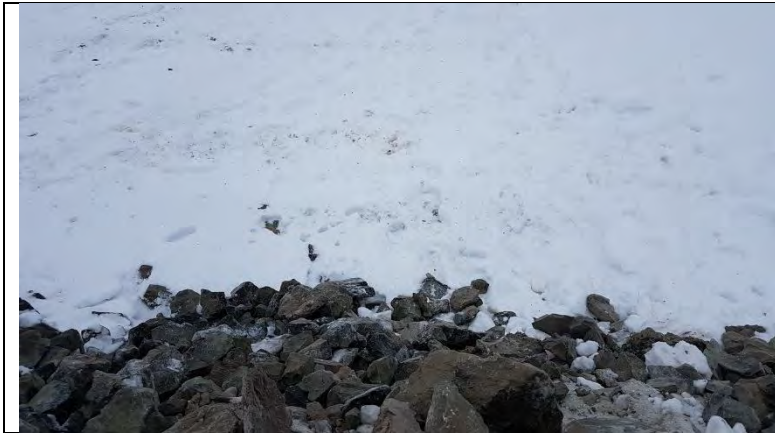
**Photo #7: The ice surface of Baker Creek near the bridge repair area.**

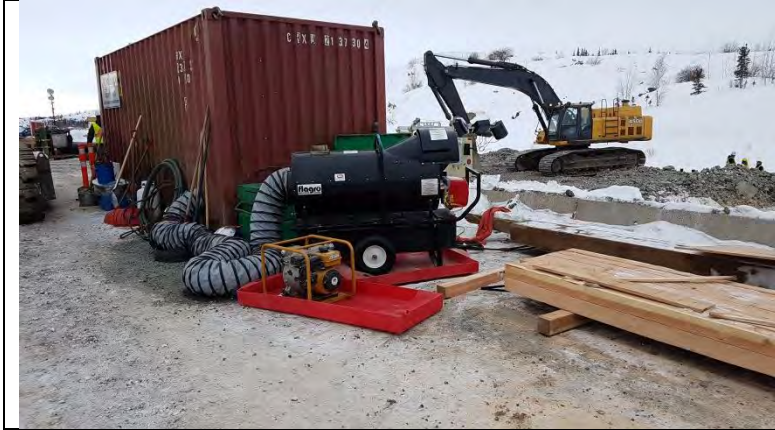
The Inspectors noted that drip trays were placed under all stationary equipment (Photo #8) in accordance with condition #26 of the land use permit and that no fuel tanks were present within the immediate land use area.

**Photo #8: Overview of the equipment staging area near Baker Creek.**
