December 18, 2018

<b>File Number</b>	<b>MV2018C0005</b>
<b>Type of Operation</b>	<b>MINERAL EXP - drilling</b>
<b>Location</b>	<b>SCS staging, M48 drilling</b>

## ENVIRONMENTAL INSPECTION REPORT

<b>Permittee:</b>	Pine Point Mining Limited	<b>Permit Expiry Date:</b>	July 19, 2022
<b>Land Use Permit No.</b>	MV2018C0005	<b>Previous Inspection:</b>	October 04, 2018
<b>Quarrying Permit No.</b>		<b>Inspection Date:</b>	December 12, 2018
<b>Contractor:</b>		<b>Subcontractor:</b>	
<b>Location(s) Inspected:</b>	SCS staging area, M48 drilling,		
<b>Current Stage of Operation:</b>	One drill operating.

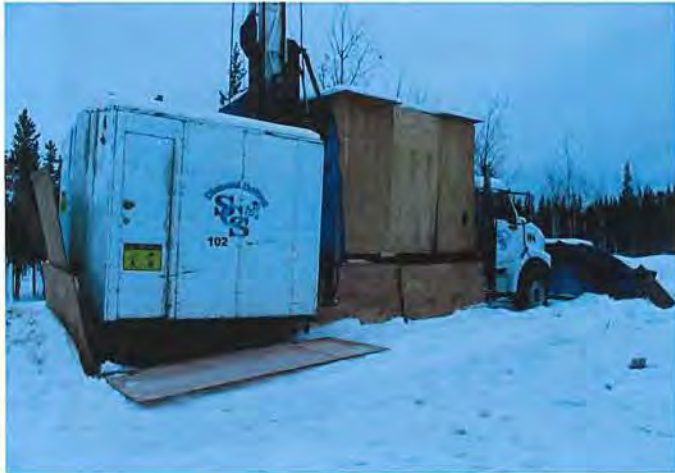
Checked on the SCS drill rig 2 still in storage at the staging area in the N-38 area at 60 51'25.0"N 114 24' 53.3" W. No issues were observed.

**Figure 1**  
SCS staging site, drill stored.

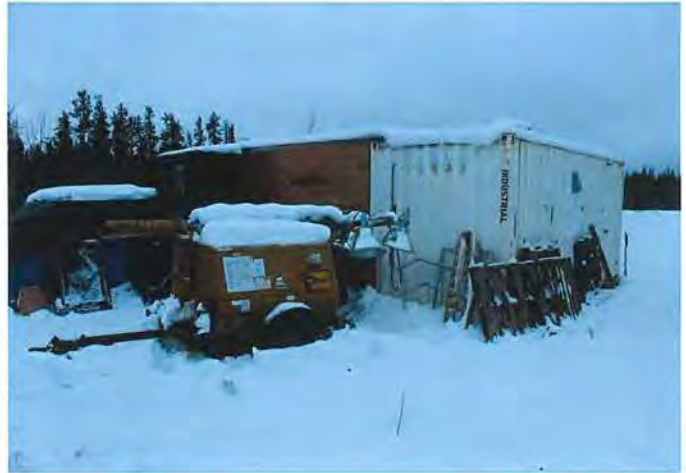
**Figure 2**  
View of staging area.

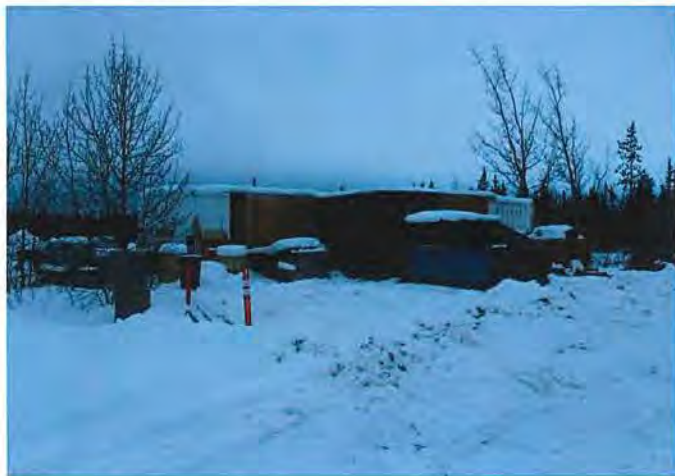
**Figure 3**  
SCS Staging area.

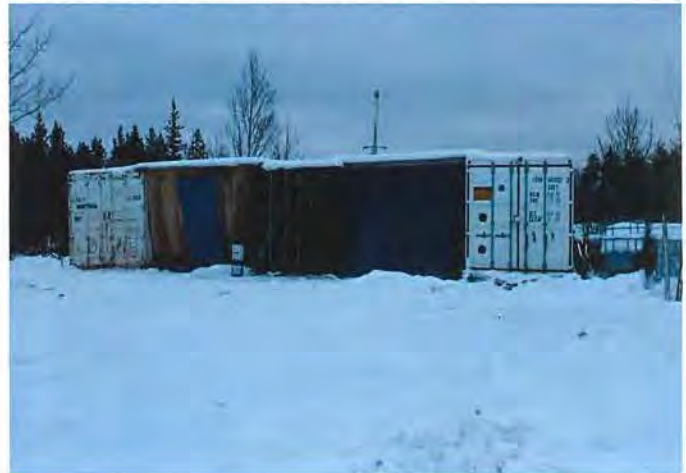
**Figure 4**  
SCS Staging area back view.

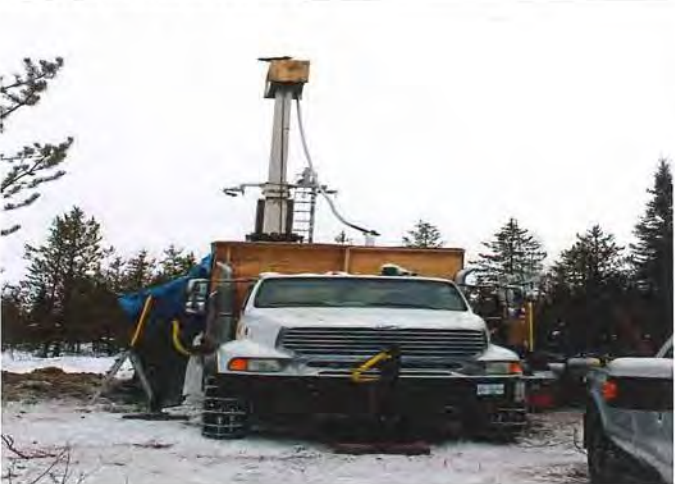
Went over to M48-18-PP-014 where SCS Rig 1 was just completing drilling. Sump for the hole was located right next to drill. M48 -014 was located at 60 50'31.1"N 114 29' 20.8" W. No issues observed.

**Figure 5**  
SCS at M48-18-PP-014

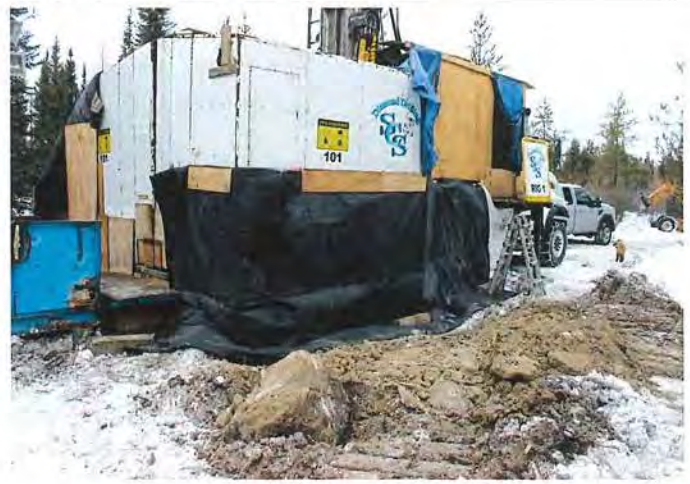
**Figure 6**  
SCS Rig set up on M48 -014 site

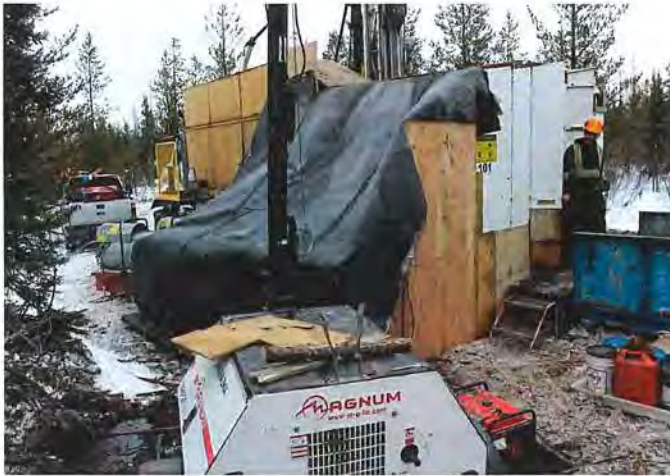
**Figure 7**  
SCS drill setup

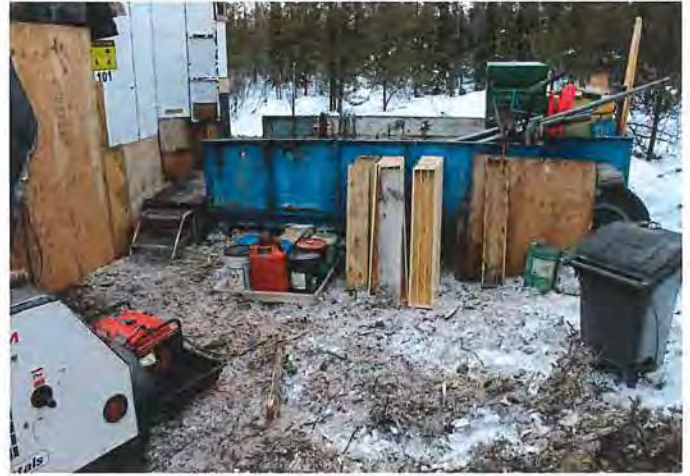
Hole M48-15 was located at 60 50' 32.7" N 114 29' 17.4" W and was well remediated. Drip trays were observed about the site for holding fuel and drilling fluids. See pictures #8 & 10. Access into the site was a little rough but windrows were minimal due to low snow fall and thin brush around the area.

**Figure 8**  
SCS drill setup

Just a reminder that any equipment parked for more than two hours should have drip trays under them.

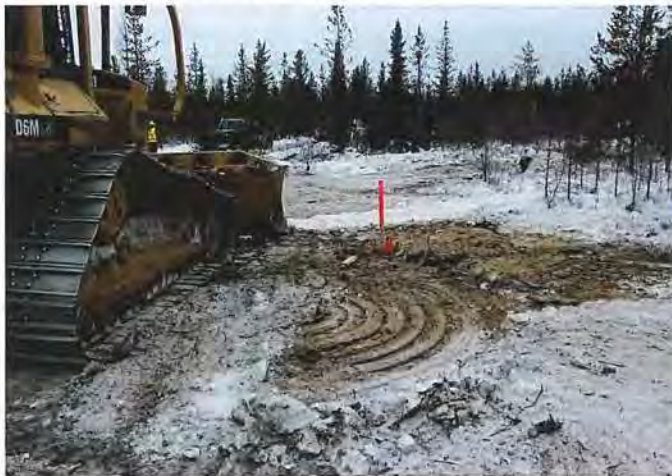
**Figure 9**  
M48-15 site recently drilled

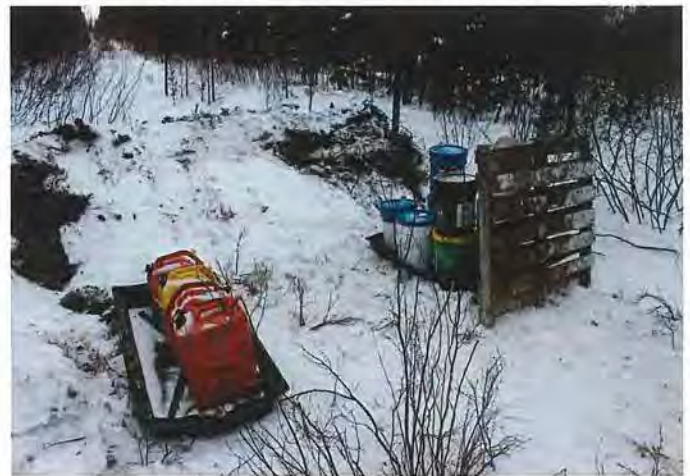
**Figure 10**  
Fuel and drilling pails in containment
