File Number MV2018Q0003
Type of Operation QUARRY SITE - New
Location Km 100, NWT Highway No. 1

ENVIRONMENTAL INSPECTION REPORT

Permittee:	Rowe's Construction (851791 NWT Ltd)	Permit Expiry Date:	March 28, 2023
Land Use Permit No.	MV2018Q0003	Previous Inspection:	New
Quarrying Permit No.	18/0007	Inspection Date:	June 26, 2018
Contractor:		Subcontractor:	
Location(s) Inspected:	Km 100, NWT Highway No. 1		
Current Stage of Operation:	Permittee is clearing the wooded area on the west side of the existing clearing in preparation for quarrying activity.		
Program Modifications Approved:

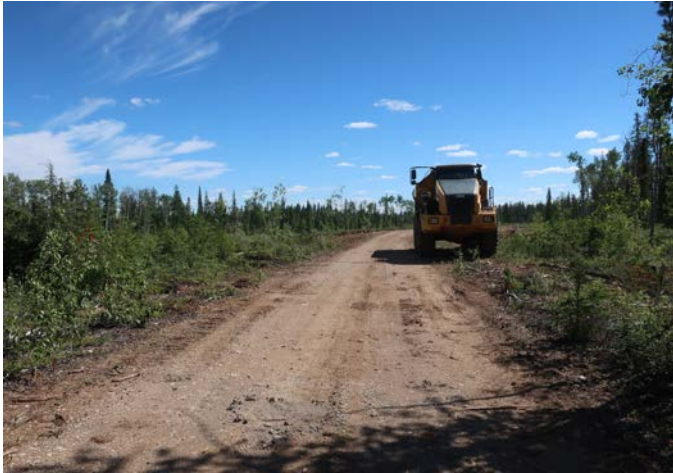
Figure 1

A dump truck was parked on the west side of the clearing, it was noted that there was no drip tray under the equipment (**Condition 35**)

West side of the land use area. Dump truck parked along access road.

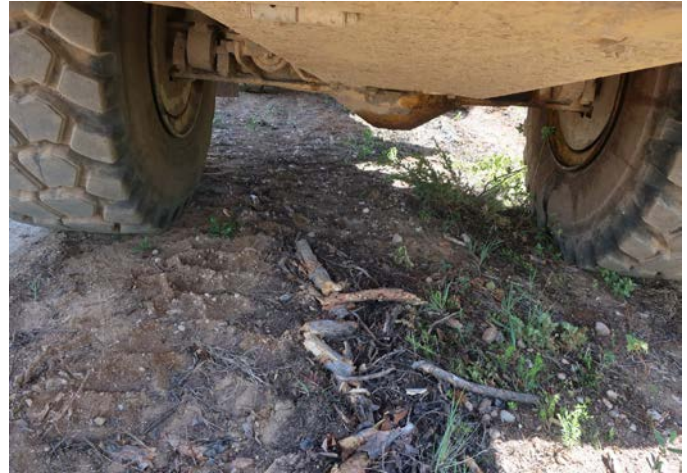
Figure 2

Dump truck requires a drip tray.

A dozer was parked on site with no drip tray underneath. **Note that Condition 35 of your LUP requires "All equipment that may be parked for two hours or more, shall have a haz-mat/drip tray under it or be sufficiently diapered. Leaky equipment shall be repaired immediately."**

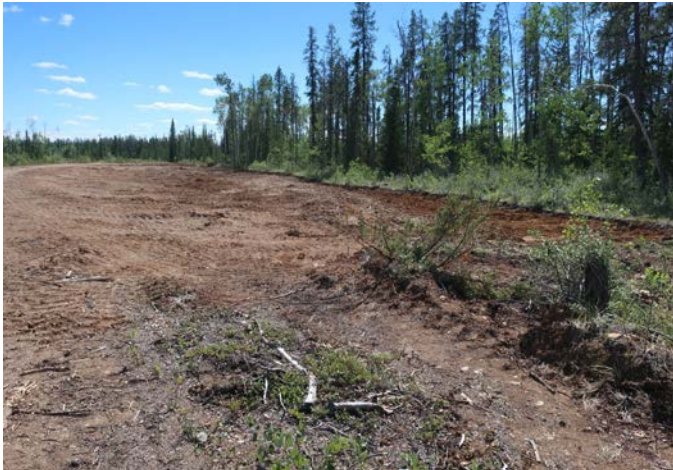
Figure 3

Overburden is being stripped from the new clearing on the west side.

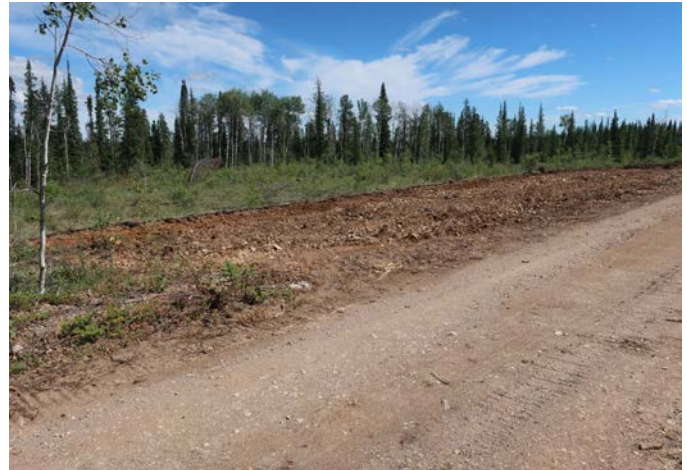
Figure 4

Overburden is being stripped from the new clearing on the west side.

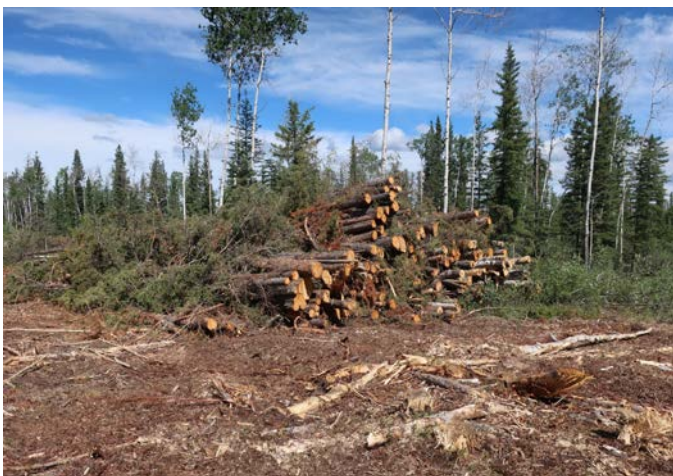
Figure 5

Salvaged timber is decked for public use.

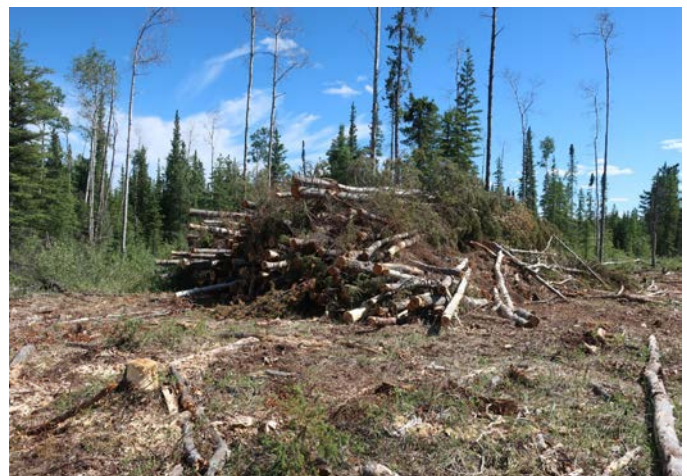
Figure 6

Second pile of salvaged timber.

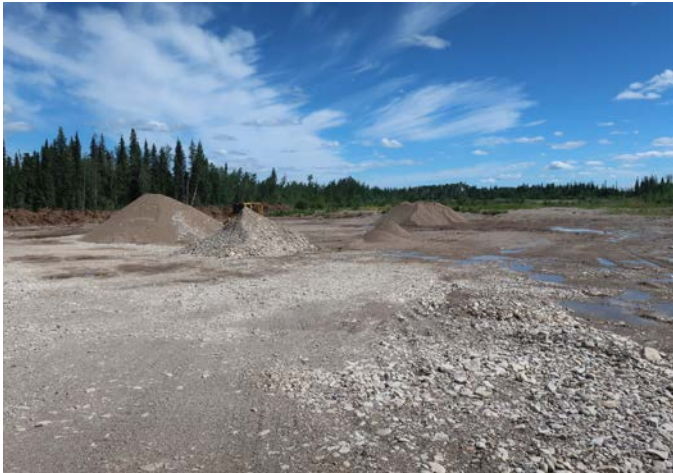
Figure 7

East side of the land use area at the existing quarry site.

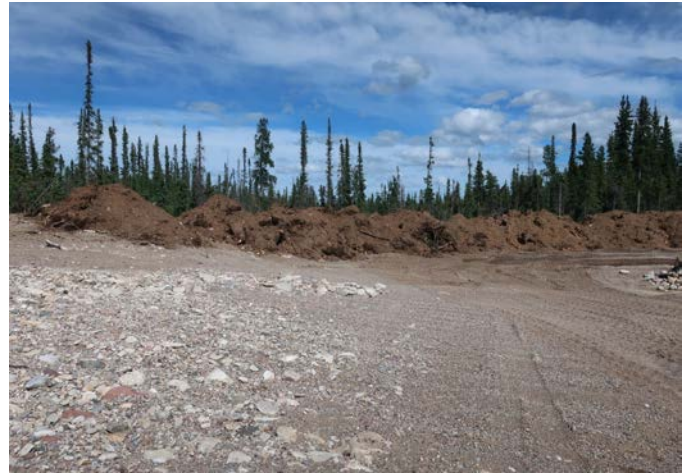
Figure 8

Overburden is being stored on the north side of the existing quarry site.

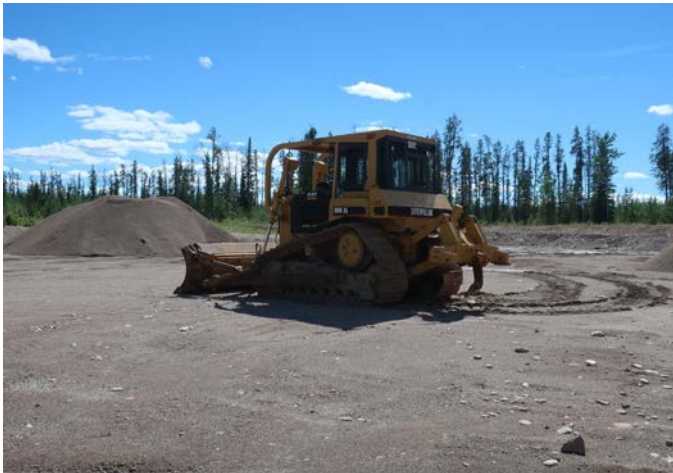
Figure 9

Dozer parked in the existing quarry.

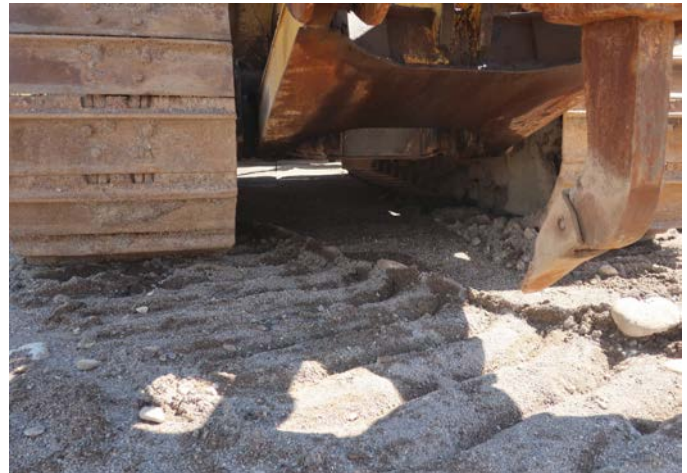
Figure 10

Dozer requires a drip tray.
