**RE: Land Use Permit S03A-008  
OIL AND GAS DRILLING - WELLSITE  
E-44, B-23 and K14 Wellsites**

## ENVIRONMENTAL INSPECTION REPORT

<b>Permittee:</b>	Apache Canada Ltd.	<b>Permit Expiry Date:</b>	December 12, 2010
<b>Land Use Permit No.</b>	S03A-008	<b>Previous Inspection:</b>	July 26, 2005
<b>Quarrying Permit No.</b>		<b>Inspection Date:</b>	September 25, 2013
<b>Contractor:</b>		<b>Subcontractor:</b>	
<b>Location(s) Inspected:</b>	E-44, B-23 and K14 Wellsites		
<b>Current Stage of Operation:</b>	Remediation Activities		
<b>Program Modifications Approved:</b>	None

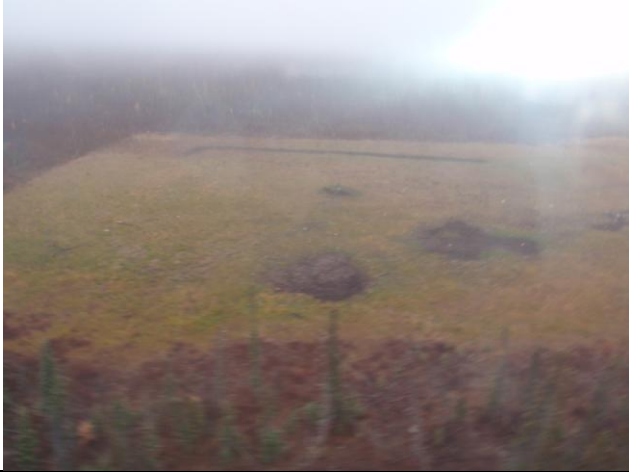
**Figure 1**

Three locations on the well site need remediation. The proponent is addressing these issues and has taken actions in the form of removing contaminated material and attempting a preliminary phytoremediation program. This project is ongoing.

B-23, This photograph depicts the three barren areas contaminated with salt and hydrocarbons. The "L" shaped disturbance is the drill site camp sump.

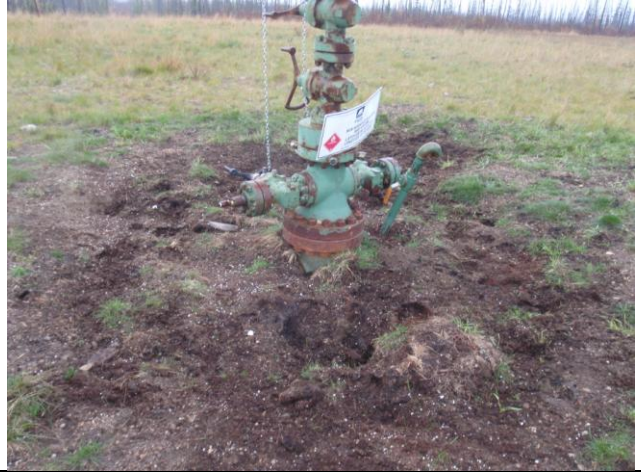
**Figure 2**

B-23, Well Center. Contaminated soil was removed, seed and fertilizer applied. Disturbance from animals makes it difficult for plant growth.

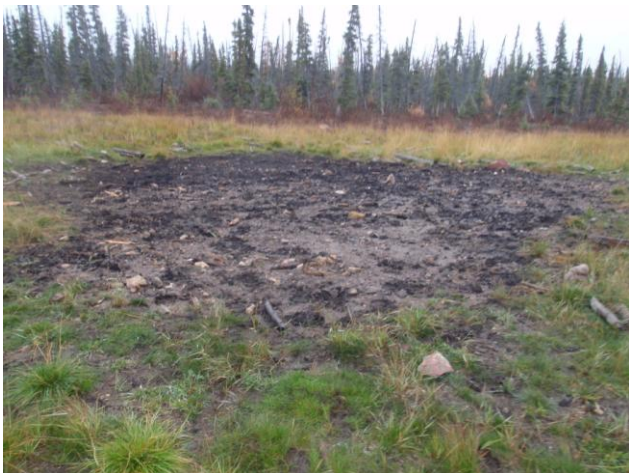
**Figure 3**

B-23, One of the three contaminated areas.

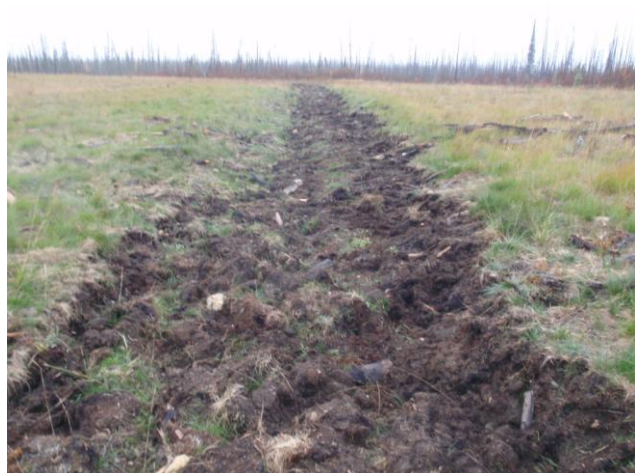
**Figure 4**

B-23, "L" shaped camp sump. Efforts have been made to fill this failed sump.

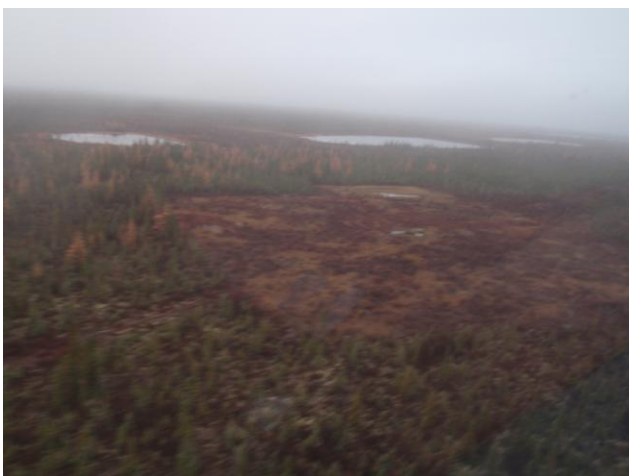
**Figure 5**

K-14, Good vegetation in the majority of the well site. Seismic line used for access.

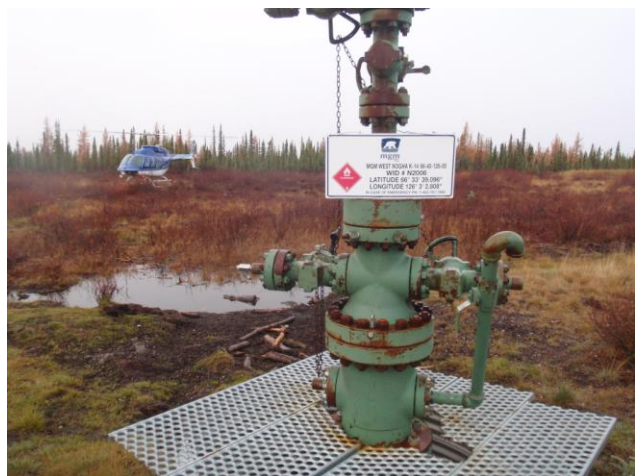
**Figure 6**

Some contamination at well center. As with B-23, contaminated material has been removed, grass and fertilizer applied but has not been successful.

K-14, Well center. Contaminated soil has been removed. Attempts to foster plant growth has not been successful.

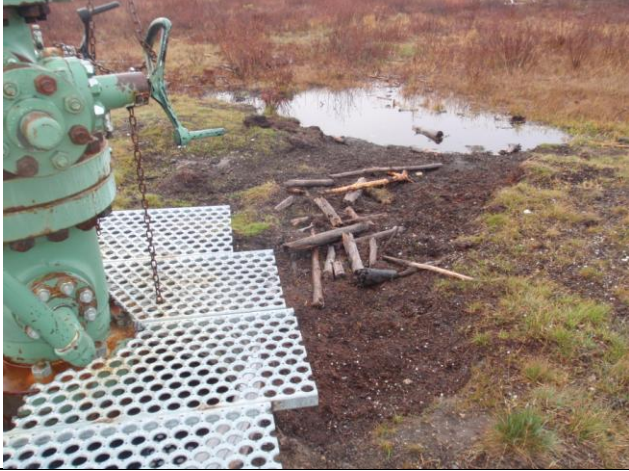
**Figure 7**

**K-14, Another look at the attempt to remediate.**

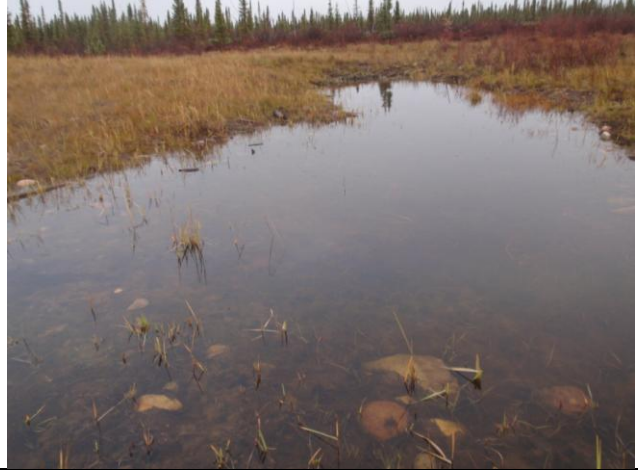
**Figure 8**

**K-14, Some minor ponding has occurred.**

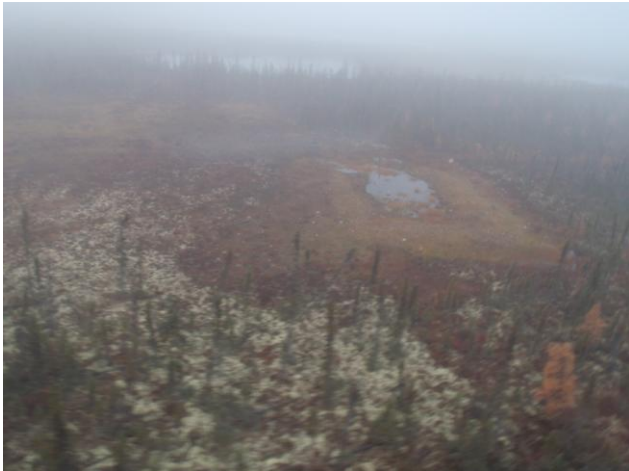
**Figure 9**

**E-44, Good vegetation growth, minor ponding.**

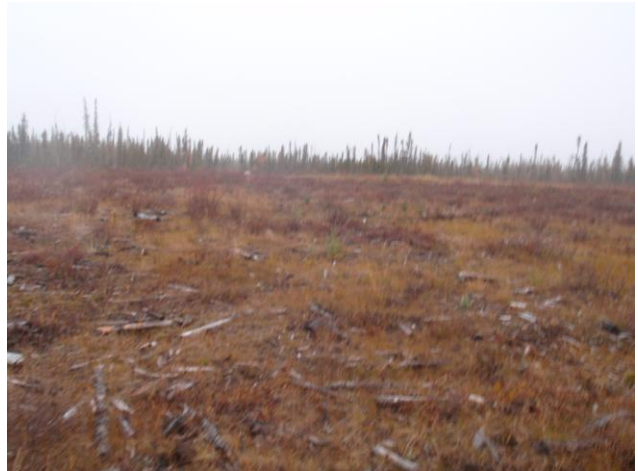
**Figure 10**

This site is well vegetated, no contamination need not be inspected again.

**E-44, Typical of the well site, 100% re-vegetated.**

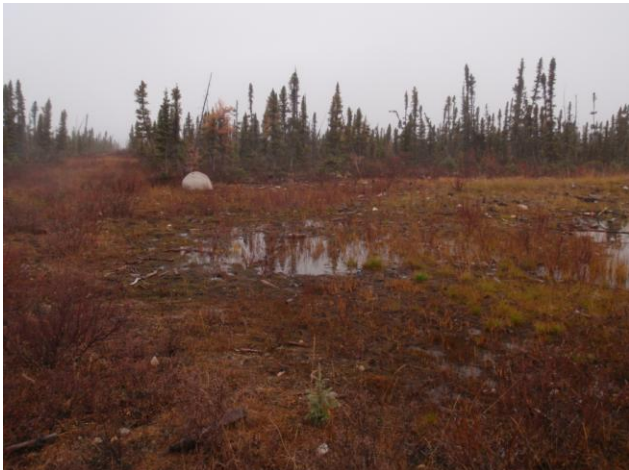
**Figure 11**

**E-44, Access to the well site. No concerns.**

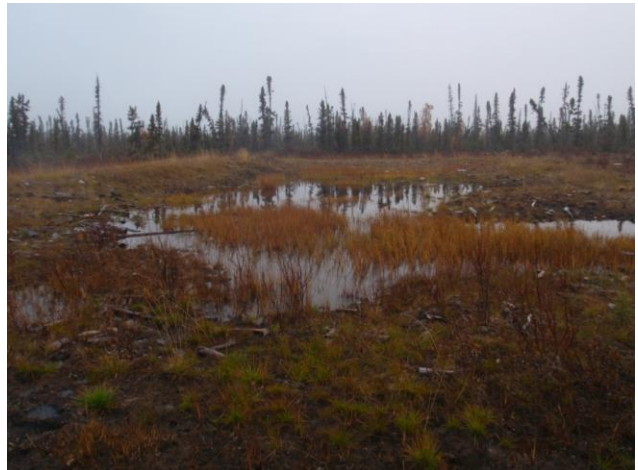
**Figure 12**

**E-44, Minor ponding.**
