File Number	S03A-008
Type of Operation	OIL AND GAS DRILLING - WELLSITE
Location	Wellsites B-23 and E-44

ENVIRONMENTAL INSPECTION REPORT

Permittee:	Apache Canada Ltd.	Permit Expiry Date:	December 12, 2010
Land Use Permit No.	S03A-008	Previous Inspection:	June 18, 2015
Quarrying Permit No.	NA	Inspection Date:	September 09, 2016
Contractor:	NA	Subcontractor:	NA
Location(s) Inspected:	Wellsites B-23, E-44		
Current Stage of Operation:	Reclamation/Monitoring		
Program Modifications Approved:	None

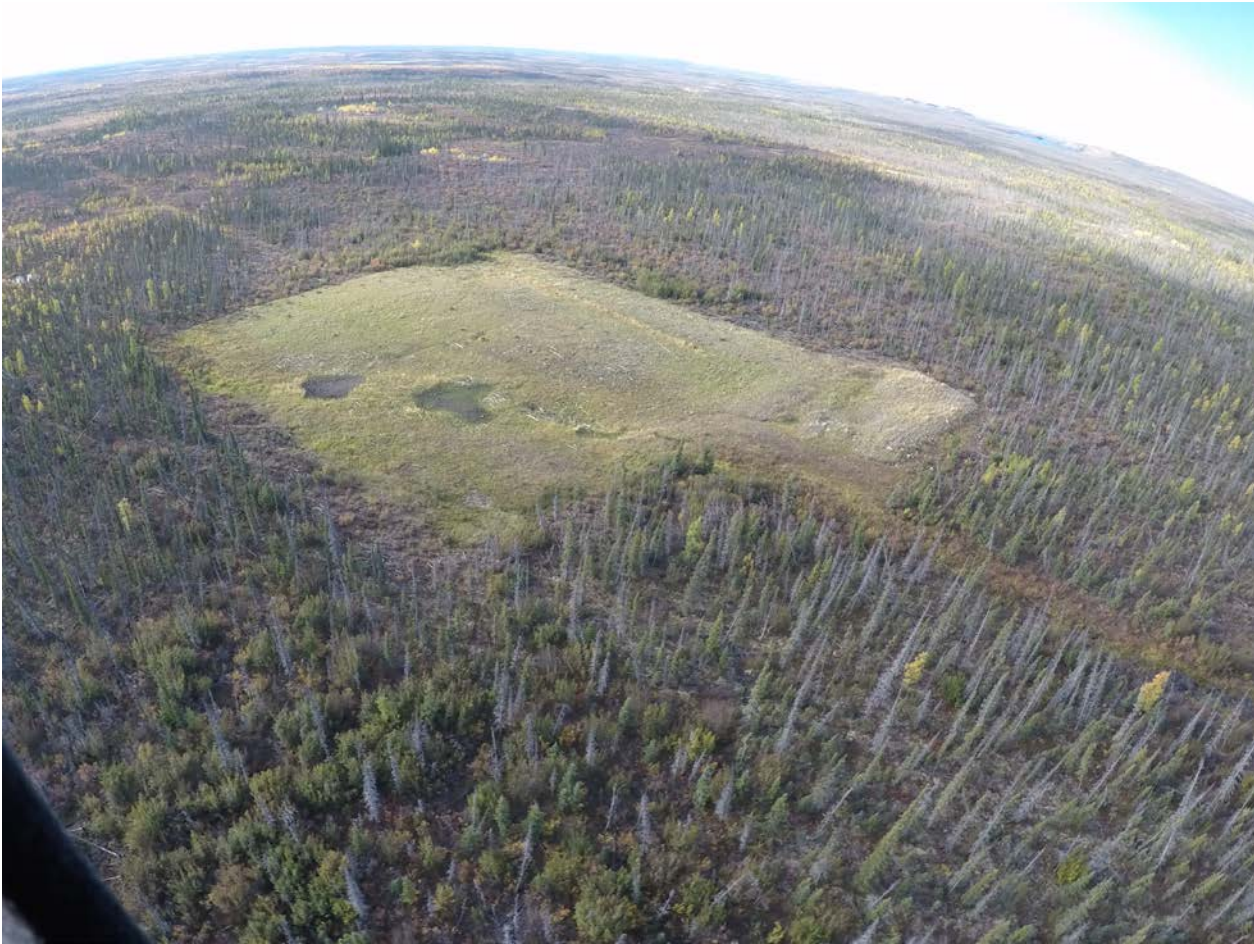
Figure 1

Vegetation is doing well in most parts on the site. The problematic areas for vegetation are the bare areas which are also holding water. Evidence of ungulate wallowing is present in these “ponds” as well. These areas are not directly related to a sump, like in most cases, but may be related to other issues such as contamination, which could also explain ungulate activity (ei. salts from muds) As previously mentioned, sampling results are not being provided to the Department of Lands; please provide these A.S.A.P. to discuss the future land management of this site. Besides the bare areas, Inspector has no concerns; sump on B-23 seems stable.

Photograph of wellsite B-23, notice pooling of water in various locations located in permit area.

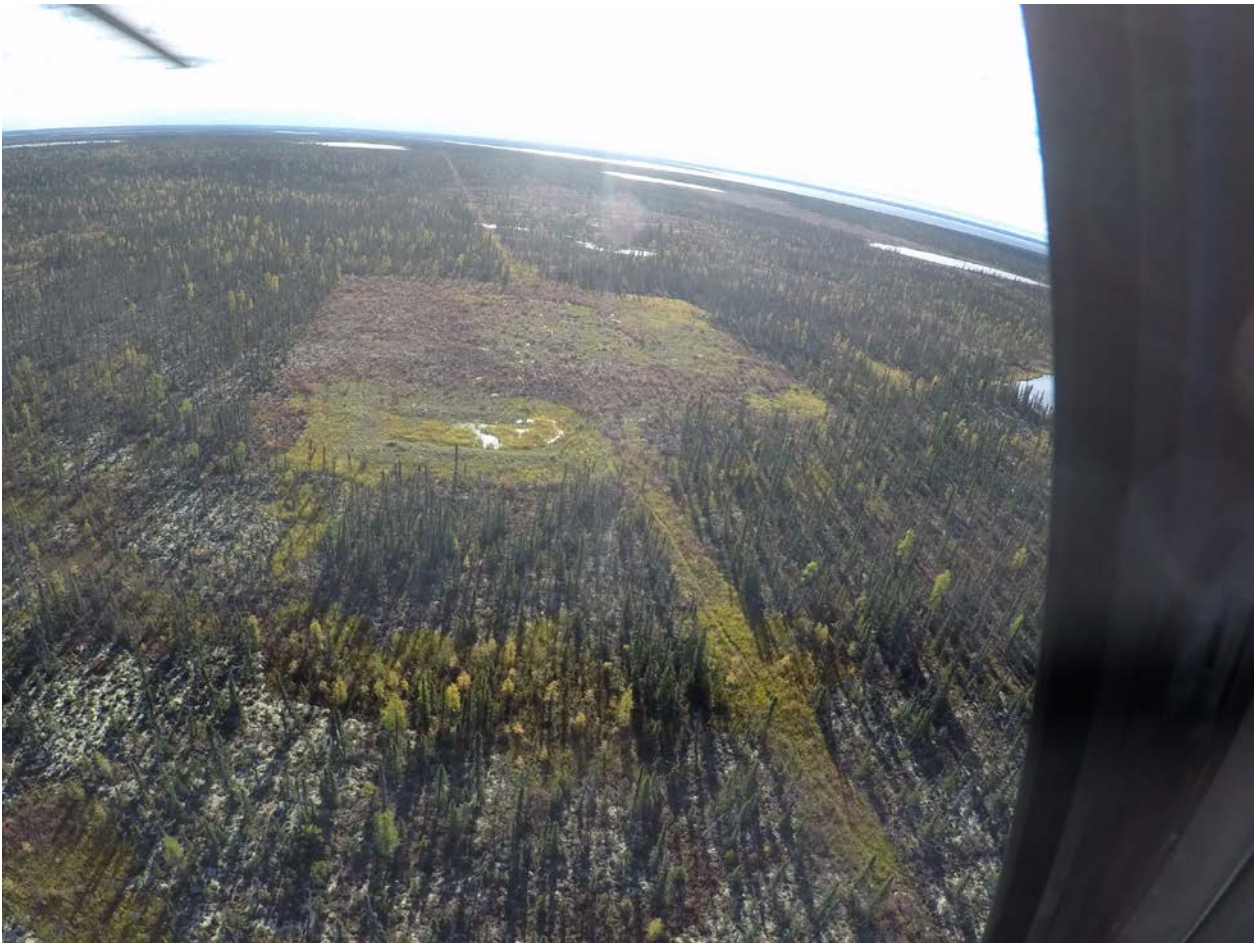
Figure 2

Vegetation is doing very well on the E-44 wellsite. The area of concern on this site is in relation to the remote sump. The sump has some slumpage in the middle section and is now pooling water. Again, it is unsure to Inspector as to when samples were taken from this site, and if so, what the results were. Inspector is interested in all studies related to the signs of slumpage with the sump.

Photograph of E-44. Notice gleam of water pooling on sump area.

Items for Follow-up: Please provide all sampling results for LUP S03A-008.
