**RE: Land Use Permit S13X-003
Staging/camp Area, Quarry M, and Quarry B**

ENVIRONMENTAL INSPECTION REPORT

Permittee:	Husky Oil Operations Limited	Permit Expiry Date:	October 23, 2018
Land Use Permit No.	S13X-003	Previous Inspection:	July 10, 2014
Quarrying Permit No.		Inspection Date:	May 28, 2015
Contractor:	N/A	Subcontractor:	N/A
Location(s) Inspected:	Staging/camp Area, Quarry M, Quarry B.		
Current Stage of Operation:	No activities on site. Equipment and materials are stored at the staging/camp area.		
Program Modifications Approved:	None

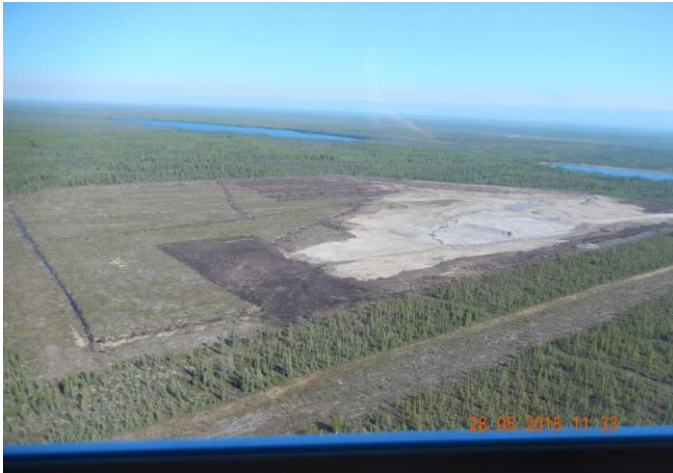
Figure 1

Aerial view of Quarry M facing North. There is good vegetation cover growing on the South side.

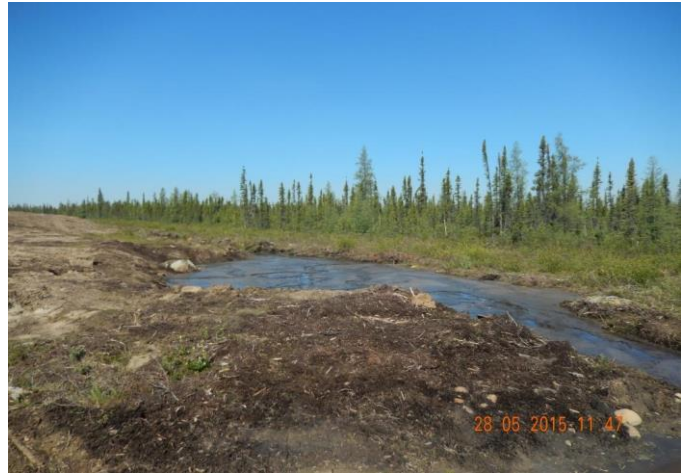
Figure 2

Settling pond in Quarry M is full of sediment.

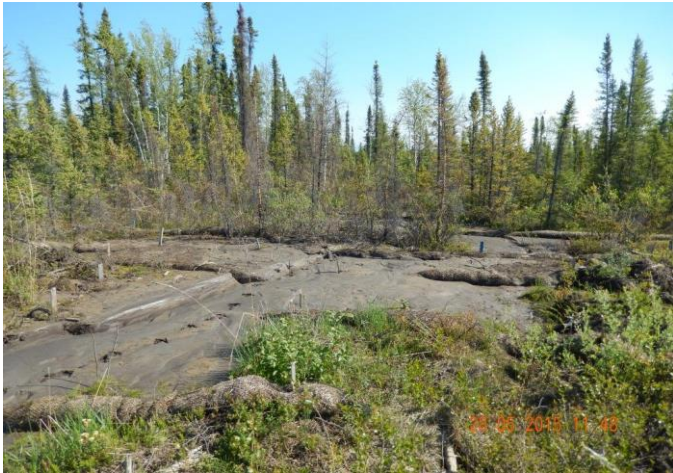
Figure 3

Enclosed is a copy of the Environmental Inspection Report. The staging/camp area is in satisfactory condition. Quarry M requires additional erosion/sediment controls; there are signs of sedimentation in the tree line where the drainage lets out (Figure 3). Quarry B shows slow vegetation growth and has rust staining, but is otherwise acceptable.

The South side of Quarry M is growing back well. *The settling pond on the North side of the quarry requires excavation as the pond has filled with sediment. *The drainage outlet into the trees from the settling ponds has filled with approximately 6 inches of sediment, covering the straw bales onsite (Figure 3). Additional erosion controls need to be installed to reduce sedimentation.

Sediment from settling ponds in Quarry M being washed into the tree line. Additional erosion and sediment controls required.

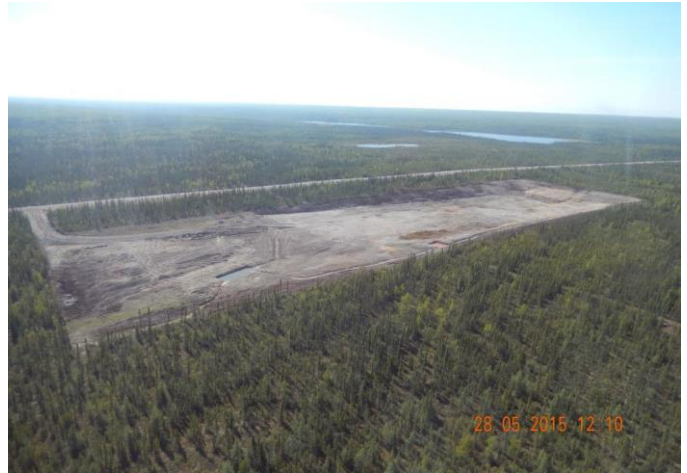
Figure 4

Quarry B has rust staining from the quarried material and little vegetation growth. No signs of erosion from air.

Aerial view of Quarry B; site is slow to regrow and shows signs of rust staining. May need additional restoration.

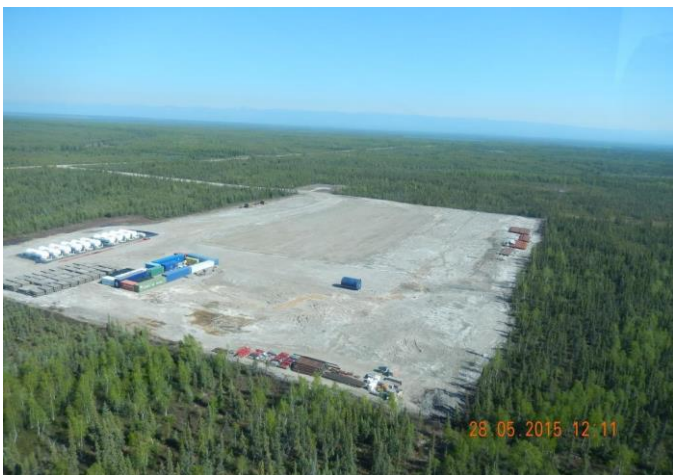
Figure 5

Aerial view facing South of the Staging/Camp area.

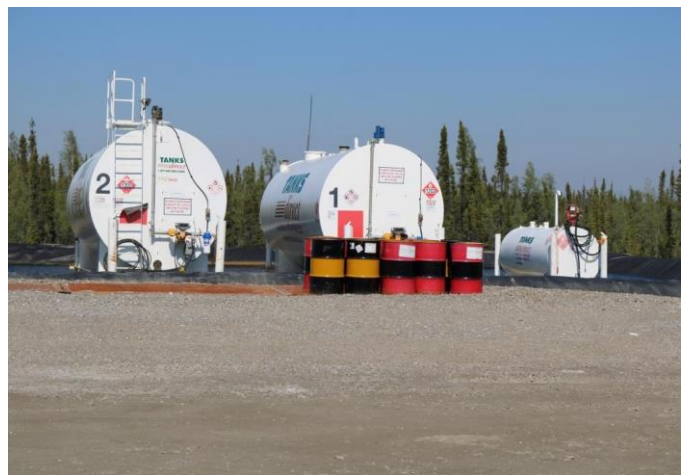
Figure 6

A 4300L, single-walled and 10x 61,000L double walled fuel tanks a stored in tertiary containment at the Staging/Camp area. Water is pooling in the berm, but shows no signs of hydrocarbon sheen. Additional 10x 45gal fuel drums stored outside the berm. No concerns.

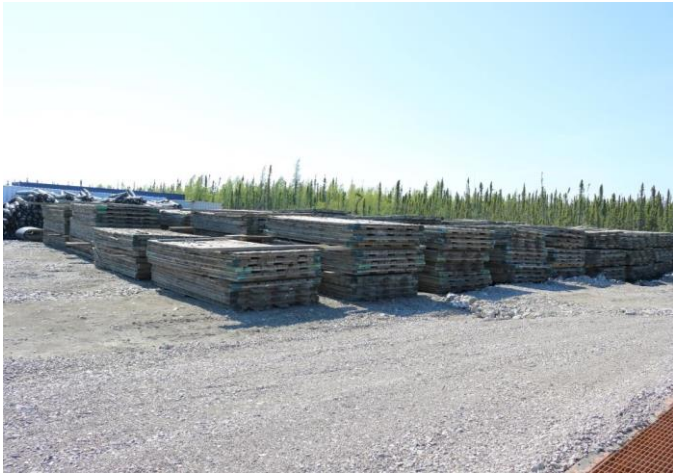
Figure 7

Rig matting and rolls of liner (left) stored at Staging/Camp area.

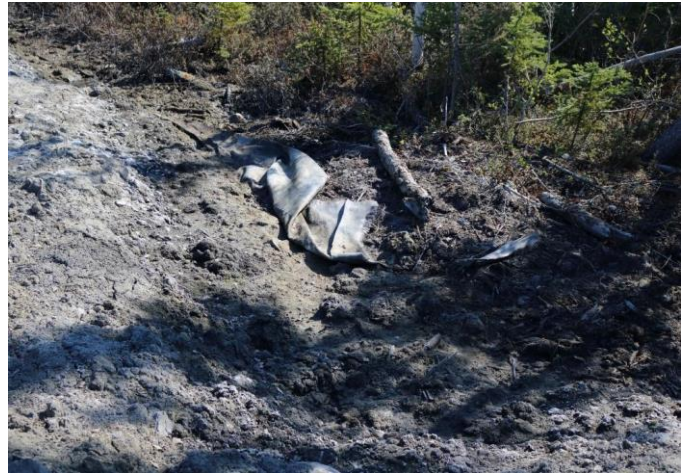
Figure 8

Piece of tarp or liner on the East of the Staging/Camp area near the pile of excavated material. Needs to be removed and disposed of.

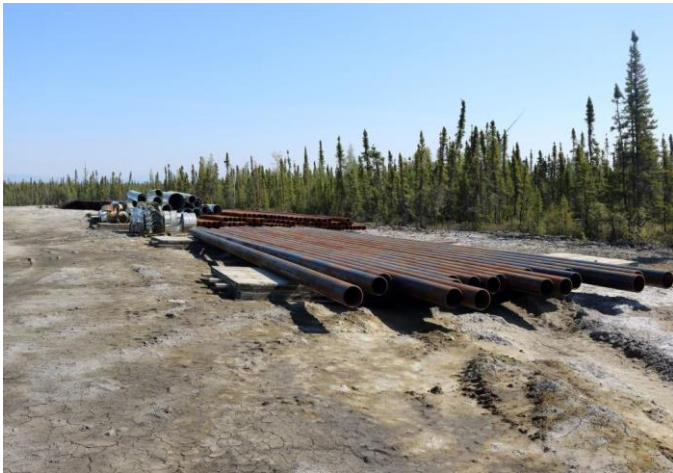
Figure 9

Extra culverts and pipes stored on rig matting at the Staging/Camp area. Some rutting present onsite, no excessive erosion occurring.
