**RE: Land Use Permit S14A-006  
Water Access, Winter Access Road, M-47 Well pad**

## ENVIRONMENTAL INSPECTION REPORT

<b>Permittee:</b>	Suncor Energy Inc.	<b>Permit Expiry Date:</b>	November 16, 2019
<b>Land Use Permit No.</b>	S14A-006	<b>Previous Inspection:</b>	January 26, 2015
<b>Quarrying Permit No.</b>	N/A	<b>Inspection Date:</b>	March 06, 2015
<b>Contractor:</b>	Suncor Energy Inc.	<b>Subcontractor:</b>	N/A
<b>Location(s) Inspected:</b>	Water Access, Access Road, M-47 Well pad		
<b>Current Stage of Operation:</b>	Re-suspension complete. Equipment and materials removed.		
<b>Program Modifications Approved:</b>	None

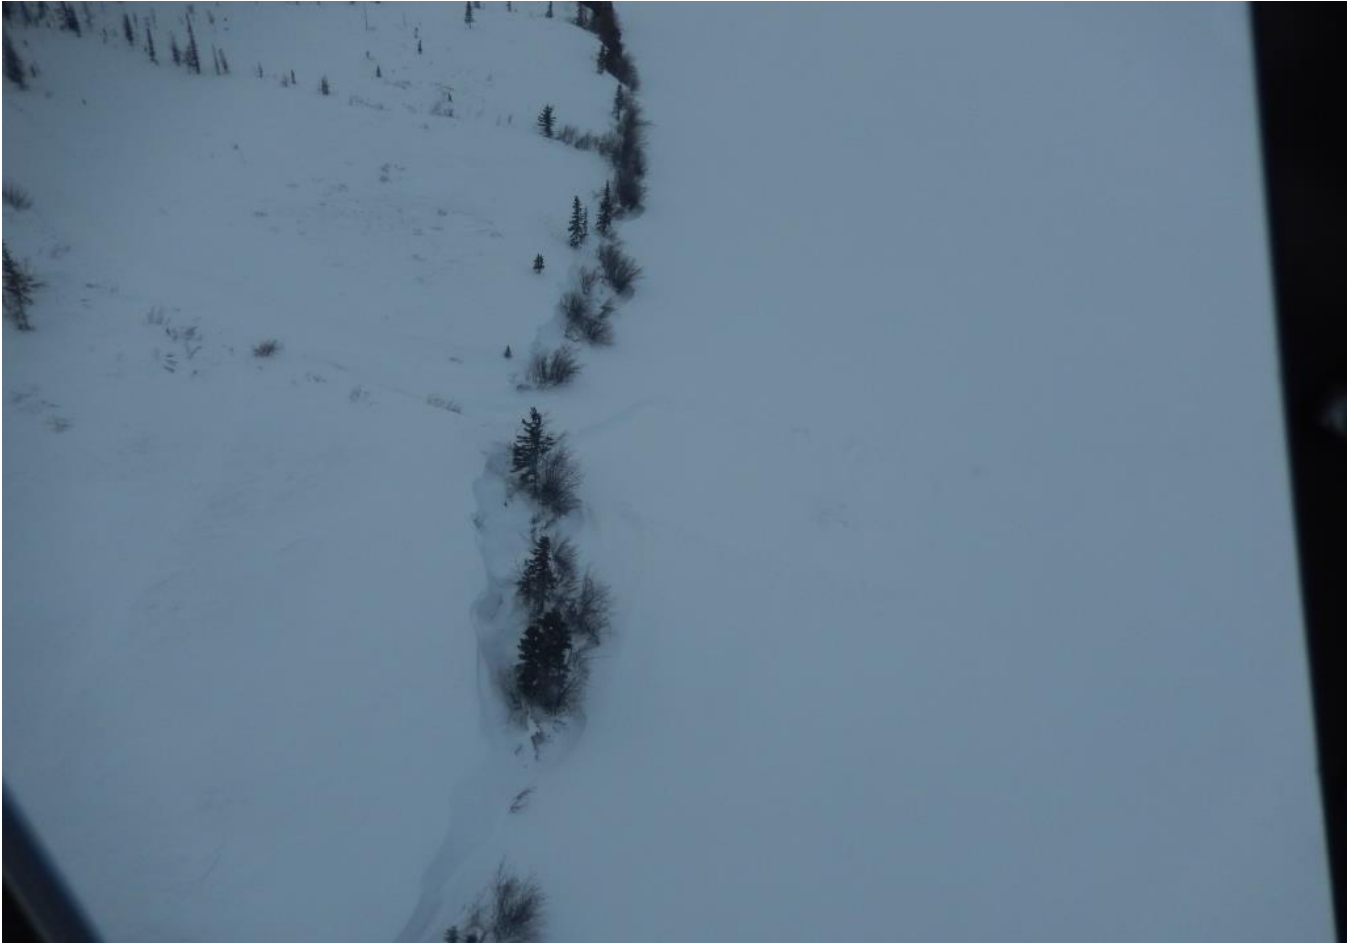
## Figure 1

Activities on site are complete. There are no concerns for the water access pad on Colville Lake (Figure 1).

Aerial view of the water access site.

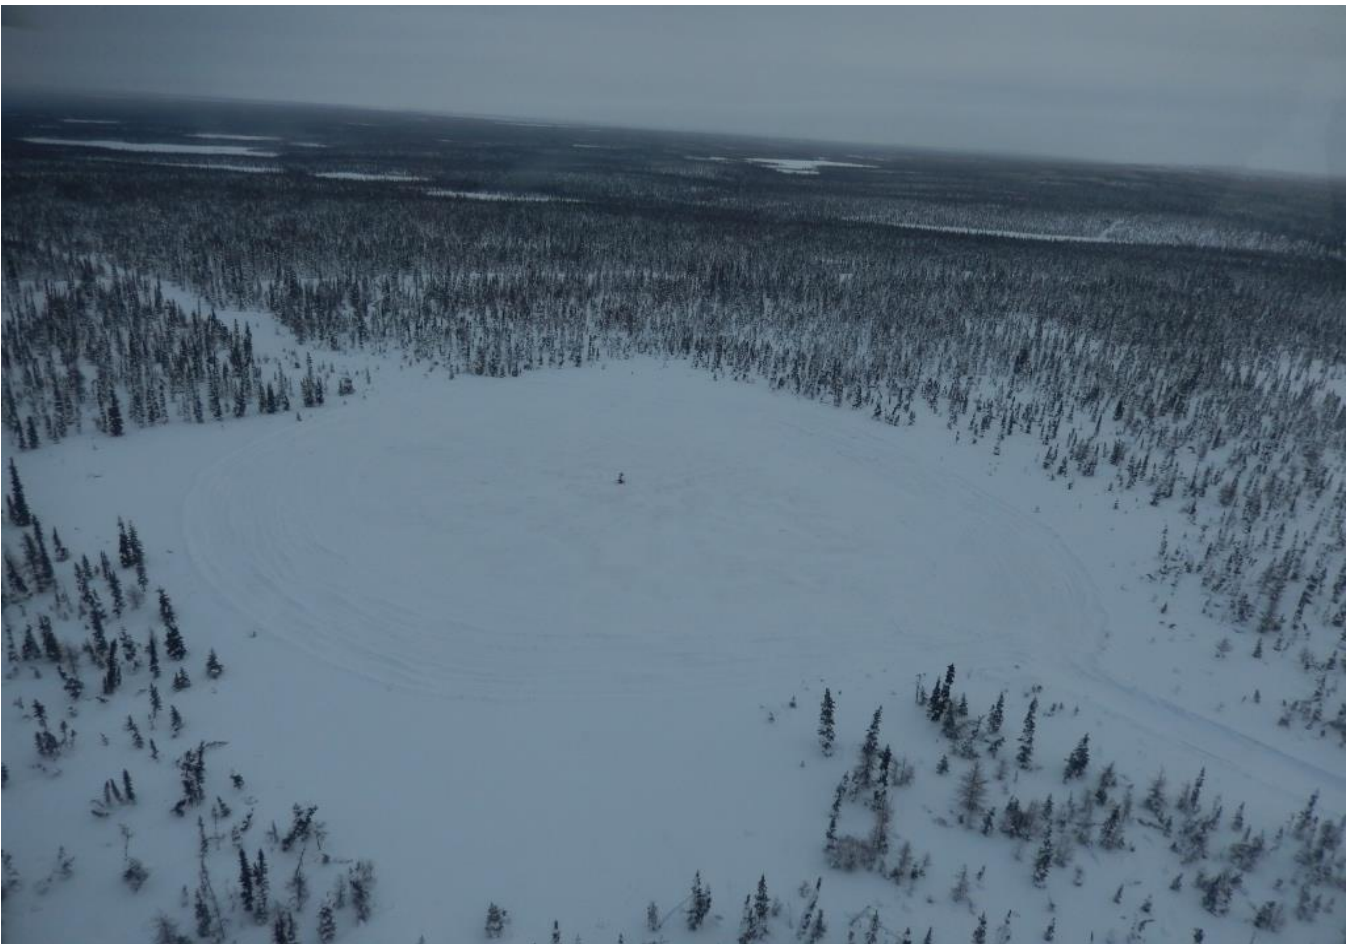
## Figure 2

All equipment, materials, garbage, etc. had been removed from the M-47 well pad at the time of inspection. The wood planks beneath the well have been replaced and the old ones removed. Due to a layer of newly fallen snow, no signs of spills or garbage were visible at the time of inspection.

Aerial view of M-47 well pad.

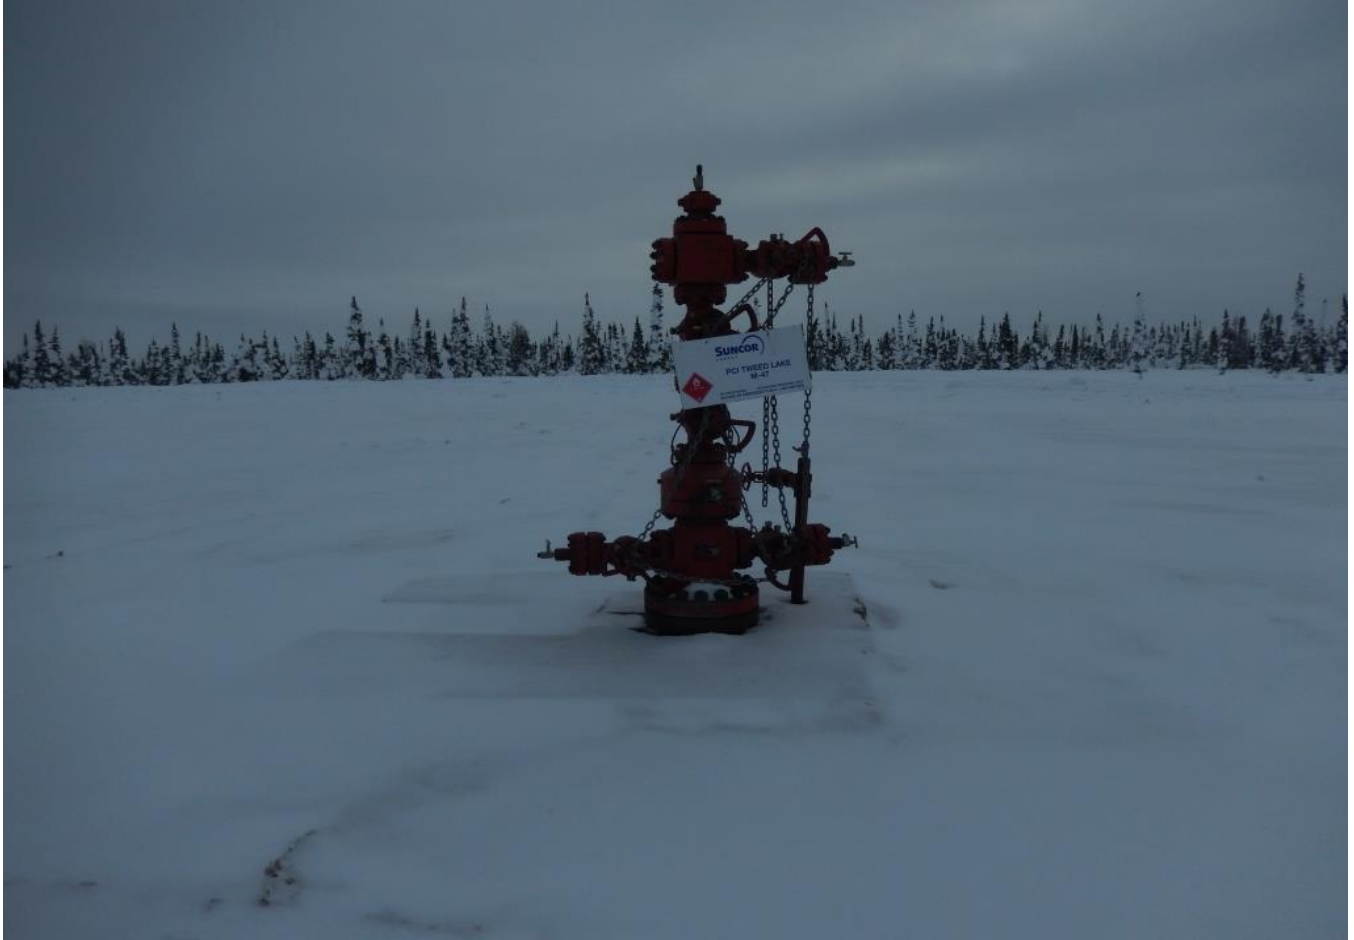
## Figure 3

Re-suspended well cap on M-47 well pad.
