**RE: Land Use Permit S14A-006
Water Access, Winter Access Road, Well pad M-47**

ENVIRONMENTAL INSPECTION REPORT

Permittee:	Suncor Energy Inc.	Permit Expiry Date:	November 16, 2019
Land Use Permit No.	S14A-006	Previous Inspection:	New
Quarrying Permit No.	N/A	Inspection Date:	January 26, 2015
Contractor:	Suncor Energy Inc	Subcontractor:	N/A
Location(s) Inspected:	Water Access, Winter Access Road, Well pad M-47		
Current Stage of Operation:	Cleared winter road and well pad. Have started watering the road and pad.		
Program Modifications Approved:	N/A

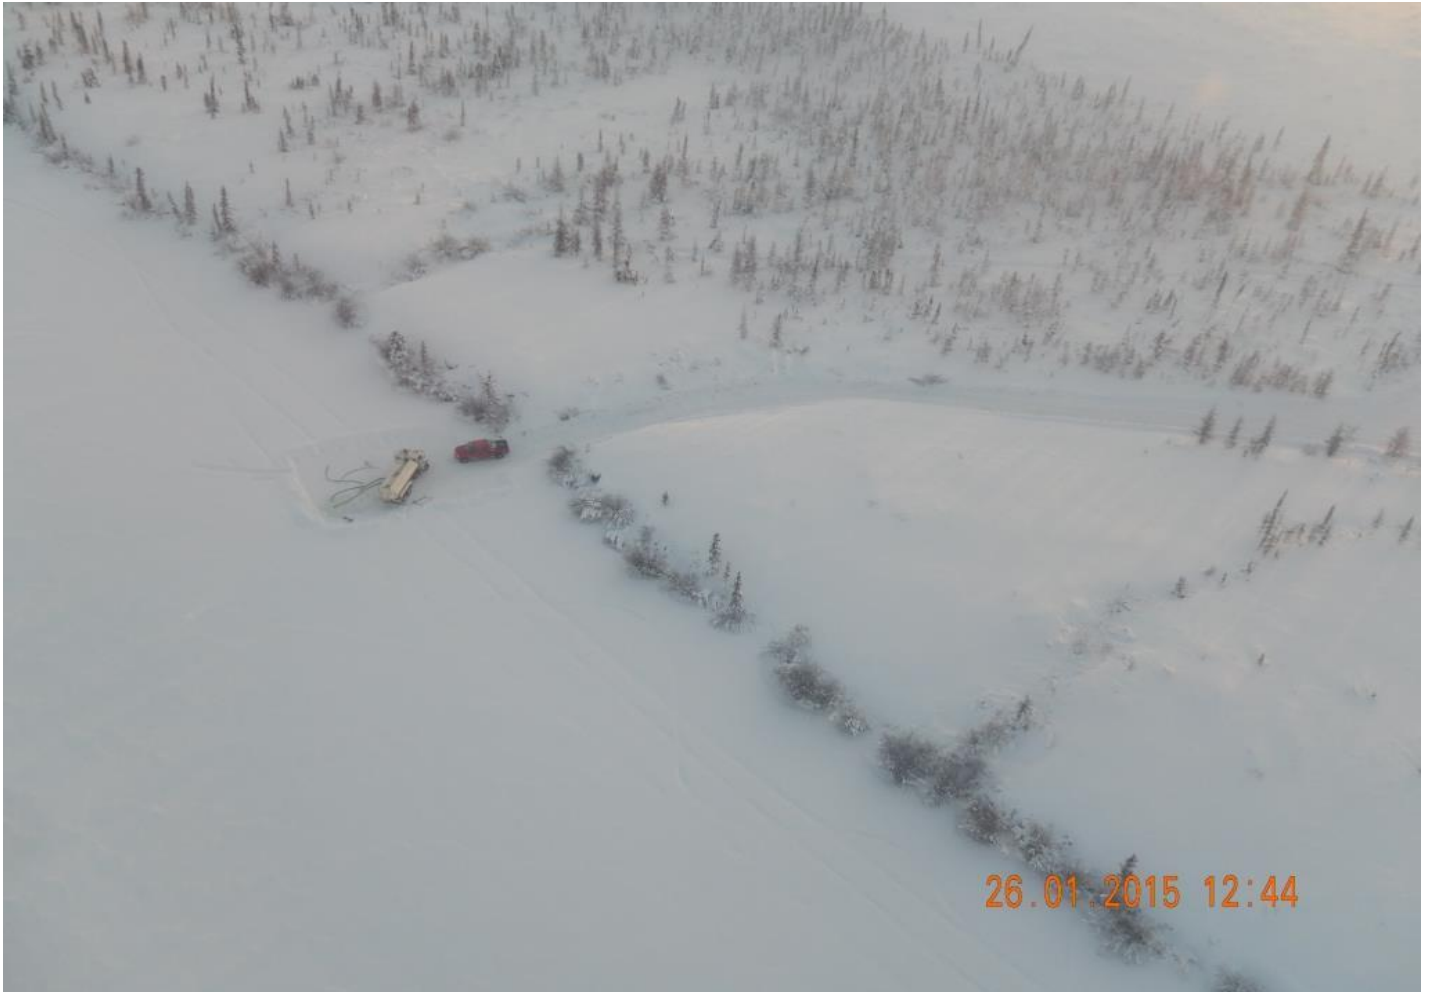
Figure 1

No concerns for the water access point. Water access site is small and there were no signs of spills/garbage.

Water truck and pickup truck on the shore of Colville Lake just North of the Airport. No concerns.

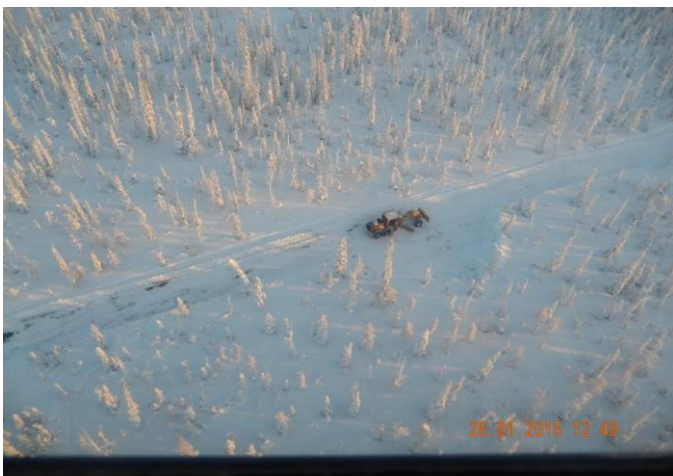
Figure 2

The winter access road was cleared on an existing cut line and little ground cover was exposed by the clearing equipment (Figure 2). This is the same for the M-47 wellpad wherein some brush was still present sticking through the snow from the ground in areas (Figures 7 & 8). This indicates that the ground surface was not gouged or badly disturbed.

Grader working the winter access road. Little exposed soil visible.

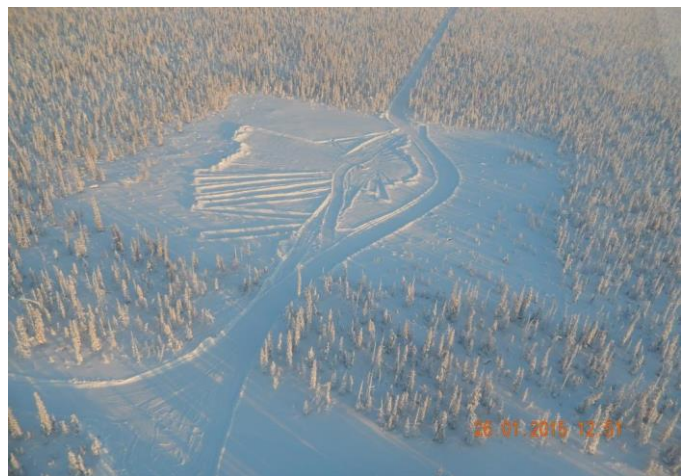
Figure 3

Snow cleaned in spots on well pad M-67 located West of M-47.

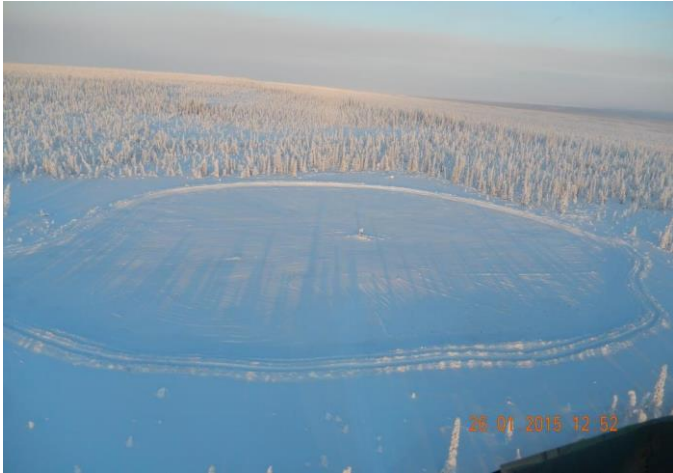
Figure 4

Aerial view of well pad M-47 showing cleared snow. Facing North.

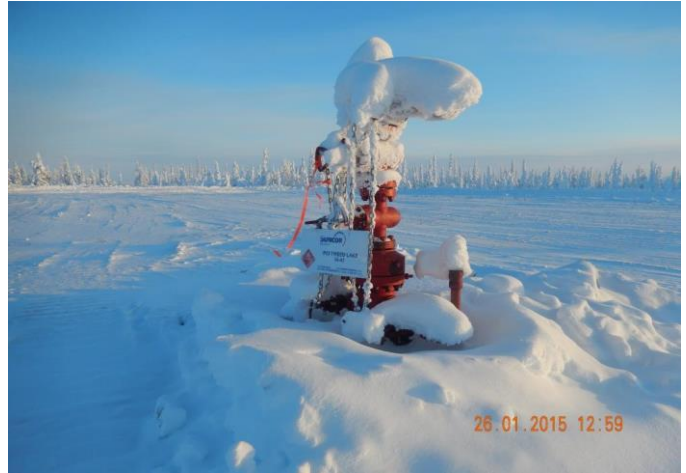
Figure 5

Well cap located on M-47 well site.

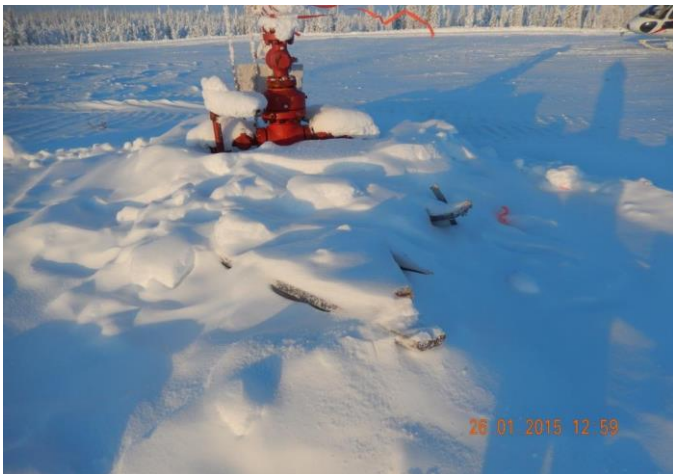
Figure 6

The well cap has some planks of wood present by it (Figure 6). If this wood is not required for operations, please ensure it is disposed of.

Pieces of wood located by the well center. Purpose unknown. Please remove if not needed.

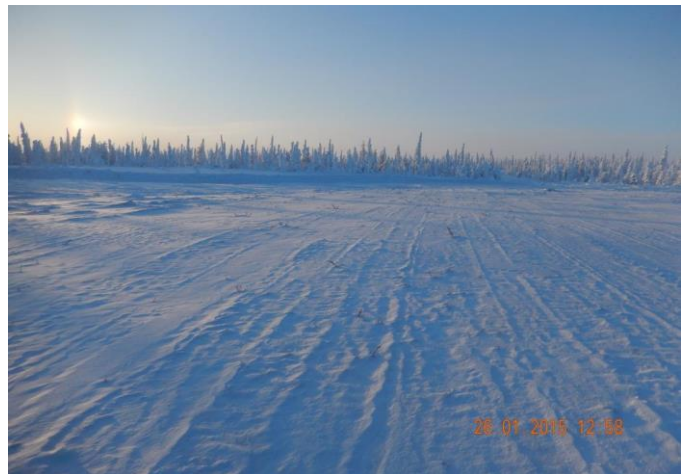
Figure 7

Parts of shrubs are still present in the ground sticking out through the snow layer. This indicates a lack of gouging of the ground surface. No concerns.

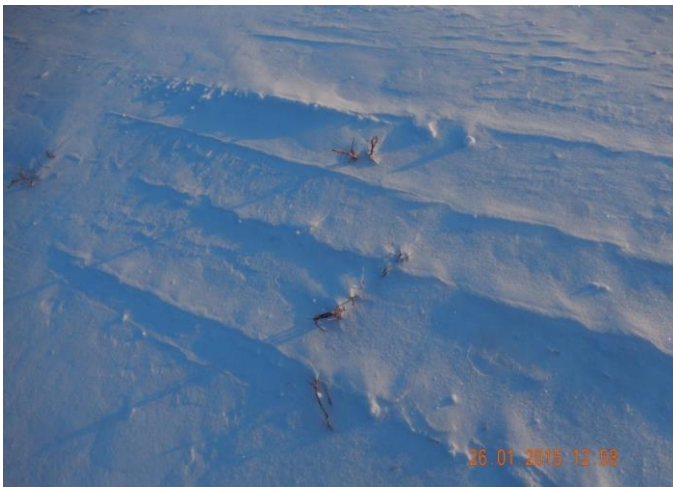
Figure 8

Close up of vegetation sticking through snow.
