2015 Summer Site Inspection Report

K'asho Got'ine District, Sahtu Settlement Area, Northwest Territories

File 25501491 | AUGUST 2015

Client:	Suncor Energy Inc.	Project:	25501491 - Summer Site Inspection
Site Name:	Tweed Lake	Site Location:	M-47

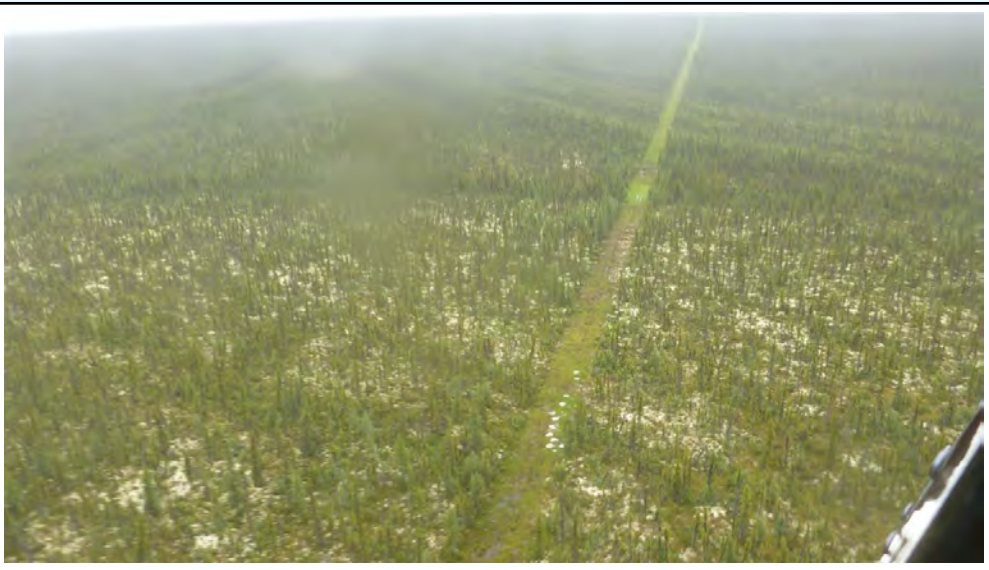
Photograph ID: 5

Photo Location: Access road - southeast to northwest portion	
Direction: Southeast	
Survey Date: 7/21/2015	
Comments: View along the winter access road.

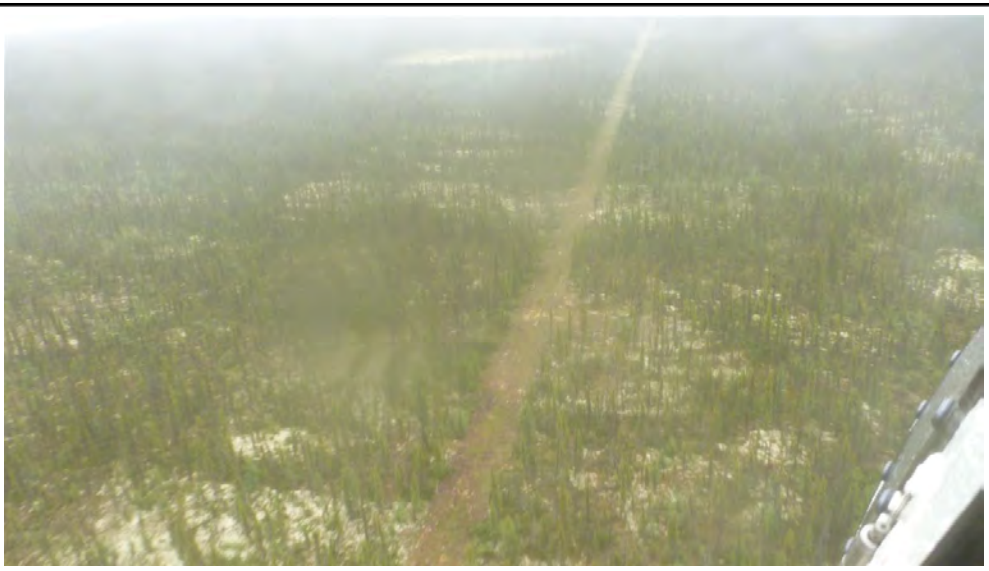
Photograph ID: 6

Photo Location: Access road - southwest to northeast portion	
Direction: Northeast	
Survey Date: 7/21/2015	
Comments: View along the winter access road towards M-47 wellsite.

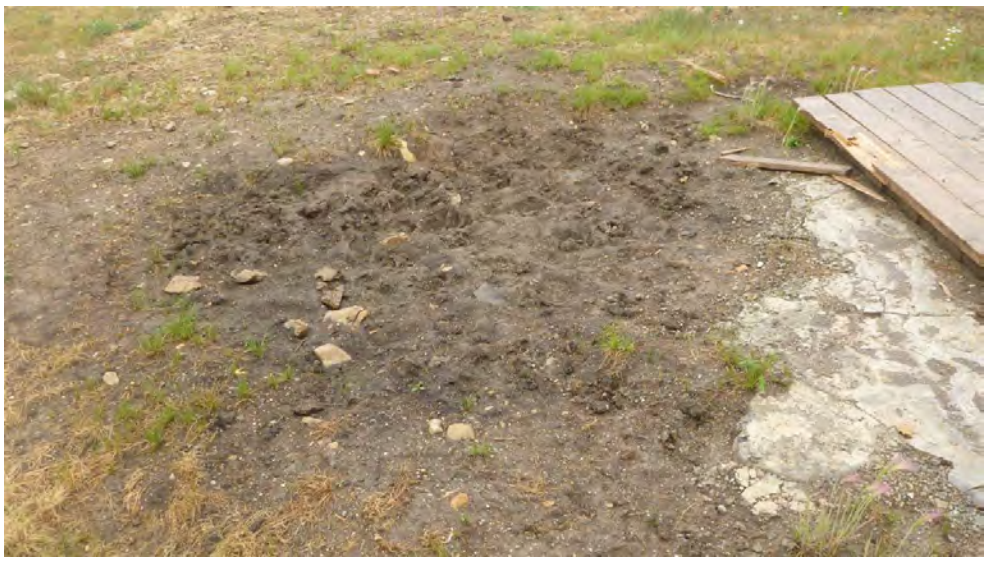
Photo Location: M-47 well centre			
Direction: Ground Surface			
Survey Date: 7/21/2015			
Comments: View of muskox tracks adjacent to the wellhead.			
Photograph ID: 10

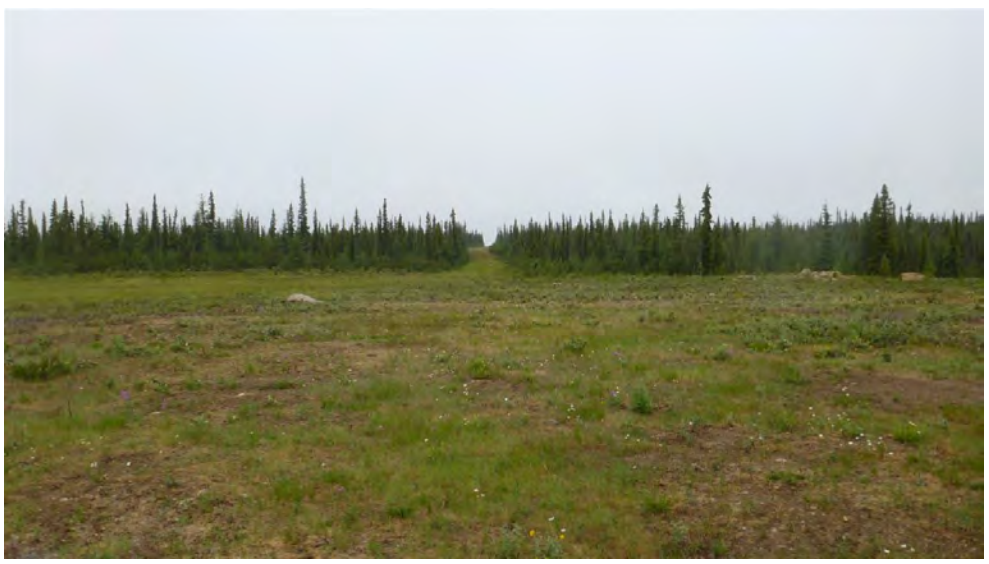
Photo Location: M-47 well centre			
Direction: Southwest			
Survey Date: 7/21/2015			
Comments: View across the wellsite.

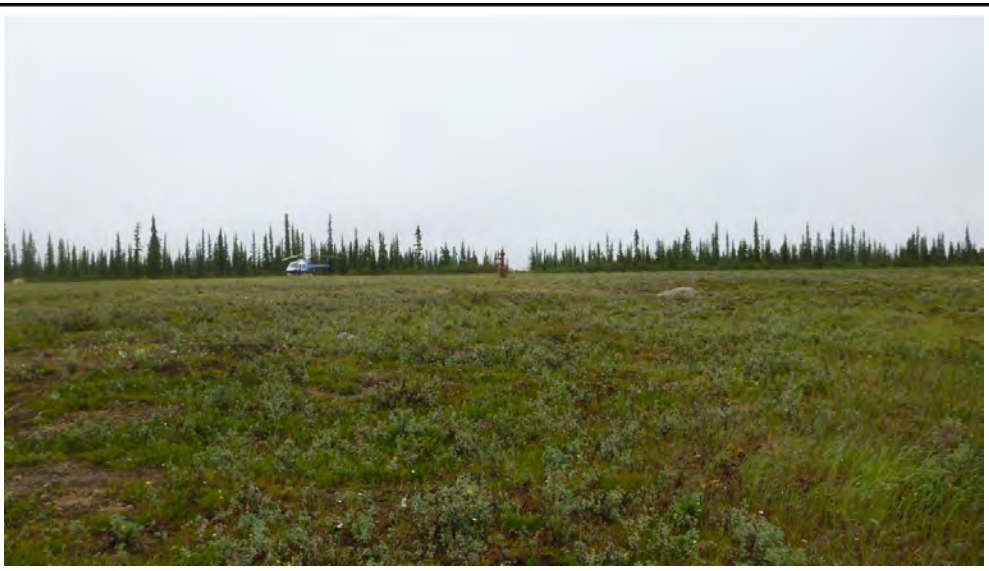
Photograph ID: 14

Photo Location: M-47 wellsite entrance	
Direction: Northeast	
Survey Date: 7/21/2015	
Comments: View across the wellsite. Note vegetation is well established.

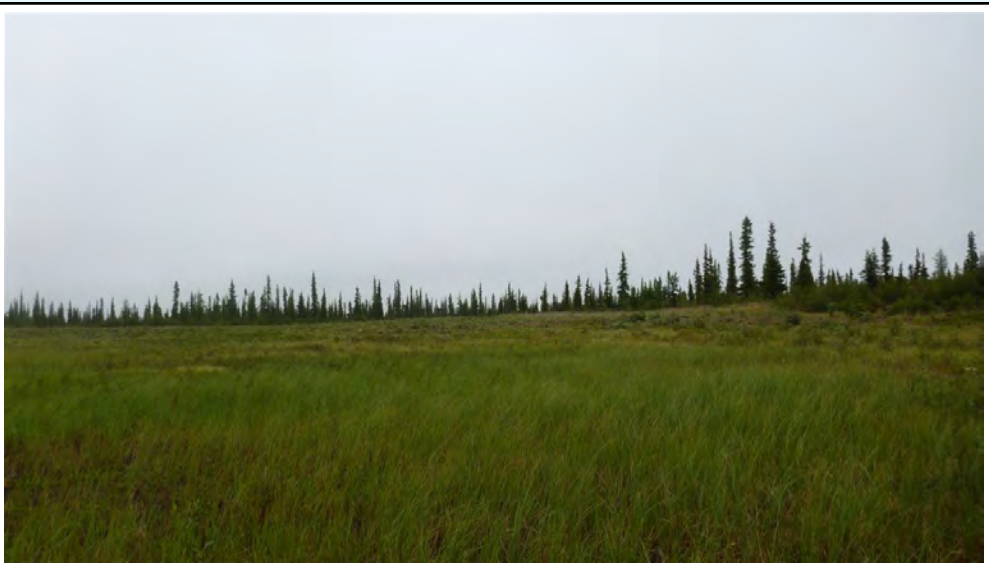
Photograph ID: 15

Photo Location: South corner of M-47 wellsite	
Direction: Northeast	
Survey Date: 7/21/2015	
Comments: View along the southeast edge of the wellsite.

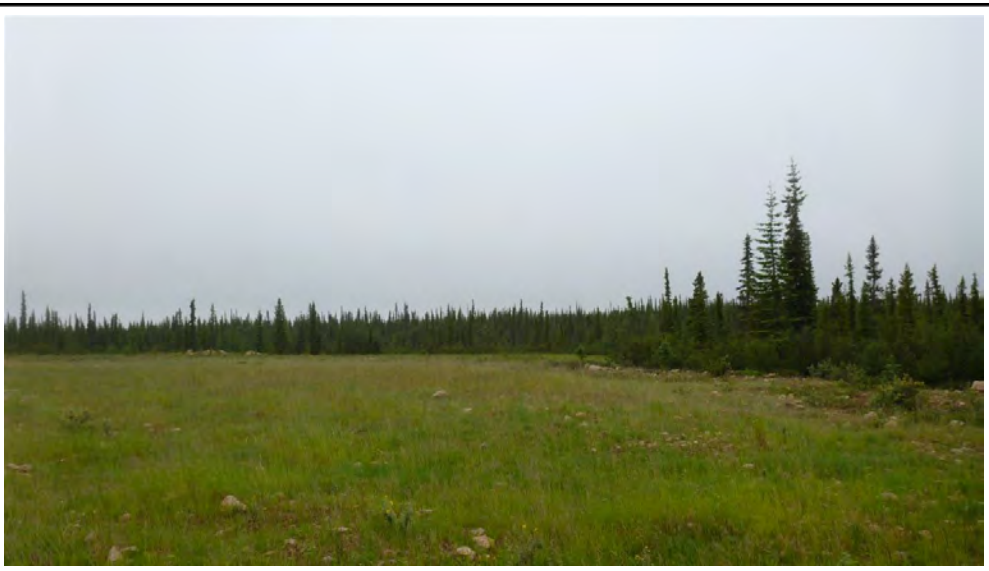
Photograph ID: 16

Photo Location: North corner of M-47 wellsite	
Direction: Southwest	
Survey Date: 7/21/2015	
Comments: View along the northwest edge of the wellsite.
