Attention:	Peter Cushman
File Number	S17L1-004
Type of Operation	Industrial Type B Water Licence
Location	Saline River

WATER LICENCE INSPECTION REPORT

LICENCE #:	S17L1-004	EXPIRY DATE:	February 6th, 2020
LICENCEE:	Enbridge Pipelines (NW) Inc.	PREVIOUS INSPECTION:	N/I
COMPANY REP:	Peter Cushman	INSPECTION DATE:	February 26th, 2018

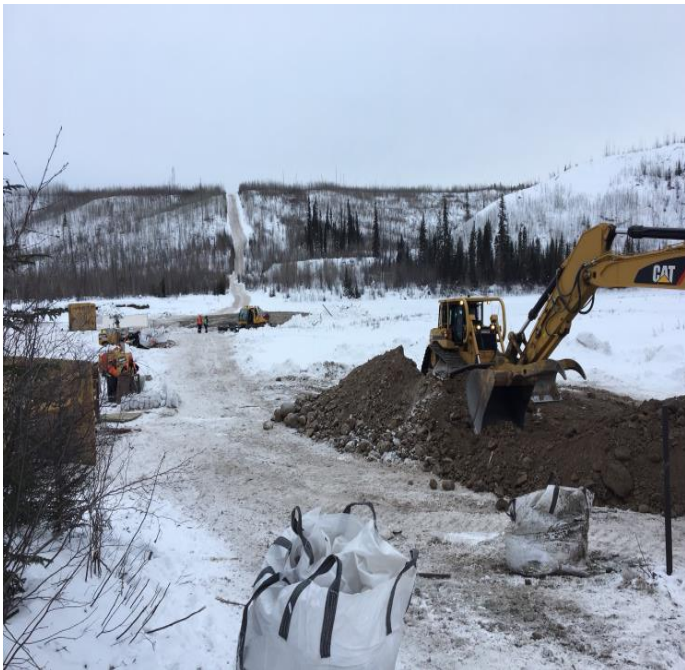
Figure 1 – Site Overview

The water licence permitted Enbridge to dewater a portion of the Saline River to support their pipeline maintenance. There was no dewatering of the river required on the project, but a channel diversion was installed to isolate the Saline River from both dig sites. Enbridge notified the Sahtu Land and Water Board of this diversion on February 16th, 2018, as per Part E, Condition 8 of their licence. The crews had already backfilled the first dig site (Photo #4) and were in the process of filling the second dig site (Photo #1) during the inspection.

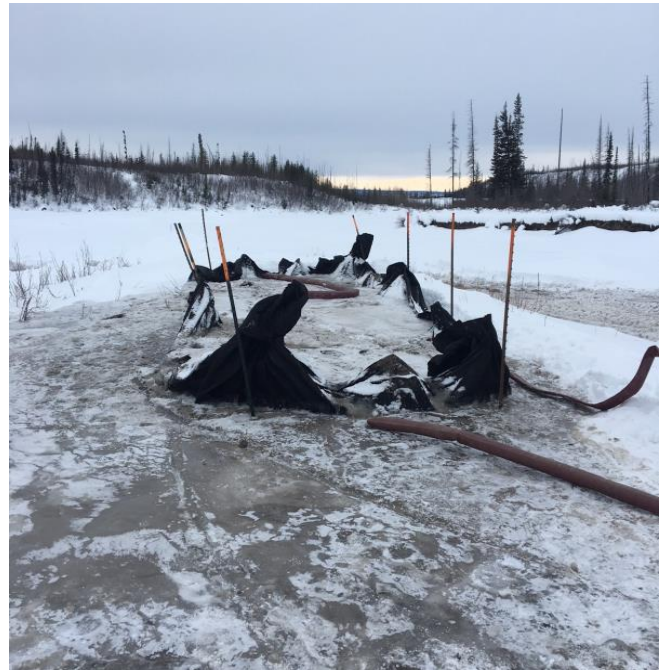
Figure 2 – Temporary Sediment Removal Basin

The discharge location (Photo #2: Temporary Sediment Removal Basin) for the dewatering of the dig pit was actively monitored by the crews on site. The Inspector was not on site to witness the dewatering, however, Enbridge has ensured the Inspector that the sediment and erosion control measures will be removed and disposed of properly following the demobilization of the site. There was some evidence that the sediment removal basin walls (Photo #2) may not have been maintained during dewatering, however, the dewatered material appeared to be clean and free of any major sediment. No erosion was noted by the crews during dewatering of the dig sites.

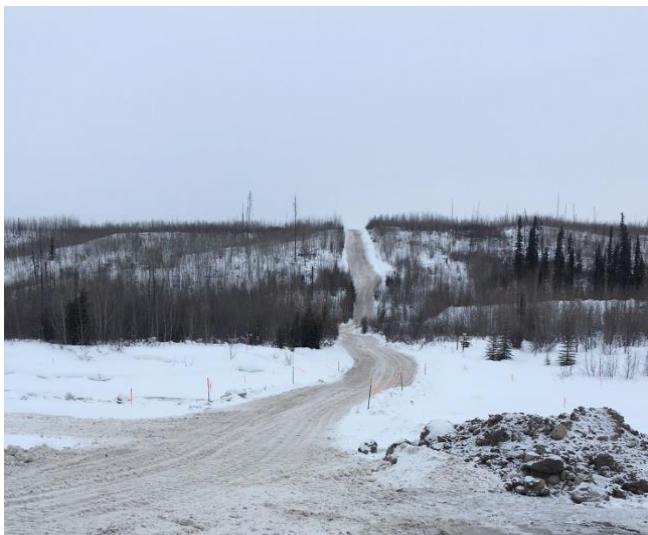
Figure 3 – Temporary Crossing of Saline River

Enbridge was required to construct a watercourse crossing over the Saline River to access their dig sites. The crossing was constructed as per the conditions laid out in Part J: Conditions Applying to Watercourse Crossings in WL# S17L1-004. Riparian vegetation was not disturbed in the immediate boundary of the temporary watercourse crossing, and Enbridge will be removing the crossing during demobilization and closure of the site. Additional comments may be required by the Inspector once the final Closure and Reclamation Plan is submitted to the Sahtu Land and Water Board.

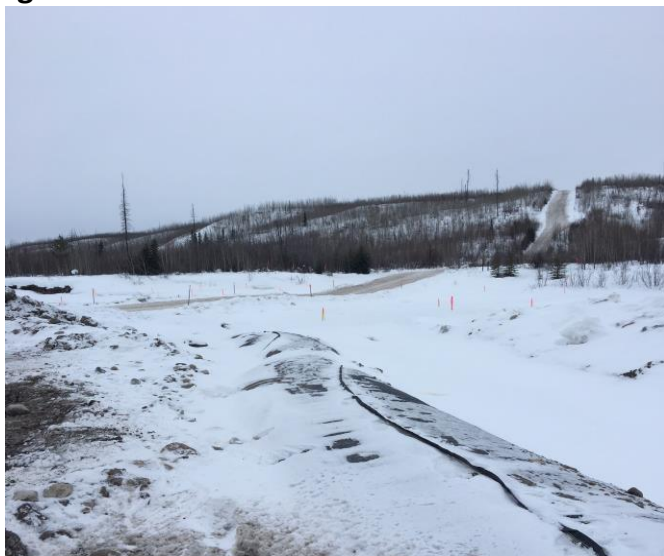
Figure 5 – Stabilization Measures

The stabilization measures (Photo #5) in place appeared to be effective in isolating the dig site from the Saline River. The water flowing around the stabilization measures appeared to be clear and free of any sediment. Additionally, no hydrocarbon impacted water was observed during the inspection.
