Re: February 15th & March 23rd, 2010 INAC Water Licence Inspections

INDUSTRIAL WATER USE INSPECTION REPORT

INSPECTION DATES: 2010-02-15 and 2010-03-23

LICENCE #: W2009L2-0001 (Water Licence)
Ekati Diamond Mine

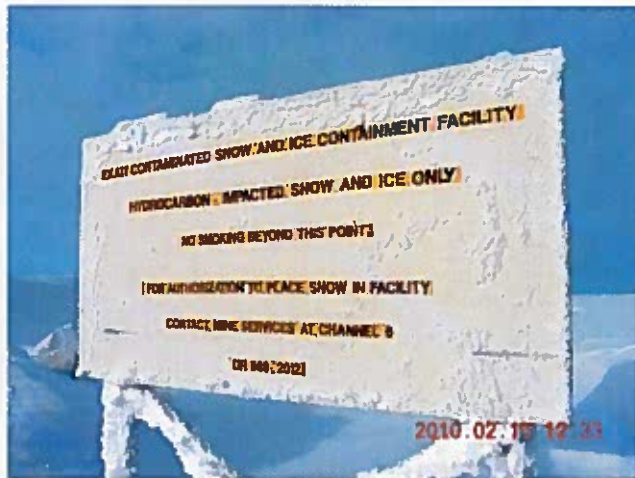
Photo 1

Inspection of the Contaminated Snow and Ice Containment Facility (CSCF) for storage of hydrocarbon impacted snow and ice was conducted on February 15th, 2010. The facility is being used regularly for its intended purpose.

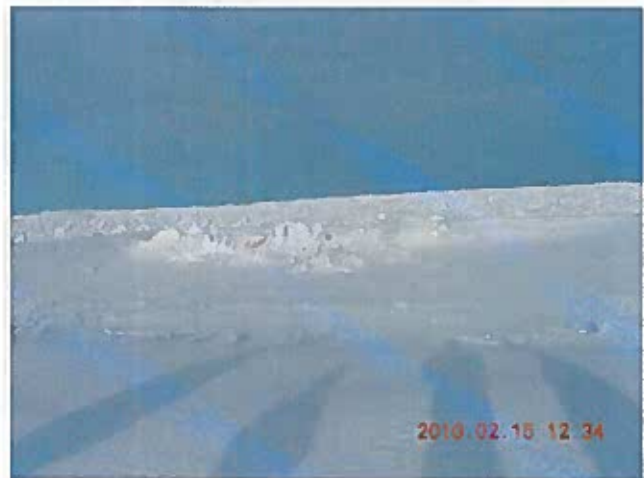
Photo 2

Inspection of the Contaminated Snow and Ice Containment Facility (CSCF) for storage of hydrocarbon impacted snow and ice was conducted on February 15th, 2010. Inspection revealed that sufficient free holding capacity in excess of an estimated 70% of reserve remains available at the CSCF for storage and containment of contaminated snow and ice. (See Photos 1 & 2) The holding capacity of the lined sump is said to be 1090 cubic meters or just over one million litres. The facility is being utilized for its intended purpose. No concerns or issues identified.

Inspection revealed that sufficient free holding capacity in excess of an estimated 70% of reserve remains available at the CSCF for storage and containment of contaminated snow and ice. The holding capacity of the lined sump is said to be 1090 cubic meters or just over one million litres.

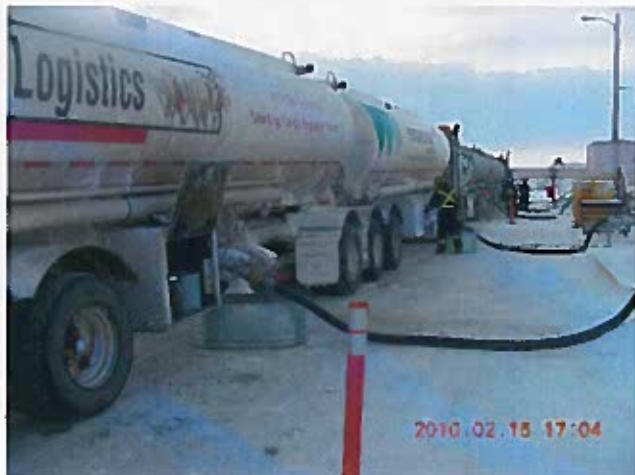
Photo 3

On February 15th, 2010 the INAC Land & Water observed diesel fuel being unloaded at the Ekati Main Camp Bulk Fuel Farm. (See Photo 3) The fuel had been transported to site via the 2010 winter haul road to help replenish fuel reserves at the mine site. Drip bins were in use while unloading fuel as a precautionary measure, ensuring that any spillage or fuel drips would be contained. (See Photo 4) It is important to note that the fuel unloading bay at the Main Camp Bulk Fuel Farm contains a sump designed into the fuel unloading pad that is capable of capturing excess fuel if a large volume spill was to occur at this particular location. On February 15th and on March 23rd the fuel unloading area was observed in clean and spill free condition. Considering the large volume of fuel unloaded from tanker trucks at this location, BHP Billiton Canada is commended on keeping this area clean and well maintained. No concerns or issues identified.

Diesel fuel being unloaded at the Ekati Main Camp Bulk Fuel Farm. The fuel was transported to site via the 2010 winter road to help replenish fuel reserves at the mine site.

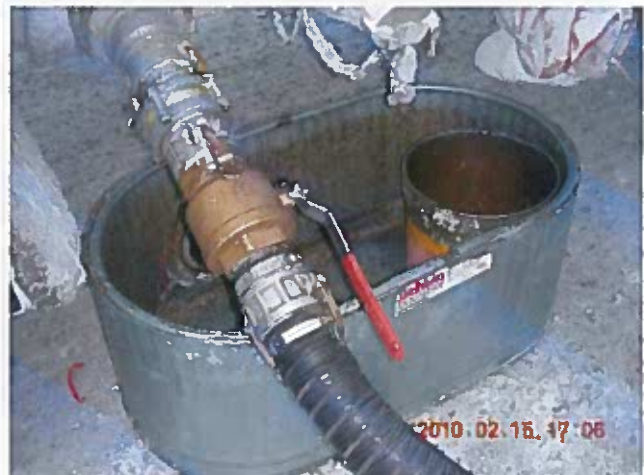
Photo 4

Drip bins are used while unloading fuel as a precaution to ensure that any spillage or fuel drips are contained. The fuel unloading area was observed as clean and spill free.

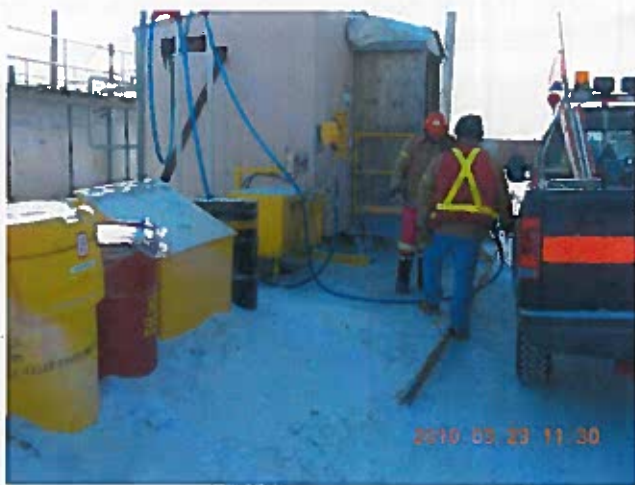
Photo 5

The Main Camp Light Vehicle Refuelling Bay was found clean and free of spills on March 23rd, 2010.

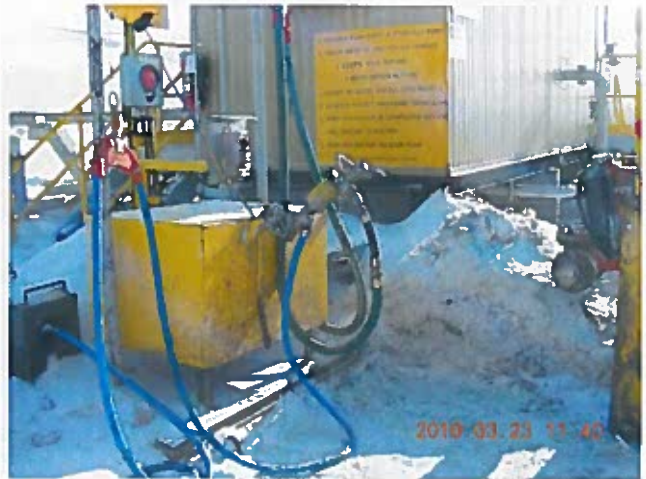
Photo 6

The Surface Refuelling Bay that is used by underground vehicles and equipment. This refuelling bay was also found to be clean and free of spills.

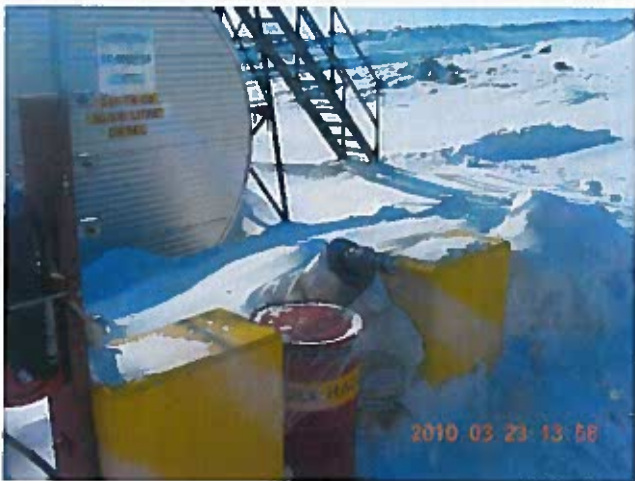
Photo 7

The refuelling station for the Koala Fresh Air Raise #1 Diesel Fuel Storage Tanks. Area observed as clean and free of spills. A spill kit and disposal drum for oily rags on hand.

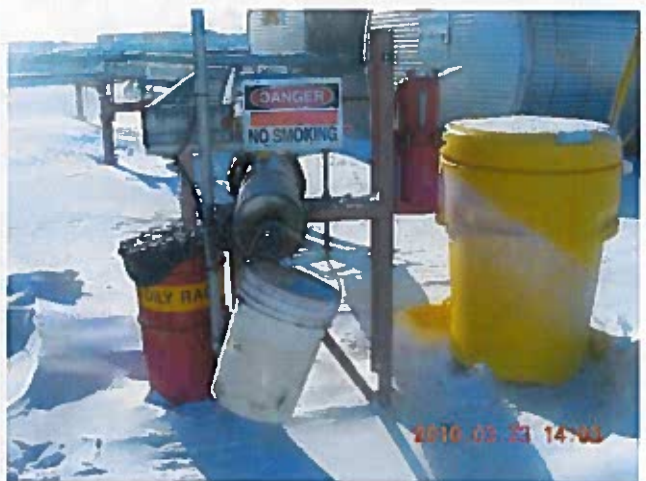
Photo 8

The refuelling station for the Koala Fresh Air Raise #2 Diesel Fuel Storage Tanks. The area was clean and free of spills with a spill kit & disposal drum for oily rags on hand.

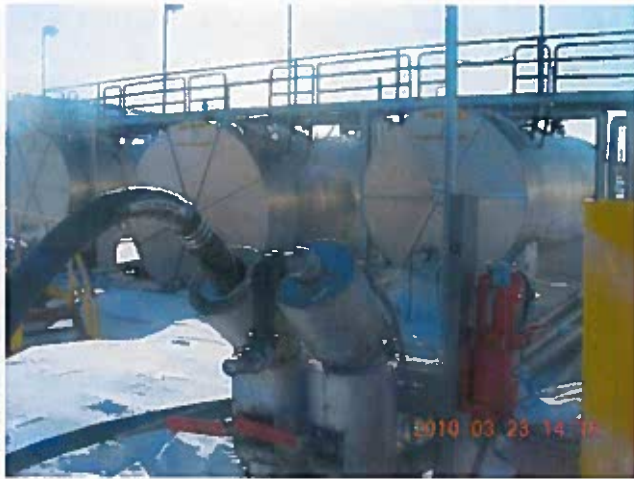
Photo 9

Panda Fresh Air Raise#1 Diesel Fuel / Used Oil Storage Refuelling Station. Area observed as clean and free of spills.

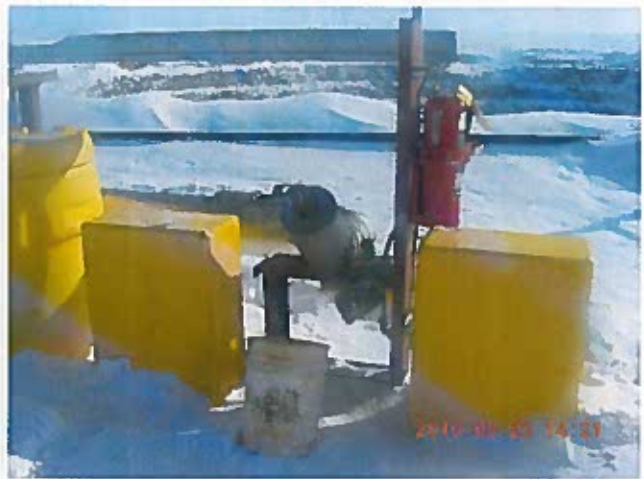
Photo 10

Panda Fresh Air Raise#2 Diesel Fuel Storage Refuelling Station. Area observed as clean and free of spills.

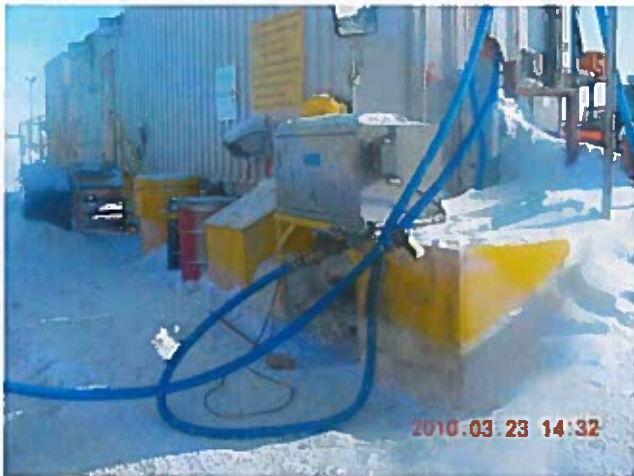
Photo 11

Koala Heavy Haul Refuelling Bay. The area was observed as clean and free of spills.

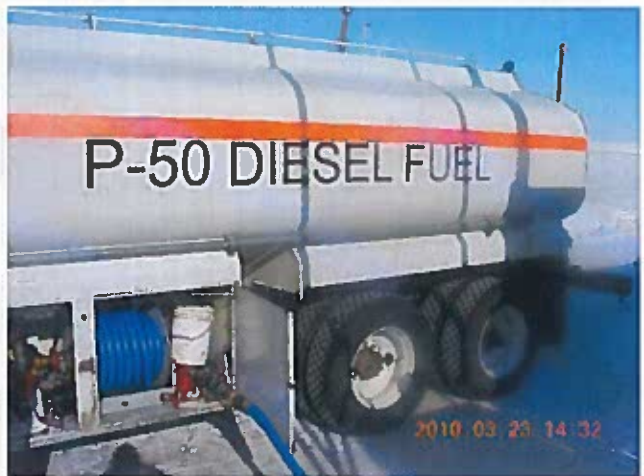
Photo 12

A Mobile Tanker Truck refuelling at the Koala Heavy Haul Bay.

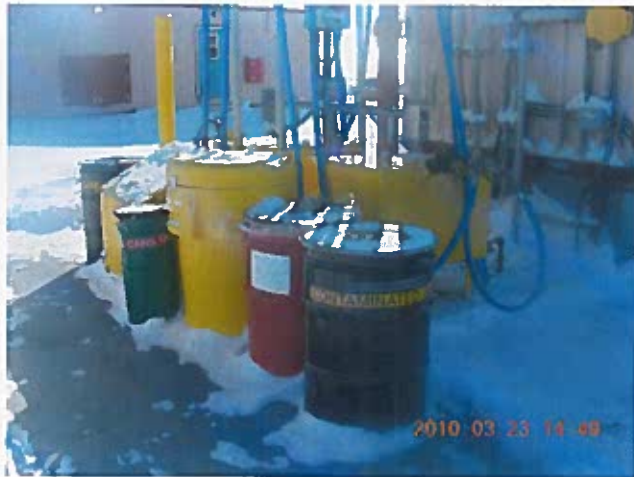
Photo 13

Fox Heavy Haul Refuelling Bay. Area observed as clean and free of spills. Drums on hand for disposal of contaminated snow and oily rags.

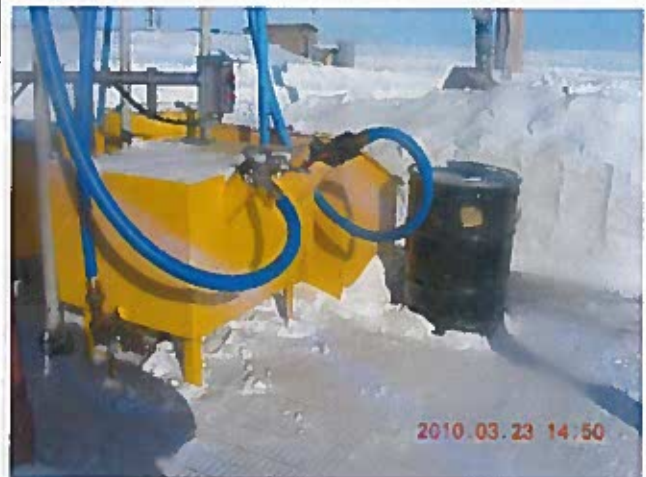
Photo 14

Second photo of the Fox Heavy Haul Refuelling Bay. This refuelling bay has been kept well maintained during the winter of 2010 with good snow clearing and care taken to avoid fuel spills. (Great improvement since previous winter)

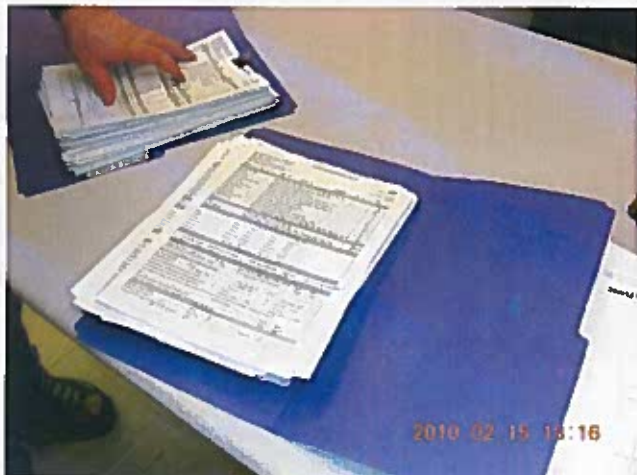
Photo 15

On February 15th, 2010 the INAC Inspector requested to view BHP Billiton Canada's internal Process Plant records to verify that daily inspections were being completed for monitoring of the Long Lake Containment Facility. No concerns identified as inspections were confirmed as occurring twice per shift on a regular basis.

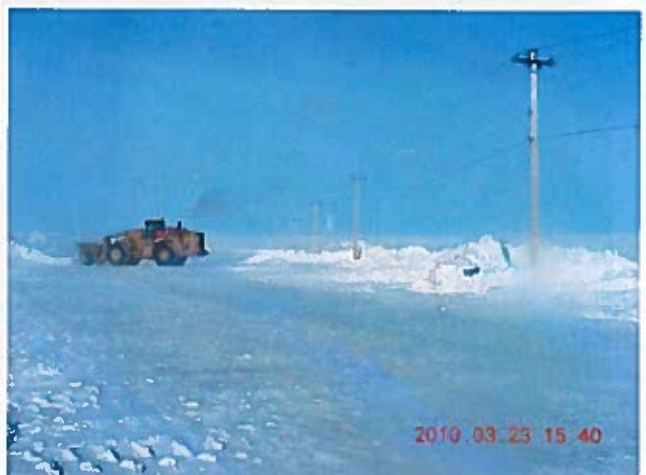
Photo 16

Likewise, on a related note, it appears that BHP Billiton Canada is ensuring that sufficient snow clearing occurs on the East side of the Cell B access road. (As this area is prone to heavy snow drifting during winter and frequent effort is required to keep this section of access road open) Frequent snow clearing will ensure that the LLCF Cell B Ring Road is accessible at all times, allowing for complete monitoring of the tailings containment facility. (See Photo 16)

Snow clearing on the East side of the Cell B access road. (This area is prone to heavy snow drifting during winter and frequent effort is required to keep this section of road open)

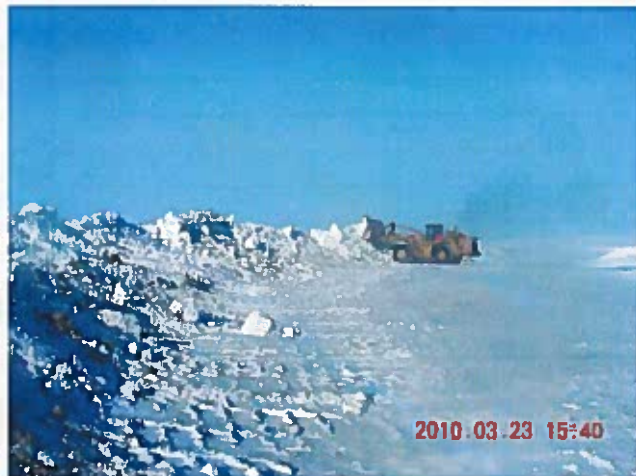
Photo 17

BHP Billiton Canada have stepped up snow clearing efforts along this troublesome section of Cell B access road. This will ensure that the LLCF Cell B Ring Road is accessible at all times, allowing for complete monitoring of the tailings containment facility.

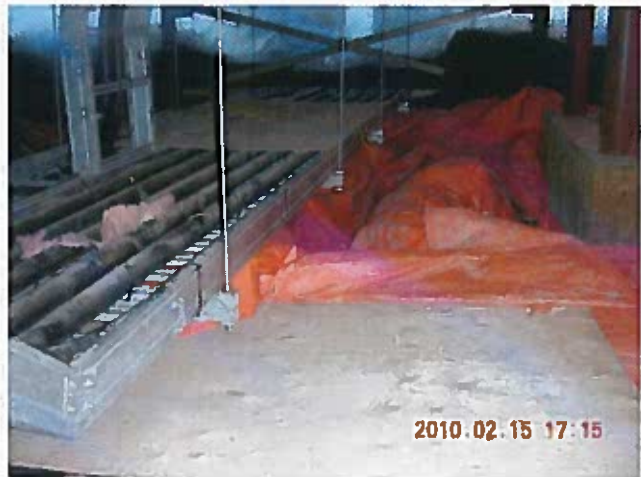
Photo 18

NWT Spill#10-018. On January 21st, 2010 a 5300 litre spill of Glycol / Water mixture occurred under the main accommodations H-Wing building due to a check valve failure on the sprinkler system.

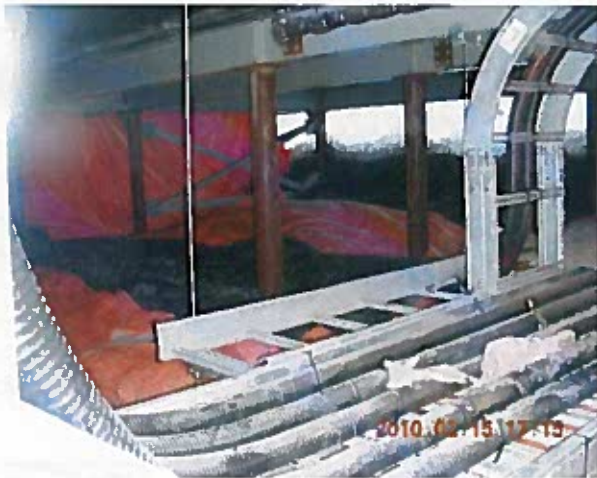
Photo 19

As NWT Spill#10-018 occurred under the enclosed and screened in crawl space of the H-Wing accommodations building, wildlife could not access the impacted spill area.

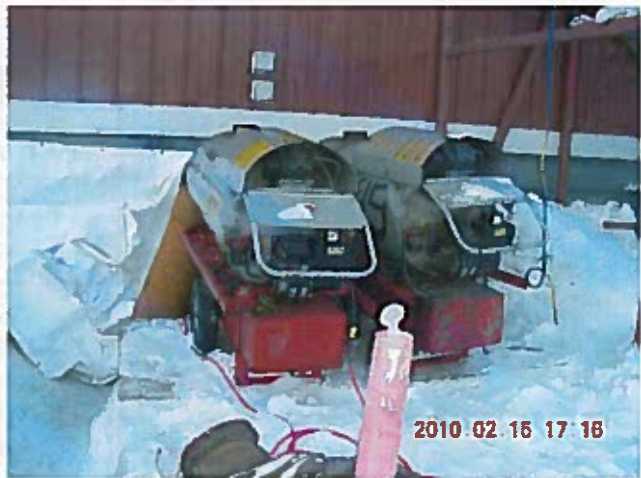
Photo 20

After the removing most of the frozen mixture of ice and glycol by chopping out as much of the frozen solids as possible, Herman Nelson Portable Heaters were then utilized to melt the remaining frozen water and glycol mixture so that absorbent spill pads could be utilized.
