CIRNAC-CARD Rayrock Remediation Project

RE: Land Use Permit W2015X0006 – Rayrock Remediation Project

INSPECTION DATE – August 6th 2019

ENVIRONMENTAL INSPECTION REPORT (W2015X0006)

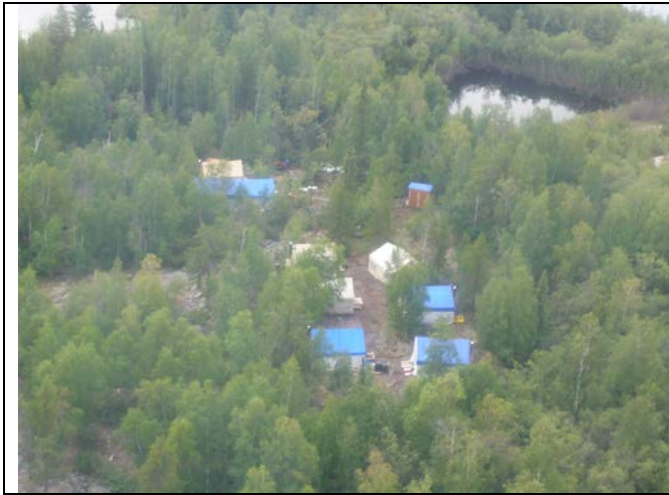
Photo #1: Ariel view of the Rayrock camp

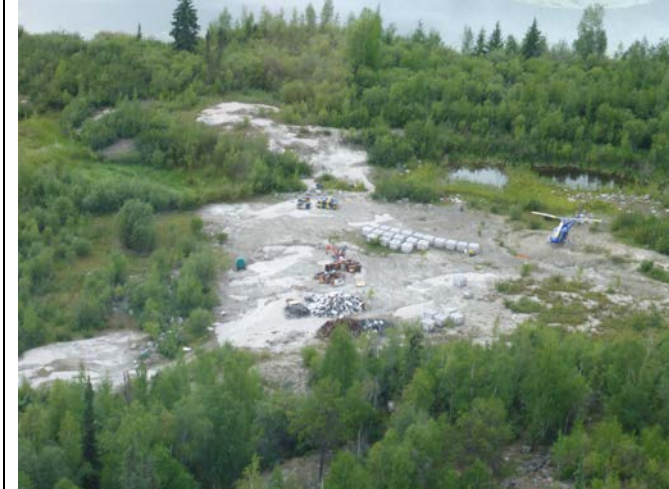
Photo #2: Ariel view of the staging area

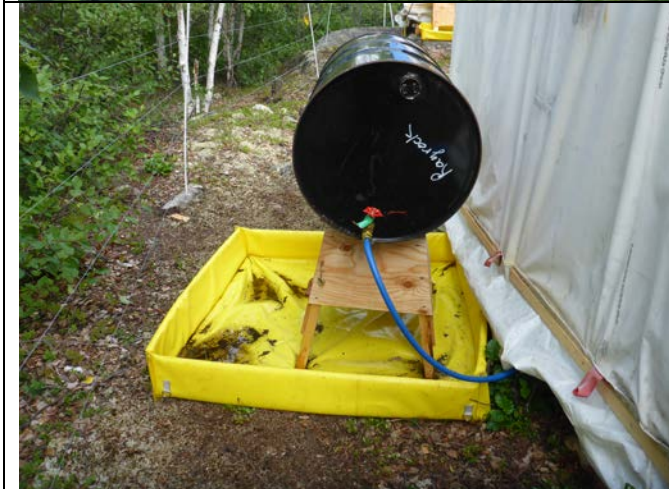
The camp consisted of eight tents frames which were connected to 205 liter drums used to fuel the internal heaters (Photo #3). The drums were placed within secondary containment as required by condition #47 of the land use permit. There were no issues noted with the camp area during the inspection as it was well organized and had minimal infrastructure.

Photo #3: Heating fuel barrel connected to one of the camp tents

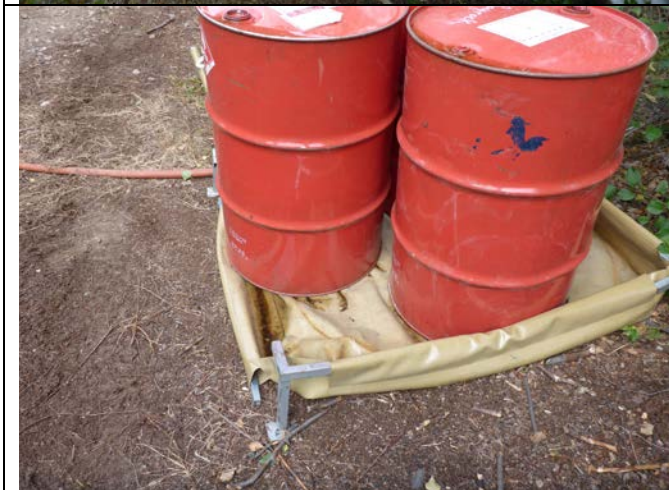
Photo #4: Fuel storage located near the Rayrock camp

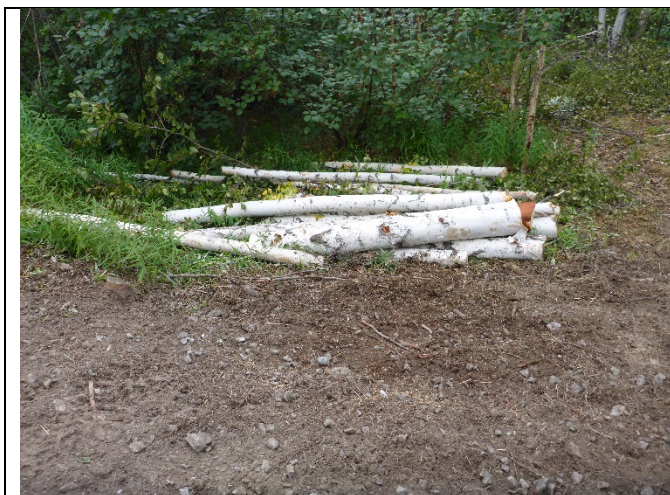
Photo #5: Tree's that have been cut down and stacked near the camp

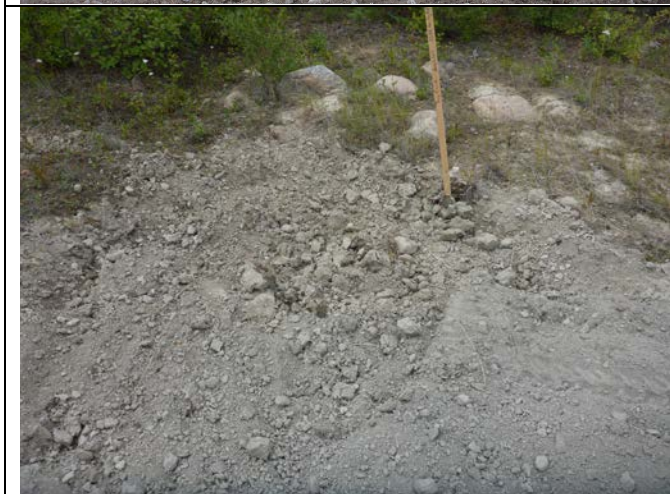
The Inspector observed that all quarry test pits were backfilled (Photo #6) and clearly marked for identification. These test pits were mainly located along the old airstrip that is to the south of the Rayrock camp.

Photo #6: Backfilled quarry test pitting located near the old Rayrock airstrip

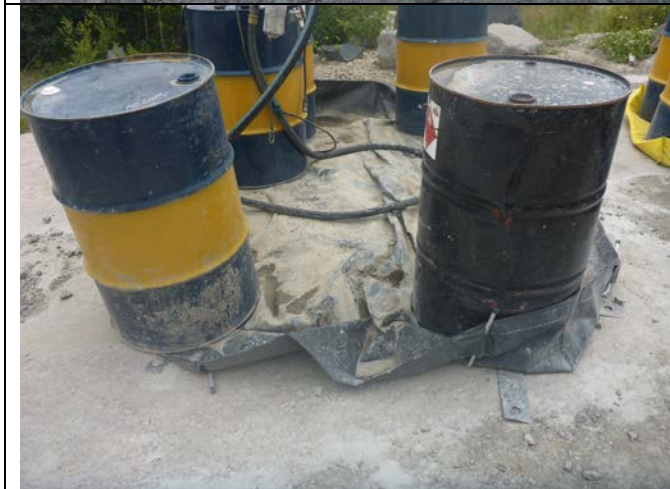
Onsite personnel explained that the land use activities for the season will be completed on August 7th 2019 and the camp facilities will be removed shortly after. The Inspector noted that some of the barrels used for the operation were placed outside of secondary containment however this was due to the project finishing the next day. There was multiple piles of large birch trees staked near the camp (Photo #5). As a reminder, the Permittee shall progressively dispose of all brush and trees during the land use operation as required by condition #62 of the land use permit. The Inspector also recommends that no unnecessary removal of large trees takes place unless it is required for the permitted land use activities.

Photo #7: Barrels of hydrocarbons staged near the helicopter landing area

Overall, the Inspector was pleased with the condition of the camp and other land use areas. It is important that all hydrocarbon storage is done in compliance with the condition stated within the land use permit in all future land use activities.
