**Land Use Permit
W2016D0003
Sable Development**

Re: April 9th 2019 Land Use Permit Inspection W2016D0003

ENVIRONMENTAL INSPECTION REPORT

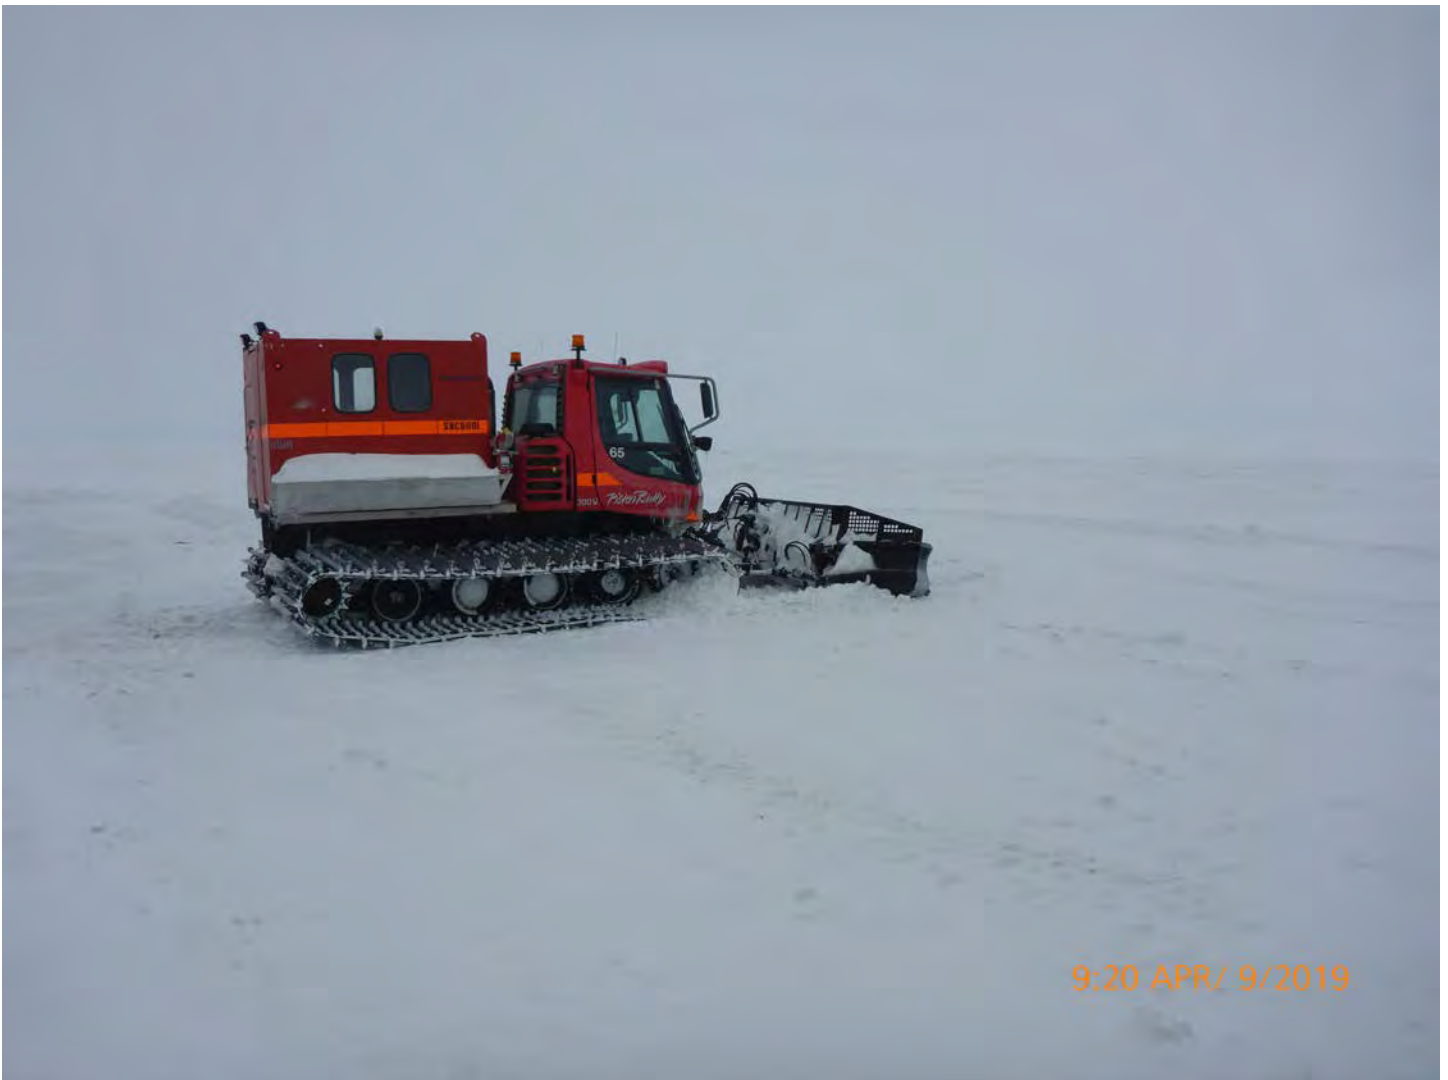
A parked Snow Cat was waiting for repairs along the Sable road. The Inspector noted some minor hydrocarbon drips coming from the hydraulic system. The inspector recommends that a drip tray be installed under any equipment that is leaking hydrocarbons, or is parked for more than two hours as per condition 37 of the Permit (Photos 1 and 2).

Photo 1 – Sable Haul Road – A Snow Cat was parked on the side of the Sable Road requiring maintenance.

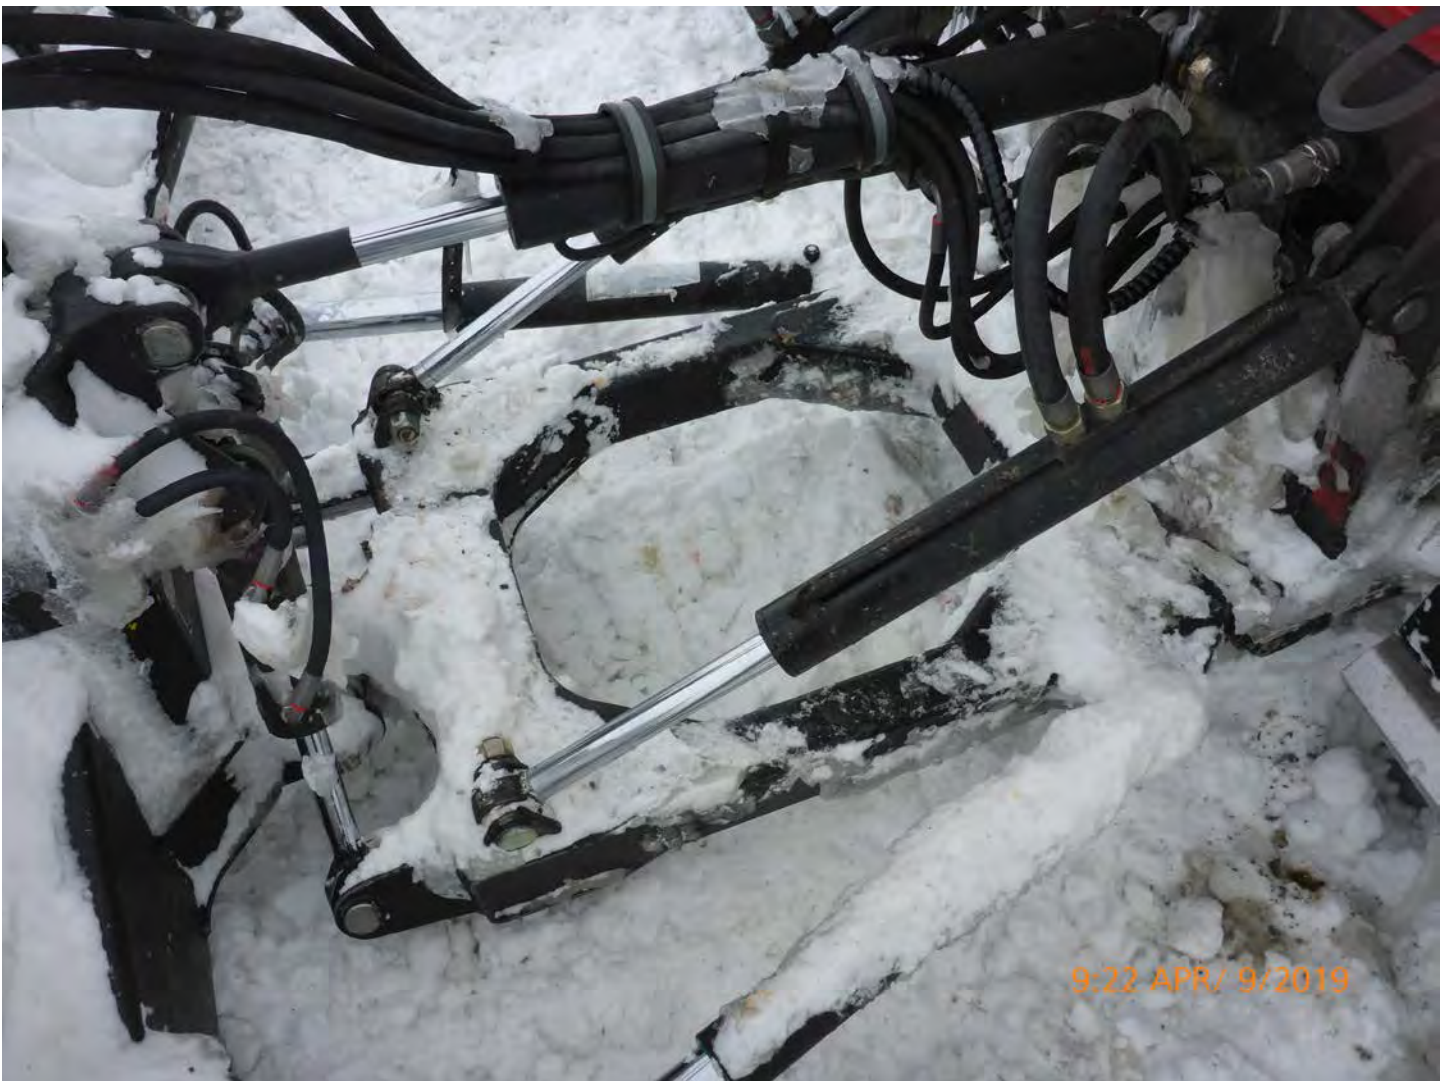
Photo 2 – Sable Haul Road – The Snow Cat had some small hydrocarbon drips and requires a drip tray as per Condition 37 of the Permit.

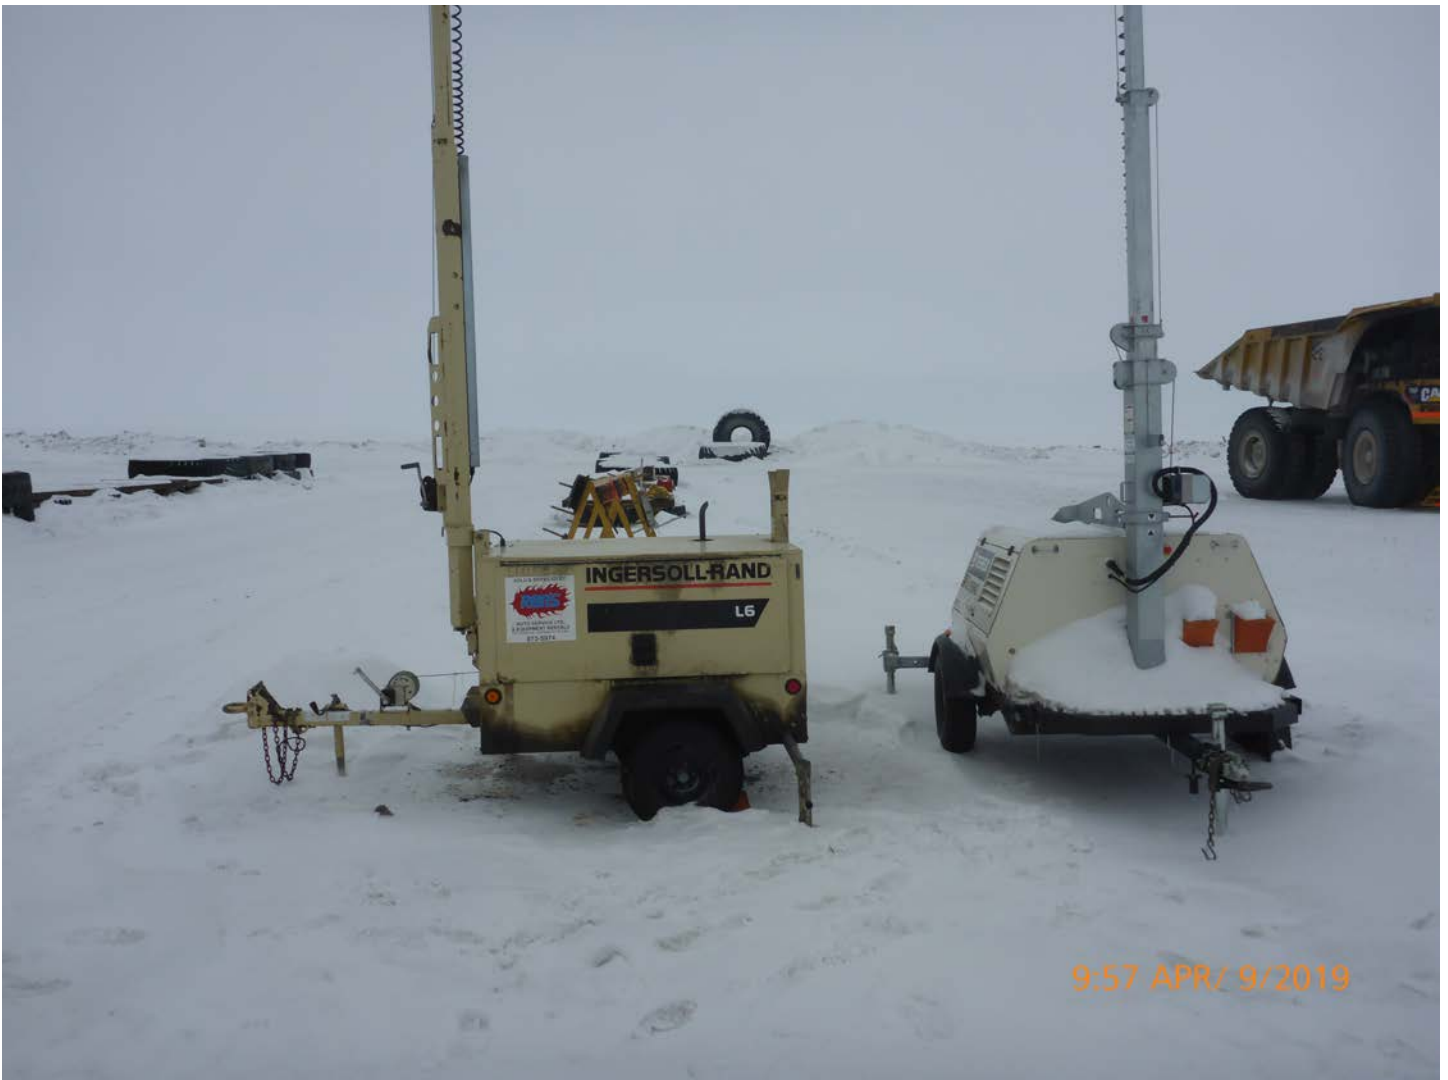
Photo 3 – Sable Laydown – Light plants are staged in the sable laydown. These light plants are equipped with integrated drip trays that satisfy Condition 37 of the Permit.

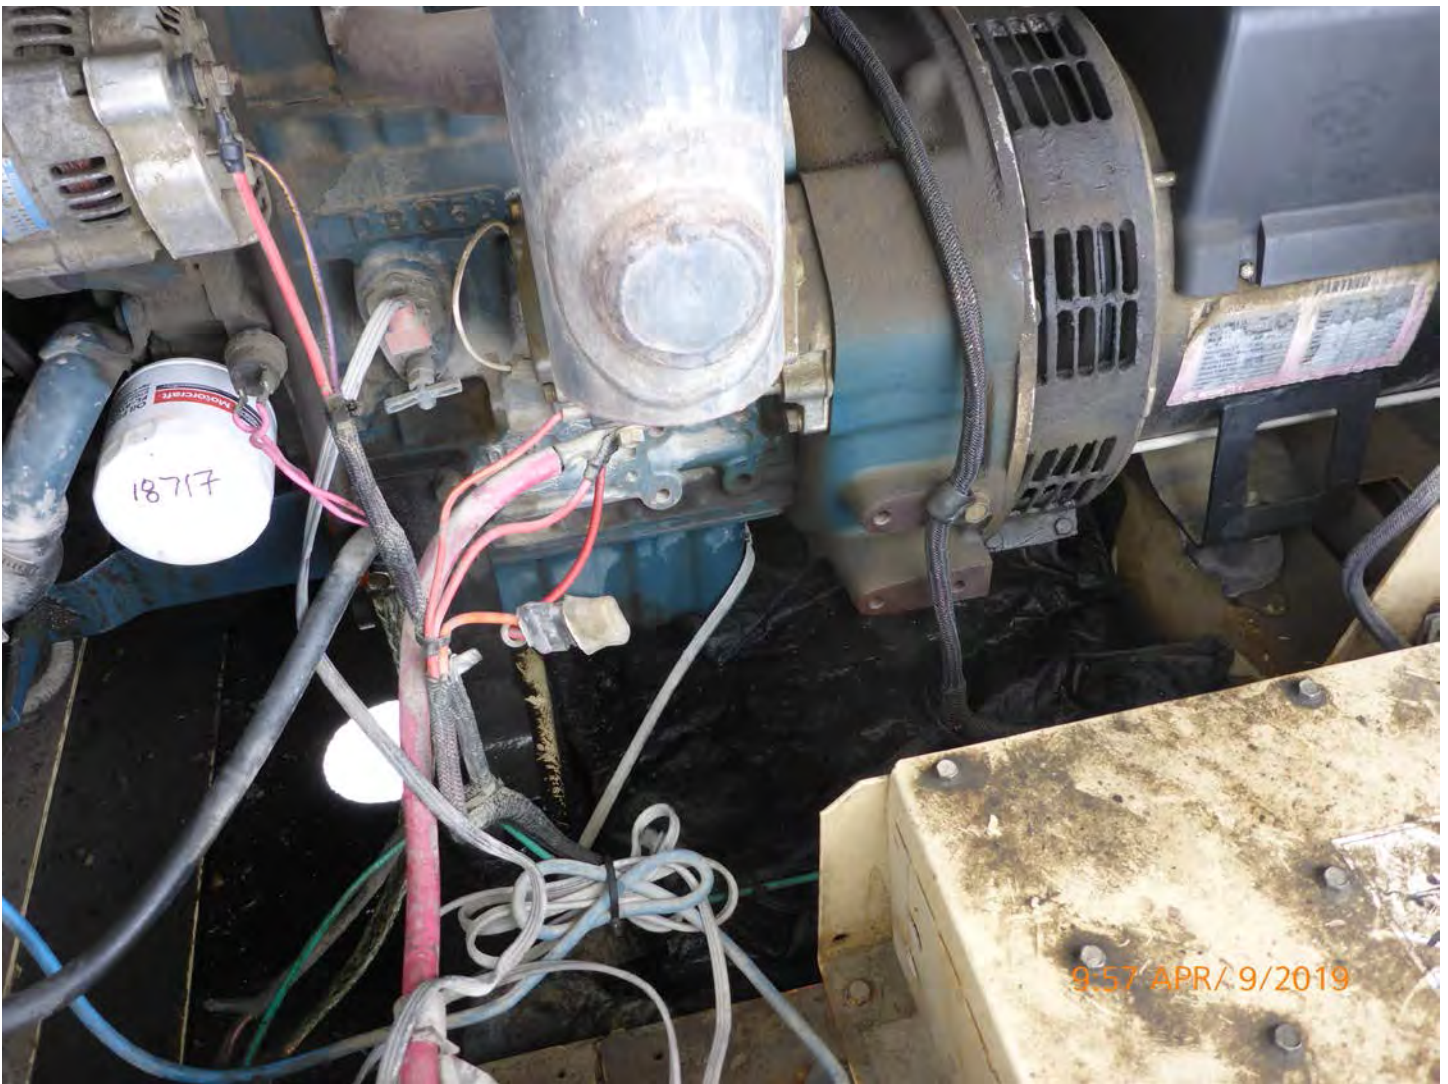
The Sable laydown area was clean and well maintained. Two light plants were parked in the laydown and were equipped with integrated drip trays. The spill pads within the drip trays had been saturated with oil and needed to be changed out. A follow-up email was received from Dominion indicating that the concern had been addressed by the Surface Mining team (Photos 3 and 4).

Photo 4 – Sable Laydown – This drip tray has spill pads that have become saturated with oil and will need to be addressed. Dominion has submitted a follow-up email to the Inspector indicating that this concern had been addressed shortly after the inspection.

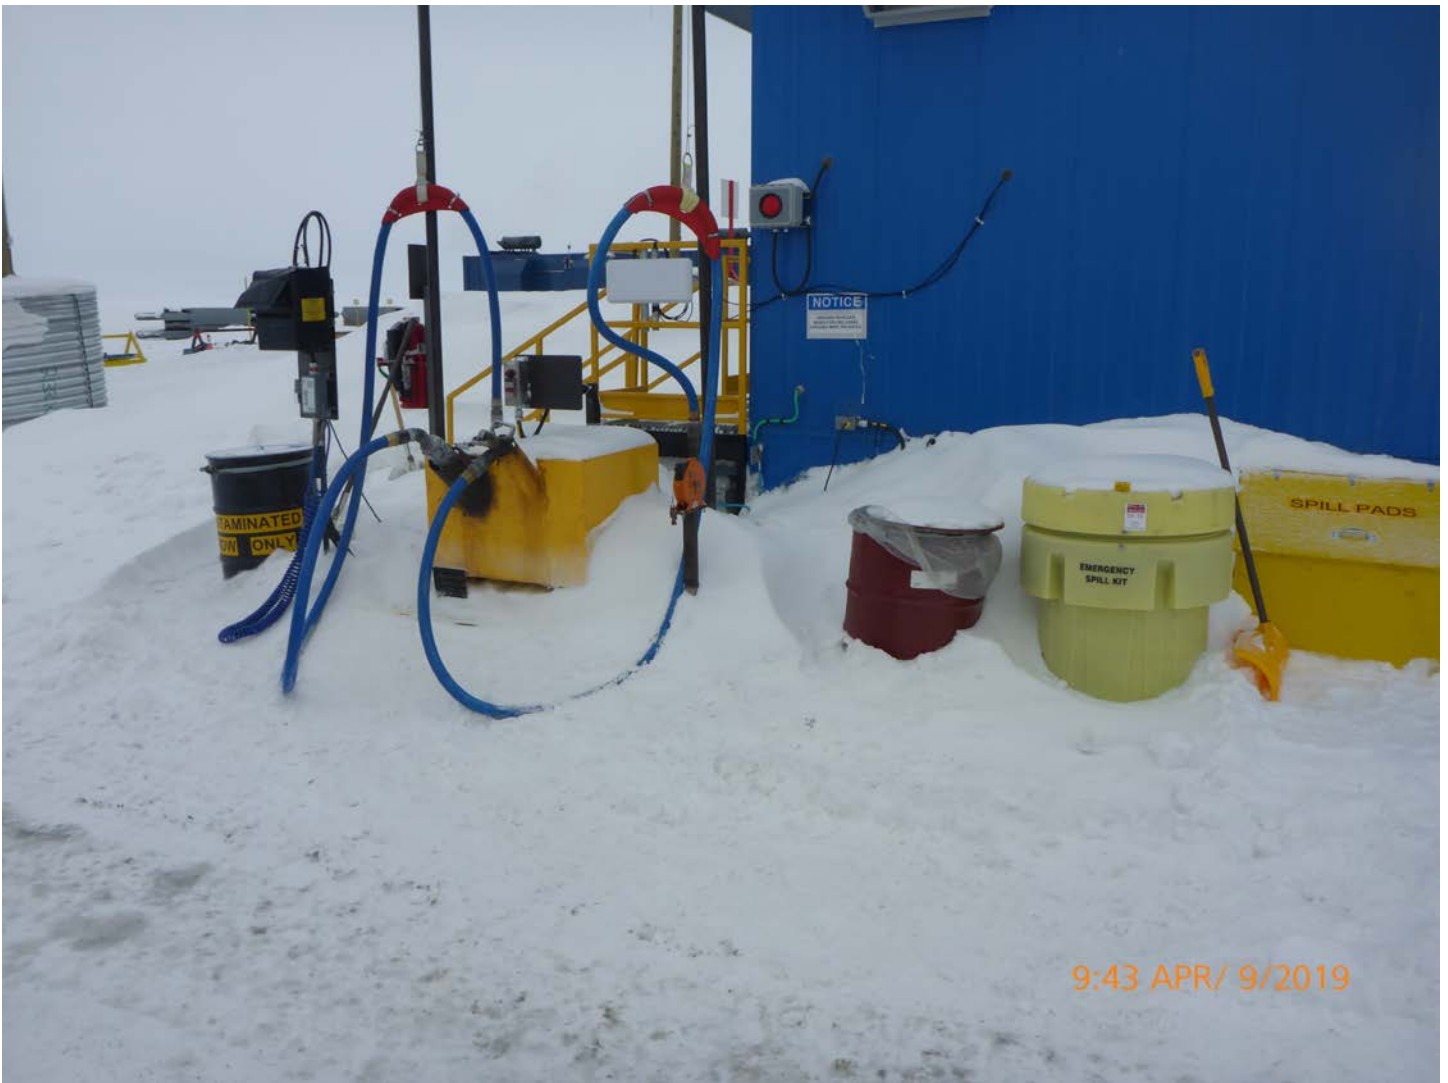
Photo 5 – Sable Refueling Station – The Sable refueling station was clean and well organized.

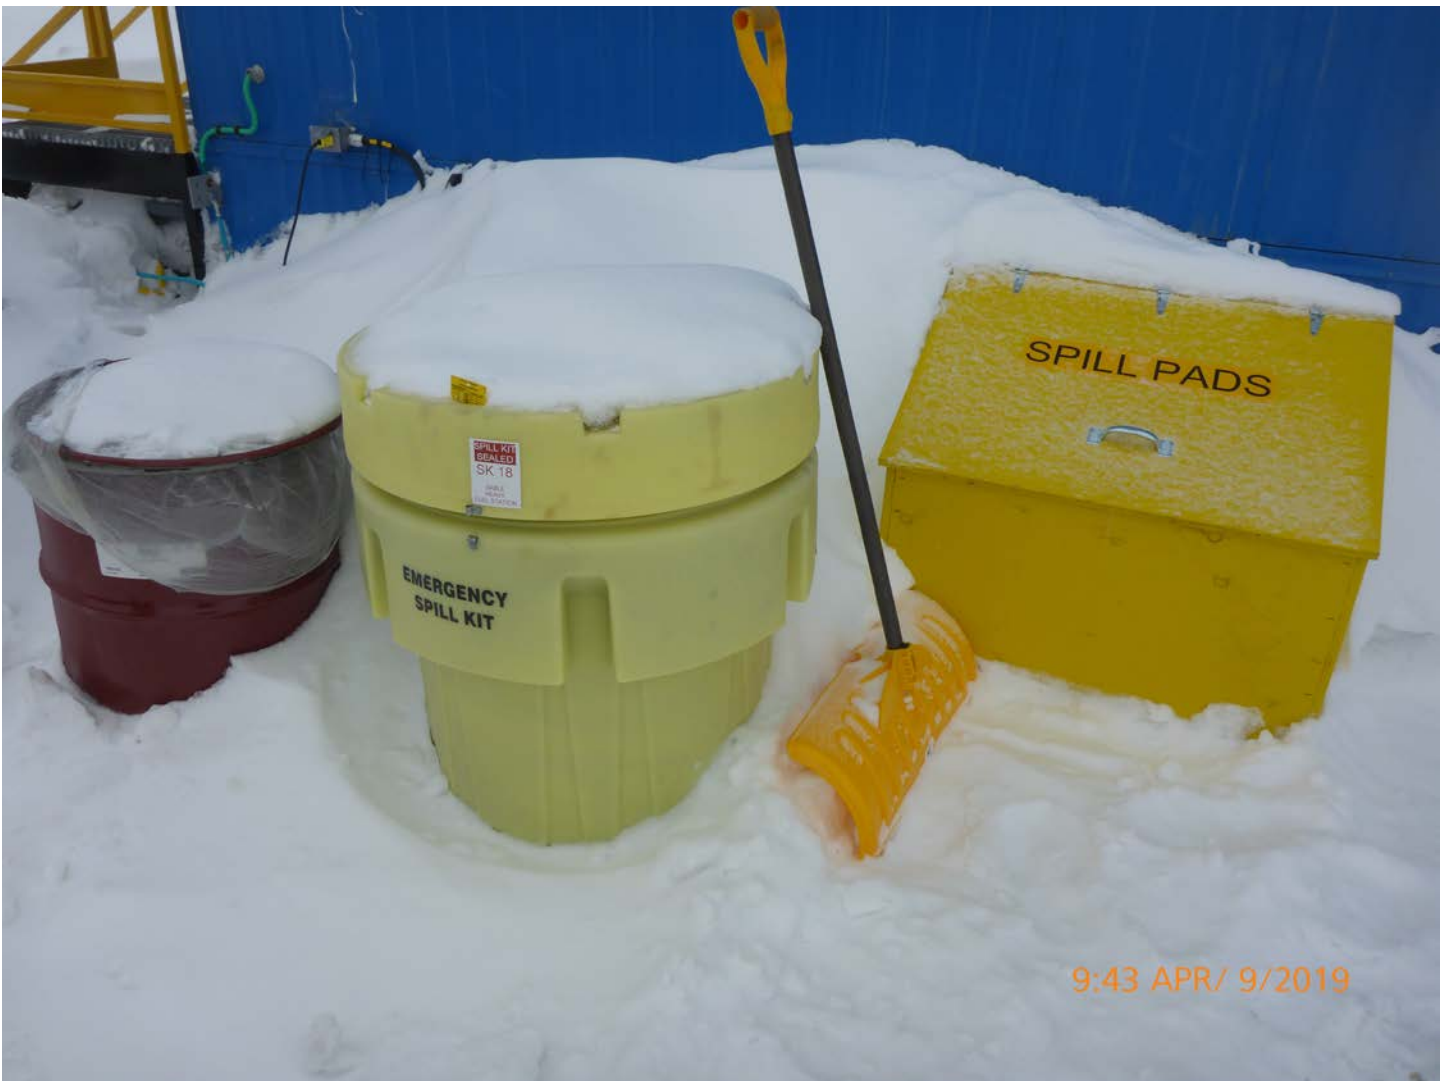
Photo 6 – Sable Refueling Station – Spill response materials were fully stocked and easily accessible.

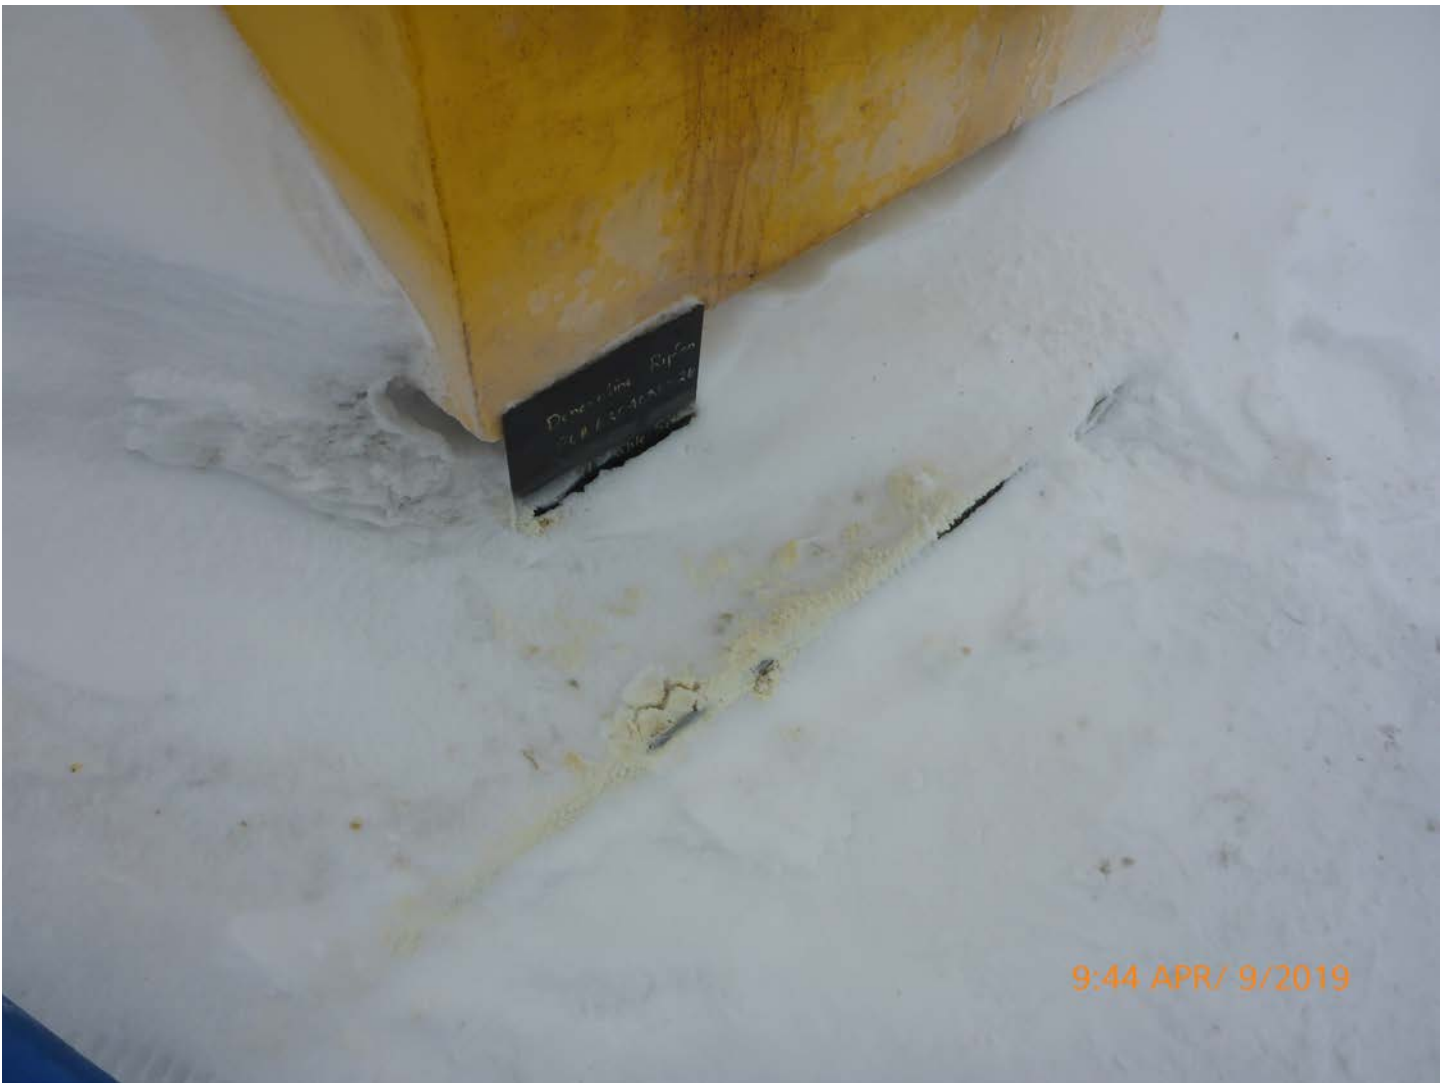
The Sable refueling station was clean and well organized. There was some slight spillage within the containment tray that has left a residue in the snow. Contaminated snow was being collected in a labelled drum for disposal in the Contaminated Snow Containment Facility (CSCF). The refueling area had fully stocked spill kits that were easily accessible to respond to potential spills as per condition 36 of the permit (Photos 5 through 8).

Photo 7 – Sable Refueling Station – Some minor spillage was identified within the containment tray at the refueling station.

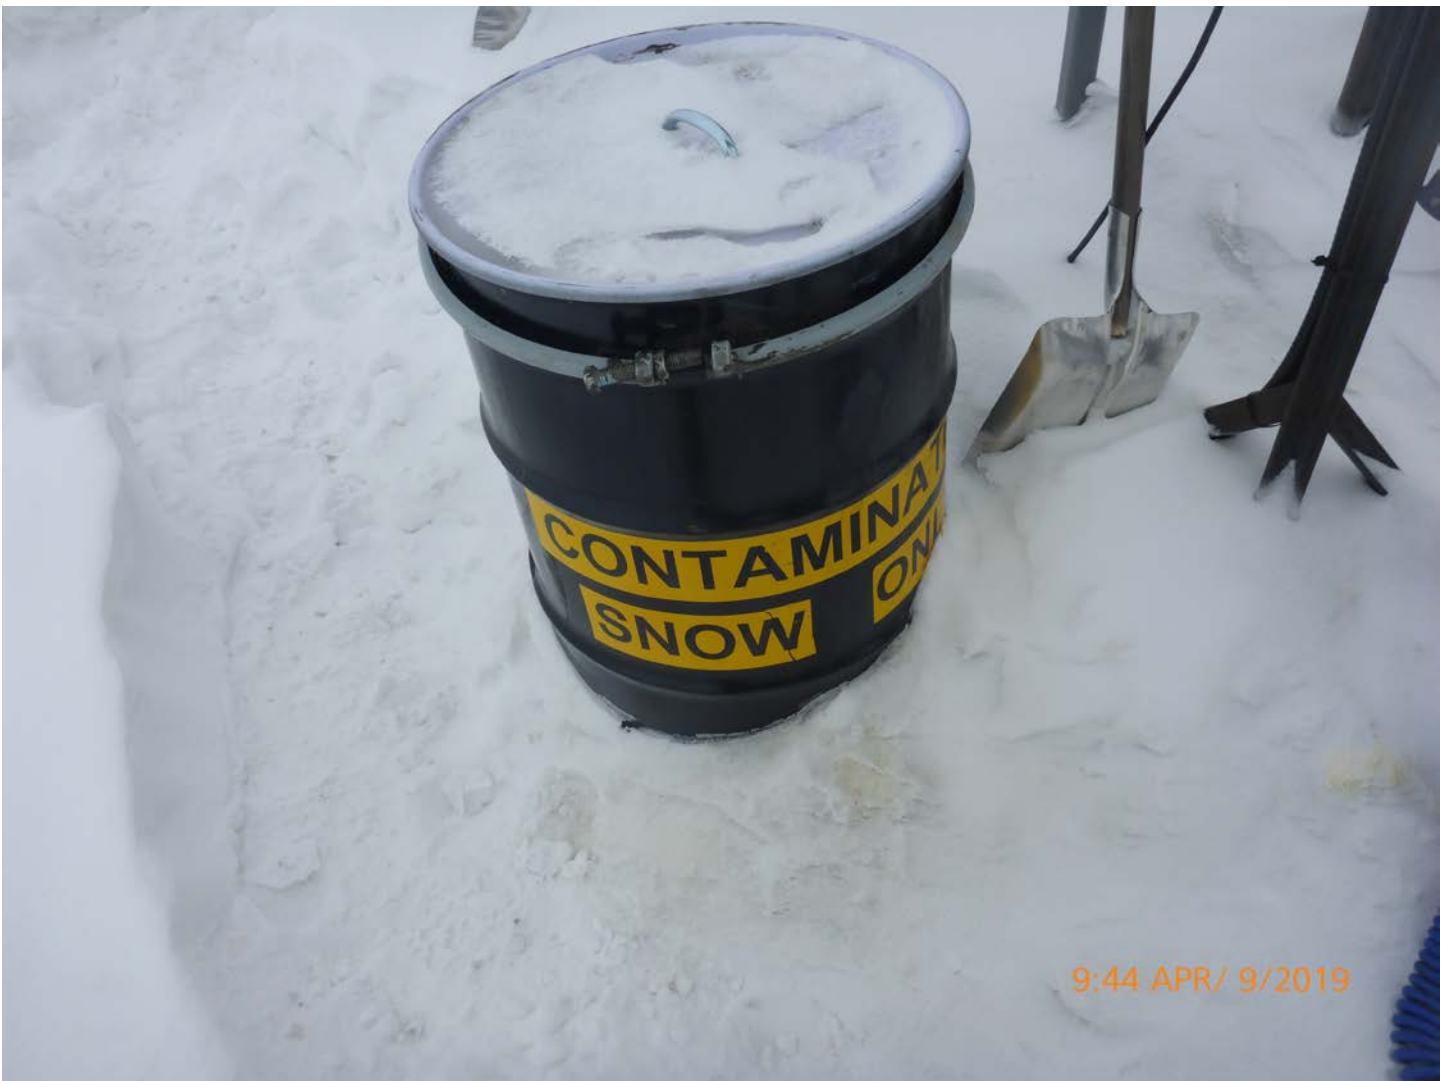
Photo 8 – Sable Refueling Station – Contaminated snow is disposed of in a marked container. Containers are emptied in the Contaminated Snow Containment Facility (CSCF).

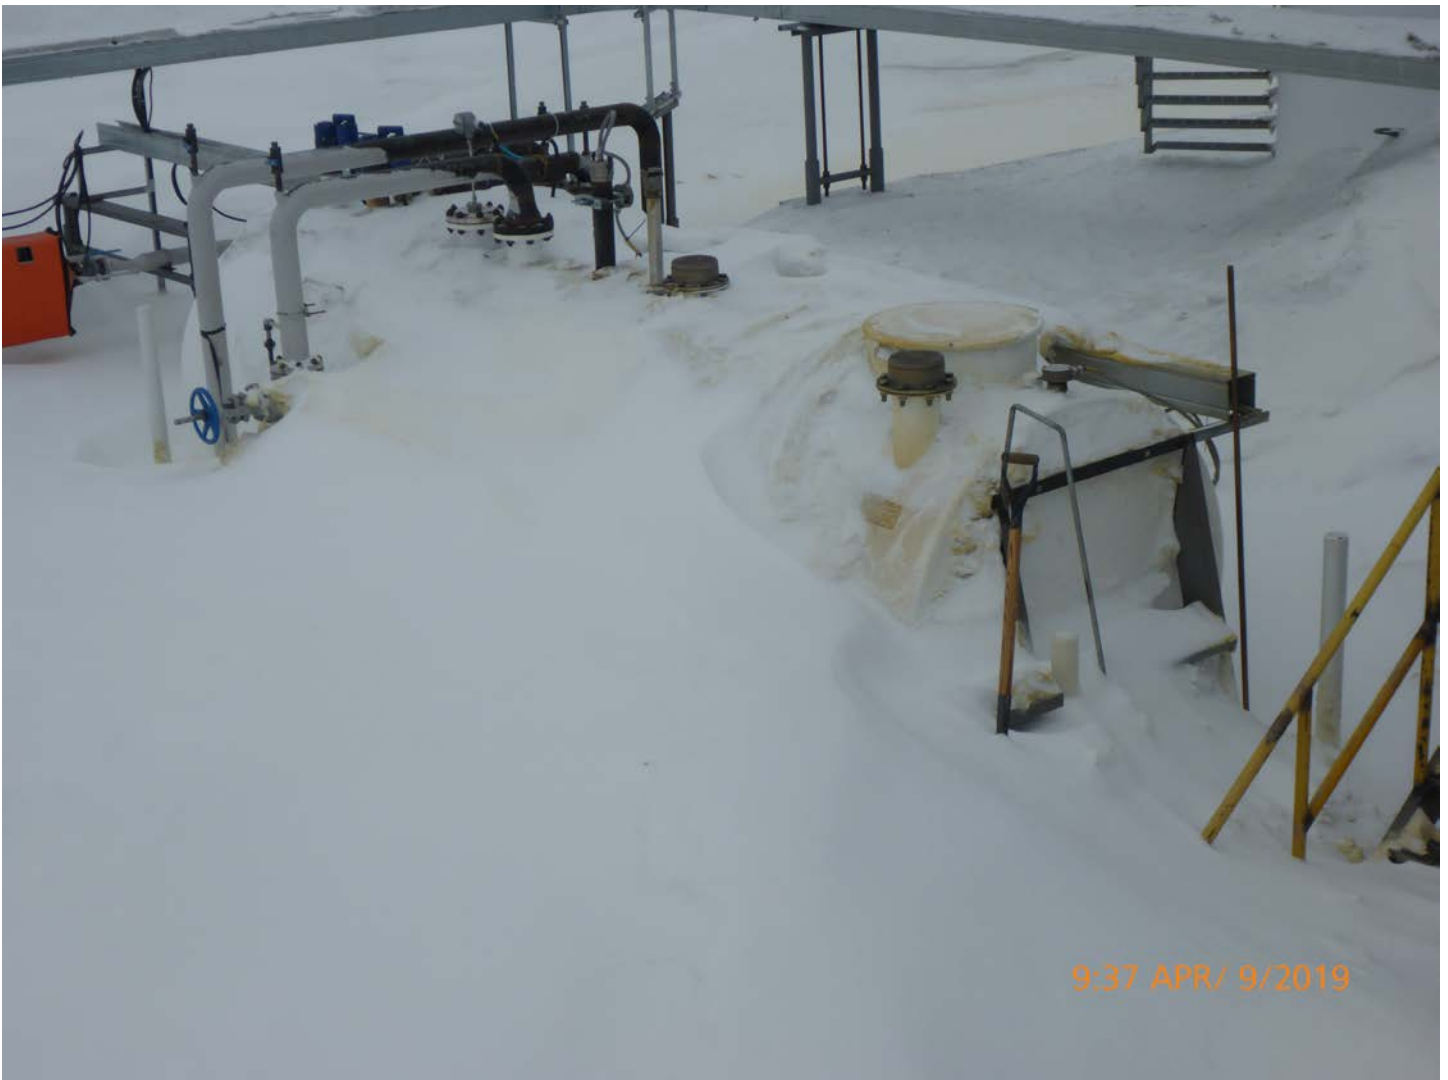
On March 20th 2019 the 9000L generator day tank within the Sable Fuel Farm containment berm was overfilled due to a frozen high level switch which prevented the automatic shutoff. Approximately 111,000L of diesel was spilled into the containment berm. A follow-up report submitted to the Inspector and the WLWB indicates that approximately 51,000L of diesel has been recovered from the containment berm and pumped back into the fuel tank. The remaining product will need to be recovered once the snow has melted in the spring. Once the snow has melted, the aggregate has thawed out, and the free product has been recovered; the clean-up efforts will begin within the containment berm. Great care should be exercised to ensure that there is no damage to the containment berm liner during the clean-up, and heavy equipment should be avoided.

Photo 9 – Tank Farm Spill #2019127 – The 9000L generator day tank was overfilled when the automatic shutoff switch froze open.

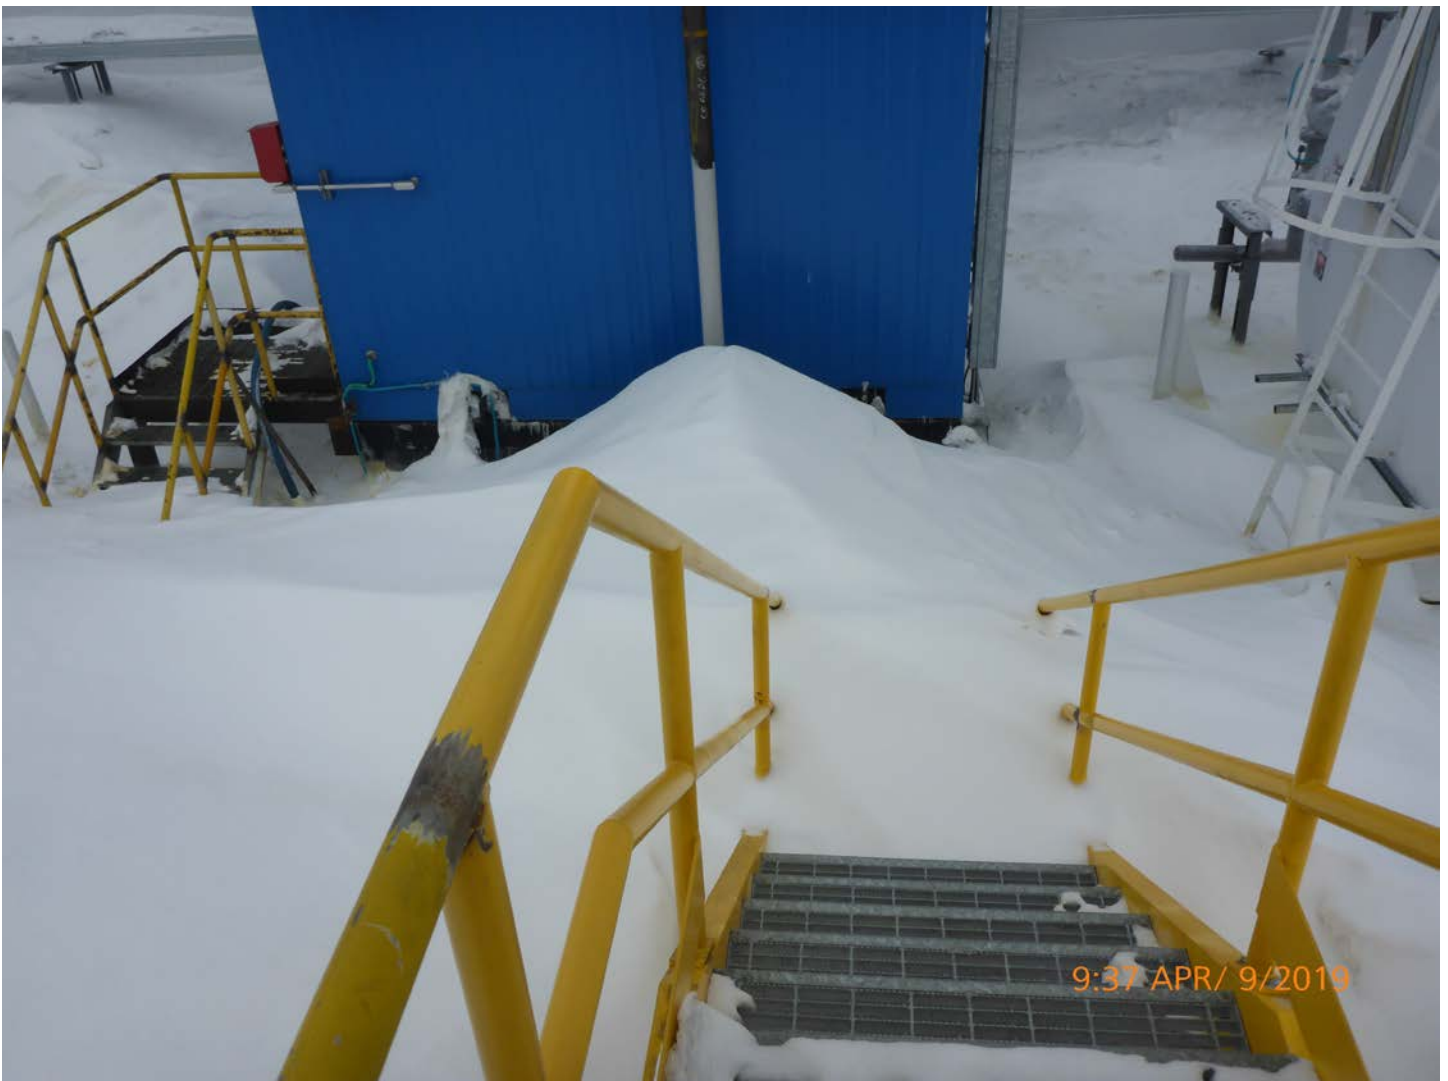
The diesel spill appears to be 100% contained within the containment berm and the berm is functioning as designed. The containment berm and the access points were blown in with snow which made inspecting the site difficult for the Inspector. The inspector recommends that access to the day tank be maintained to help facilitate inspections for both the Inspector and Dominion staff. Follow-up inspections will occur on a regular basis to monitor clean-up efforts and ensure that the spill remains contained in the containment berm (Photos 9 through 12).

Photo 10 – Tank Farm Spill #2019127 – Access to the day tank in the sable fuel farm was snowed in, which made the tank difficult to inspect. The Inspector recommends better maintenance at the access points to the tank farm containment to facilitate inspections.

The Inspector noted one concern while inspecting the Sable Tank Farm. Access to the spill site was difficult due to the stairways being blown in with snow. The Inspector recommends that access to the containment berm be maintained to help facilitate inspections for the Inspector and for Dominion Staff.

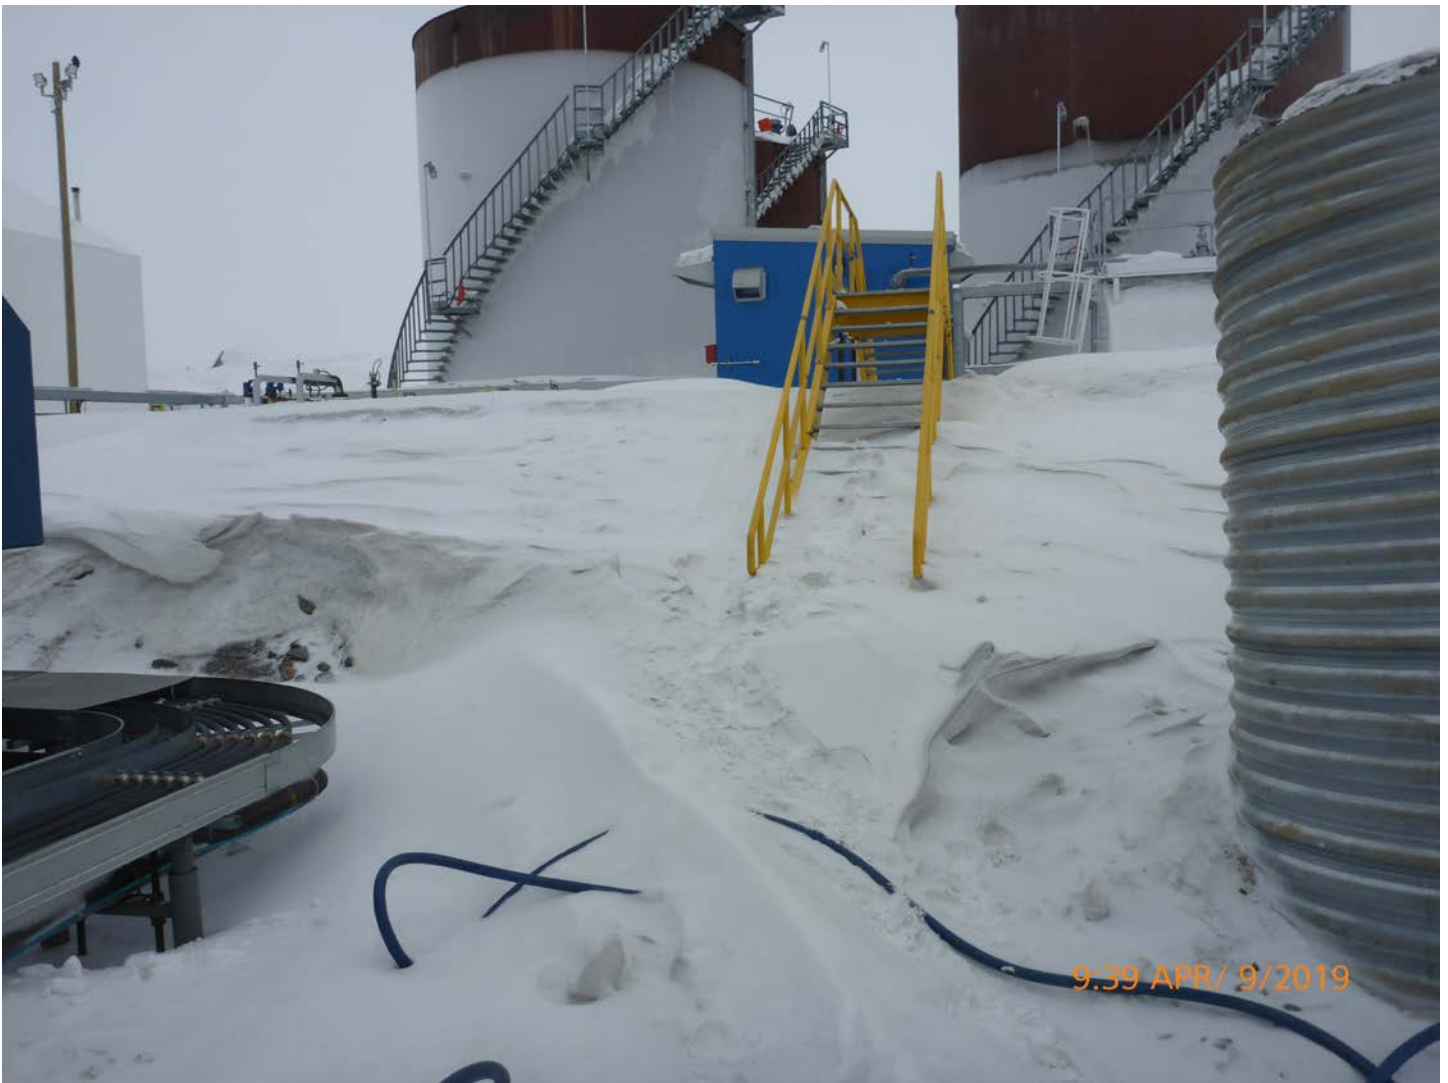
Photo 11 – Tank Farm Spill #2019127 – Access to the day tank in the sable fuel farm was snowed in which made the tank difficult to inspect. The Inspector recommends better maintenance at the access points to the tank farm containment to facilitate inspections.

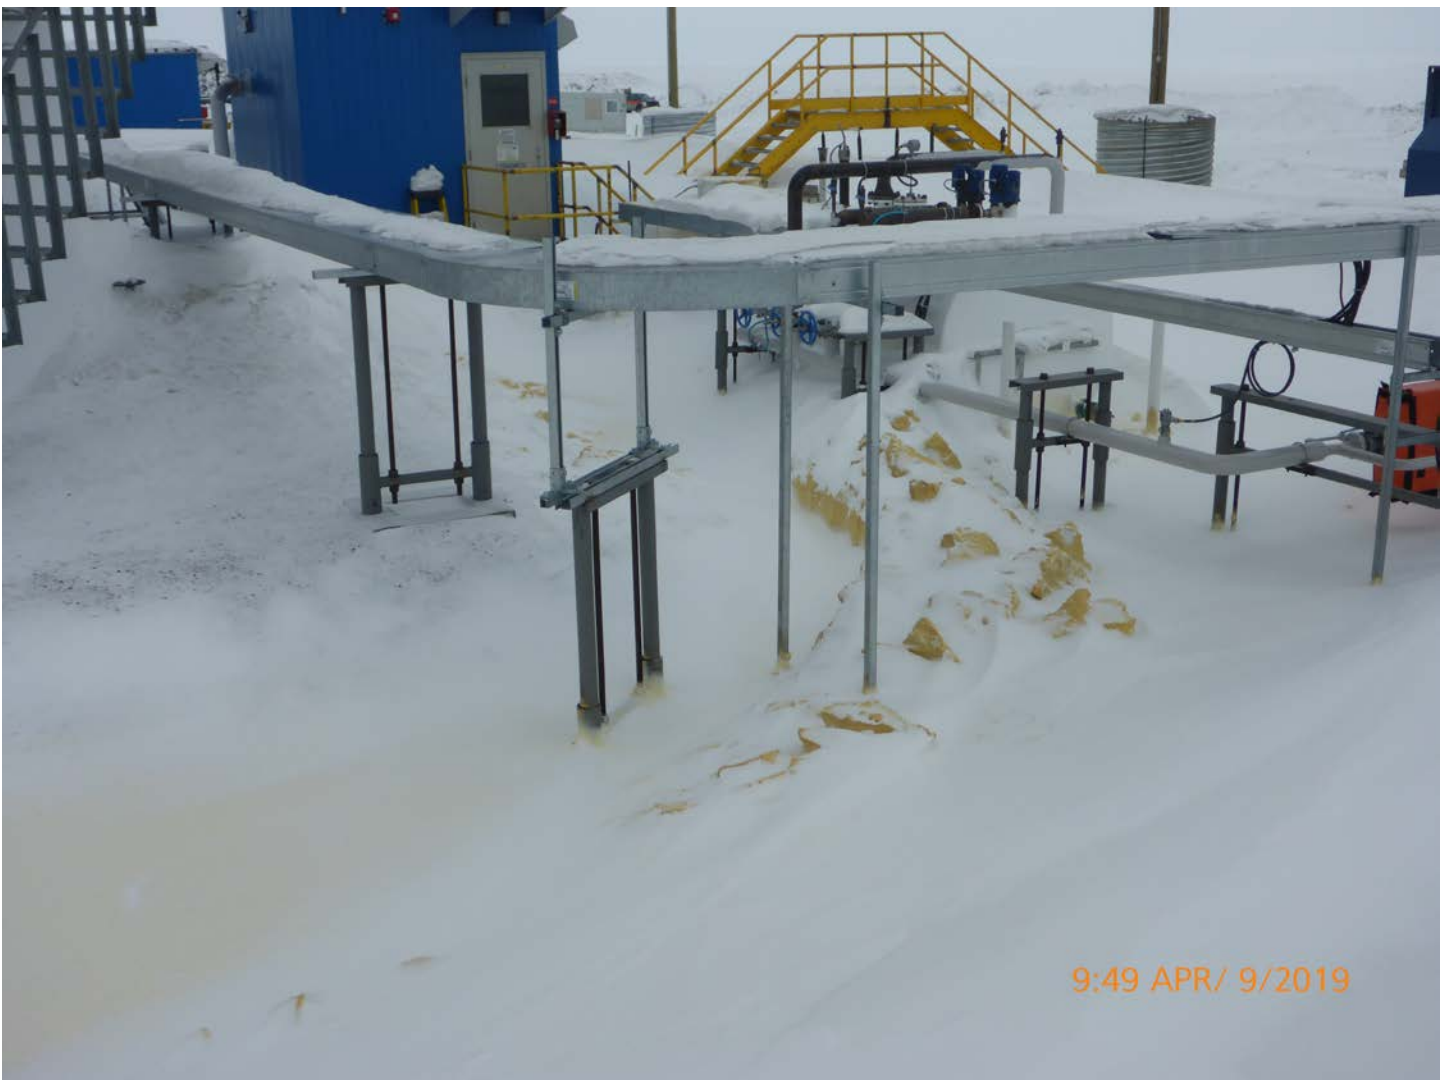
Photo 12 – Tank Farm Spill #2019127 – 100% of the diesel spilled was within lined containment and the containment berm worked as designed. There was no evidence of seepage from the berm at the time of inspection.
