RE: Municipal Water Licence (G03L3-001)

An inspection was conducted of the Municipal Water Supply and Waste Disposal Facilities on September 17, 2010. Enclosed is a copy of the Municipal Water Licence Inspection Report.

WATER LICENCE INSPECTION FORM

DATE:	September 17, 2010	COMPANY REP:	Dennis Wright
LICENCEE:	Hamlet of Fort McPherson	LICENCE #:	G03L3-001

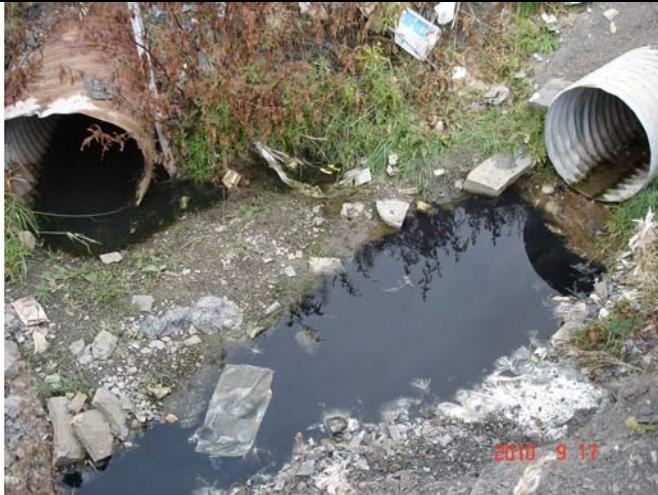
Figure 1

1. At the time of inspection the freeboard of the sewage lagoon was close to the 1m threshold. The sewage lagoon needed to be discharged. It was unknown if the sewage lagoon was decanted in the Fall and what the discharge quality was. Samples had been taken but there was no communication with this office or further sampling results submitted.
2. During inspection it was noted there was very slow seepage from the culverts (decant structure and the other culvert beside it) at the sewage lagoon discharge (see Figure 1). The sewage lagoon was really high and there maybe bypassing wastes around the closed decant structure. This possible seepage should be confirmed to ensure the culverts/decant

structure is secure otherwise repairs will need to occur. There should not be any decanting material unless samples have been taken to confirm compliance with discharge criteria.

Slow seepage of what appears to be effluent from sewage decant structure when it is closed.

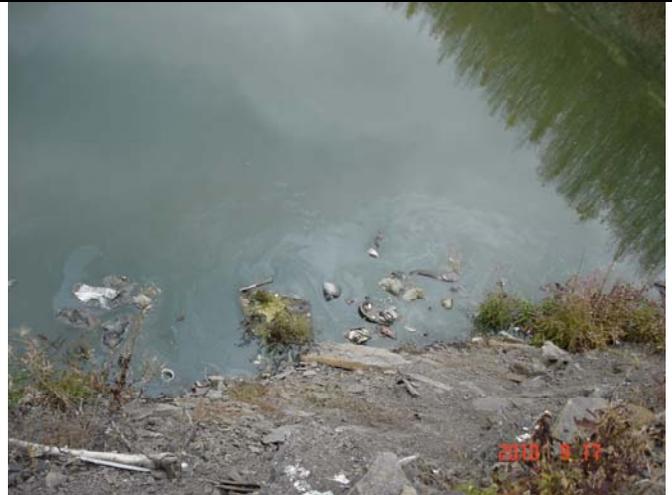
Figure 2

3. It was noticed there were two sheens on the north end of the sewage lagoon, one by the sewage discharge chute amongst garbage (see Figure 2) and another located in the northwest corner past the discharge chutes. It was unclear what the source of the sheen was but please note that if a sheen is detected a sample needs to be taken to determine the source. Please note that only sewage from domestic origins is to be discharged into the sewage lagoon.

Sheen observed at North end of sewage lagoon.

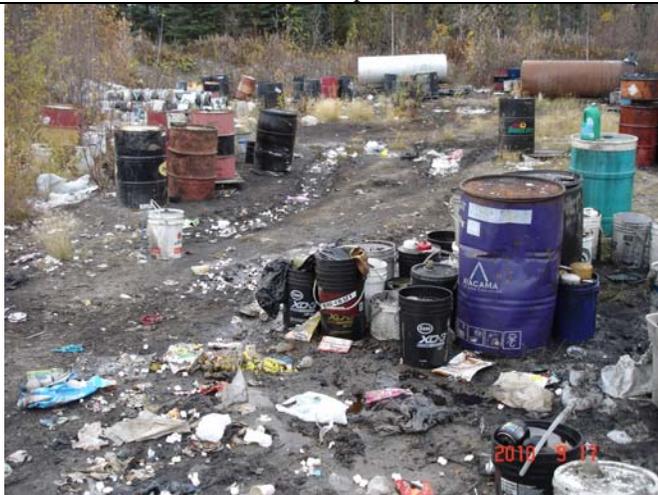
Figure 3

4. Waste oil storage area was in the process of being cleaned up. A lot of oil is being put into a very large storage tank that is on site. The five gallon pails of oil have been emptied and stacked in the waste oil storage area. The oil soaked lids unfortunately were discarded in the vicinity of the waste metal area of the Solid Waste Disposal Facility as compared to remaining in the waste oil storage area to await final disposal. Lids were precariously sitting on an unstable waste metal pile and appear difficult or unsafe to move back to the waste oil storage area.

With the large storage tank now full of waste oil the Hamlet of Fort McPherson needs to submit notification of what they intend to do with the tank. This tank of oil is now a further risk if it gets vandalized or a leak. At the time of inspection there were lots of containers with waste oil that were still open. There was lots of waste oil spillage which may now be more evident with the area being cleaned up. This contaminated soil needs to be cleaned up, contained and properly disposed of (see Figure 3).

Waste Oil storage area, oil put into the large brown tank, but further work is needed to clean up the site.

The Hamlet needs to ensure there is a proper procedure to maintain the organization and cleanliness of the waste oil storage area. When there has been spillage, make sure the soil and waste oil is cleaned up, contained and properly disposed of. Further, ensure that the hazardous waste storage area is regularly inspected, maintained and materials stored properly. This will ultimately keep the area clean and encourage the public to segregate waste properly.

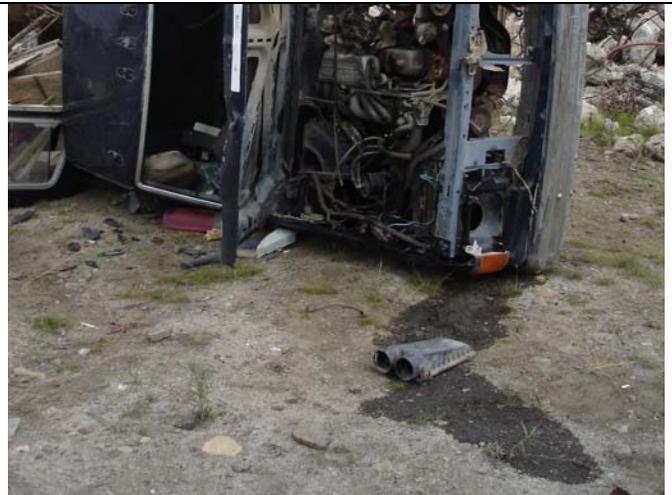
Figure 4

7. Waste vehicles need to be emptied of their fluids as this is a source of contamination. There was evidence that this hasn't occurred as there appeared to be vehicular fluids that had been spilled (see Figure 4).

Waste vehicles need to have fluids removed. It appears this has not occurred and is a source of contamination.

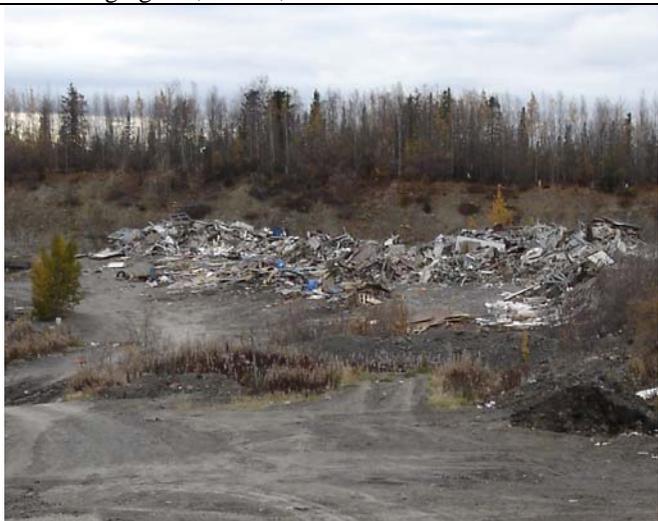
Figure 5

10. Demolition/building waste in greater quantity is being disposed in the area of the SWDF behind the honey bag pit on the north side of the sewage lagoon. It is recommended that this waste can be further segregated as there is clean wood present that could either be reused or burned as noted above in comment #5 (see Figure 5).

Building/demo. waste in behind honey bag pit that can be further segregated, reused, or clean wood can be burned.

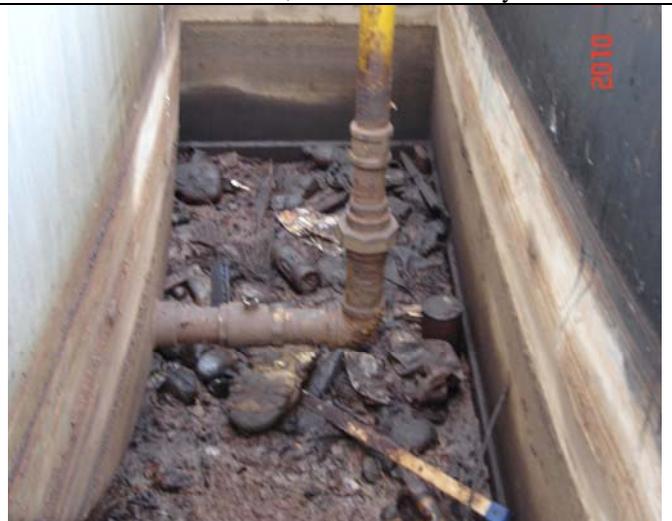
Figure 6

- At the time of inspection the outside fuel storage tank at the Water Treatment Plant had less water within the berm. Compared to previous inspections the water level within the berm was greatly reduced (see Figure 6). There was a lot of debris present in the bottom of the berm. There was a distinct odour emanating from within the berm that smelled of hydrocarbons and a sheen that was present on the remaining water. The Hamlet of Fort McPherson needs to provide details of where the water was disposed of. There was another double walled tank present that appeared to be a replacement for the old tank.

Water Treatment Plant outside fuel storage tank had water removed from metal berm, which smelled of hydrocarbons.
