**RE: Municipal Water Licence G03L3-001  
CLASS B - MUNICIPAL  
Deep Water Lake**

**RE: MUNICIPAL Water Use G03L3-001  
CLASS B - MUNICIPAL  
Deep Water Lake**

## MUNICIPAL WATER USE INSPECTION REPORT

<b>LICENCE #:</b>	G03L3-001	<b>EXPIRY DATE:</b>	August 31, 2013
<b>LICENCEE:</b>	Hamlet of Fort McPherson	<b>PREVIOUS INSPECTION:</b>	August 19, 2011
<b>COMPANY REP:</b>	Susan Blake	<b>INSPECTION DATE:</b>	June 27, 2013

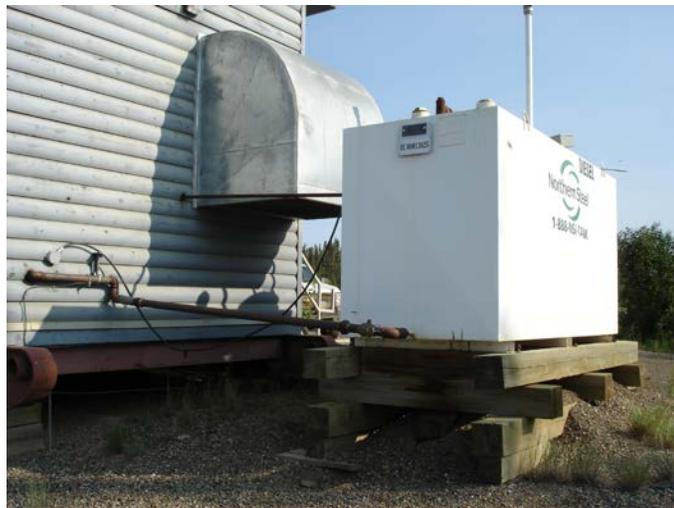
**Figure 1**

1. No leakage or fuel issues were observed at the Deep Water Lake Water Supply Facility except the fuel supply line is feeding into the bottom of the fuel storage tank. This is a concern because if there ever is a leak in the fuel line or where it connects to the base of the fuel tank the contents could empty out completely. This bottom feed tank is a risk to the Deep Water Lake Water Supply in its current state as compared to fuel tank with fuel lines that connect to the top of the fuel tank.

Any leakage is always a risk but in this instance the tank is directly up hill of the lake and if there was ever any shifting of the tank, ground surface etc then leaking fuel could run downhill and be catastrophic for the Hamlet of Fort McPherson's Water Supply. The Deep Water Lake Water Supply Facility fuel storage tank piping needs to be monitored to ensure no maintenance and stability issues.

Water Supply Facility - Deep Water Lake Intake Facility fuel storage is a concern. The piping is attached to the bottom of the fuel tank and is susceptible to any instability which could cause a spill.

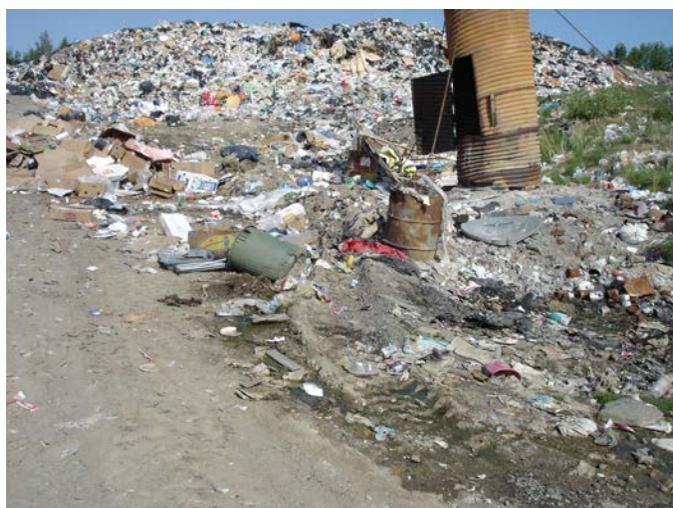
**Figure 2**

1. Burning (for acceptable materials) area within drainage ditch for landfill an environmental concern. Burned material leaves ash which any flowing water will flow through and leach out any potential contaminants not to mention this just provides a way for water to get contaminated unnecessarily. This is an impact that can be easily mitigated by moving the burning area to another location at the land fill, for example to the top of the waste cells to the open pit at the top as discussed during the Inspection. This will prevent the drainage and runoff from flowing through burned materials.

The area for burning acceptable waste such as cardboard, paper and untreated wood waste lies within the drainage of the Solid Waste Disposal Facility. Any runoff will be contaminated with left over ash from burning.

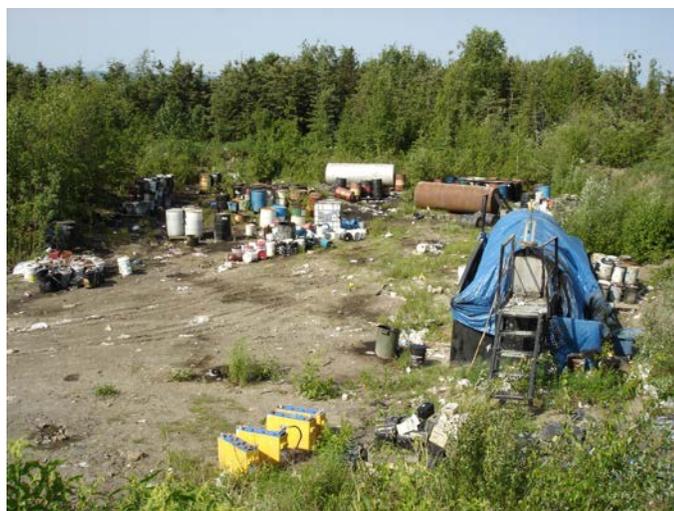
**Figure 3**

1. Many remaining used oil containers and oil needs to be disposed of at proper recycling or burning facilities. Open containers of used oil need to be emptied/secured and the used oil needs to be transferred to proper containers and the empty containers disposed of. It appears that more soil is contaminated due to poor storage and disposal of used oil.

This issue was improved at the time of the September 17, 2010 Water Licence Inspection, in which a lot of the oil and containers were consolidated and emptied. The oil storage and disposal situation has become much more critical and there will be further problems and contamination unless the Hamlet dedicates the proper resources to clean up the site. Right now this is an environmental liability with tremendous risk of further uncontrolled leaks/spills, vandalism and even a fire hazard for the town given the open containers and large used oil tanks.

The Solid Waste Disposal Facility waste oil storage area is at a critical stage where containers are unsecured, full and spilling over. The soil is very contaminated with used oil. This represents a huge liability for the Hamlet.

The remaining contaminated soil needs to be cleaned up, contained and properly disposed of. The Hamlet needs to ensure there is a proper procedure to maintain the organization and cleanliness of the waste oil storage area. When there has been spillage, make sure the soil and waste oil is cleaned up, contained and properly disposed of. Further, ensure that the hazardous waste storage area is regularly inspected, maintained and materials stored properly. This will ultimately keep the area clean and encourage the public to segregate waste properly. The Hamlet might want to consider collecting used oil at the Hamlet Public Works shop where there can be regular and proper supervision and care of the oil collection/storage.

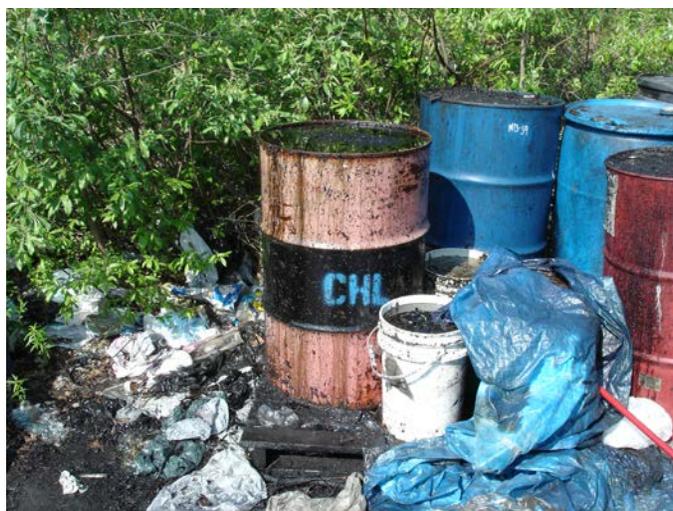
**Figure 4**

2. Currently there are storage tanks on site for used oil storage. One particular tank that is being filled has its associated metal berm full of oil and what's estimated to be water. It is only a matter of time till it is overflowing. This actually provides no contingency containment if there ever was a leak since the berm is full.

Waste oil storage area has open or unsecured containers with used oil leaking out. The oil needs to be consolidated into strong and secure containers to ensure proper storage of used oil until time for disposal or recycling.

At the very least until the tank is emptied and removed, the tank and berm need to be covered properly to prevent further water from getting in the berm and being contaminated. Currently there is a tarp that is not well secured and not providing adequate coverage. This needs to be improved on in the meantime while there is rain. Covering with corrugated metal has been used in other places.

The storage of oil in the larger tanks has created another problem and a plan is needed to empty it for proper disposal which would consist of shipping out for disposal or burning in local waste oil burners. The best and permanent solution would be for the used oil to be emptied from the berm and the tank while being transferred to more manageable totes or barrels. Storage of used oil in large metal storage tanks is only a short term solution and they eventually fill up and need to be emptied.

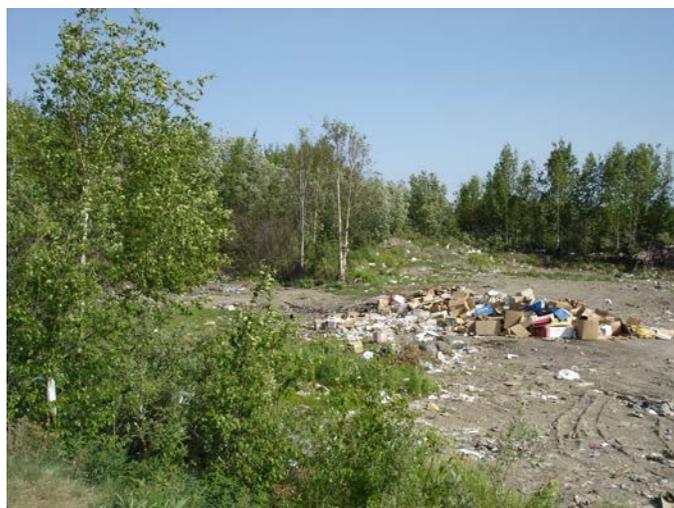
**Figure 5**

3. Currently there is domestic waste being disposed of at the top of the cell behind the used oil storage area. This area needs to be cleaned up and/or buried because the surrounding garbage is confusing and residents are not disposing of domestic waste all in the

Domestic waste is being disposed in an area other than to the designated waste cell. The surrounding area needs to be cleaned and barricades set up so there is no confusion and opportunities to put waste in the wrong place.

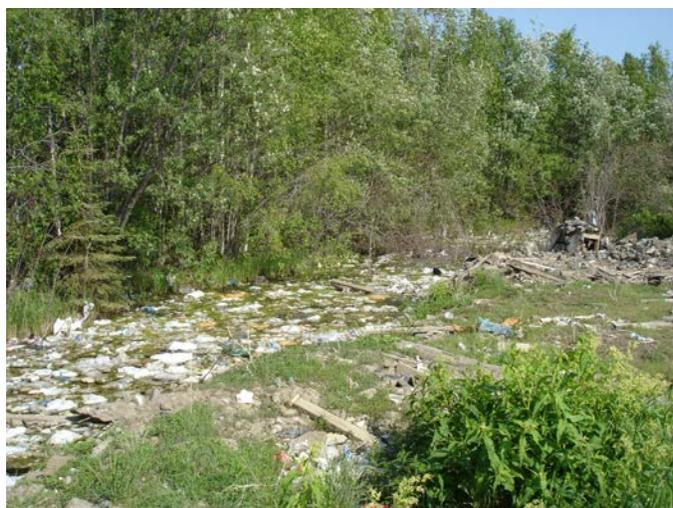
**Figure 6**

3. There was an area of ponded water (behind the domestic waste cell and the used oil storage area) with solid waste present in it that should be dealt with. The waste needs to be removed from the water and properly disposed of in the main domestic waste cell.

Ponded water in area behind the waste oil storage needs to be cleaned up and permanently prevented for people disposing of their waste there.
