**File Number** G16Q001  
**Type of Operation** QUARRY SITE - Existing  
**Location** Frog Creek

## ENVIRONMENTAL INSPECTION REPORT

<b>Permittee:</b>	L.J.'s Septic Services & Contracting Ltd.	<b>Permit Expiry Date:</b>	March 14, 2021
<b>Land Use Permit No.</b>	G16Q001	<b>Previous Inspection:</b>	April 26, 2017
<b>Quarrying Permit No.</b>		<b>Inspection Date:</b>	July 12, 2017
<b>Contractor:</b>		<b>Subcontractor:</b>	
<b>Location(s) Inspected:</b>	Frog Creek		
<b>Current Stage of Operation:</b>	Completed		
<b>Program Modifications Approved:</b>	NIL

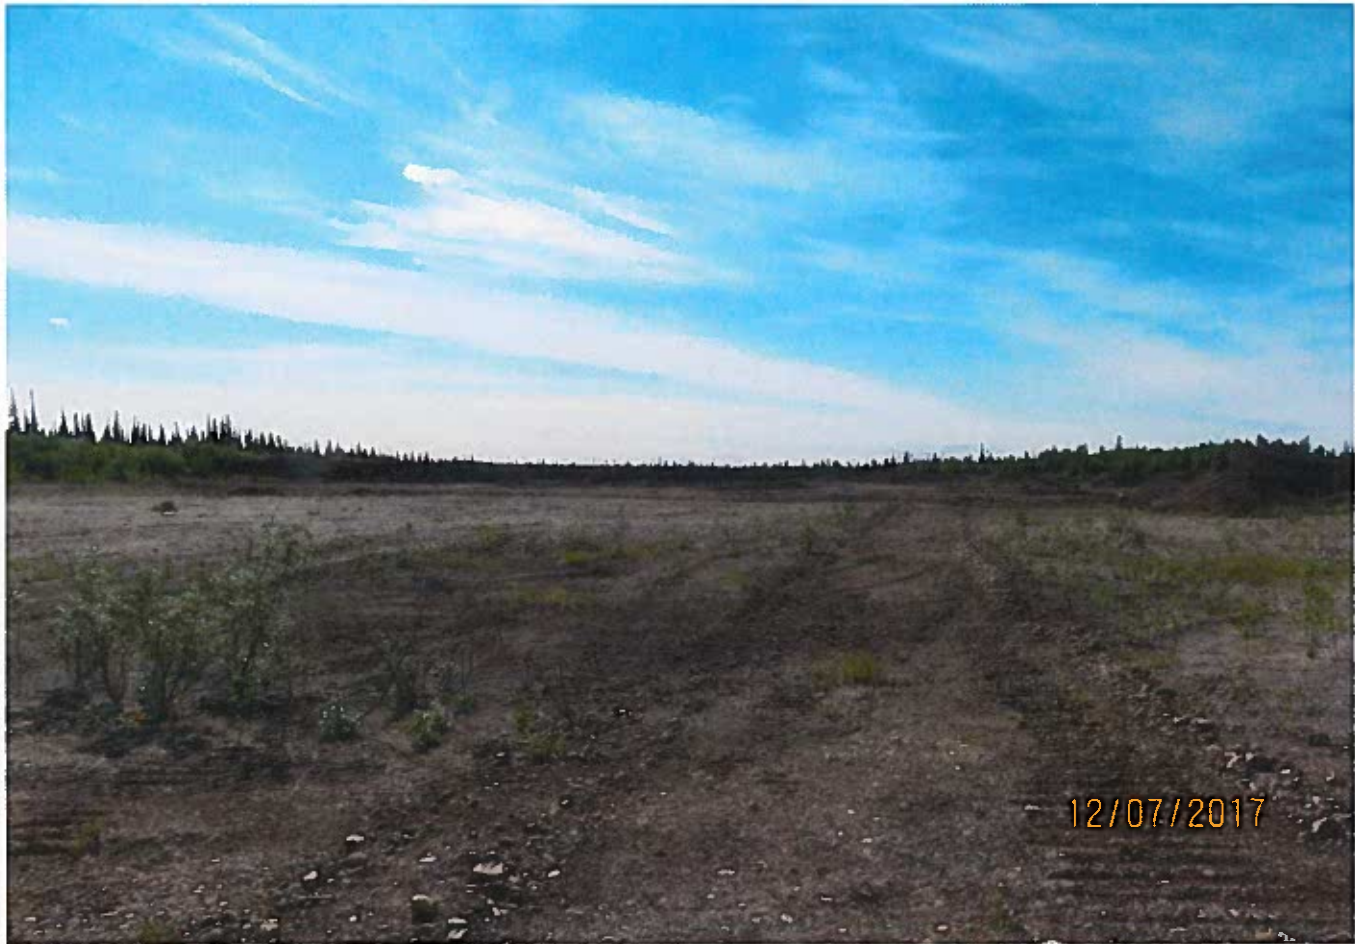
Figure 1

Work at the location is completed and materials removed, the site during the inspection looks all satisfactory with no concerns for reclamation the pit floor and walls are satisfactory.
