File Number G16Q004
Type of Operation QUARRY SITE - Existing
Location Km 251

ENVIRONMENTAL INSPECTION REPORT

Permittee:	Bob's Welding Ltd.	Permit Expiry Date:	May 25, 2021
Land Use Permit No.	G16Q004	Previous Inspection:	May 27, 2016
Quarrying Permit No.		Inspection Date:	August 26, 2016
Contractor:		Subcontractor:	
Location(s) Inspected:	Km 251		
Current Stage of Operation:	on going		
Program Modifications Approved:	New Quarry Permit was issued for 15000 cubic meters under a condition that no drilling or blasting will occur until all previously blasted material was removed.

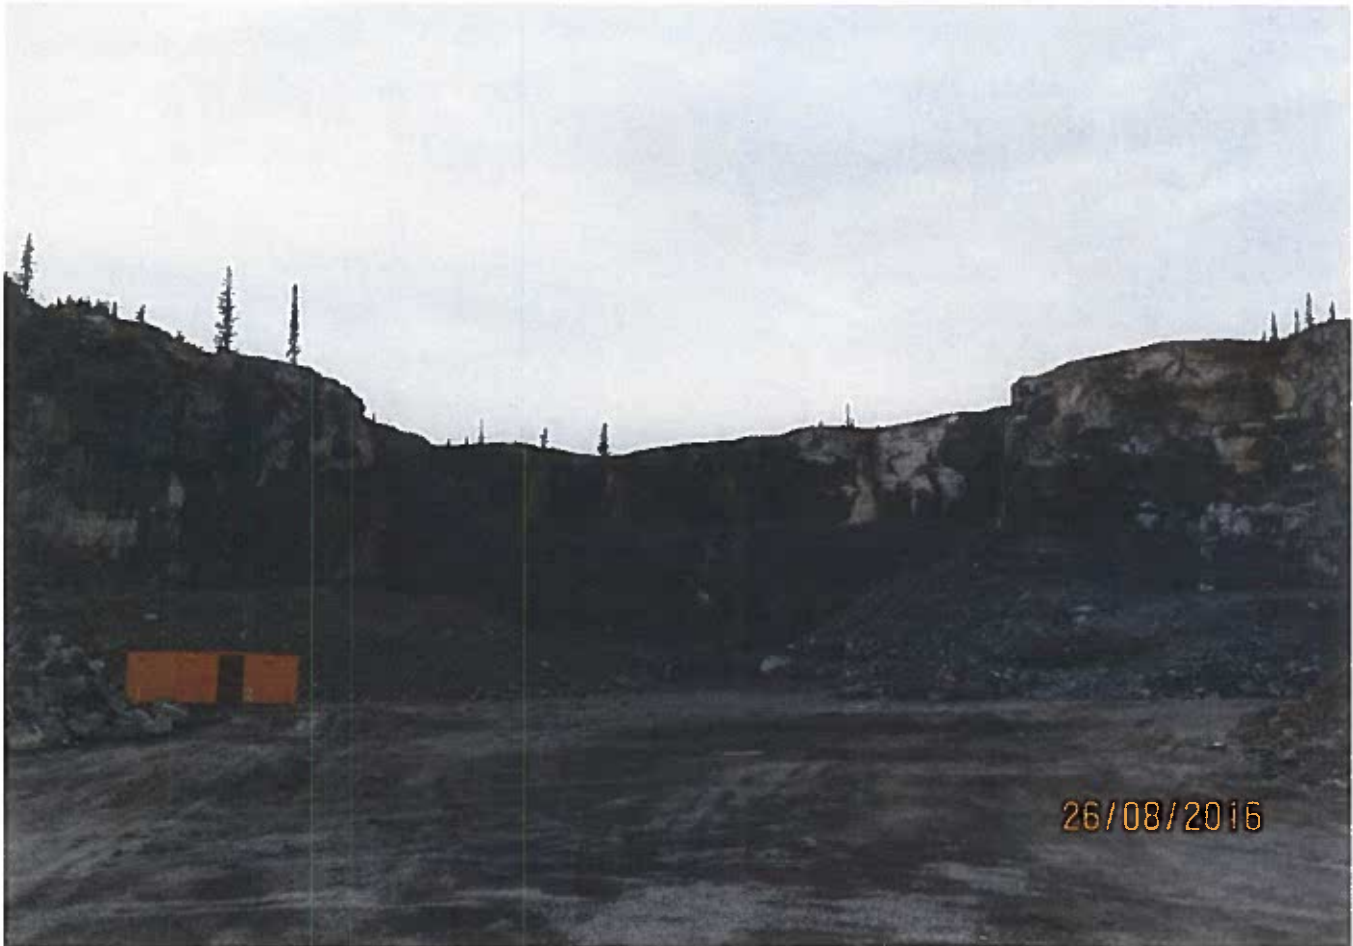
Figure 1

Pit floor view of bench

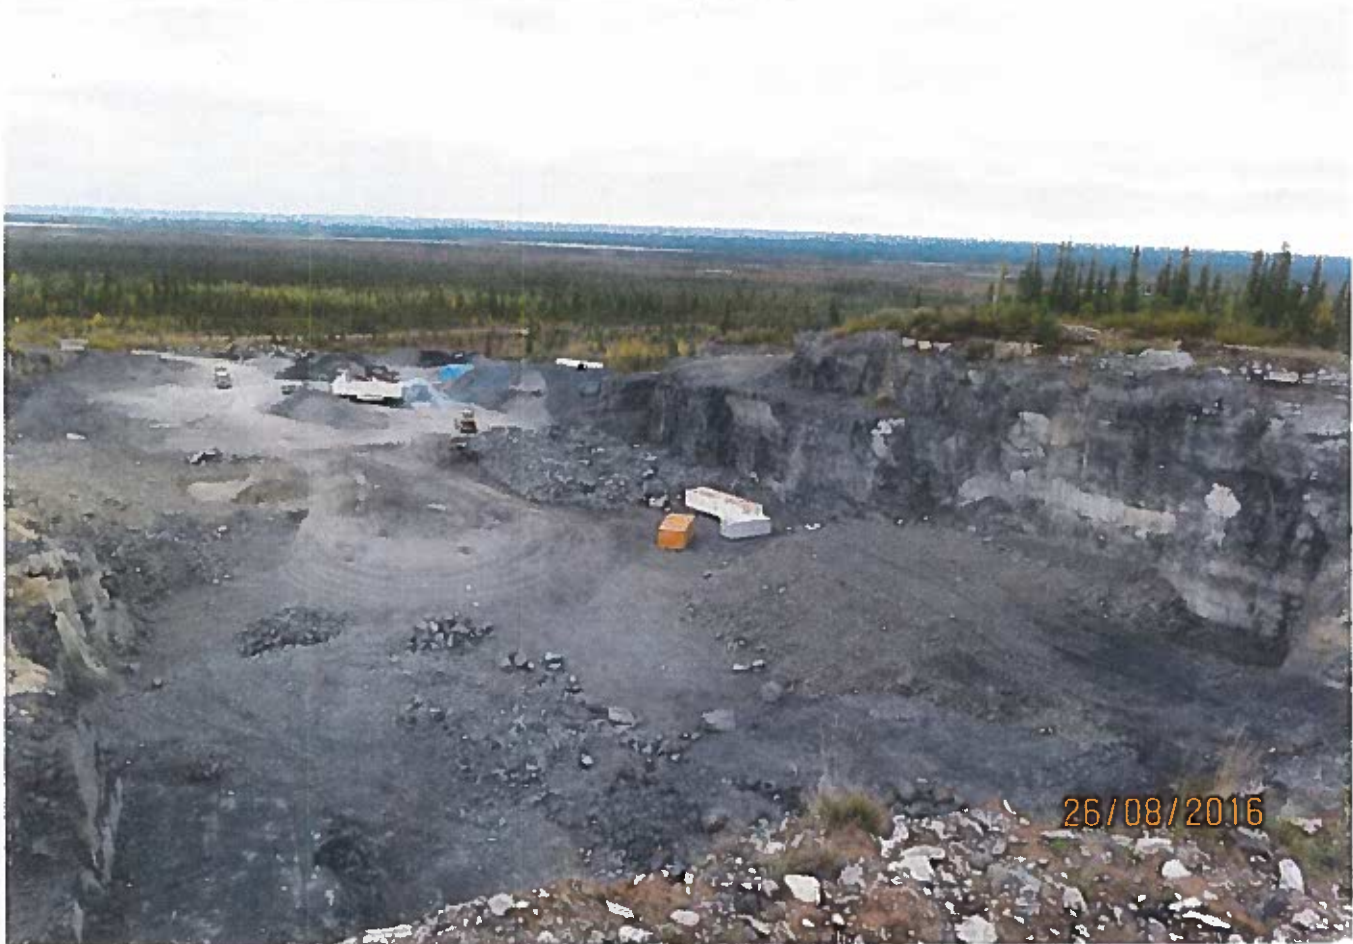
Figure 2

view at end of pit

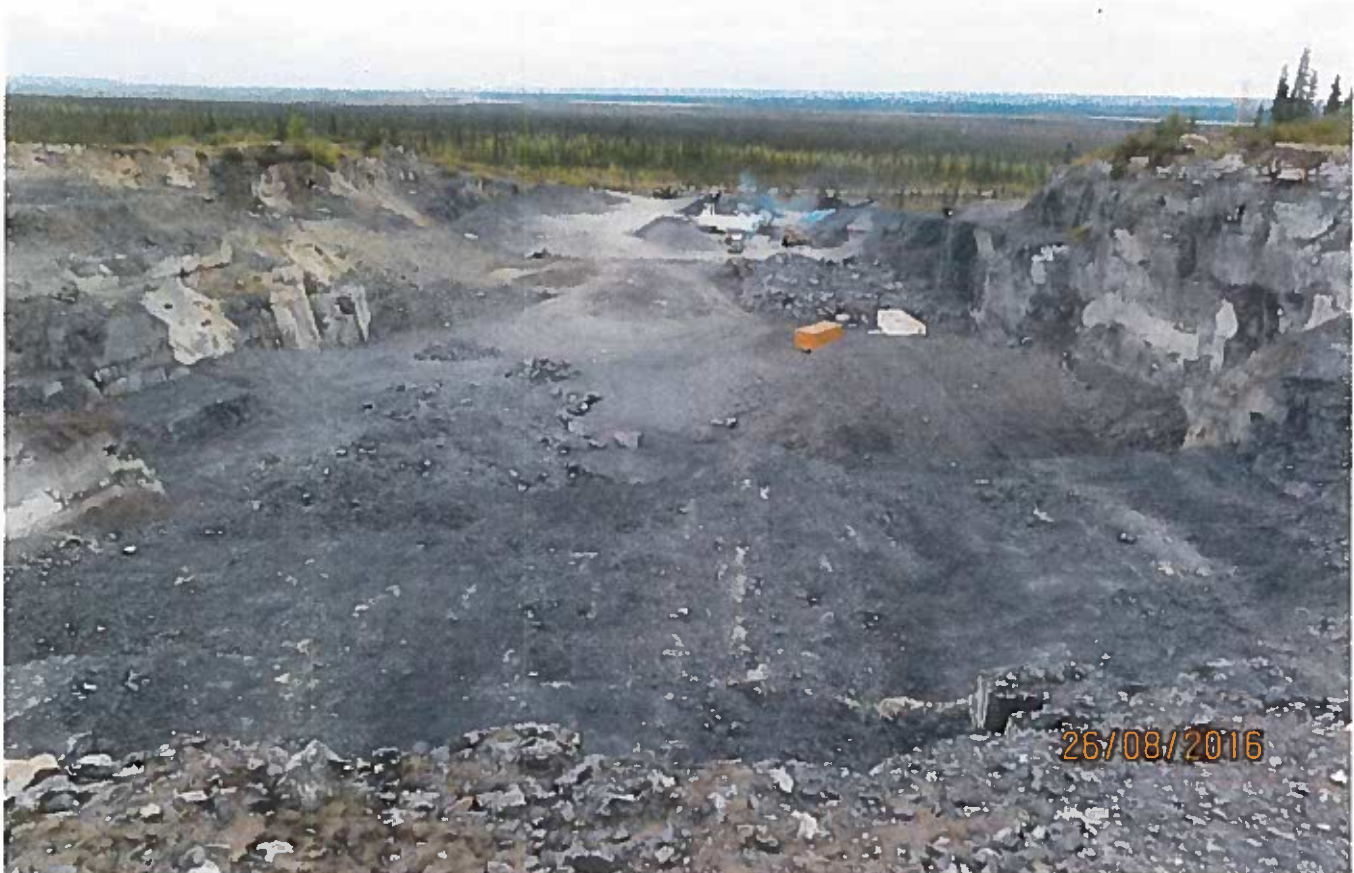
Figure 3
view at end of pit

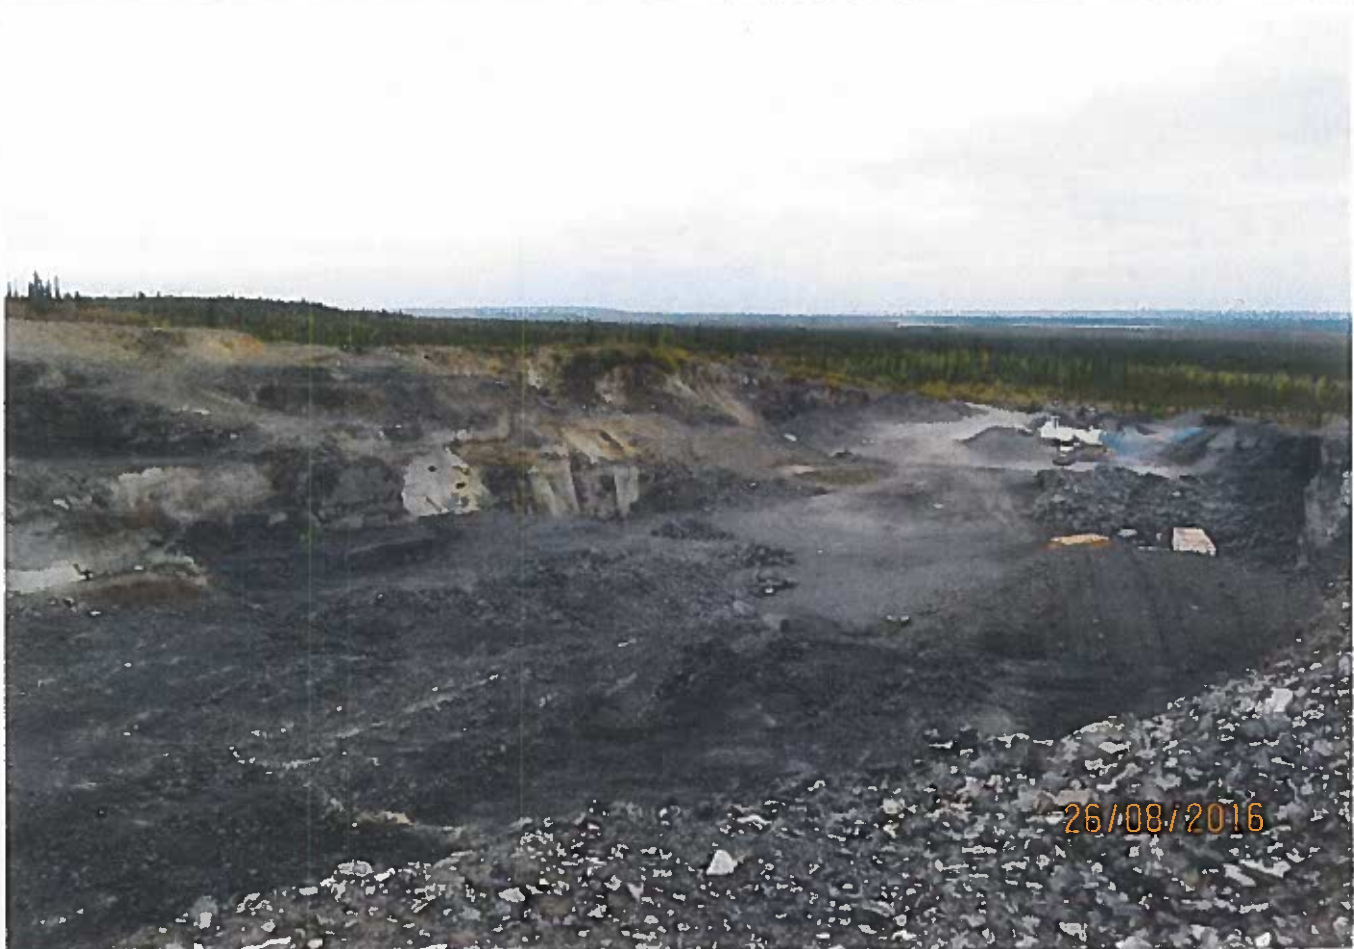
Figure 4
view at end of pit
