**File Number** G16Q004  
**Type of Operation** QUARRY SITE - Existing  
**Location** Km 251 Dempster Highway

## ENVIRONMENTAL INSPECTION REPORT

<b>Permittee:</b>	Bob's Welding Ltd.	<b>Permit Expiry Date:</b>	May 25, 2021
<b>Land Use Permit No.</b>	G16Q004	<b>Previous Inspection:</b>	December 04, 2020
<b>Quarrying Permit No.</b>		<b>Inspection Date:</b>	January 19, 2021
<b>Contractor:</b>		<b>Subcontractor:</b>	
<b>Location(s) Inspected:</b>	Km 251 Dempster Highway		
<b>Current Stage of Operation:</b>	ongoing		
<b>Program Modifications Approved:</b>	QP for removal of stock piles only

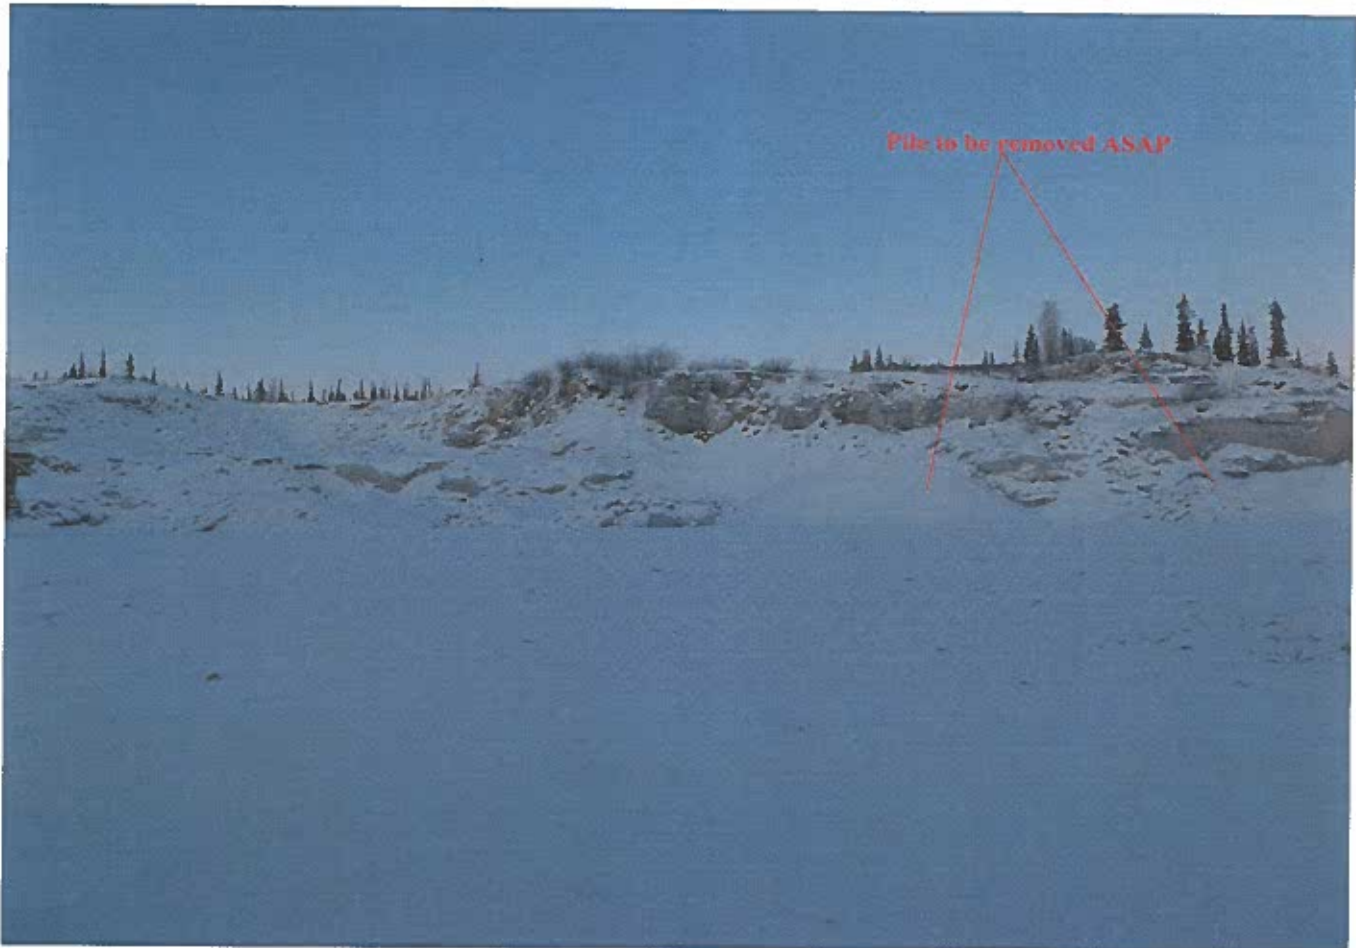
**Figure 1**

It is evident that past requests for removal of material to the north side wall were not followed, attached images from Dec 4, 2020 inspection requested the material on the north wall be removed ASAP as another contractor will be going into do some work, since this Dec. 04 inspection these materials were not touched at all.

**Dec. 04, 2020 image and requested for removal.**

Materials to the North side wall are to be removed.

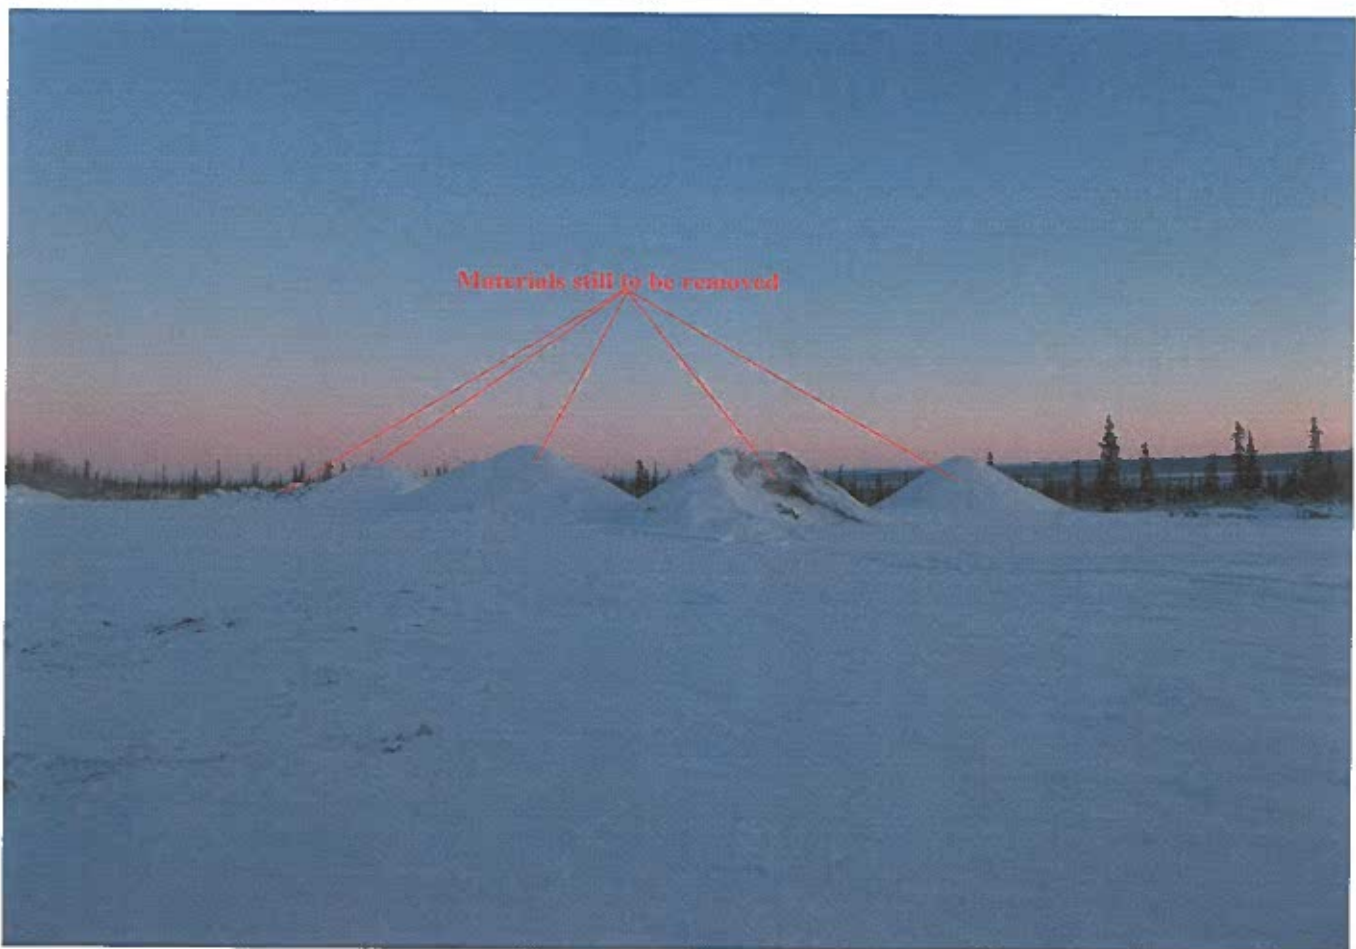
**Figure 2**

**Dec. 04, 2020 image and requested for removal.**

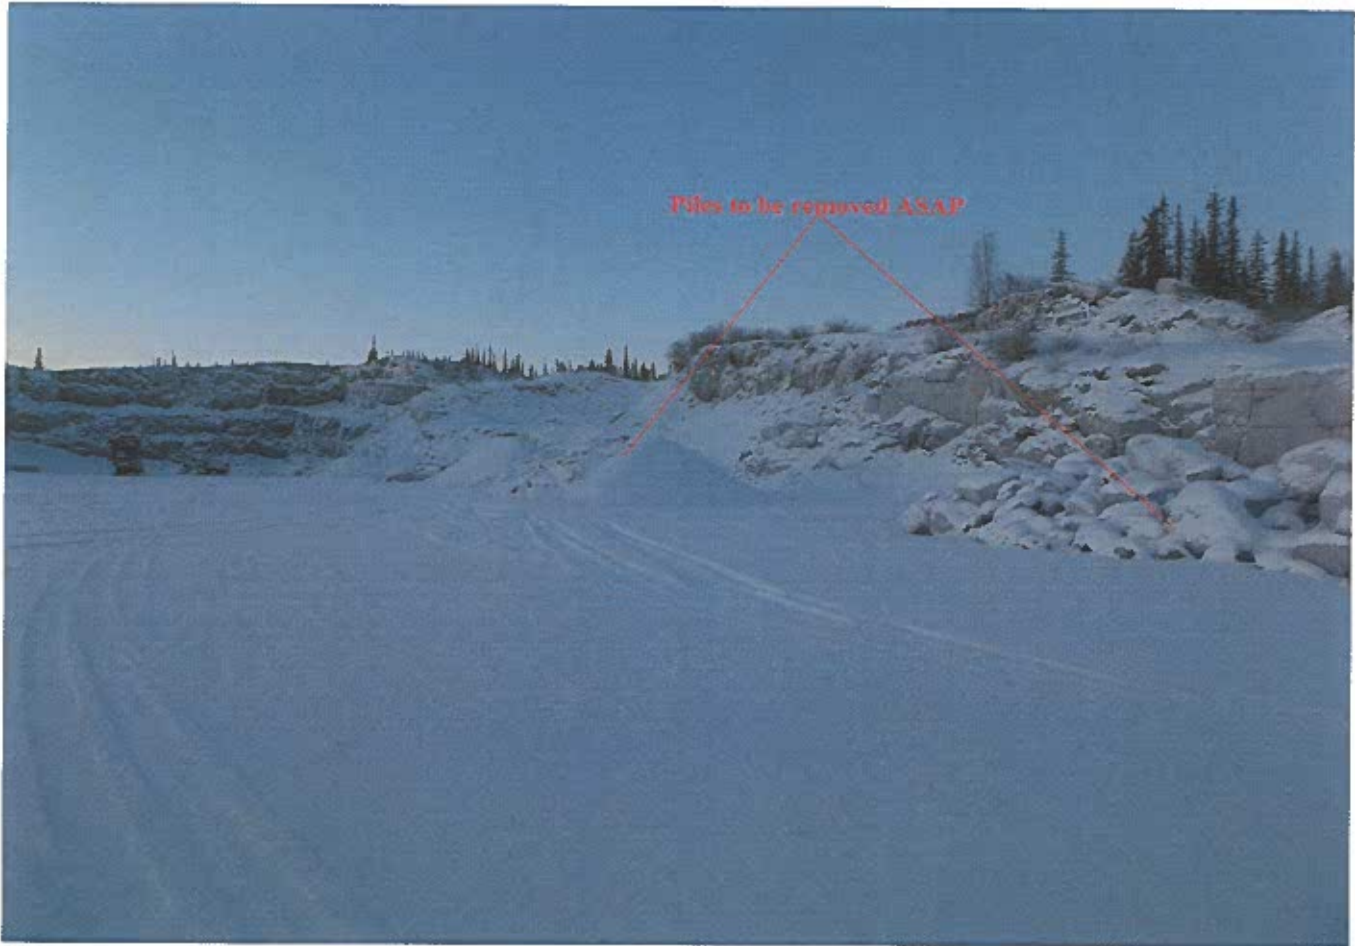
**Figure 3**

**Dec. 04, 2020 image and requested for removal.**

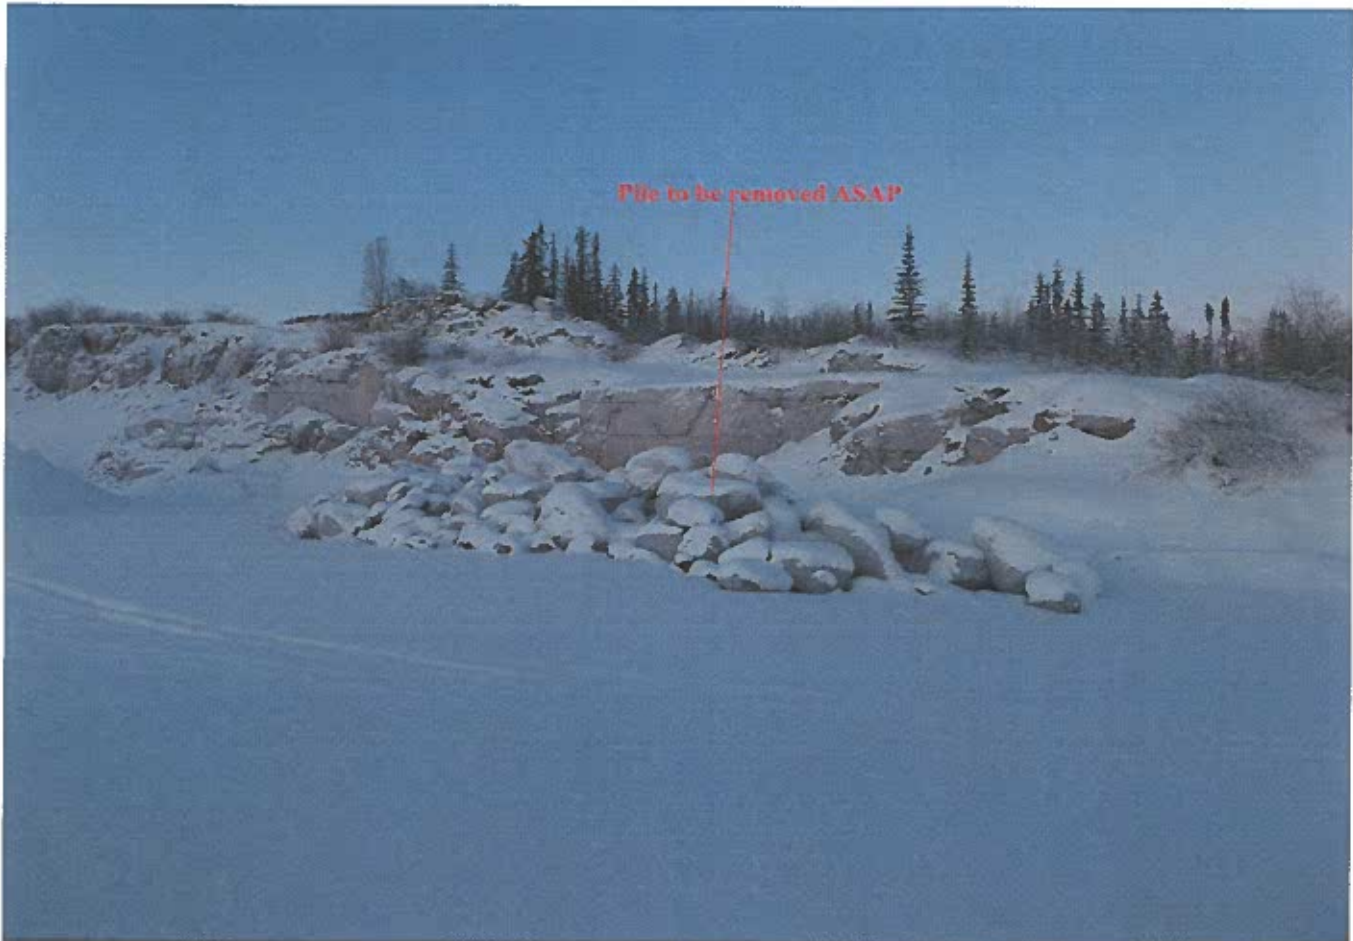
**Figure 4**

**Dec. 04, 2020 image and requested for removal.**

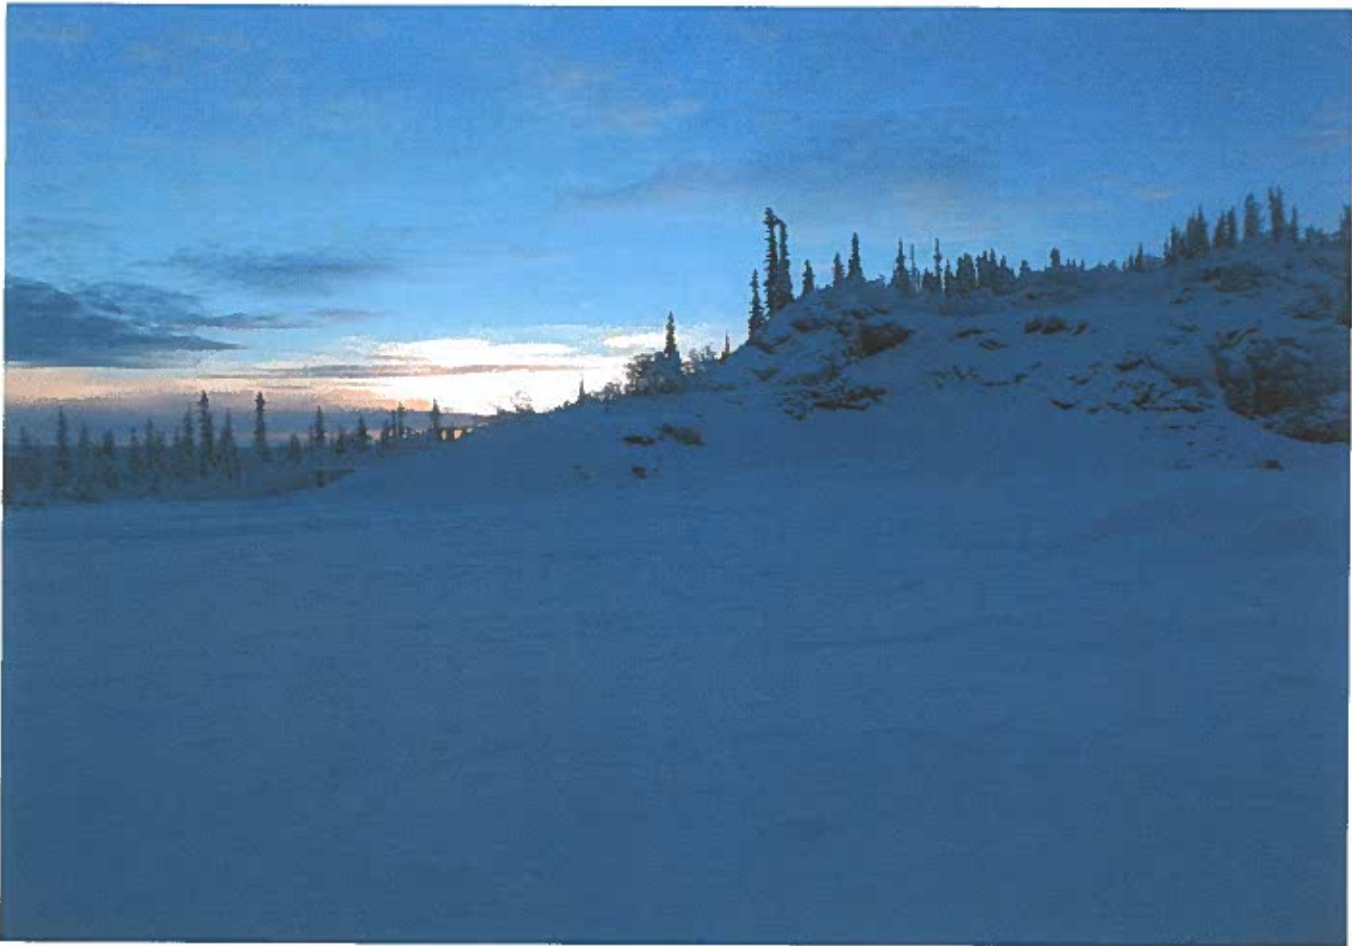
**Figure 5**

During this inspection it was observed that material from the central area of the pit was removed, this is a good start however, you are again reminded that this source is a multi user source and work location are to be adhered to.

**Central material removed**

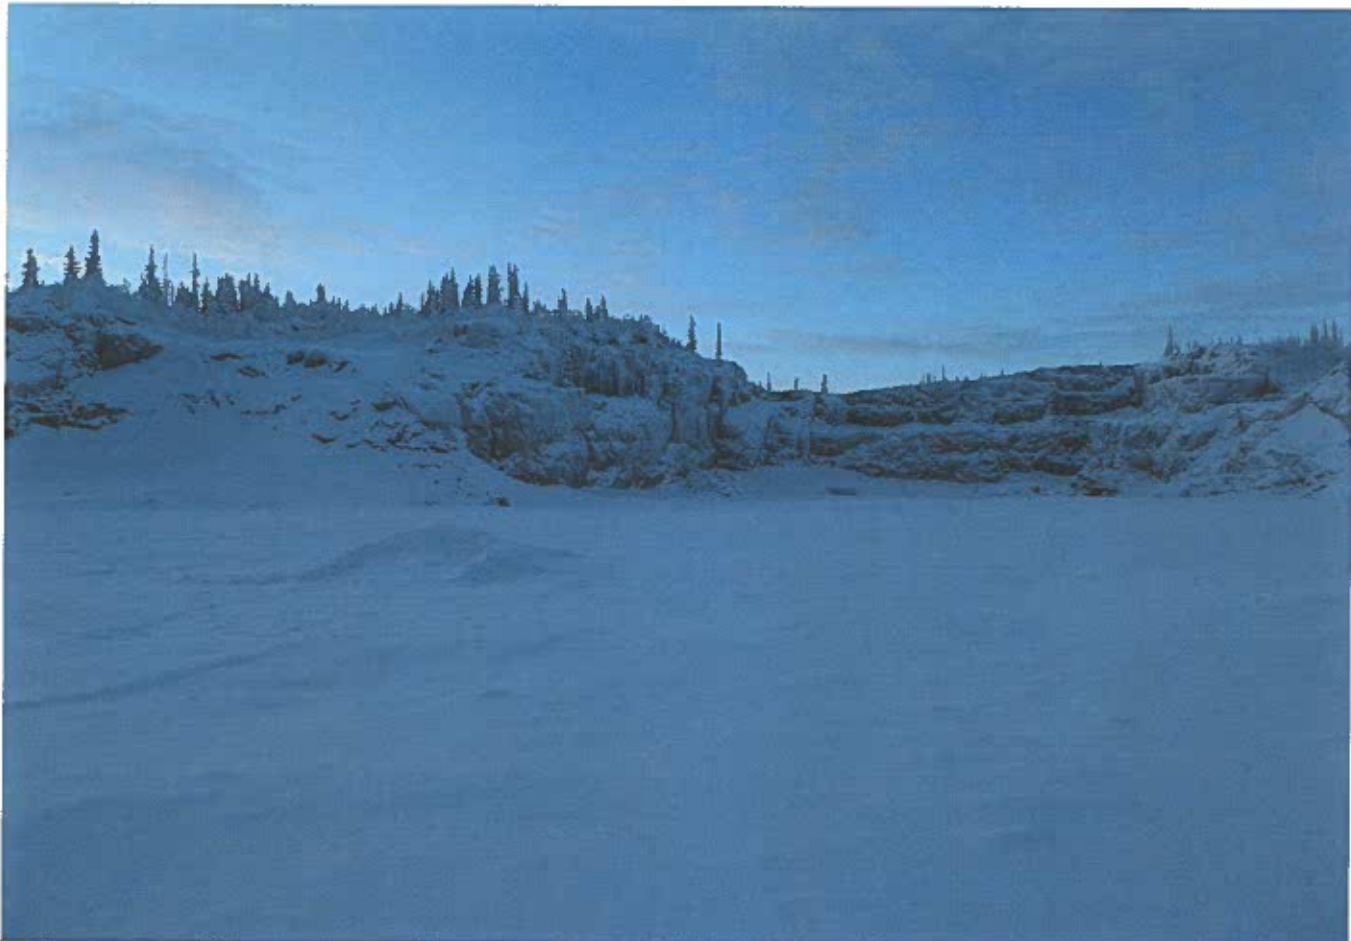
**Figure 6**

**Central material removed**

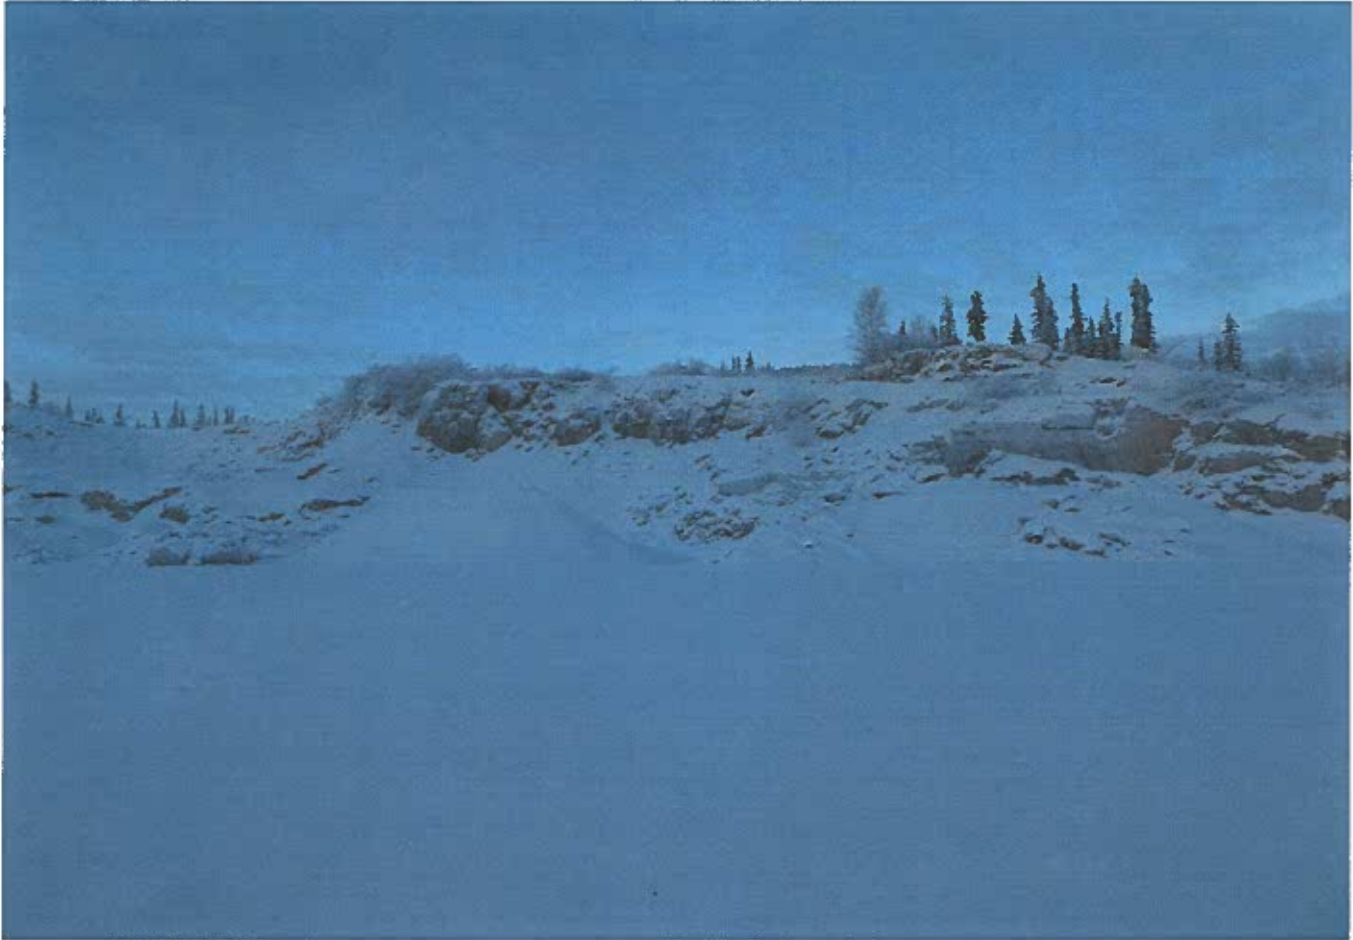
**Figure 7**

The main concern observed again is the material stock piled at the north side of the source

that was previously requested during the Dec 04 2020 inspection to have them removed as they are blocking access to work location for another permit holder.

**Dec. 04, 2020 requested for removal Jan 19, 2021 material still blocking another permit holder access**

The Department of Lands is willing to work out solutions for issuing a new quarry permit, however material to the Northside wall are to be removed to another location. One aspect is to have materials to the south area where the storage shed is located. however this will be determined on removal of requested material.

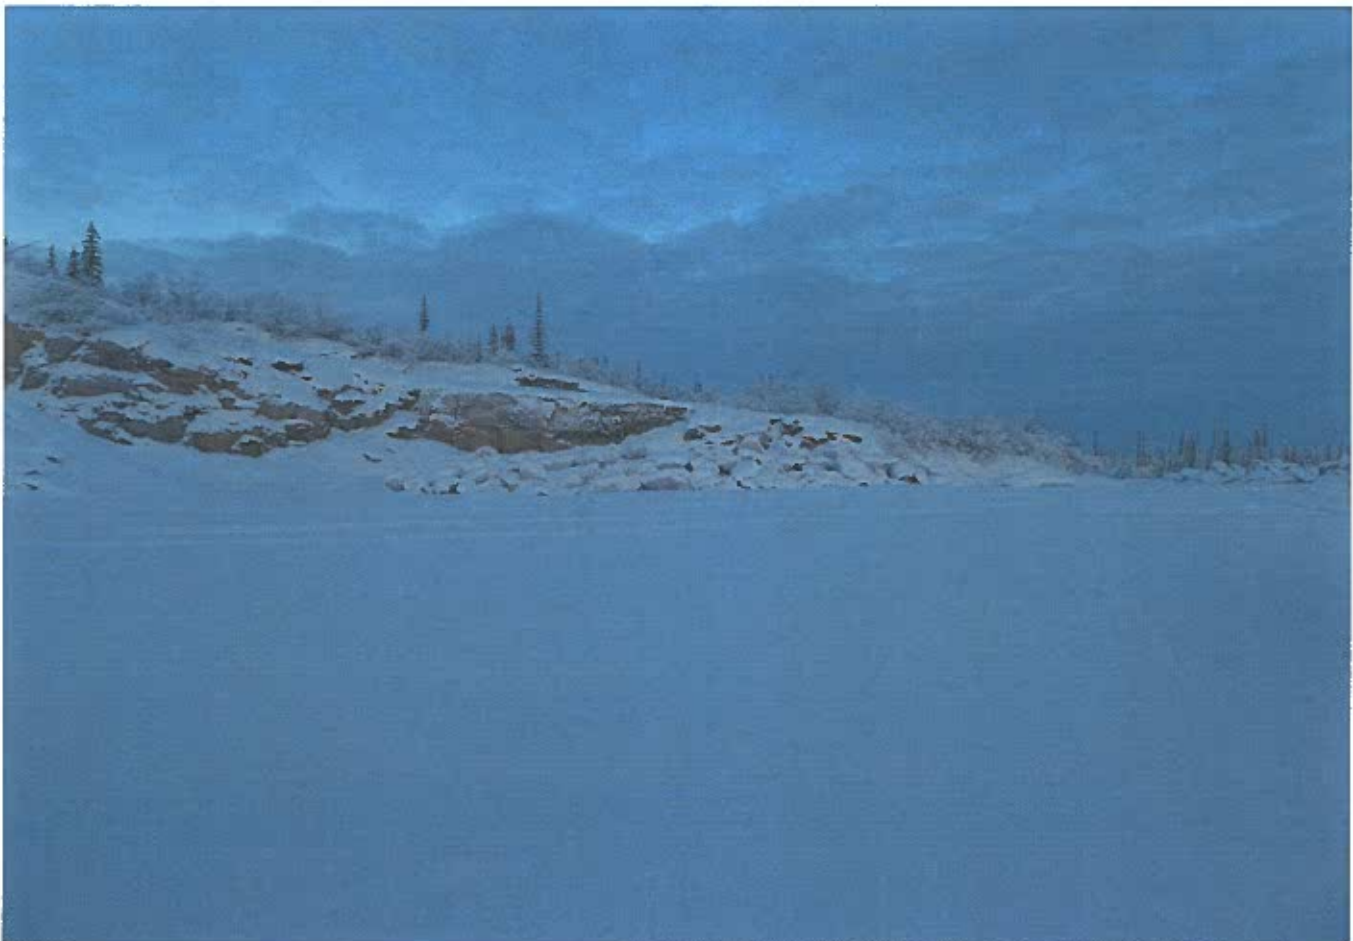
**Figure 8**

**Dec. 04, 2020 requested for removal Jan 19, 2021 material still blocking another permit holder access**

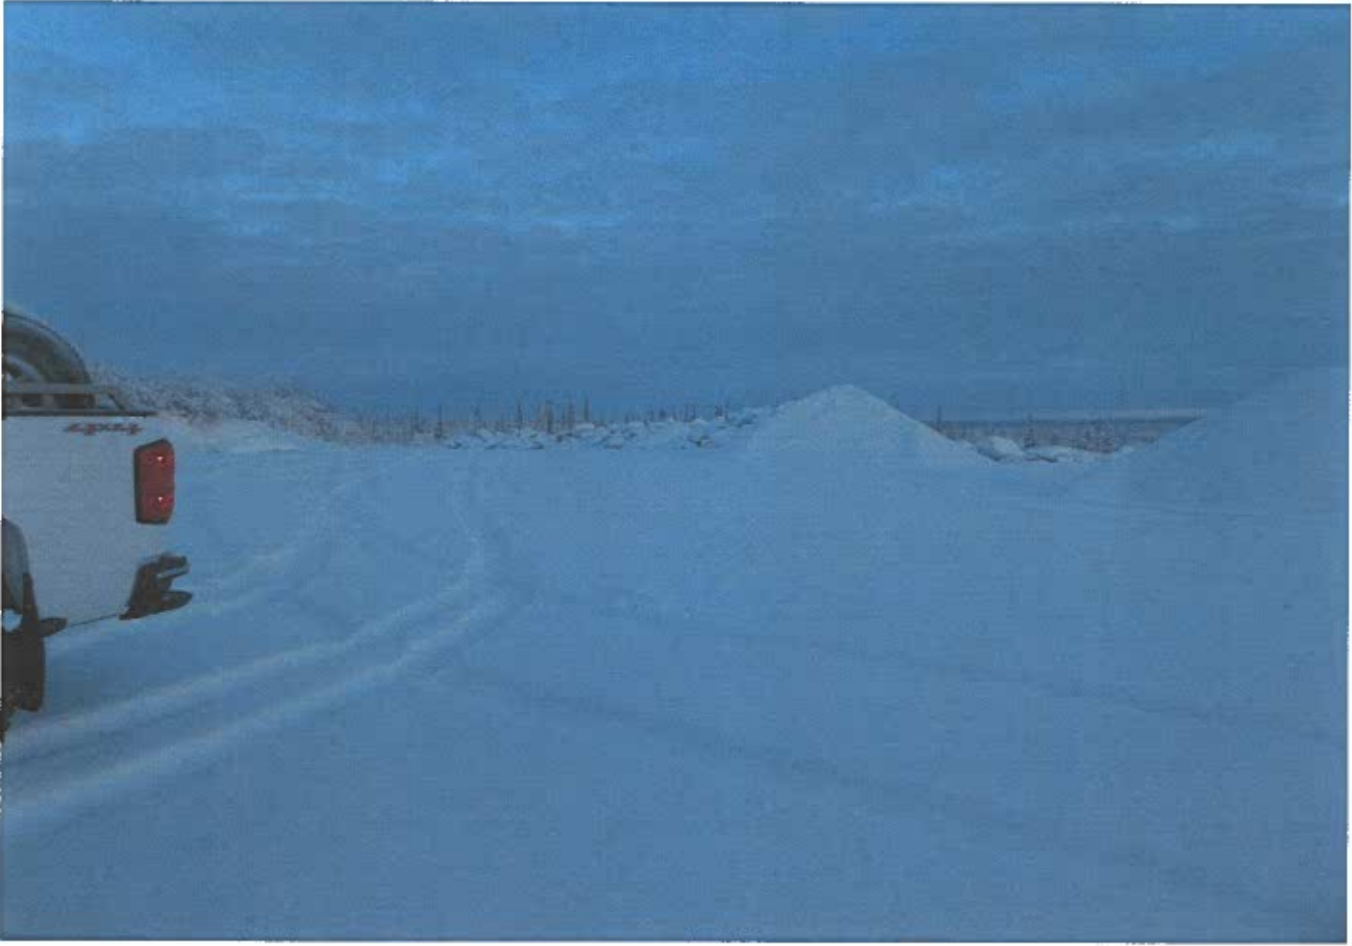
**Figure 9**

**Dec. 04, 2020 requested for removal Jan 19, 2021 material still on site.**

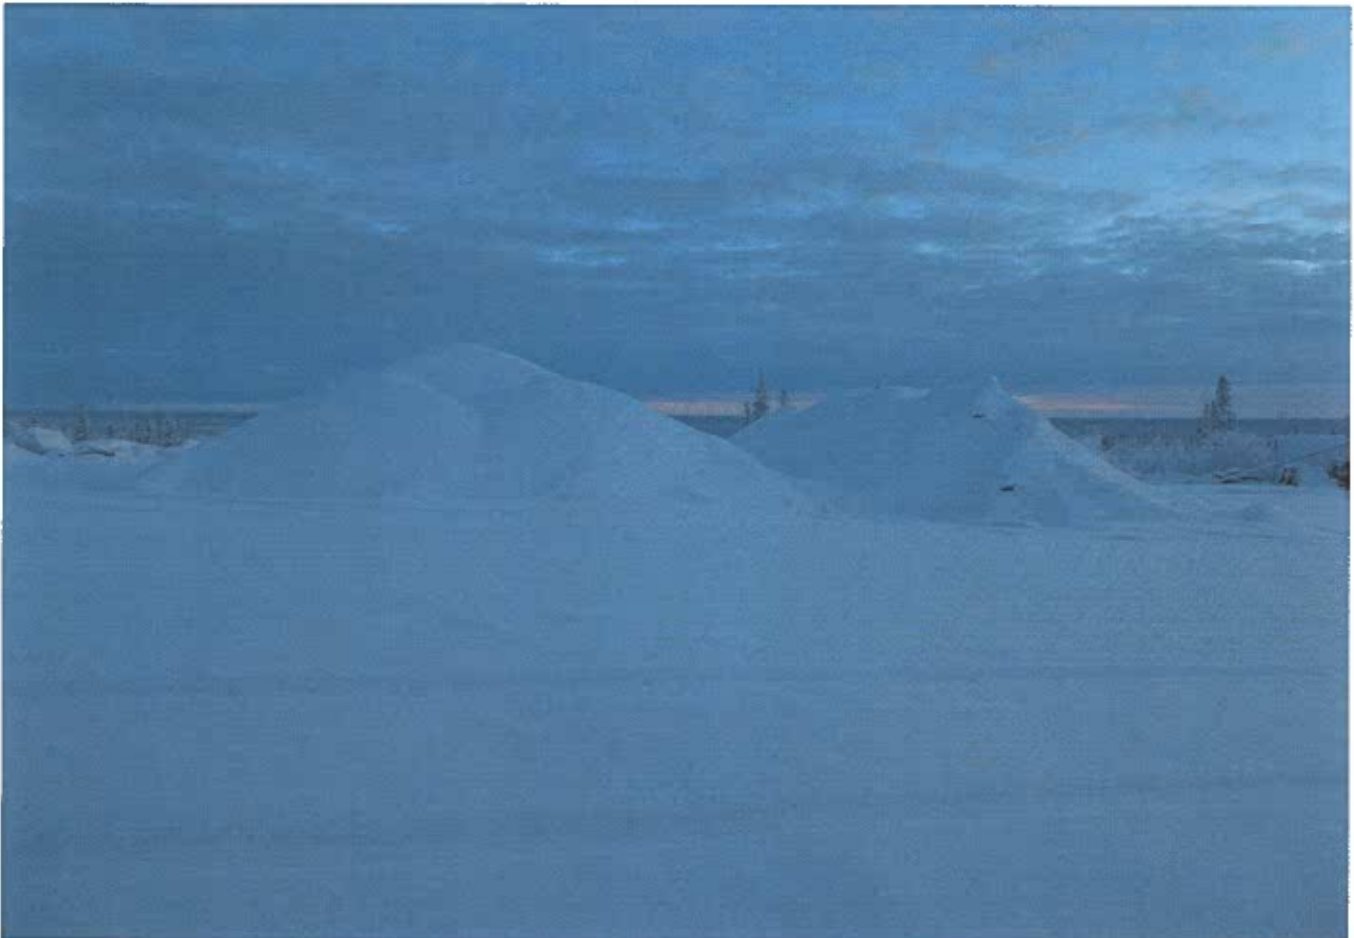
**Figure 10**

**Dec. 04, 2020 requested for removal Jan 19, 2021 material still on site.**

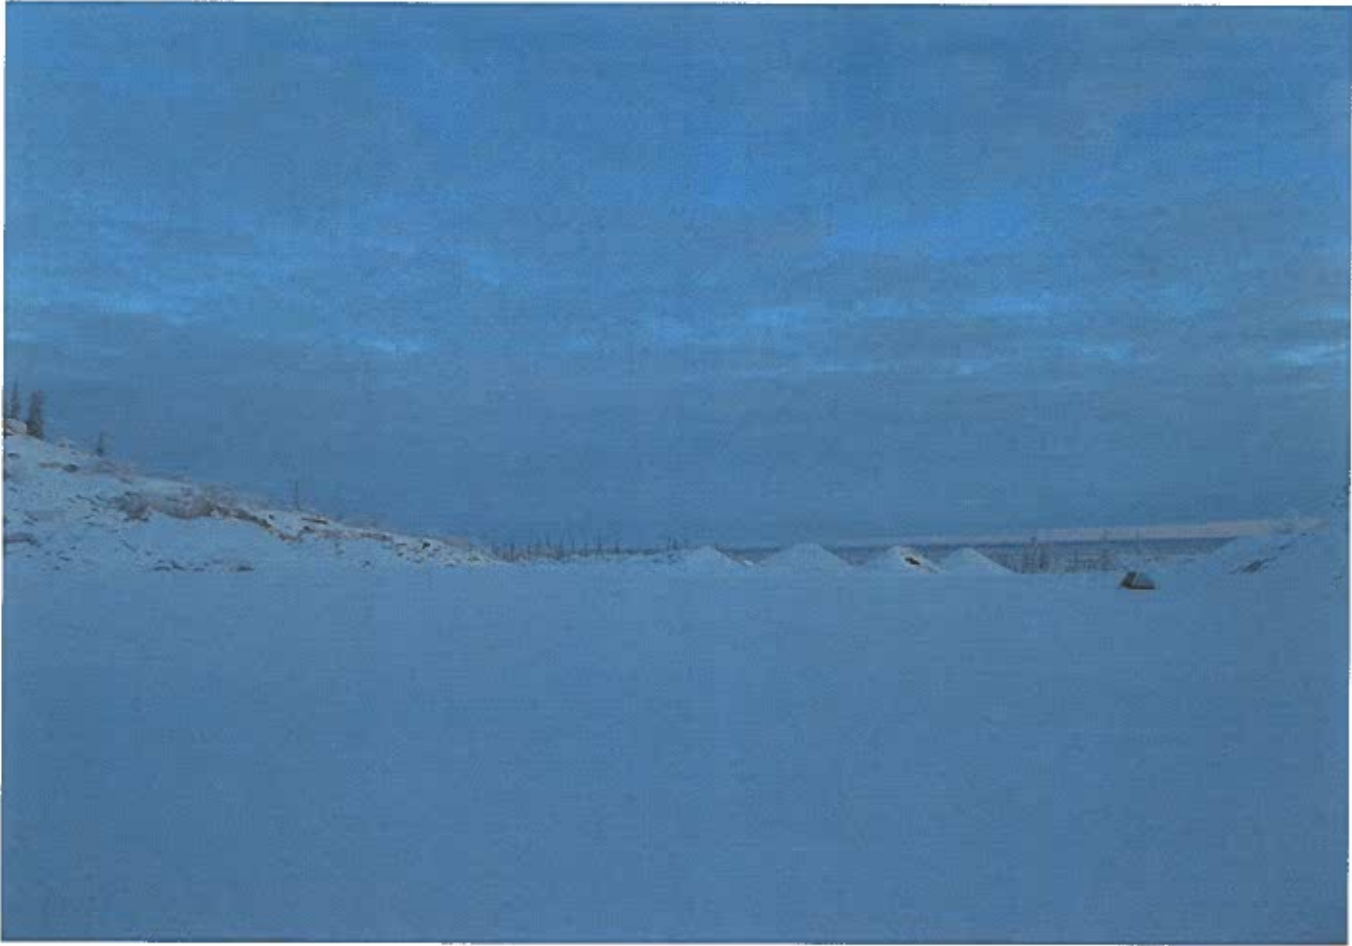
**Figure 11**

**Dec. 04, 2020 requested for removal Jan 19, 2021 material still on site.**
