<b>File Number</b>	<b>G17X001</b>
<b>Type of Operation</b>	<b>MISC.</b>
<b>Location</b>	Weather shelter

## ENVIRONMENTAL INSPECTION REPORT

<b>Permittee:</b>	GNWT Industry, Tourism and Investment	<b>Permit Expiry Date:</b>	March 28, 2022
<b>Land Use Permit No.</b>	G17X001	<b>Previous Inspection:</b>	New
<b>Quarrying Permit No.</b>		<b>Inspection Date:</b>	May 22, 2019
<b>Contractor:</b>		<b>Subcontractor:</b>	
<b>Location(s) Inspected:</b>	Weather shelter		
<b>Current Stage of Operation:</b>	Construction complete. Land Use Permit currently active until March 2022.		
<b>Program Modifications Approved:</b>

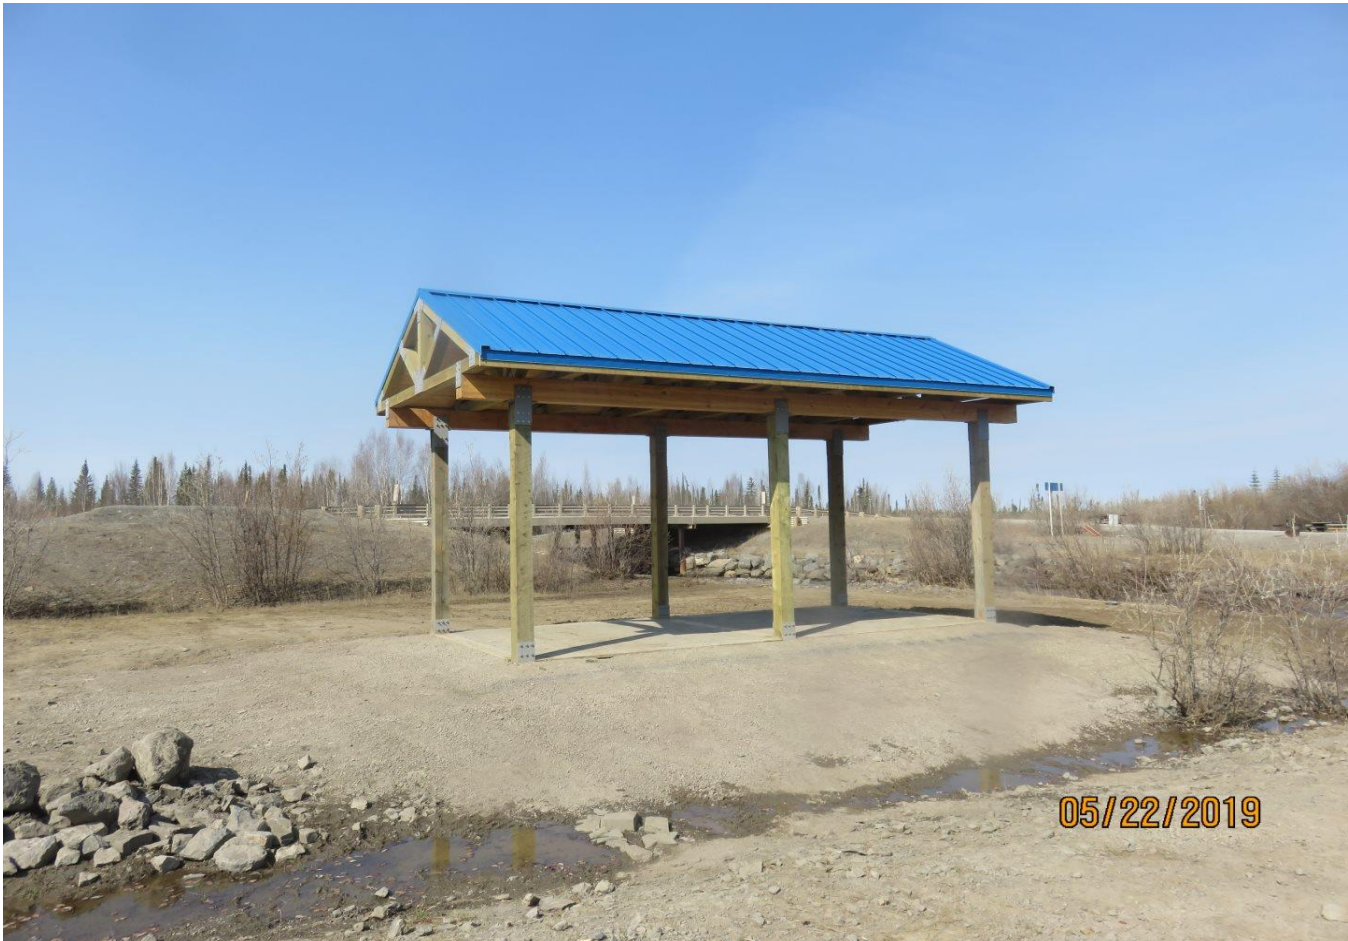
**Figure 1**

During this initial inspection it was observed that the structure appeared to be stable. It was constructed as per the design on a mound of crushed rock with a freeboard of approximately 3 metres on each side. There is a drainage ditch to the east (approximately 2-3 metres) that appears to be very effective at draining water.
