File Number G18X005
Type of Operation MISC.
Location High Point Access Road, Foundation Pad and KM 251 Gravel
Source

ENVIRONMENTAL INSPECTION REPORT

Permittee:	NWT Energy Corporation (03) Ltd.	Permit Expiry Date:	November 26, 2025
Land Use Permit No.	G18X005	Previous Inspection:	April 13, 2023
Quarrying Permit No.	2021QP0032 - for 300,000cm	Inspection Date:	April 25, 2023
Contractor:		Subcontractor:	
Location(s) Inspected:	High Point Access Road, Foundation Pad and KM 251 Gravel Source		
Current Stage of Operation:	Active		
Program Modifications Approved:

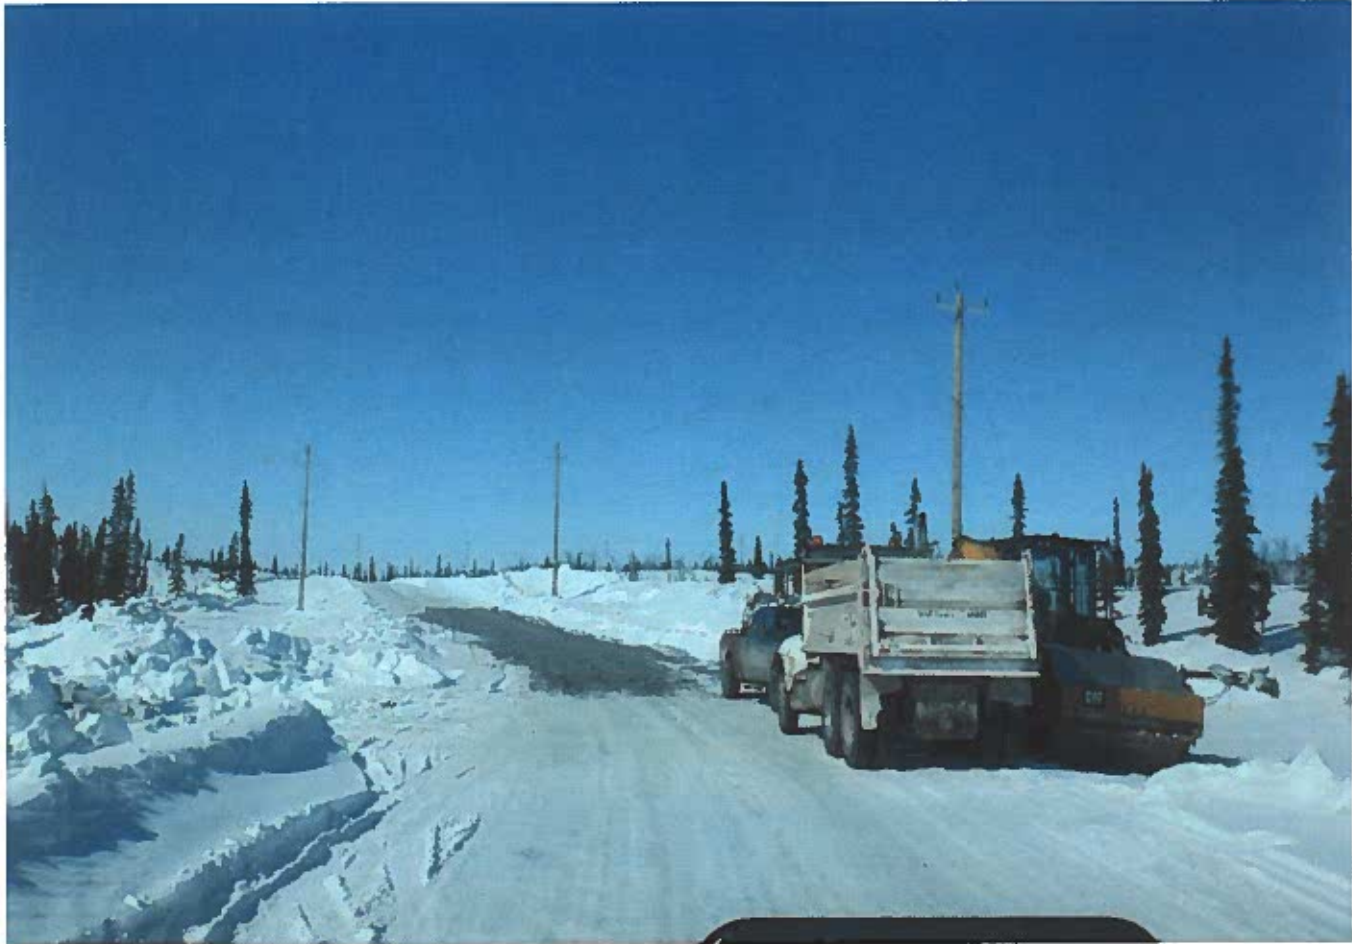
Figure 1

During the inspection on April 25, 2023 it was observed that the Right-of-Way (ROW) was surveyed in preparation for building the access road up to grade but the contractor was not hauling any material to the site. The inspector was told by the contractor that they were done hauling gravel material for the access road earlier during the day and was not certain when hauling would continue.

There is a small strip of gravel that was recently spread, with the marked survey lath.

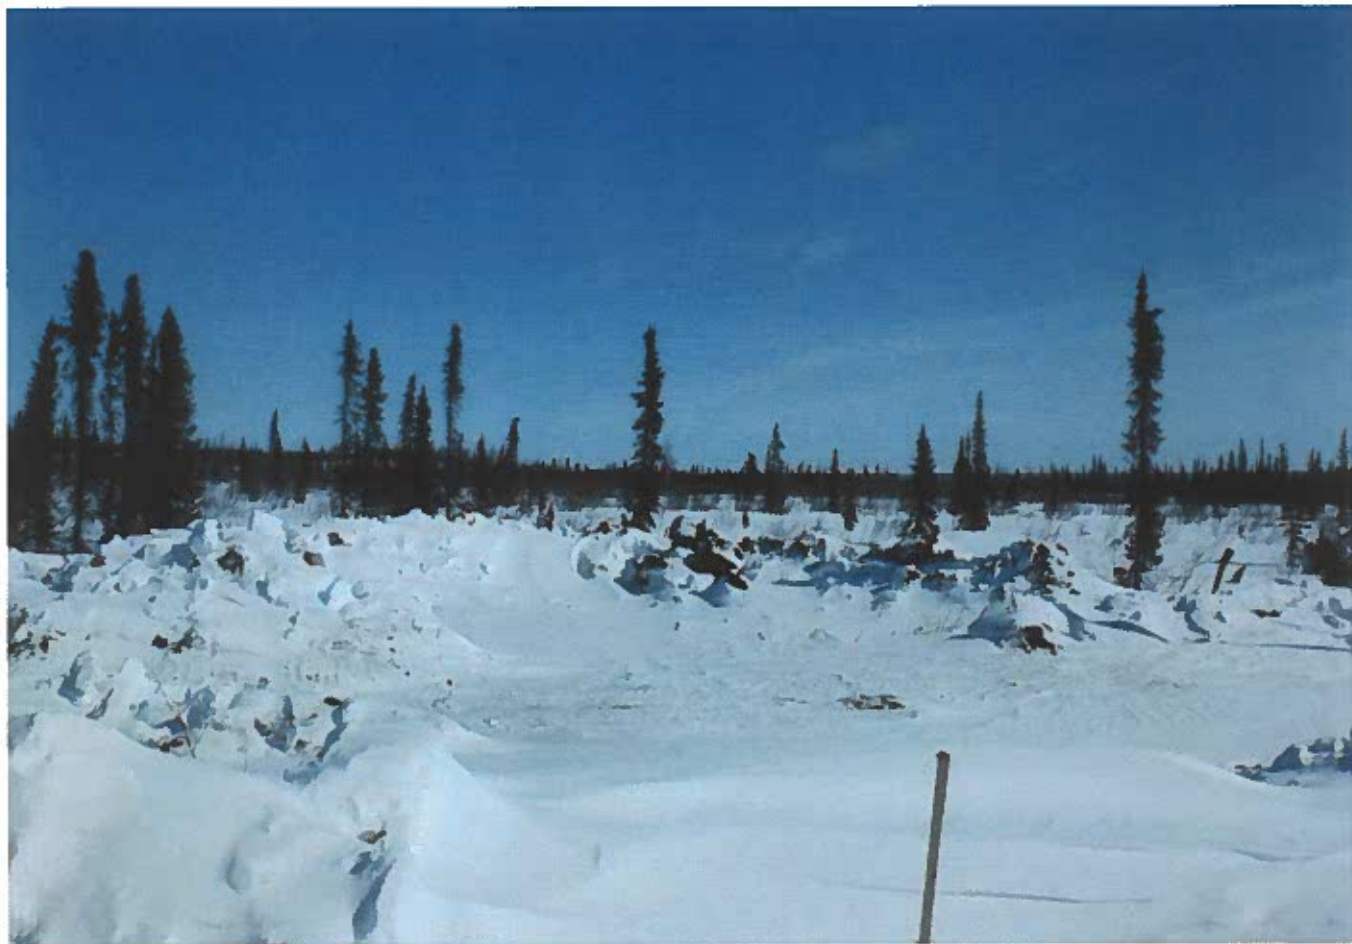
Figure 2

Erosion (Control or Prevention): During the inspection there were areas along the ROW that had unnecessary surface excavation.

Restoration of Lands: Until the unnecessary surface excavation is mitigated, this condition will remain unacceptable.

A photo of the unnecessary surface excavation. This is just one spot, and there are more.

Review and implement the EROSION AND SEDIMENT CONTROL PLAN and the WASTE MANAGEMENT PLAN.

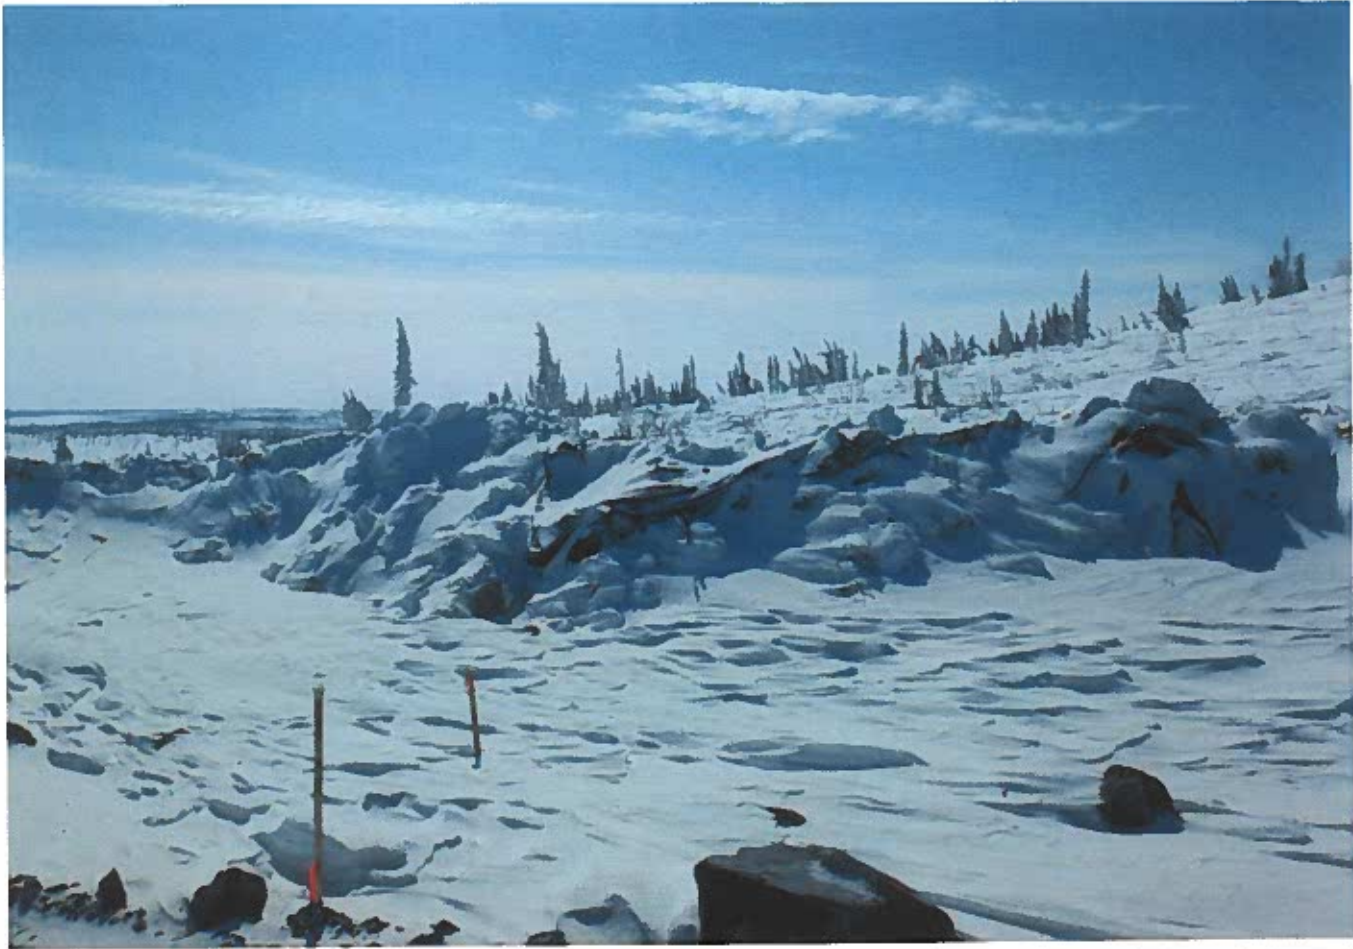
Figure 3

Wastes: Along the ROW there were a few empty rolls of the geotextile and geotextile material that has not been properly disposed of. The geotextile appeared to be rolled out prior to the snowfall and later plowed with a dozer in an attempt to remove the snow for continuation of construction on the ROW.

A photo of the geotextile material that was torn up during snow clearing.

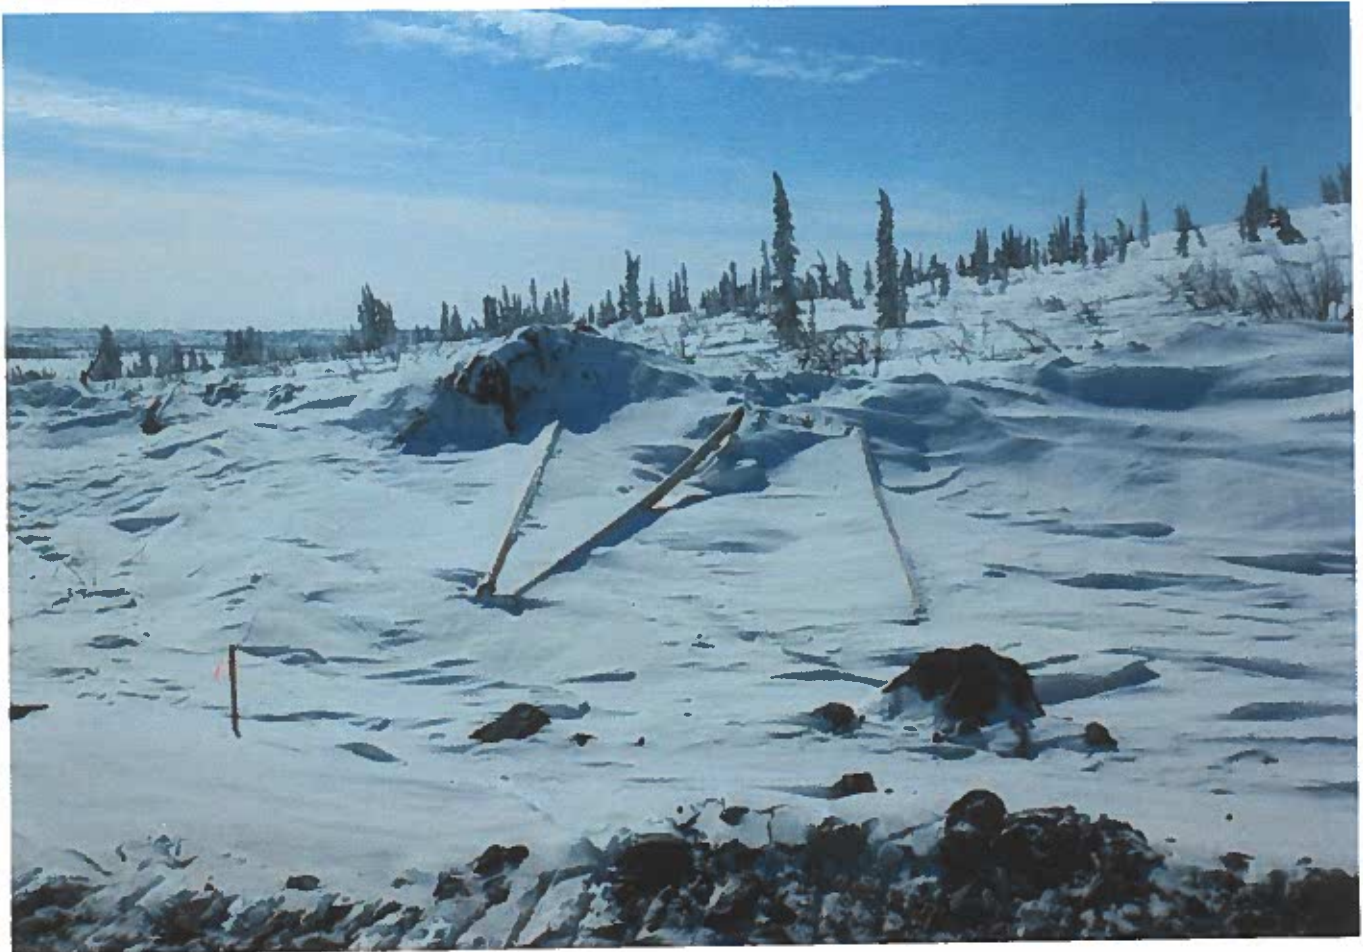
Figure 4

A few empty rolls of the geotextile, left on site.

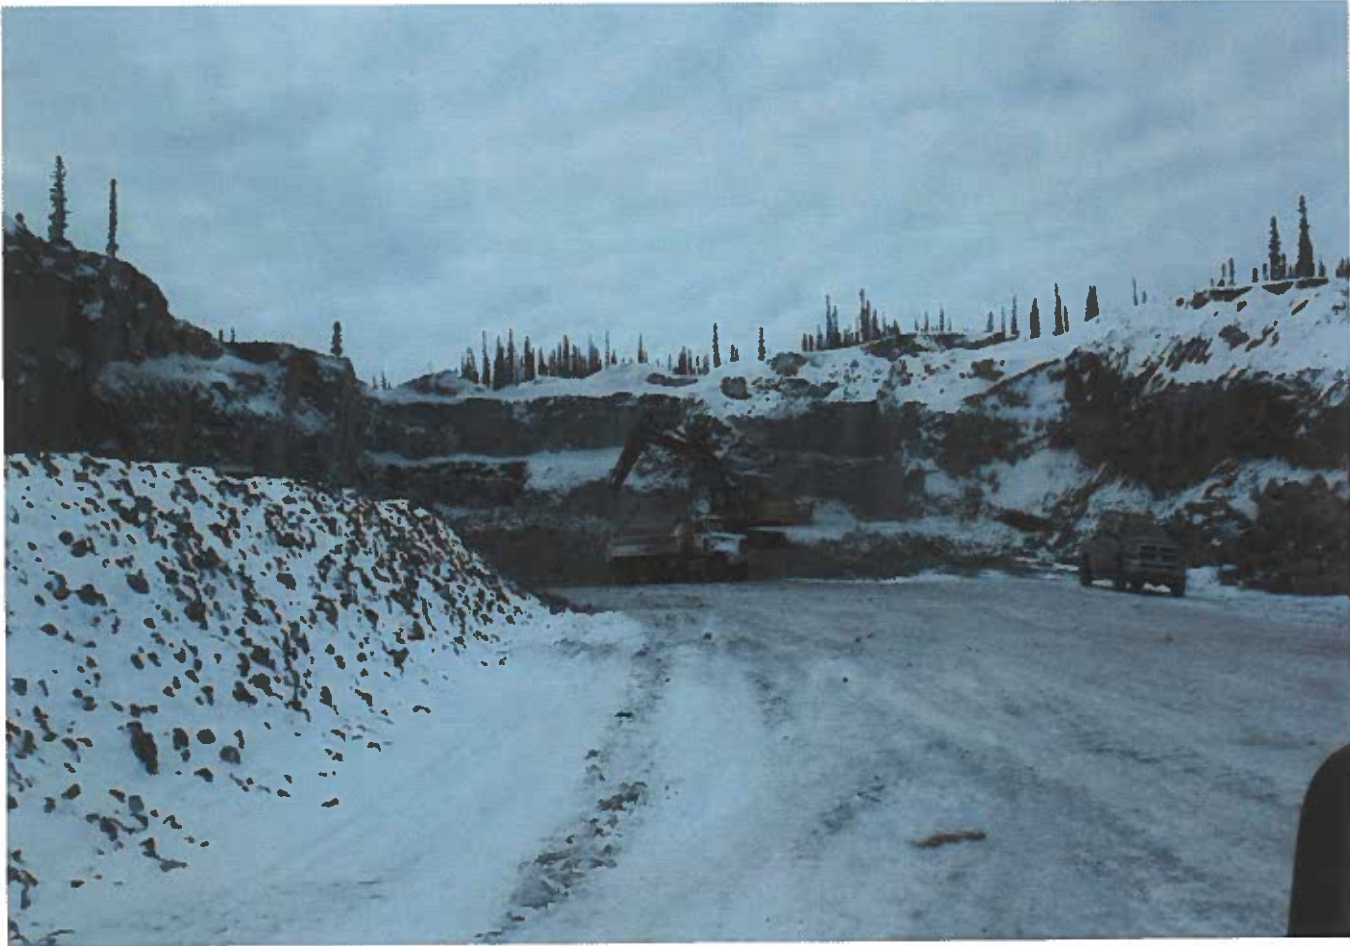
Figure 5

The excavator loading one of the trucks at KM 251.

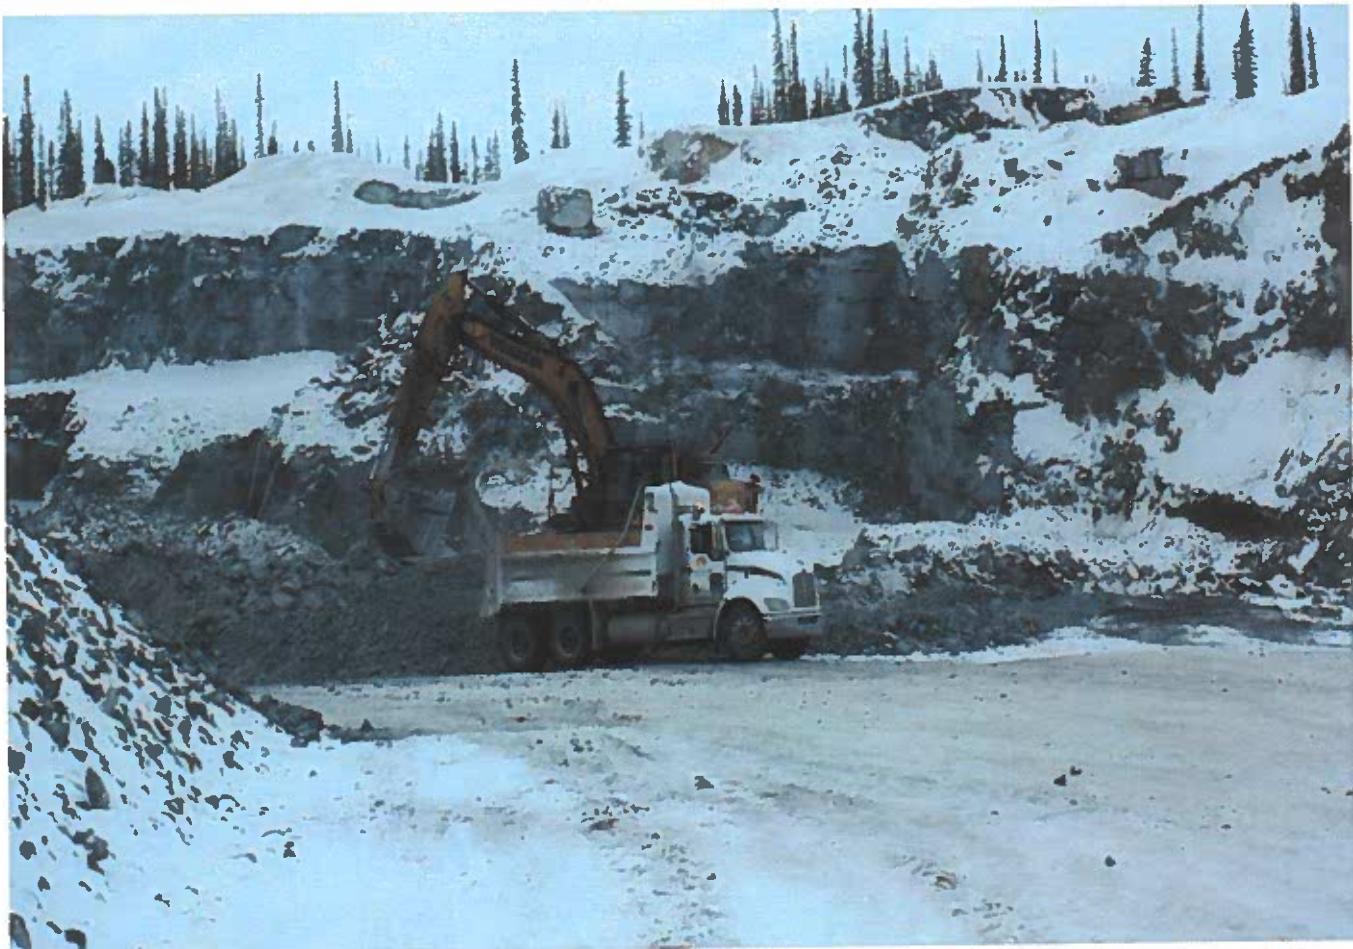
Figure 6

The other truck getting loaded at KM 251.
