File Number	G18X005
Type of Operation	MISC.
Location	Wind tower access and Km 251 quarry

ENVIRONMENTAL INSPECTION REPORT

Permittee:	NWT Energy Corporation (03) Ltd.	Permit Expiry Date:	November 26, 2025
Land Use Permit No.	G18X005	Previous Inspection:	March 31, 2022
Quarrying Permit No.	2021QP0032 - for 300,000cm	Inspection Date:	April 12, 2022
Contractor:		Subcontractor:	
Location(s) Inspected:	Wind tower access and Km 251 quarry		
Current Stage of Operation:	On-going		
Program Modifications Approved:

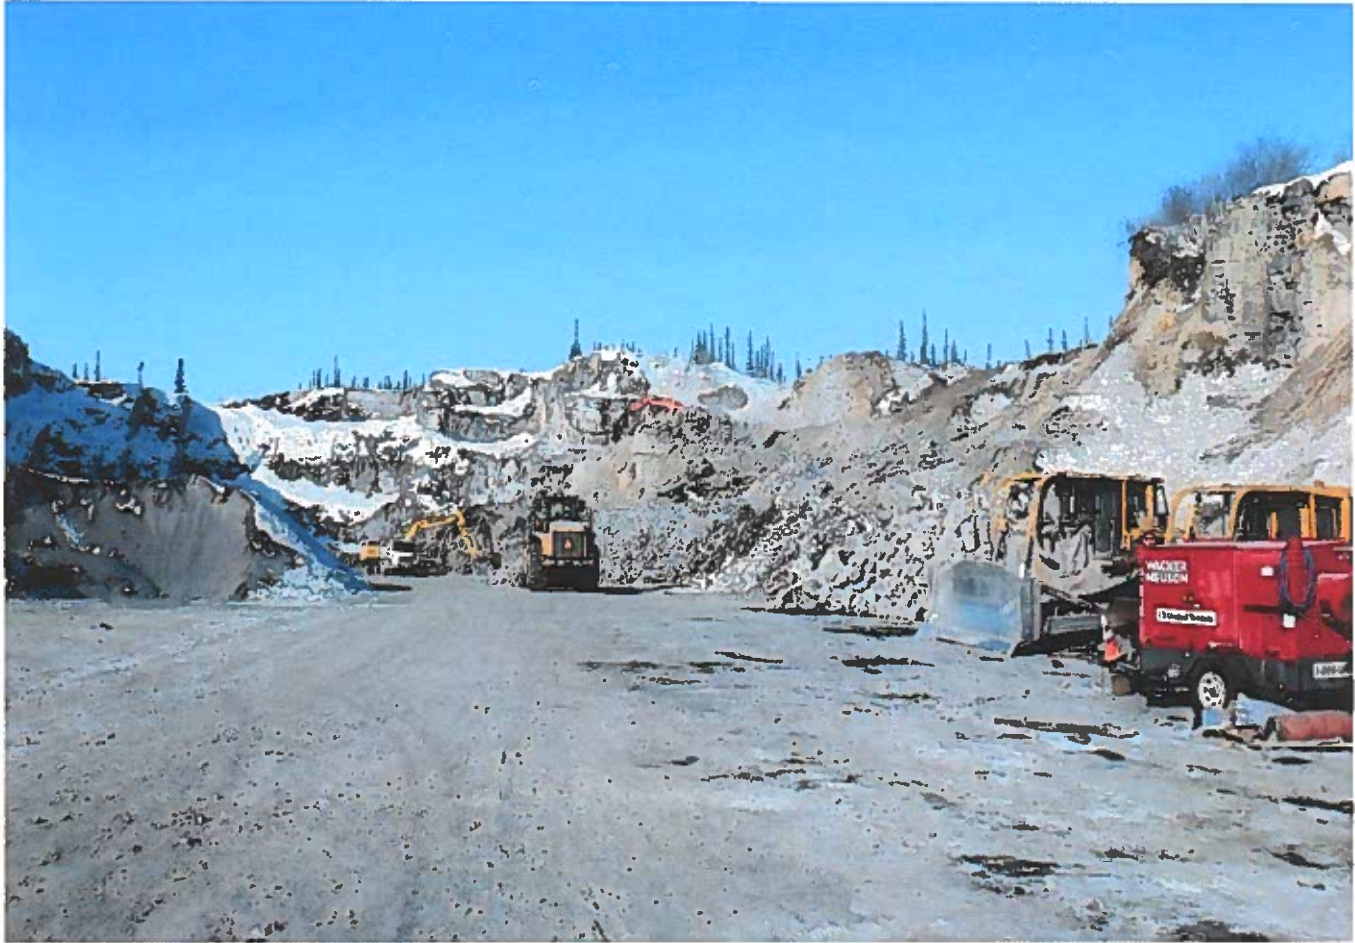
Figure 1
Km 251(1)

There is a lot of material stock piled in different locations on the pit floor at the site and could be hazardous for operators maneuvering equipment around in the area.

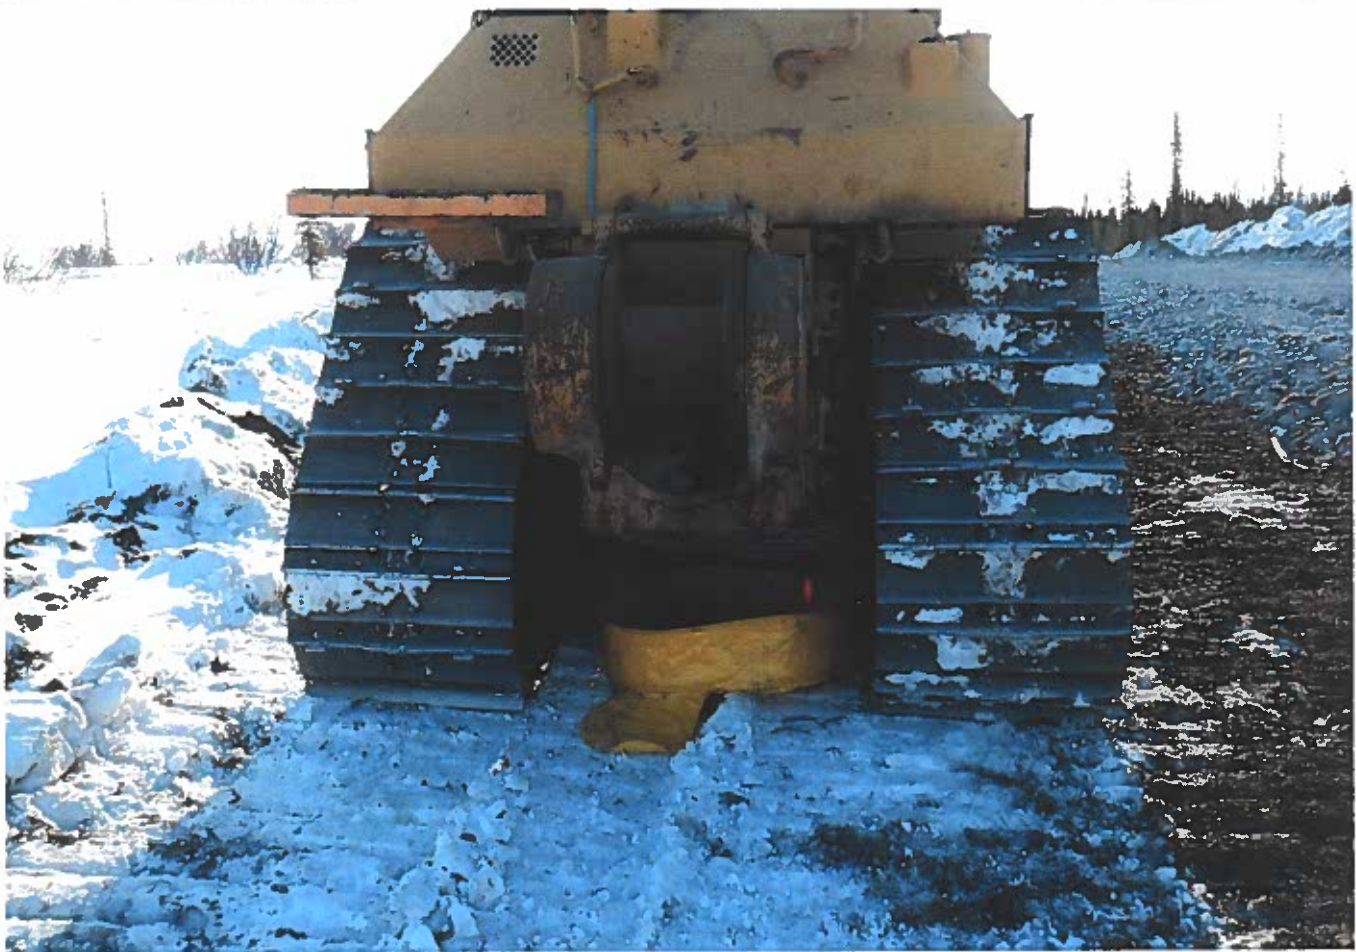
Figure 5
Wind tower Access(1)

During the inspection at wind tower access road, there was one concern observed by the inspector. There is some plastic wrapping and paper tubing in a couple of places that needs to be removed before the wind takes it away.

I met up with Rob Adams, President of ONEC, Northern Operations and Scott Dimitroff, Senior Project Technologist for Tetra Tech during my inspection and Scott was keeping track of the work that is being conducted at the site. I had a conversation with both Rob and Scott to go over what the Inspector will look for during an inspection at the work site. Scott indicated he will have the garbage cleaned up before the end of the day.
