File Number G21E001
Type of Operation HWY MAINTENANCE & OPERATIONS
Location Km 230, 235 and 251

ENVIRONMENTAL INSPECTION REPORT

Permittee:	Department of Infrastructure	Permit Expiry Date:	June 27, 2026
Land Use Permit No.	G21E001	Previous Inspection:	July 13, 2021
Quarrying Permit No.		Inspection Date:	August 05, 2021
Contractor:		Subcontractor:	
Location(s) Inspected:	Km 230, 235 and 251		
Current Stage of Operation:	ongoing		
Program Modifications Approved:	NIL

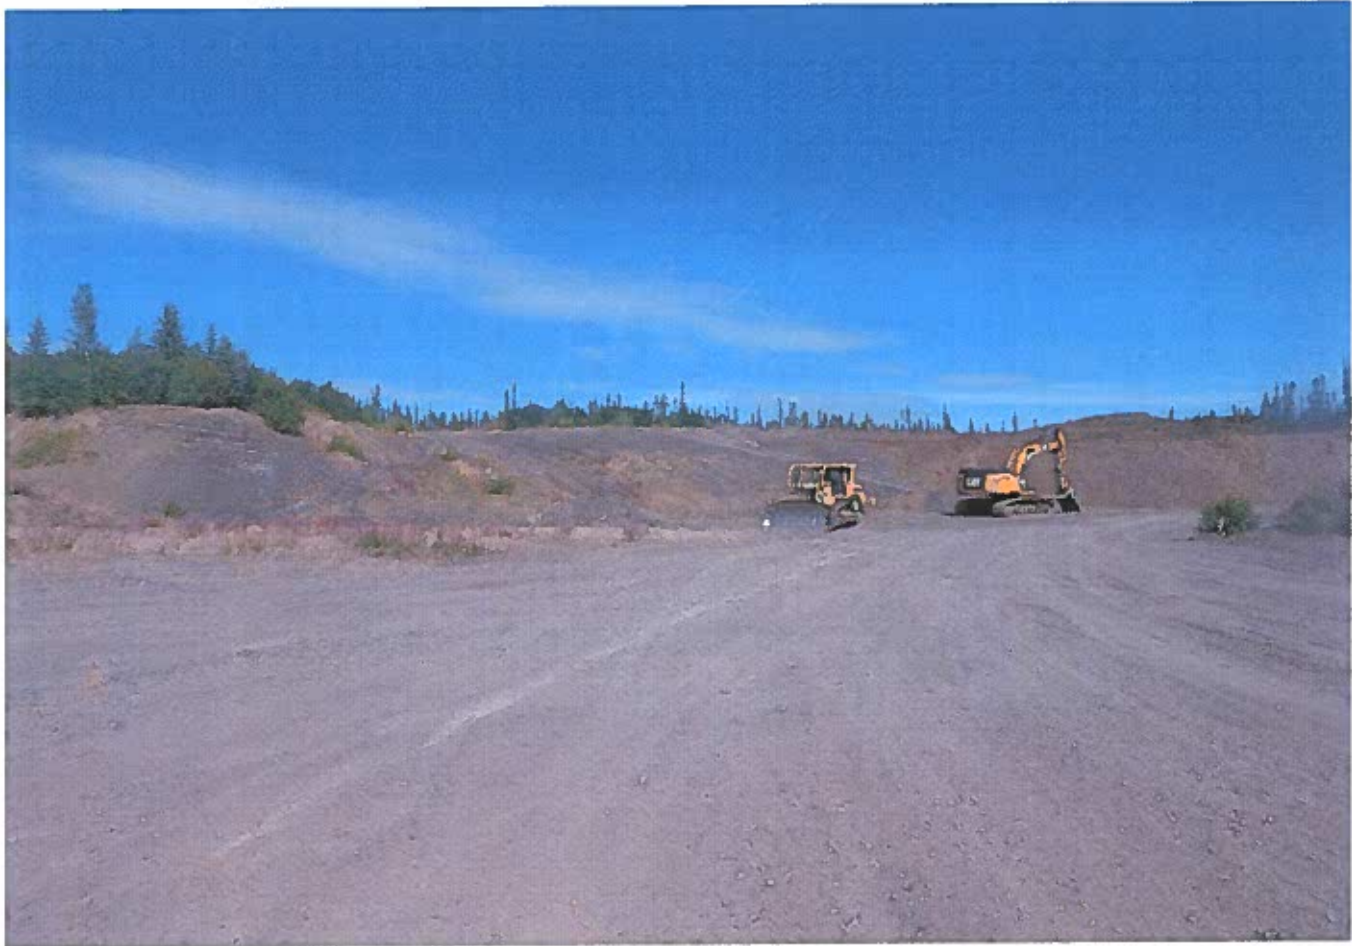
Figure 1
Km 230

During the inspection at km 230 it was observed and learned that the original work location given to INF had too much ice content for the intended volume required of 30,000cm. It was also observed that work was being conducted in a different location as a result of the ice content findings, D.O.L. did not have an issue with this location and reassigned INF another location at the site.

Currently INF has large stock piles at this location which is giving little maneuverability in the pit floor this can be hazardous. Stock piles should be removed as soon as possible.

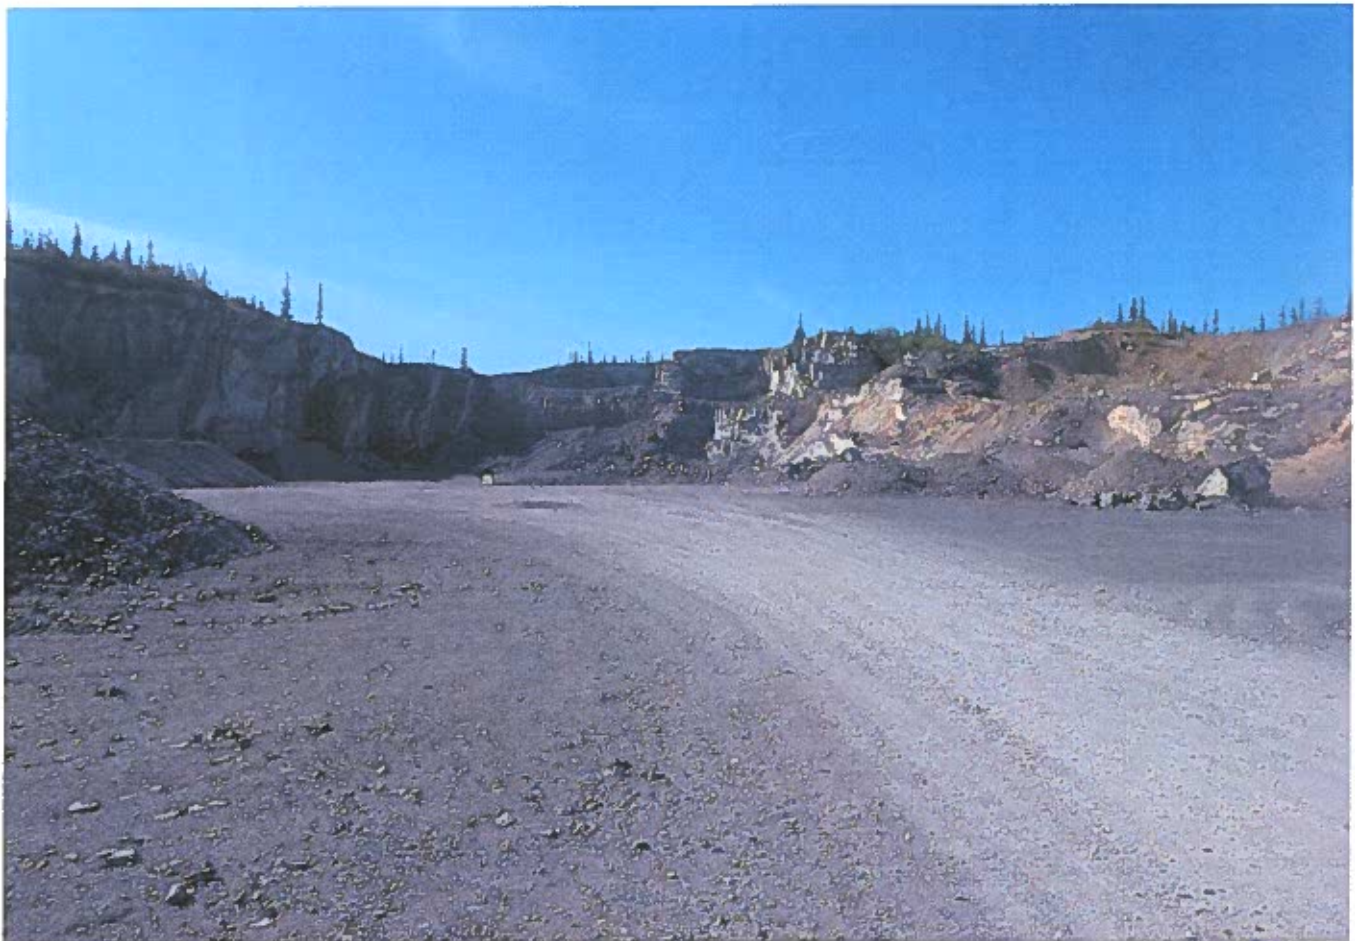
Figure 12
Km 251

At Km 251 it is understood from the volumes removed provided that the current QP 2019QP0035 is for 40000cm at km 251 and what was removed was 9193cm, please note that this material is for blast rock material.
