File Number G21E001
Type of Operation HWY MAINTENANCE & OPERATIONS
Location Km 230, 235 and 251

ENVIRONMENTAL INSPECTION REPORT

Permittee:	Department of Infrastructure	Permit Expiry Date:	June 27, 2026
Land Use Permit No.	G21E001	Previous Inspection:	July 13, 2021
Quarrying Permit No.		Inspection Date:	August 05, 2021
Contractor:		Subcontractor:	
Location(s) Inspected:	Km 230, 235 and 251		
Current Stage of Operation:	ongoing		
Program Modifications Approved:	NIL

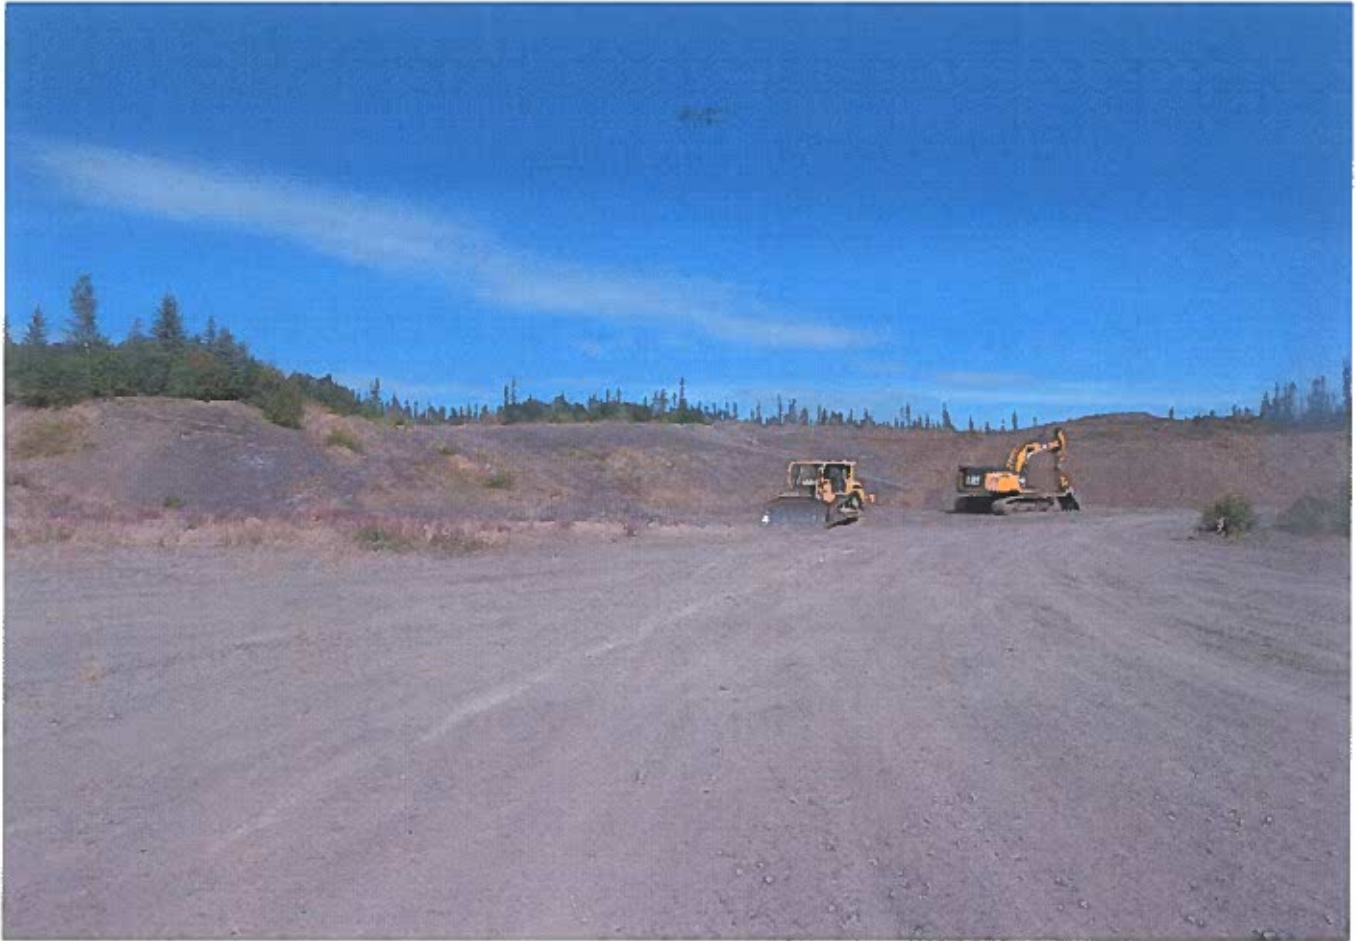
Figure 1

During the inspection at km 230 it was observed and learned that the original work location given to INF had too much ice content for the intended volume required of 30,000cm. It was also observed that work was being conducted in a different location as result of the ice content findings, D.O.L. did not have an issue with this location and reassigned INF another location at the site.

Currently INF has large stock piles at this location which is giving little maneuverability in the pit floor this can be hazardous. Stock piles should be removed as soon as possible.

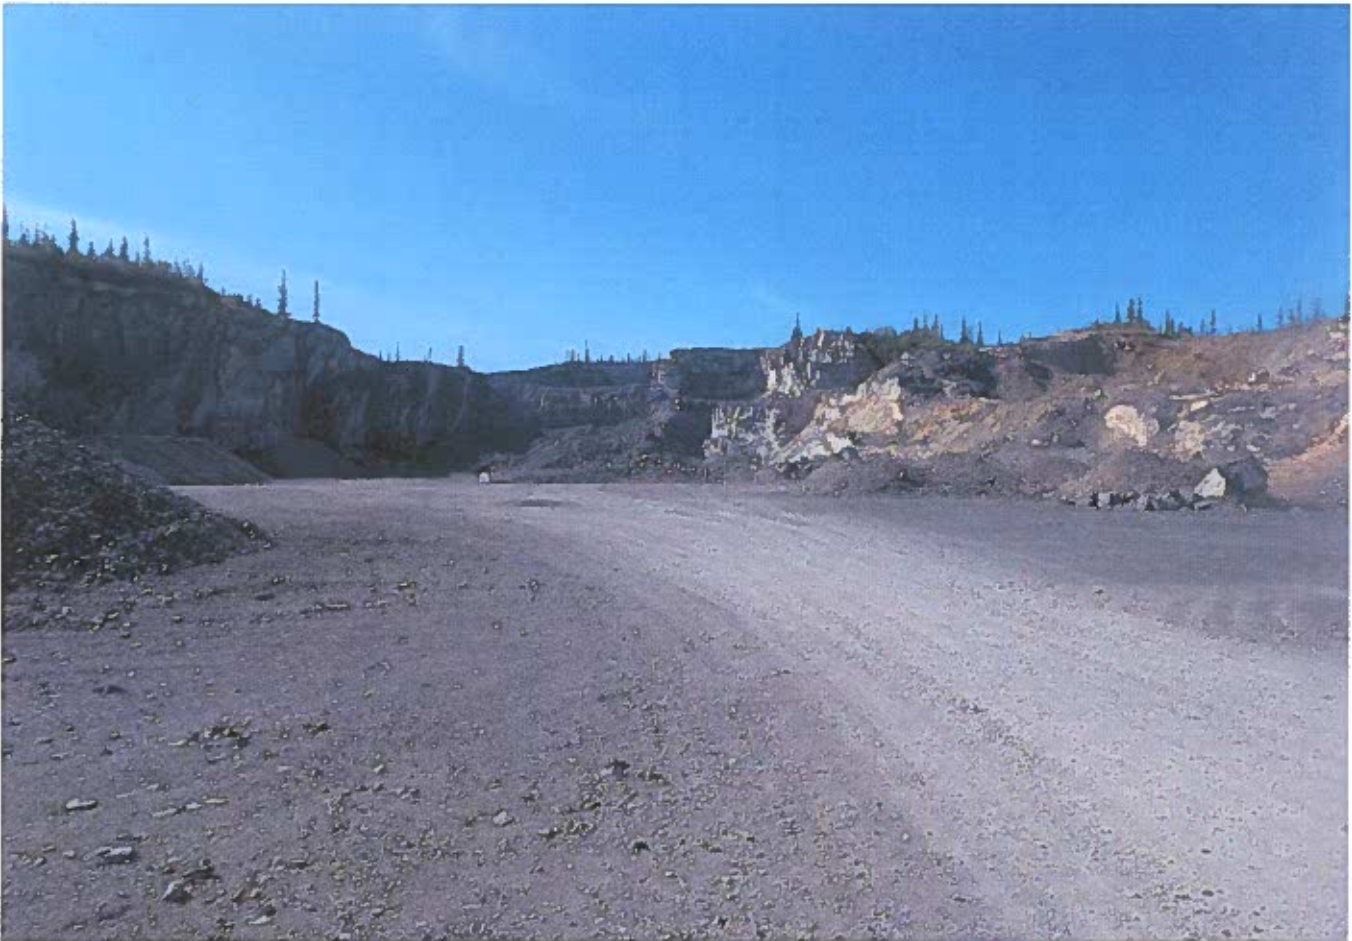
Figure 12
Km 251

At Km 251 it is understood from the volumes removed provided that the current QP 2019QP0035 is for 40000cm at km 251 and what was removed was 9193cm, please note that this material is for blast rock material.
