DE BEERS GROUP

Subject: Follow-Up Spill Report – Hydraulic Oil – Gahcho Kué Mine – July 13, 2024 (GNWT Spill #2024269)

Pursuant to Part H Condition 3(d) of Water License MV2005L2-0015, De Beers Canada Inc. (De Beers) is submitting this follow-up spill report for GNWT Spill #2024269, which occurred at the Gahcho Kué Mine at 12:00 on July 13, 2024.

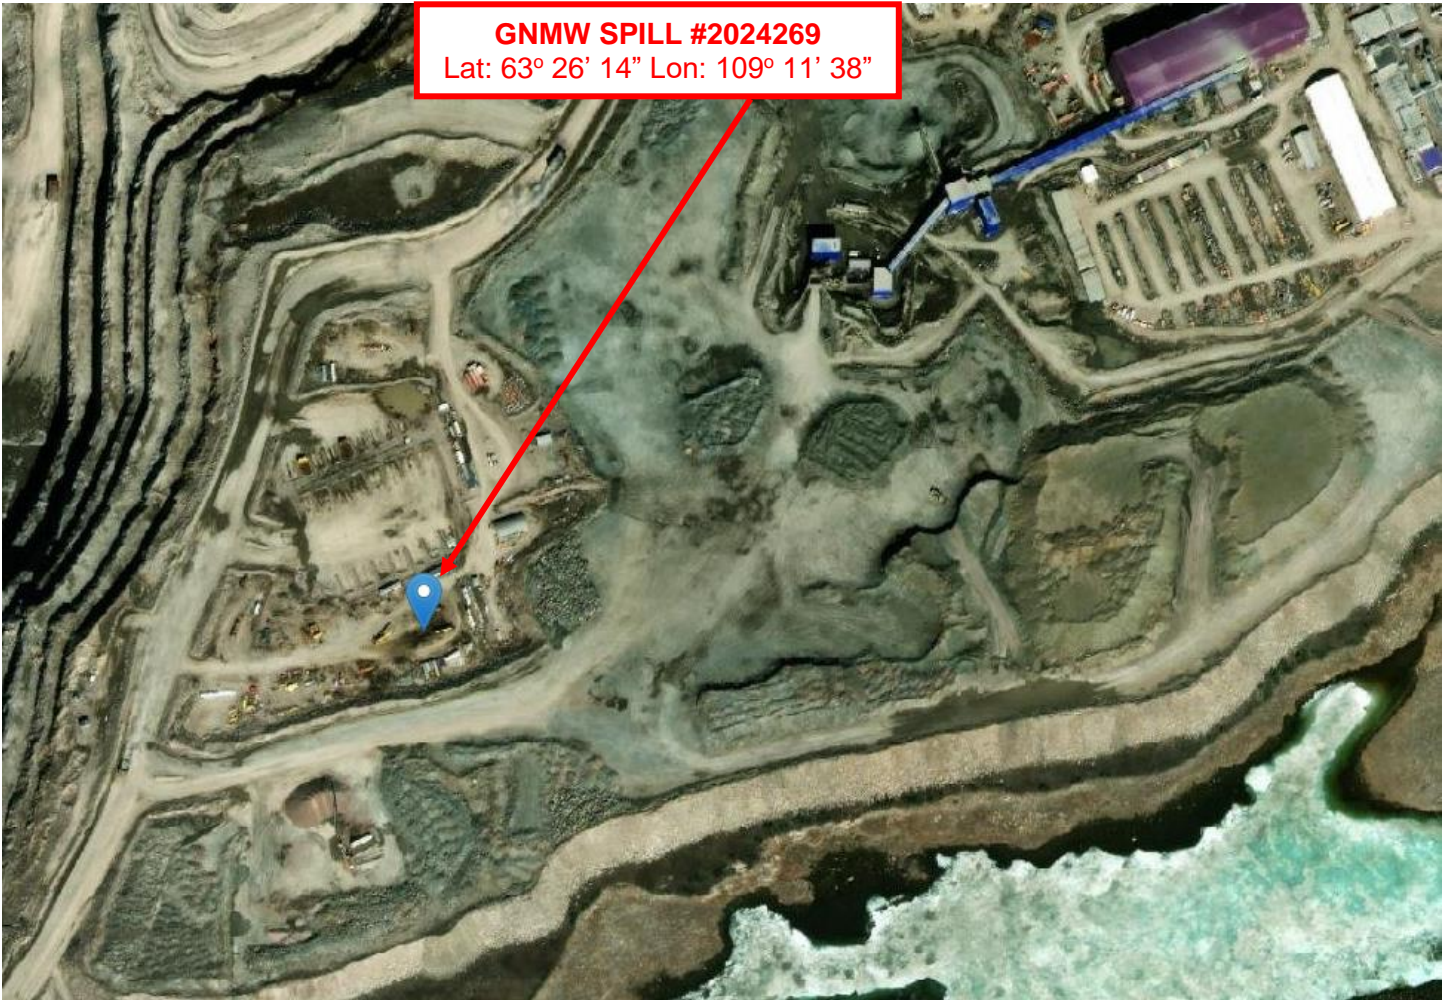
Figure 1. Location of GNWT Spill #2024269

At approximately 13:25 on July 13, 2024, the Environment Department received notification of a hydraulic oil spill involving a Komatsu PC 5500, designated as SH-002, which was located at the Build Pad. The specific location of the spill is illustrated in **Figure 1**. The incident occurred at 12:00 during the course of routine maintenance operations on the shovel. At the time, the maintenance team was engaged in aligning the shovel's bucket body with its back wall. During this procedure, a critical failure occurred in the clam cylinder hose. This failure precipitated an unforeseen collapse of the back wall, which subsequently led to the uncontrolled release of 200 liters of hydraulic oil. The extent and nature of the spill are depicted in **Figure 2**.

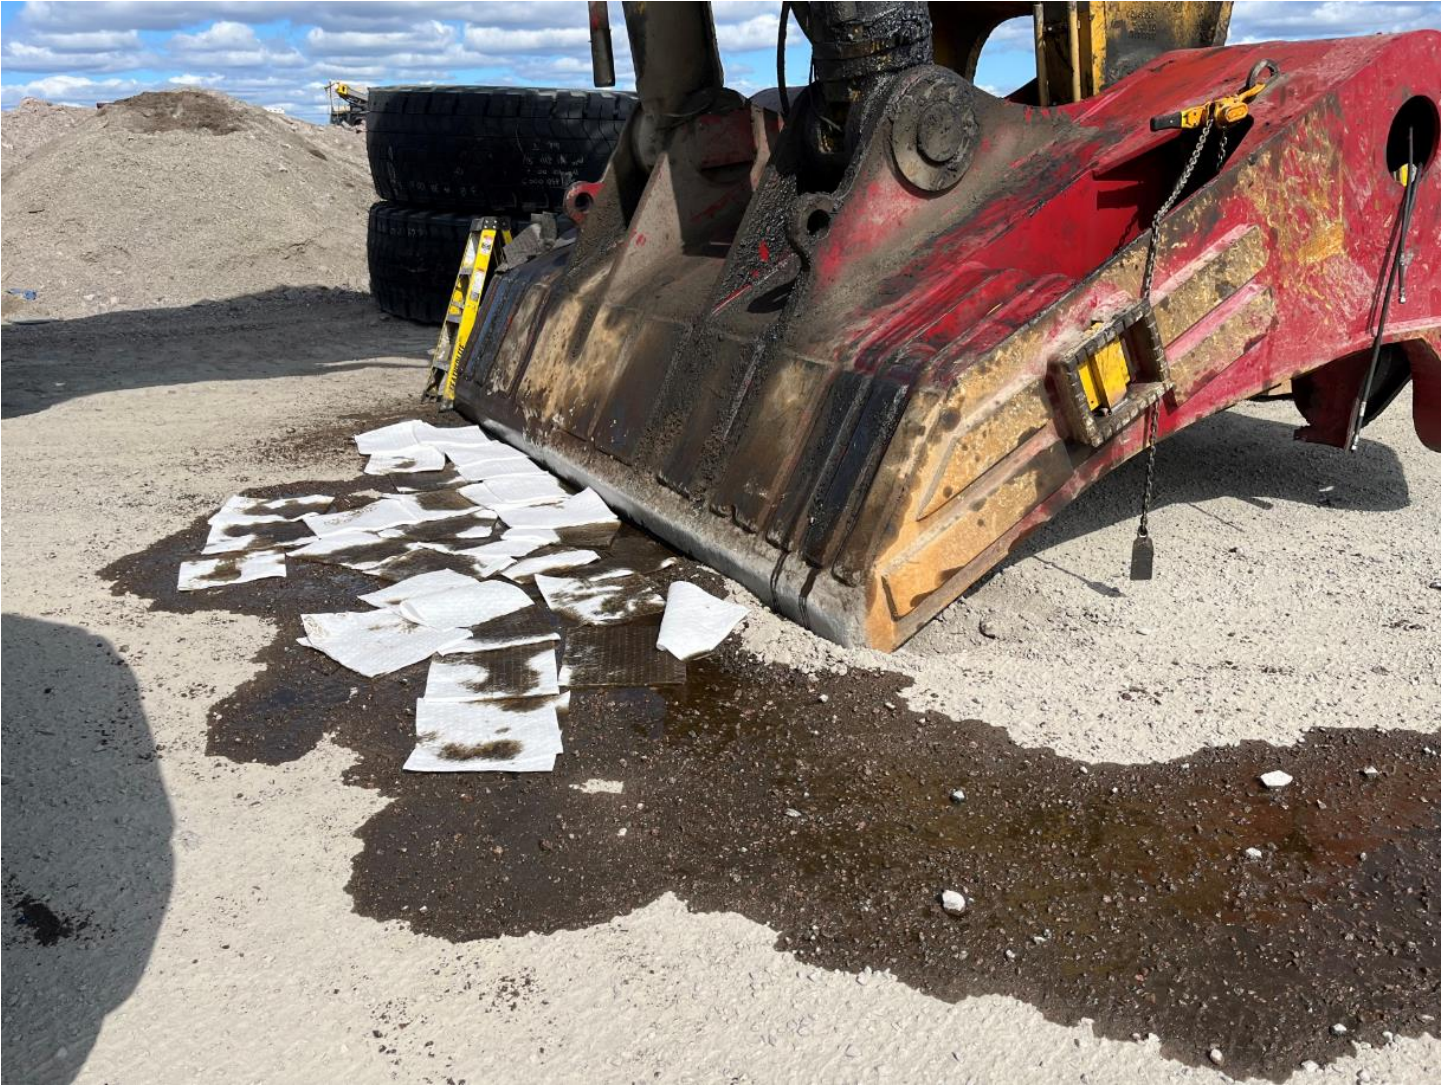
Figure 2. Spill at Build Pad, GNWT Spill #2024269

Following a comprehensive investigation into the recent spill incident, it has been determined that the primary cause was attributable to a manufactured parts failure, coupled with workplace factors. Specifically, the investigation revealed that the spill originated from a failure of a hose, which led to the separation of the flange head from the hose assembly. This equipment malfunction appears to be a direct consequence of inadequate quality control measures implemented by the original equipment manufacturer (OEM).

Furthermore, the investigation uncovered deficiencies in the inspection protocols followed by DeBeers staff. It was noted that the new components, which were installed on the machinery, had not undergone thorough inspection prior to their integration into operational equipment. This oversight in the pre-installation inspection process contributed to the failure of the hose and subsequent spill.

All maintenance activities involving the shovel were promptly halted. Immediate response measures were implemented, including the deployment of spill containment pads and the construction of a gravel berm. These actions were taken to effectively contain and manage the spill within the affected area. The shovel was relocated away from the spill site to get better access to the contaminated material. All contaminated materials were collected, placed into appropriately labeled drums, and then transported to the designated Waste Management Area (WMA). There, the materials will be processed for off-site disposal in accordance with regulatory standards.

1. **Inspecting Hydraulic Hoses:** Conducted a thorough examination of hydraulic hoses on two additional shovels that utilize the same OEM hose to identify and address any potential future issues.
2. **Engaging with the OEM:** Followed up with the original equipment manufacturer to review their quality control procedures and investigate the root cause of the hose failure at the point of production. This will help in understanding the failure mechanism and implementing measures to prevent future occurrences.

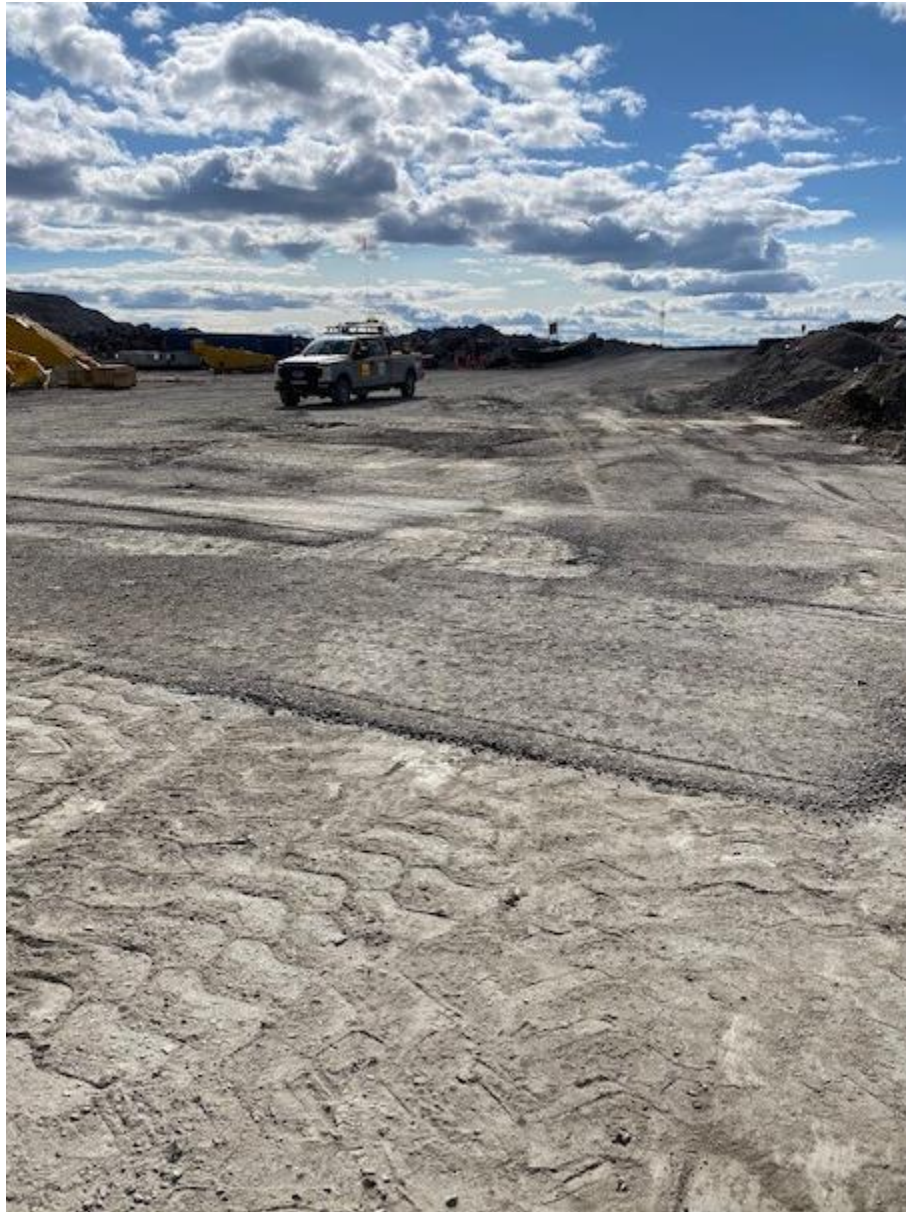
Figure 3. Verification of Spill Clean Up, GNWT Spill #2024269

Given the nature of the spill and the characteristics of the affected area—specifically, its lined surface and gravel pad—the overall environmental impact is assessed as minimal. The area was confirmed to be completely free of any residual contaminants, as illustrated in **Figure 3**.
