DE BEERS GROUP

Subject: Follow-Up Spill Report – Black Water – Gahcho Kué Mine – July 08, 2024 (GNWT Spill #2024259)

Pursuant to Part H Condition 3(d) of Water License MV2005L2-0015, De Beers Canada Inc. (De Beers) is submitting this follow-up spill report for GNWT Spill #2024259, which occurred at the Gahcho Kué Mine at 07:45 on July 08, 2024.

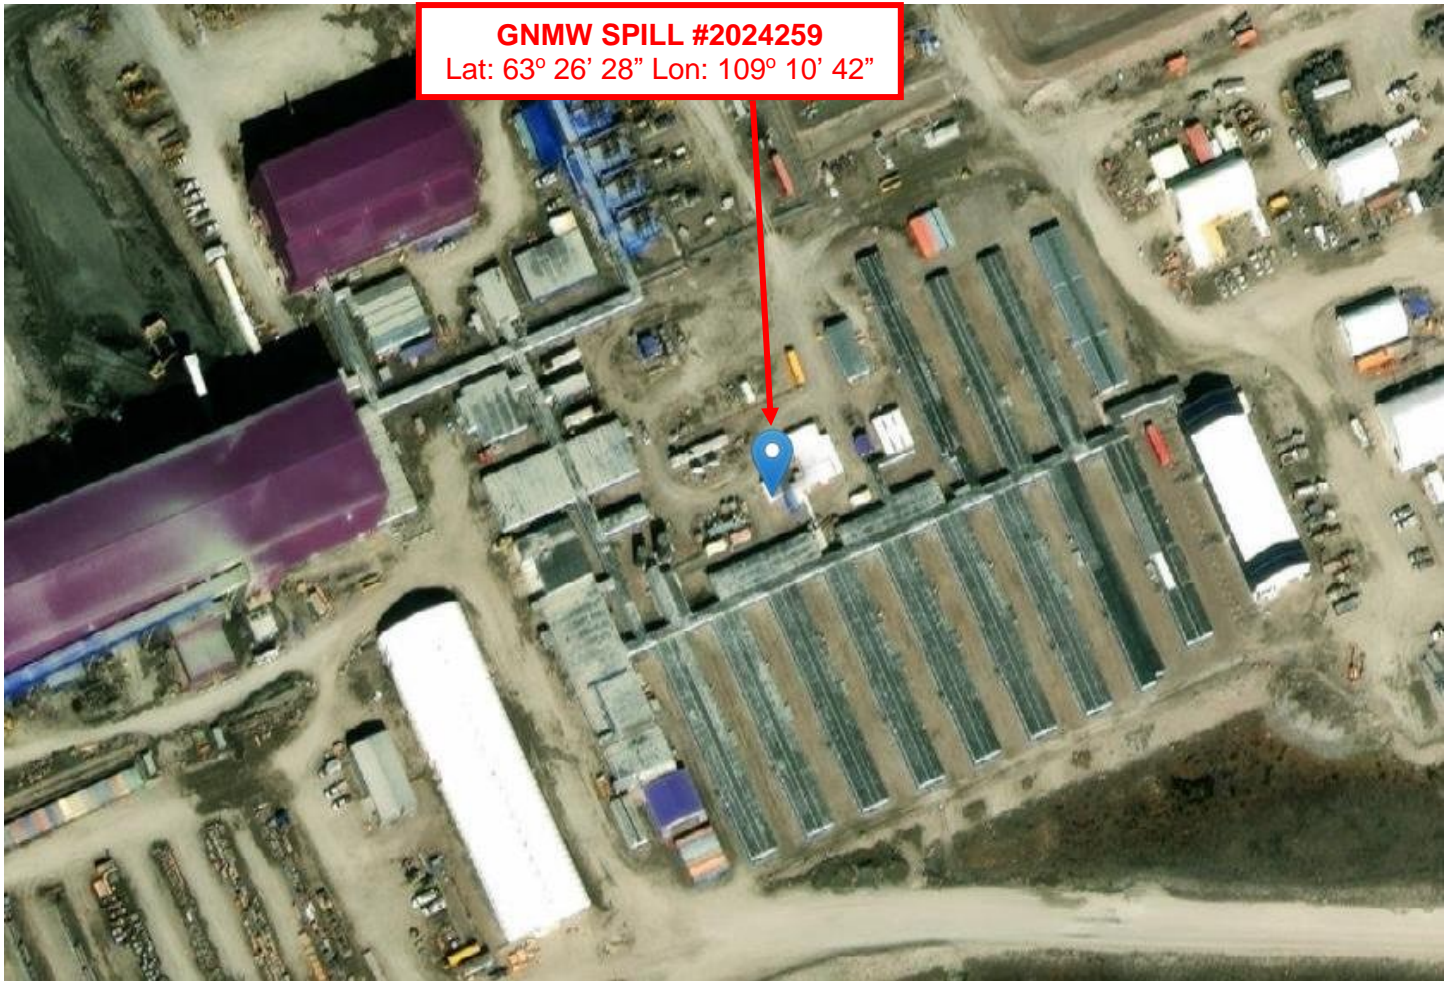
Figure 1. Location of GNWT Spill #2024259

At approximately 7:45 a.m. on July 8, 2024, the waste water treatment plant (WWTP) operator discovered a spill at the WWTP facility. The location of the spill is shown in **Figure 1**. The investigation determined that the high-level float failed to activate when the equalizer tanks reached capacity. This resulted in an overflow of approximately 100 liters of black water onto the ground outside the plant. After the plant operator observed and contained the spill, Environment staff were alerted, and a spill report was filed the same day. Given that the spill occurred in a small, lined area, it is deemed to have posed an insignificant environmental risk. The spill is depicted in **Figure 2**.

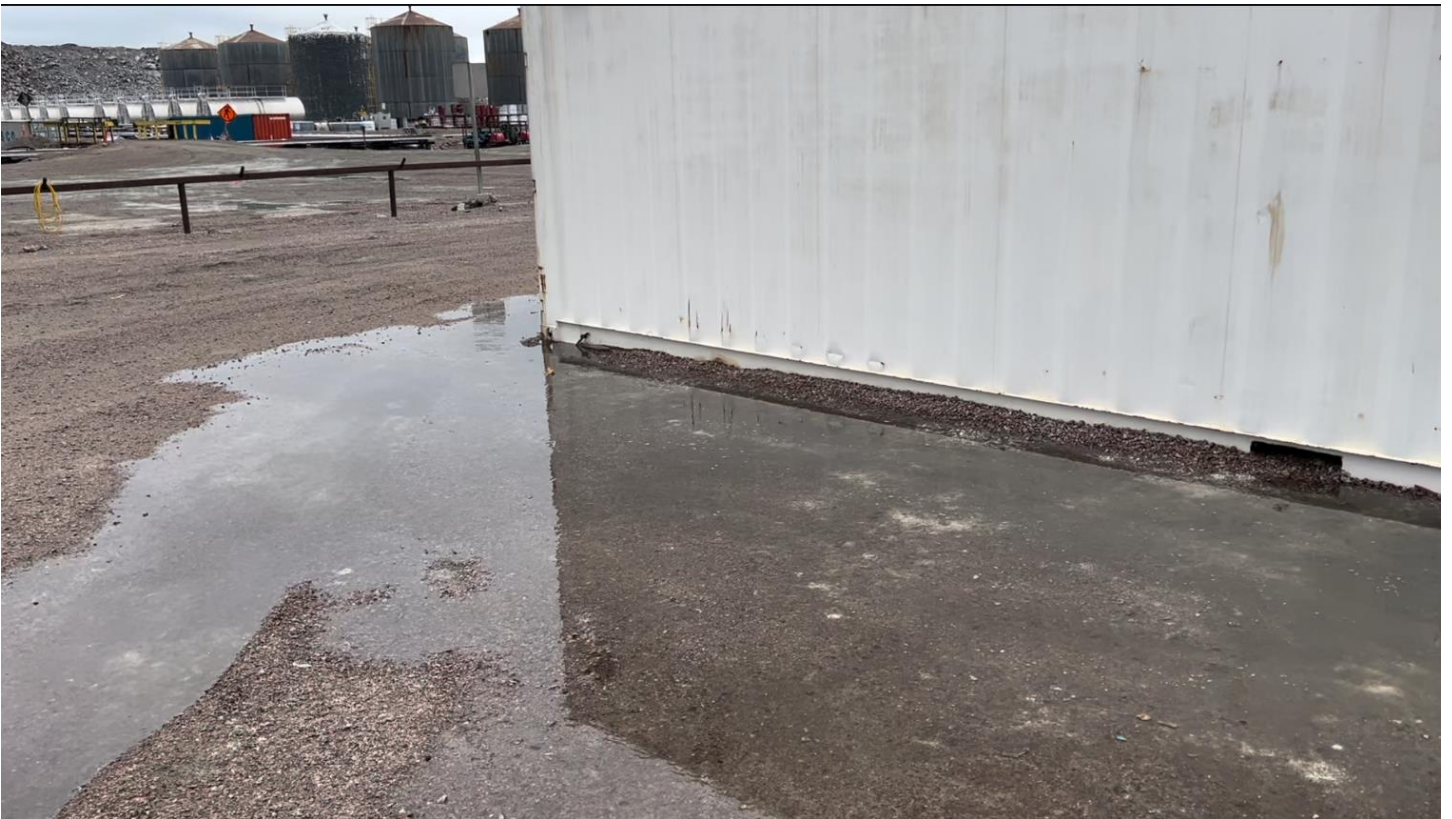
Figure 2. Spill at Dorm A11 Lift Station, GNWT Spill #2024259

Upon further investigation, it was determined that the root cause of the spill was primarily caused by workplace factors. Specifically, during the cleaning of the camp's water intake and the flushing of pipes around the camp—necessitated by high chlorine levels in the treated water—an unusually large volume of water was introduced into the Sewage Treatment Plant. This influx of water exceeded the plant's designed processing capacity, leading to an overflow.

Upon discovering the spill, the team promptly contained the contaminated material and transported it to the Waste Management Area for proper disposal offsite at an accredited facility. In addition to managing the spill, the team reset the high-level floats and pumps, which have since been operating effectively and without issue since this event.

1. **Review of Design Parameters and Capacity:** De Beers has conducted an in-depth review of the Sewage Treatment Plant's design parameters and capacity. This review, carried out in close collaboration with plant operators, aimed to assess and confirm that the plant operates within its designed limits. By evaluating the current operational parameters and identifying any potential gaps, De Beers has ensured that the plant's capacity aligns with its intended use, and should not experience failures such as this within normal operations.

2. **Installation of Enhanced Signage:** To address potential confusion during overflow situations, De Beers has installed clear and informative new signage within the Sewage Treatment Plant. This signage explicitly indicates that the valve will not automatically shut off the tank in the event of an overflow. The signage is intended to provide operational guidance to staff and prevent similar incidents by ensuring that all personnel are aware of the system's limitations and response procedures. In the event of upset conditions regarding additional flow into the WWTP, operators are now informed that they will need to actively manage the tank volumes in order to mitigate any potential future spills.

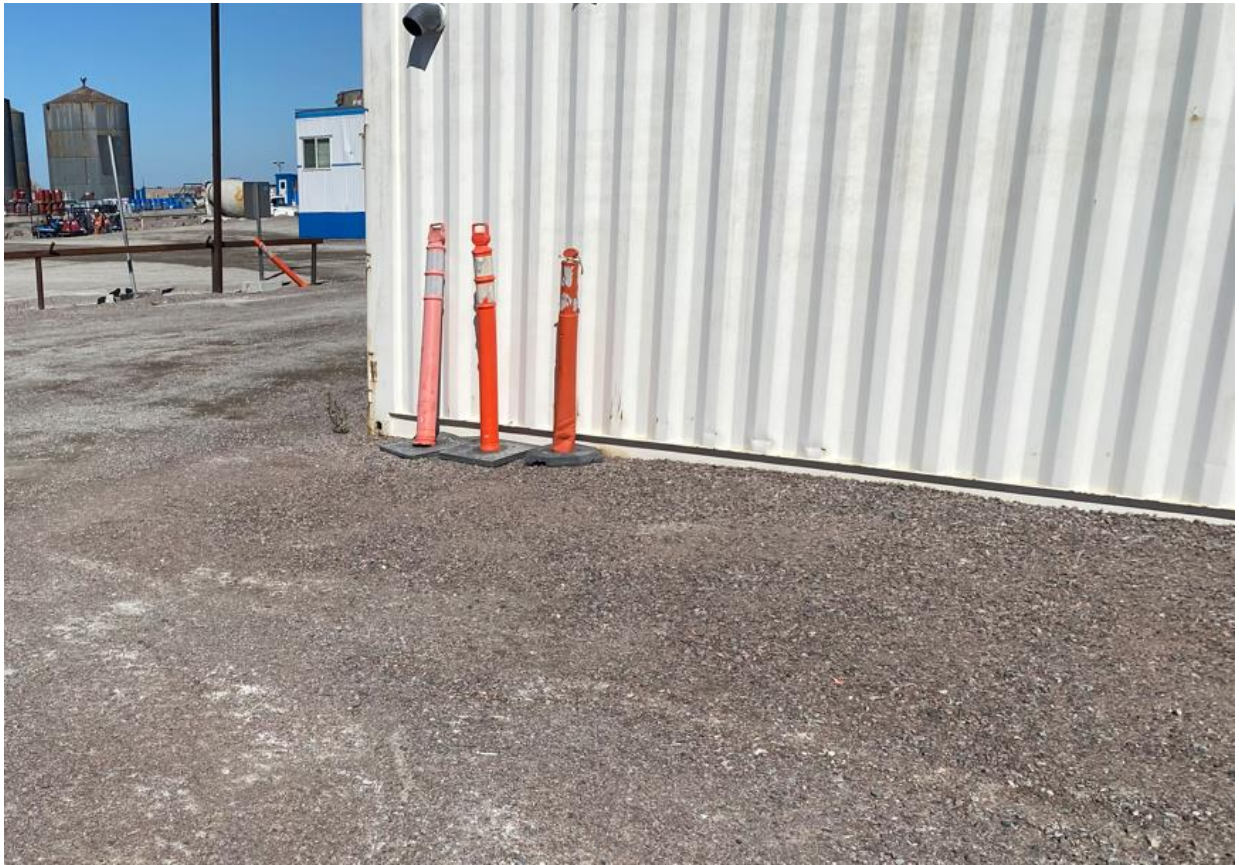
Figure 3. Verification of spill clean up, GNWT Spill #2024259

Following the cleanup, a comprehensive remediation effort was conducted. The affected area was subjected to a thorough inspection to ensure that all contaminants were fully removed. The area was confirmed to be completely free of any residual pollutants, as illustrated in **Figure 3**.
