DE BEERS GROUP

May 4, 2022

Subject: Follow-Up Spill Report – Hydraulic Oil – Gahcho Kué Mine – April 4, 2022 (GNWT Spill #2022117)

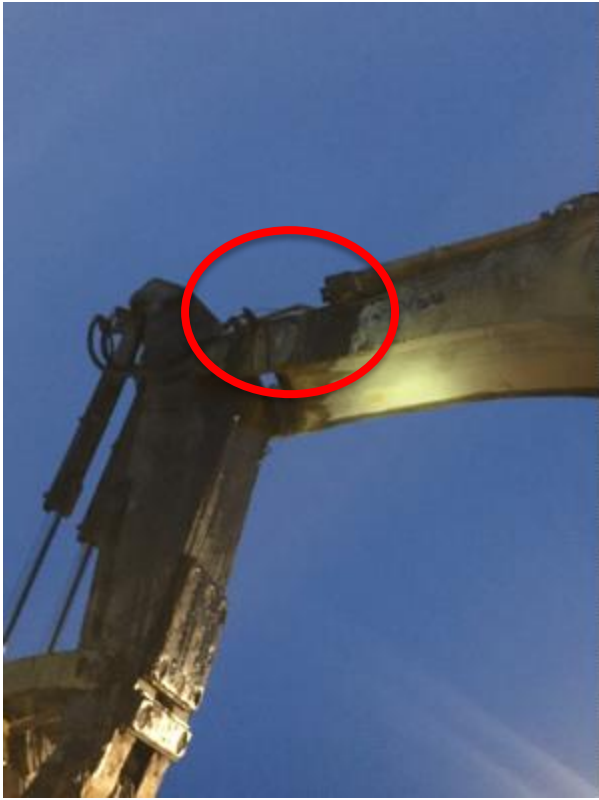
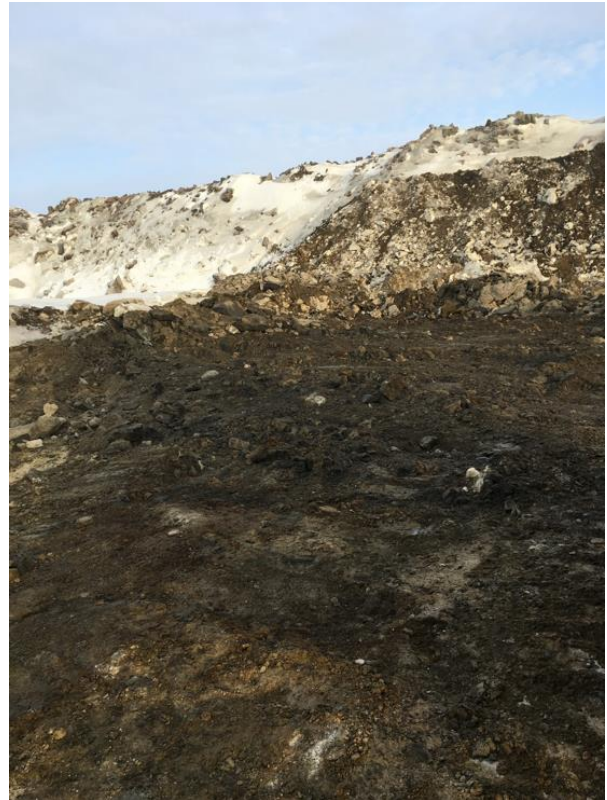
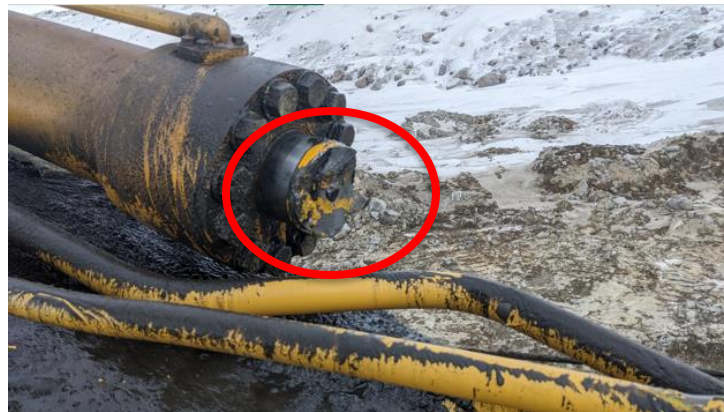
Figure 2. Photos GNWT Spill #2022117

On April 4, 2022 at approximately 05:30, the operator of TV-003 was resourcing till in the Tuzo burrow pit, however the area was frozen the operator was scratching the burrow bottom to produce the material required for construction. While doing so, a hydraulic boom cylinder failed, resulting in a significant spill. Upon failure the operator grounded the implement and hit the emergency stop before notifying their supervisor and deploying spill containment.

Once the operator was aware of the malfunction, the equipment was shut down and the pit supervisor and mobile maintenance were notified. The maintenance technician and operator then deployed spill pads, while the mine operations supervisor coordinated the cleanup of contaminated materials and remediation of the area. During the repair process it was noted that the hydraulic reservoir had lost approximately 500L of hydraulic oil due to the malfunction.

The cylinder failure was likely due to excessive use against frozen till material, which accelerated the wear of the component leading to failure.

1. Planned preventative maintenance program put in place to review remaining cylinder components life expectancy and schedule replacements for next major services or mid-life.
2. Review incident with crews and ensure operators are operating within specified requirements to prevent similar incidents in the future.
3. Remaining identical stick cylinder warrants change out before releasing back to operations.

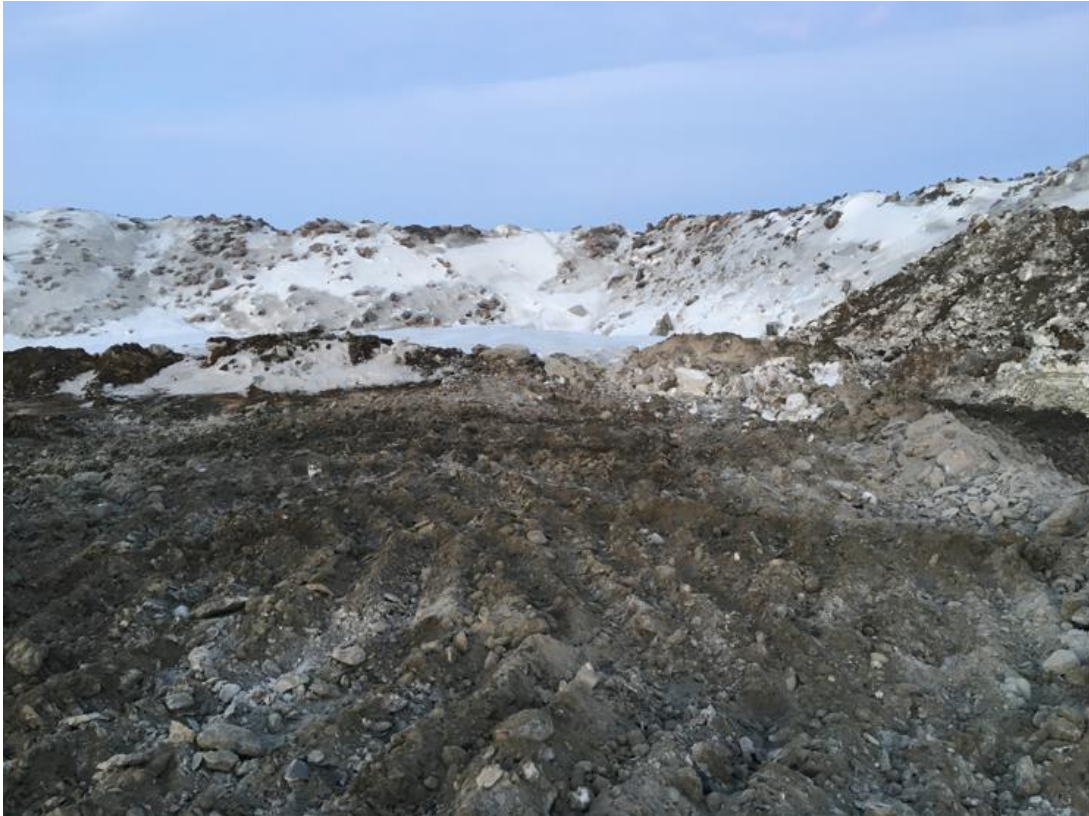
Figure 3. Clean Up Photos GNWT Spill #2022117

The spill occurred in the Tuzo Pit and all contaminated material was removed and loaded out to the Type 3 Area of the West Mine Rock Pile.
