CITY OF YELLOWKNIFE

# 2011 INSPECTION OF DAMS 1, 2 AND 3 ON FIDDLER'S LAKE SEWAGE LAGOON, CONTROL STRUCTURE F9 AND OTHER TRAPPER'S LAKE OUTLET STRUCTURES

## REPORT

APRIL 2012  
ISSUED FOR USE  
Y14101405

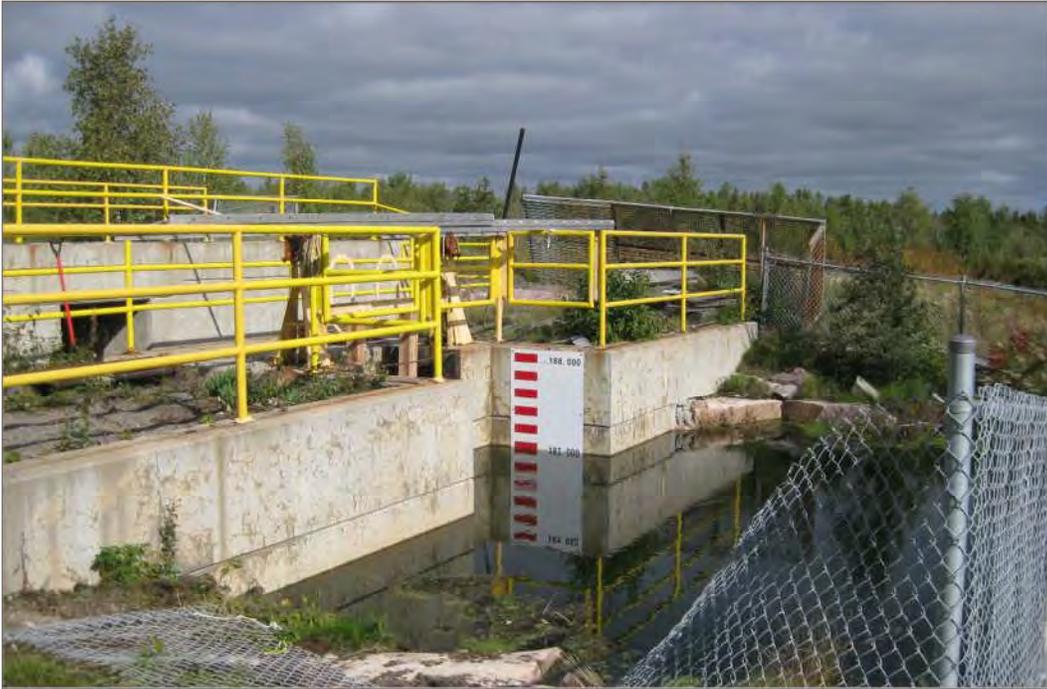
- The water level was observed at an elevation of 187.03 m and no evidence of a higher water level was visible (Photo 1). It is noted that this water level exceeds the maximum recommended water level (186.6 m) by about 0.4 m.
- A small amount of water seepage was observed between the fractured bedrock and the northeast side of the control structure at the outlet (Photo 2). Such seepage has been observed in past inspections when the lagoon water level is high.
- No signs of erosion on upstream face of dam.
- The upstream face of the dam was obscured by accumulations of vegetation and soil (Photo 3). Further from shore, the vegetative mat appears to be floating.
- No apparent seepage or subsidence was observed during the inspection of the downstream face (Photo 4).

Item Observed	September 10, 2009	September 1, 2011
Water Gauge	Water gauge has been replaced. The reference elevation marked on the top of the control structure was 188.179 m as opposed to 188.45 m used in previous inspections.	Reference elevation at 188.18 m.
Relative Reservoir Water Elevation at Dam Outlet (Concrete at top of outlet structure is 188.179m)	At the time of inspection, the top stop log had been removed and water was flowing over the remaining logs; water level was approximately 186.88 m.	Water elevation at 187.03 m (Photo 1).
Observed High Water Mark	187.01 m (187.28 m in 2008 datum).	No higher elevation apparent on gauge (no detritus clinging to gauge).
Seepage Outlet Structure	Small seepage.	A small amount of water seepage was observed between the fractured bedrock and the northeast side of the control structure at the outlet (Photo 2). Although moist mossy areas were observed on the southwest side of the outlet, no seepage was noted there.

**Photo 1:** Water level at Dam 1 outlet structure measured at 187.03 m, about 0.4 m over maximum recommended level.

- Maintain better control of Fiddler's Lake water elevation, so as not to exceed the maximum recommended water level of 186.6 m.
- Infill the apparent waterbar cut into the top of Dam 2 to restore the integrity of the upstream face. Apply gravel surfacing to the dam crest road so as to fill in the low ponding area, and allow water to drain as sheet flow onto the dam slopes, instead of as concentrated flow at that location.

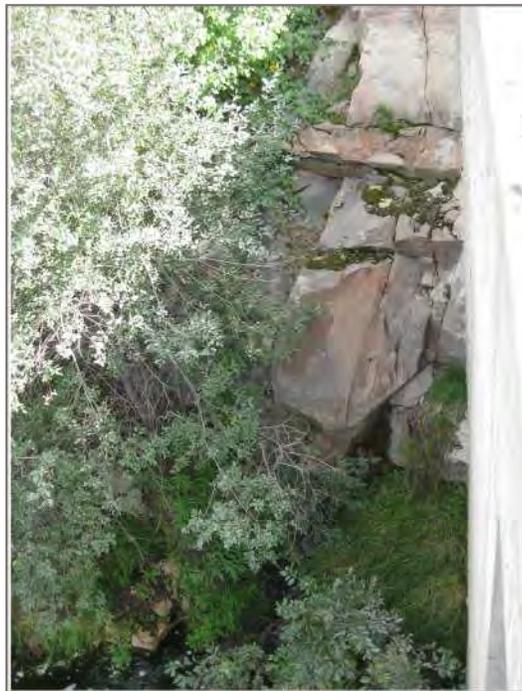
**Photo 2:** Seepage from bedrock on northeast side of Dam 1 outlet, downstream side.

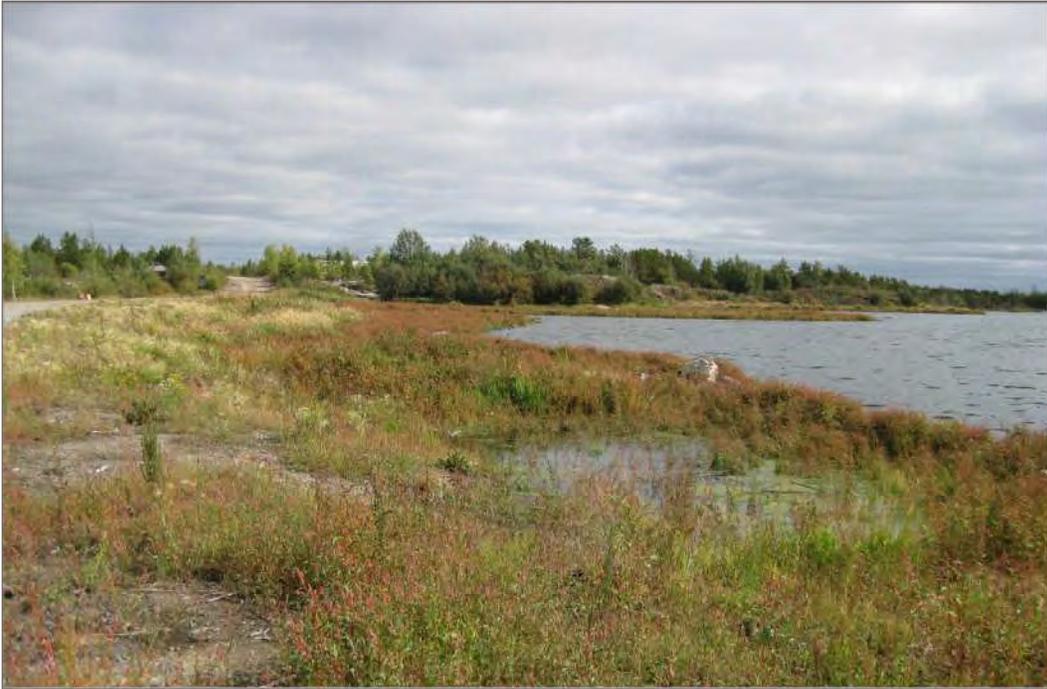
**Photo 3:** Typical upstream area of Dam 1.

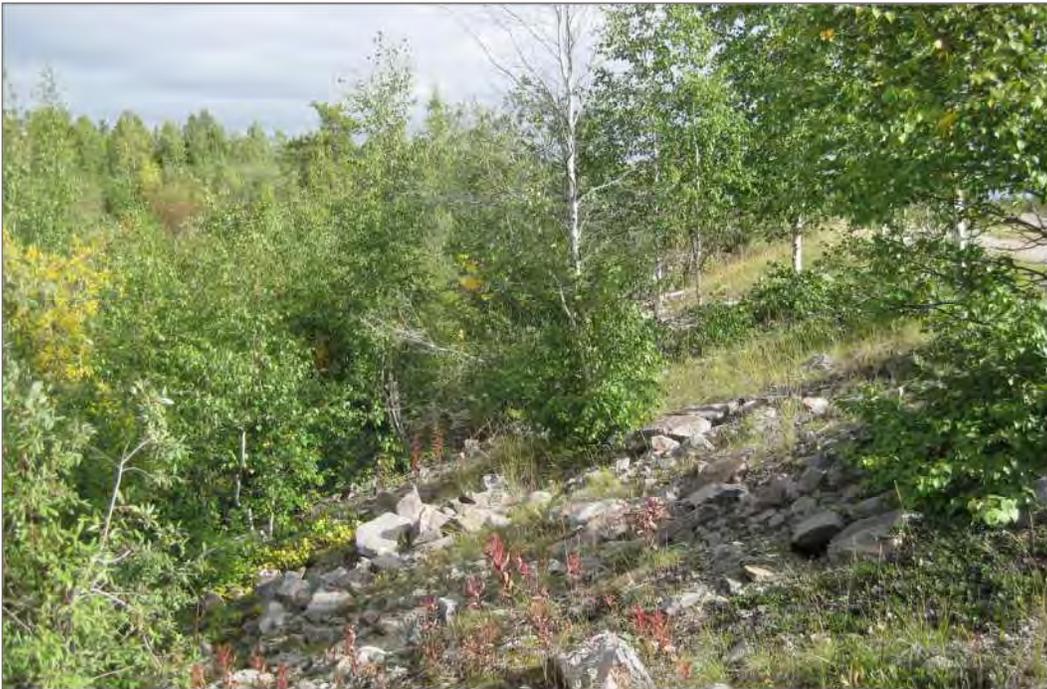
**Photo 4:** Typical downstream face of Dam 1 where riprap is exposed. Dam toe is generally very brushy.

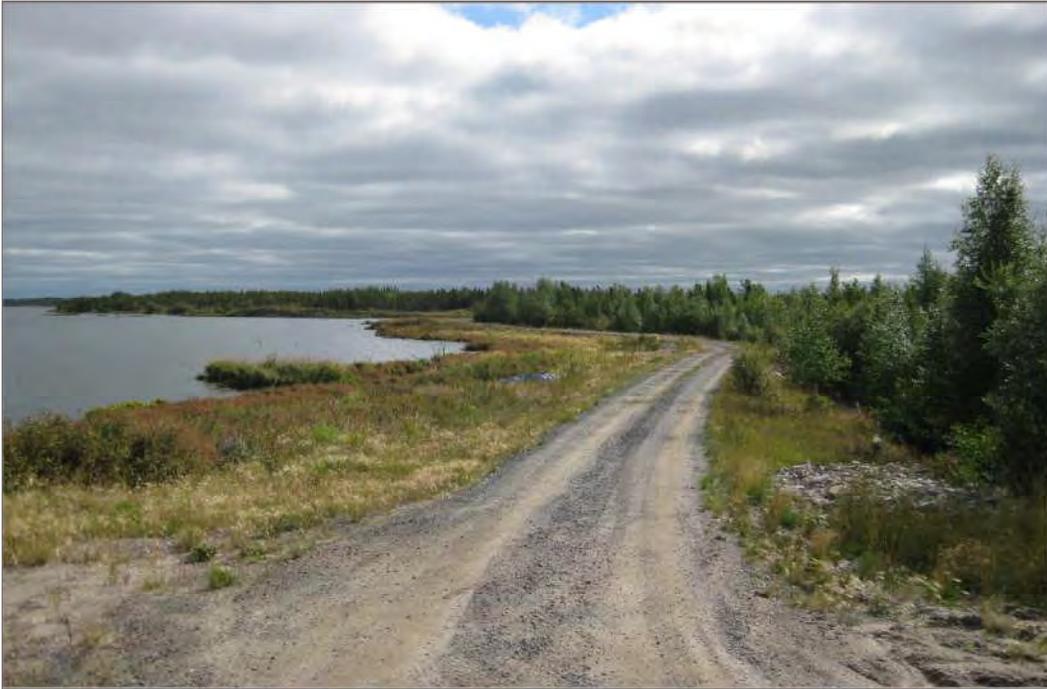
Item Observed	September 10, 2009	September 1, 2011
Crest Width	Dam crest was gravel surfaced, over about 5 m top width. 8 m top width where blast rock has been placed on downstream side.	No changes in crest width, minor washboarding or potholes (Photo 5). A small slot has been cut down from the crest onto upstream face to help drain low area on road (Photo 6).
Upstream Face	Observed depressions in the upstream face as a result of the removal of organic debris, face remains highly vegetated.	No sign of erosion, good vegetative cover (Photo 7). The ground surface on the upstream side of the dam is not uniformly sloped, possibly due to uneven stripping of the vegetation and organics and/or local low areas between bedrock outcrops along the upstream face.
Downstream Face	No erosion observed.	No erosion observed.
Downstream Toe of Dam	Ponded water was observed at the downstream toe at Station 0+340.	Marshy ground below the downstream toe was common along the east half of the dam (Photo 8), where the terrain is flat, with mixed mossy grassy meadow and brush (alder, larch, birch, willow, poplar). Two areas of ponded water were specifically noted, at about 0+530 on the 2009 survey, and at about 0+335 (Photo 9).

**Photo 5:** Crest of Dam 2, looking east from west end. Minor washboarding and potholes on gravelled surface.

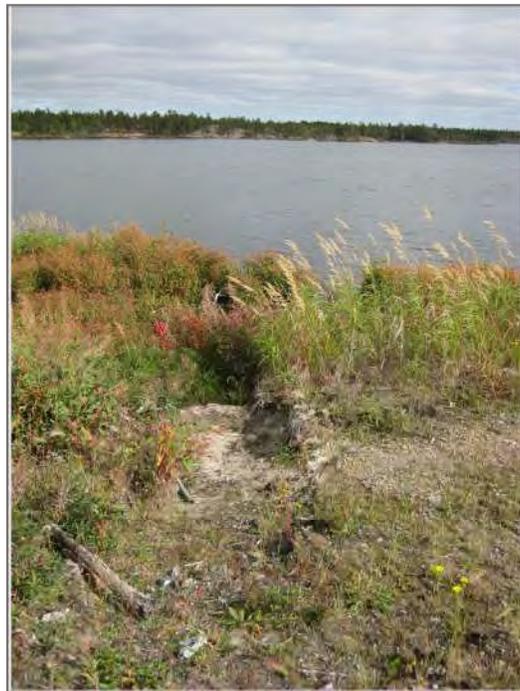
- Dam crest width appears to have had no change from 2009 (Photo 5), but a small slot has been made from the road into the upstream face to drain water of a low area in the road (Photo 6).
- No signs of erosion on upstream face of dam.
- The upstream face of the dam was obscured by accumulations of vegetation and soil (Photo 7). Further from shore, the vegetative mat appears to be floating.
- No apparent seepage or subsidence was observed during the inspection of the downstream face, although the terrain downstream tended to be marshy and wet (Photo 8) with at least two areas of ponded water noted (Photo 9).

**Photo 6:** Waterbar (slot) cut into upstream face of Dam 2 to help drain low area on road.

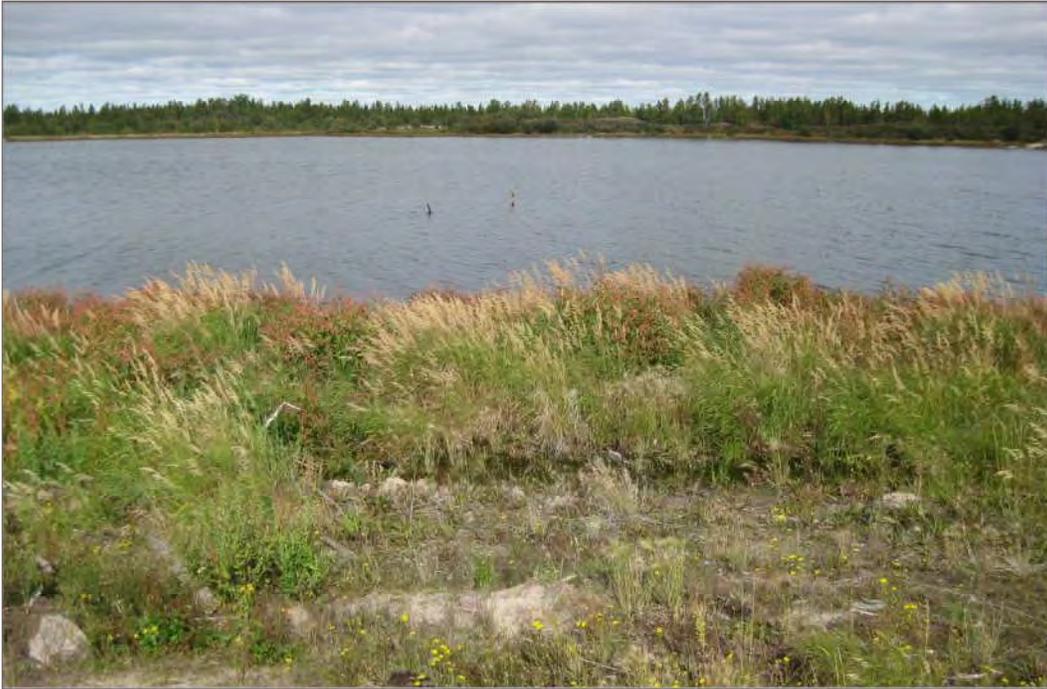
**Photo 7:** Typical upstream area of Dam 2.

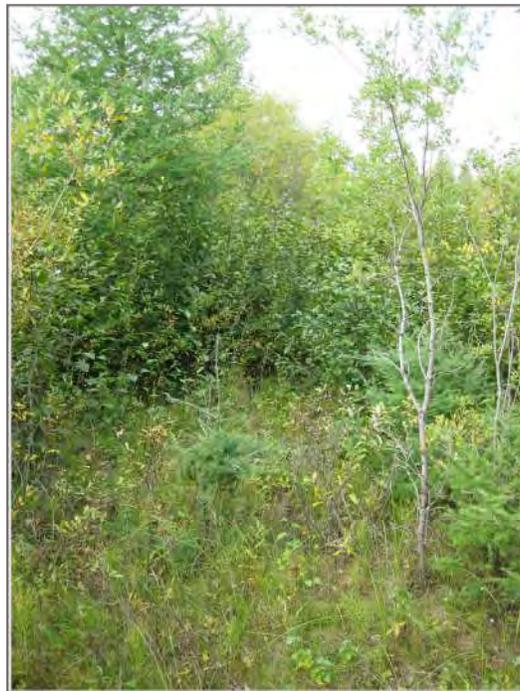
**Photo 8:** Typical marshy area downstream of east half of Dam 2.

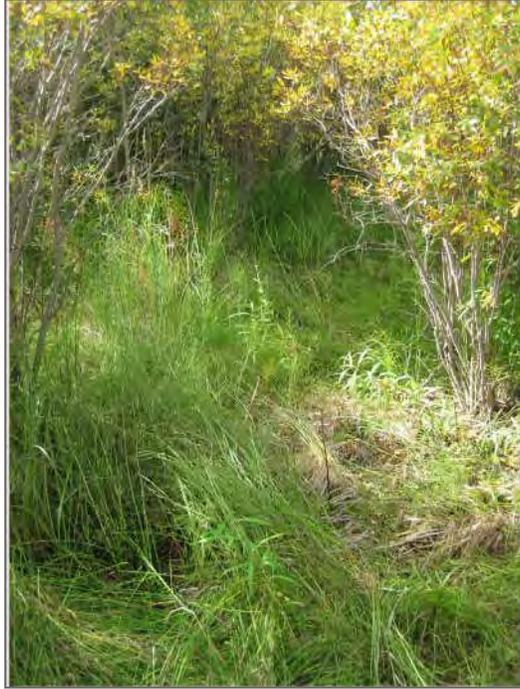
Possible Drainage Downstream of Dam	The water ponded at Station 0+340 had drained away by September 15, 2009.	No follow-up visit was made, but since the week prior to the site visit was characterized by heavy rain, and no flowing water was noted, the ponded water was considered more likely due to poor soil drainage, not dam seepage.

**Photo 9:** Ponded water below Dam 2, about 95 m east of west abutment.

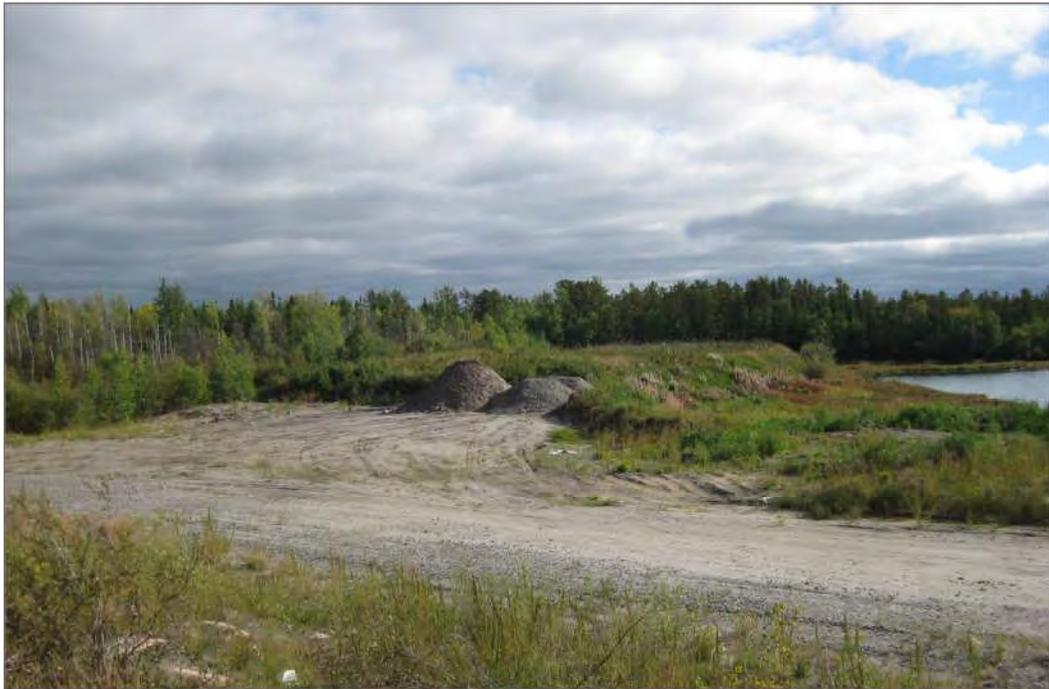
- Dam 3 extends between two large bedrock outcrops and appears stable. Piles of sand are present over the dam (Photo 10).
- EBA is certain that the upstream face of the dam has been covered; it is not clear if the downstream face of the dam is visible. While there are no obvious signs of erosion, the generally well-vegetated surfaces of the present earth structure have localized areas of exposed soil (Photos 10, 11 and 12). Erosion noted at northwest corner of dam/disposal cells is related to periodic surface water flowing off the access road to the downstream side of dam (Photo 13).

**Photo 10:** Looking east at Dam 3 and bagged sewage disposal area.

- Prepare a plan for upgrading of the Dam 3 and bagged sewage disposal facility in accordance with the recommendations provided in 2008.
- Evaluate the performance of water control structures on Trapper's Lake: Dyke 1, Dyke 2, Dyke 3, F9, and former outlet near F9. It could be that water inflow from Trapper's Lake is contributing to the difficulty of limiting the water level in Fiddler's Lake to its recommended maximum. Investigation of these items is proposed for 2012.

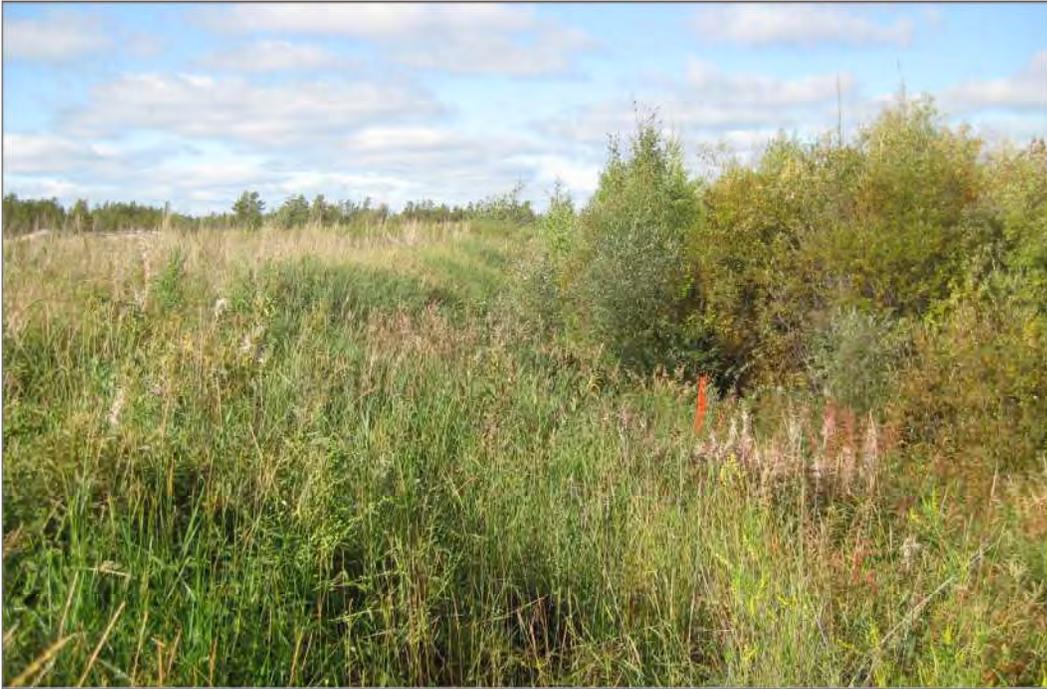
**Photo 11:** Downstream area of Dam 3 is mostly very well vegetated.

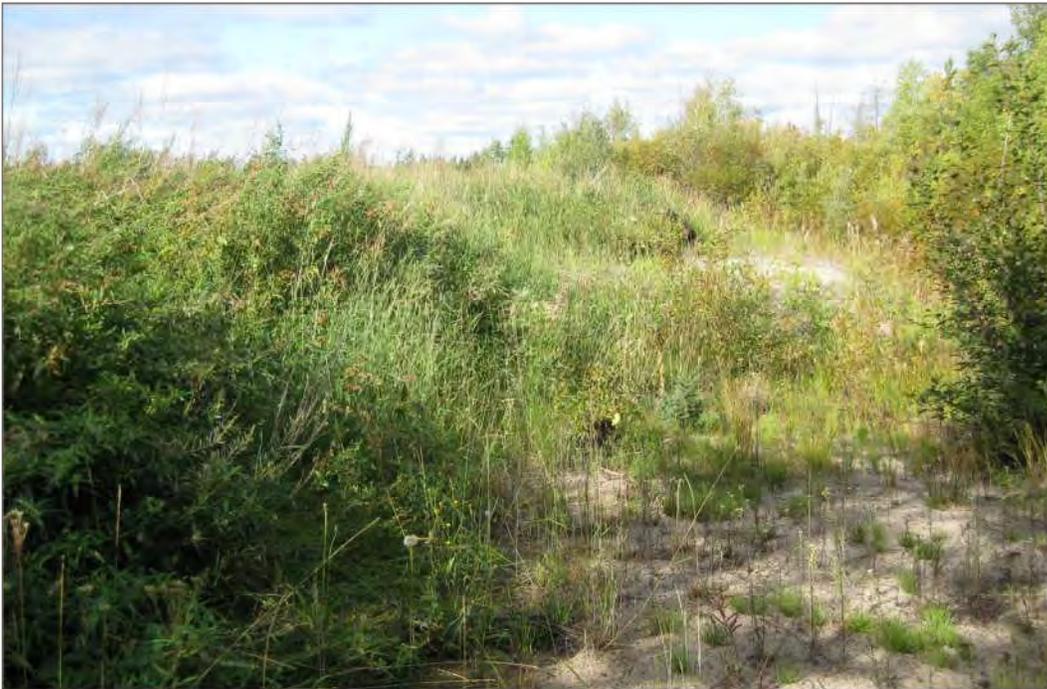
**Photo 12:** Exposed sand at east end of Dam 3 on downstream side does not appear to have ponding or erosion.

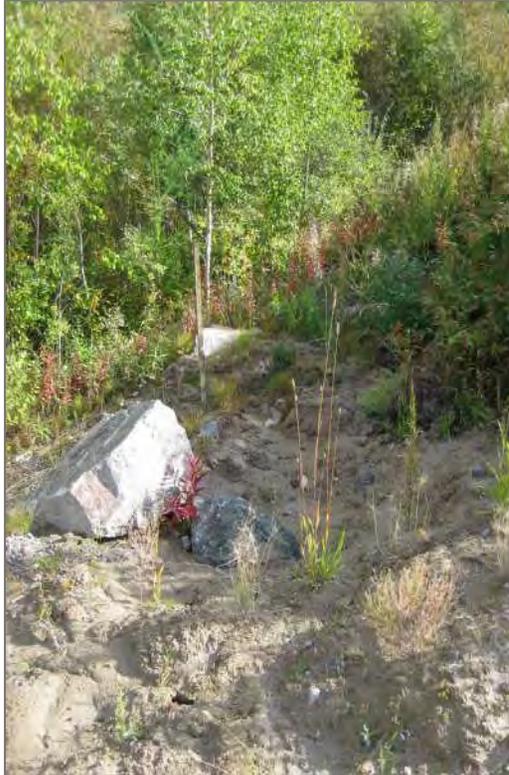
Item Observed	June 10, 2008	September 1, 2011
General Comment	Dam 3 appears to be stable. Cells on top of the dam appear to be downstream of the clay core. Water samples were collected from an existing monitoring well, from ponded water downstream, and from the lagoon upstream of Dam 3. Piles of sand, presumably for future cover, are located on west end of the dam. General debris and garbage found around the site.	Dam 3 extends between two large bedrock outcrops and appears stable. Piles of sand are present on the dam (Photo 10). Debris and garbage appears minor around the site, and is mostly windblown, possibly from the bagged sewage drop-off area in the rock outcrop located to the west.
Upstream Face	Vegetated, no signs of erosion.	Upstream face of the dam is not visible, but area upstream is generally well vegetated, with no signs of erosion.
Downstream Face	Highly vegetated with grasses, no signs of erosion. Two large pits dug into the sand fill.	Highly vegetated with grasses and weeds, no sign of erosion, but ground surface is very rough, especially west half (Photo 11). This area presumed to be part of old downstream bagged sewage disposal cell area reported in 2003. Possibly winter operations resulted in frozen fill placement, or deterioration of bagged materials beneath eventually results in very rough surface. Flat area downstream of east end of dam is sand on the surface, with no apparent ponding or erosion (Photo 12). Water draining off road at west end of dam is causing localized minor erosion of downstream slope (Photo 13).

**Photo 13:** Erosion at northwest corner of Dam 3 / bagged sewage disposal area, due to water flowing off road access.

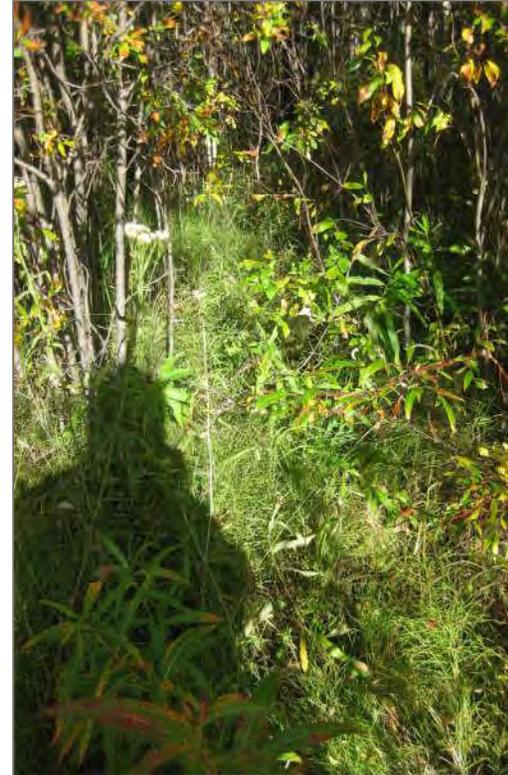
- No apparent seepage or subsidence was observed during the inspection of the downstream side of the dam, although the terrain downstream tended to be marshy and wet, with a few areas of ponded water noted below the toe (Photo 14). We recall, however, that laboratory tests on water sampled from downstream of the dam in 2008 suggested either a breach of Dam 3 itself, or a breach of the bagged sewage disposal cells created on top or downstream of the clay core of Dam 3.

Seepage or Overtopping	No signs of seepage through dam or overtopping.	No signs of seepage or overtopping noted anywhere along downstream side of dam.
Crest	Clay core is not exposed. Sand generally level, no evidence of subsidence or erosion.	Top of dam generally appears level, except for one unvegetated sand pile.
Water Levels	Fiddler's Lagoon water level is about 15 m from upstream toe. Seasonally-ponded water has collected adjacent to the downstream toe of Dam 3.	Fiddler's Lake water level is about 10 m from the upstream toe at the east end of Dam 3 (further away from toe heading west), although some of this distance is very marshy and likely includes some floating vegetative mats. Ponded water is present intermittently beyond the downstream toe. Areas likely to pond are characterized by grasses and horsetail under the willows (Photo 14). Areas less subject to ponding have wild rose, currant, Labrador tea.

**Photo 14:** Downstream of Dam 3 in ponded area. Grasses and horsetail under willows are diagnostic of periodic wet areas here.

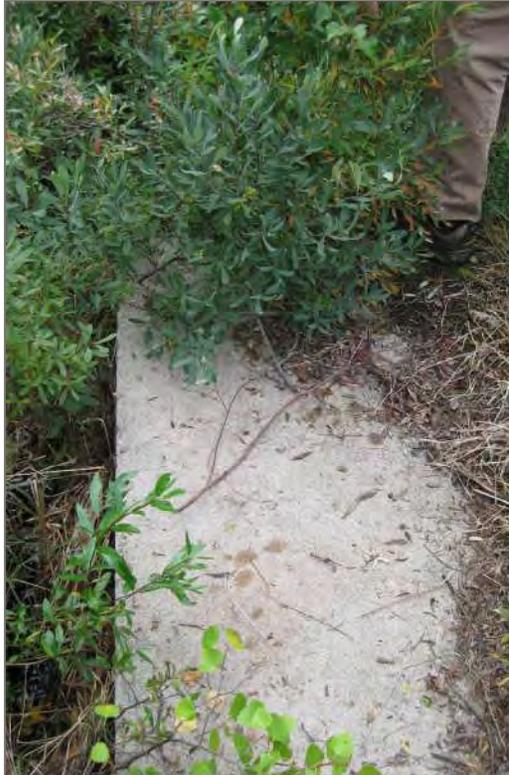
- The concrete east half of the dam is cast onto a local bedrock outcrop. The concrete section is 91 cm thick from upstream to downstream side, and 144 cm long across the top surface, from the vertical west edge at the earth spillway to the east abutment on the bedrock. The earth spillway is possibly also supposed to be concrete but, if so, has overgrown considerably with willow roots and vegetation (Photos 15 and 16).

**Photo 15:** Control Structure F9, Ed Hoeve standing at transition between concrete structure east side and earth spillway west side.

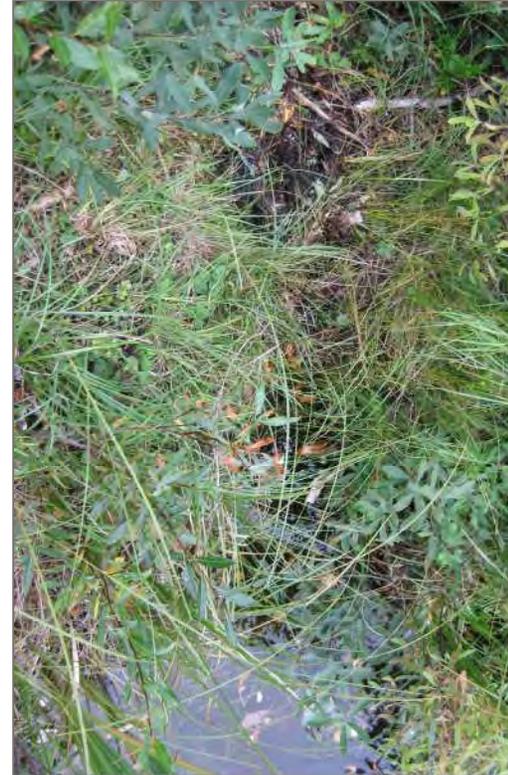
**Photo 16:** Apparent earth spillway at F9 is overgrown with willows and grasses.

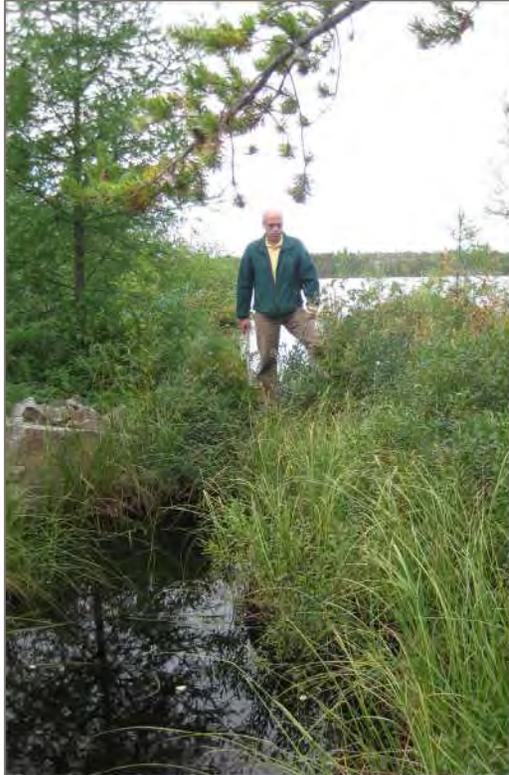
- Water level was 20 cm below the top of the concrete and 6 cm below the top of the earthen spillway on the upstream side, and 51 cm below the top of the concrete on the downstream side. Photos 17 and 18 present upstream and downstream views at F9.

**Photo 17:** Looking upstream at Control Structure F9, Ed Hoeve standing on the structure. Trapper's Lake in background.

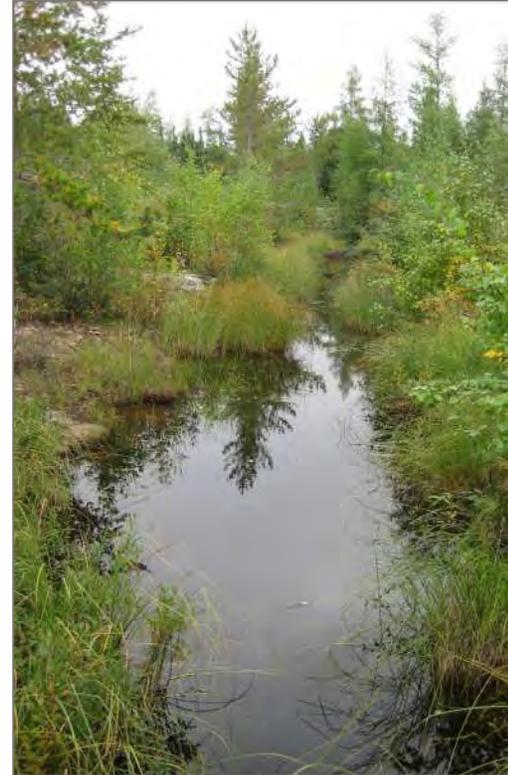
**Photo 18:** Looking downstream from F9 along man-made channel.

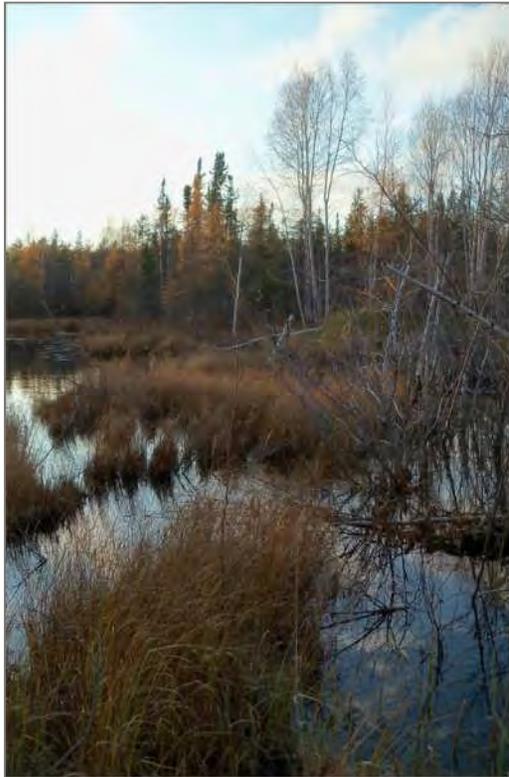
**Photo 19:** Looking west along the crest of Dyke 1, which is breached near the east end.

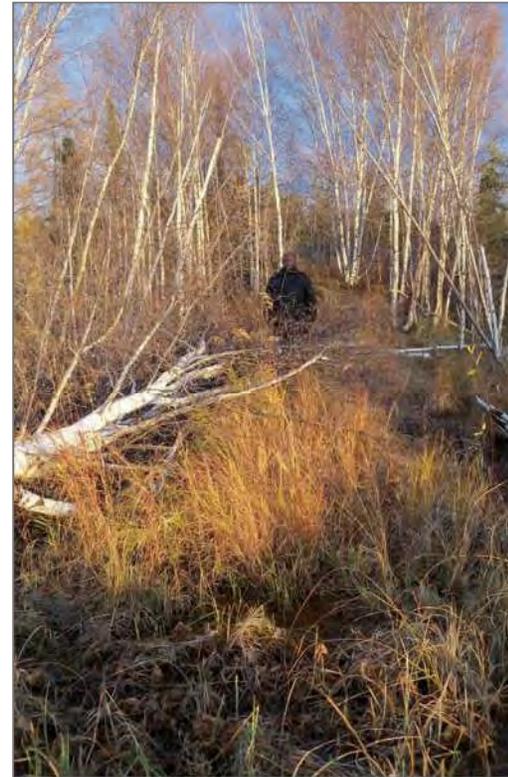
**Photo 20:** Looking east at the east abutment of Dyke 1, which is preserved due to near-surface bedrock.

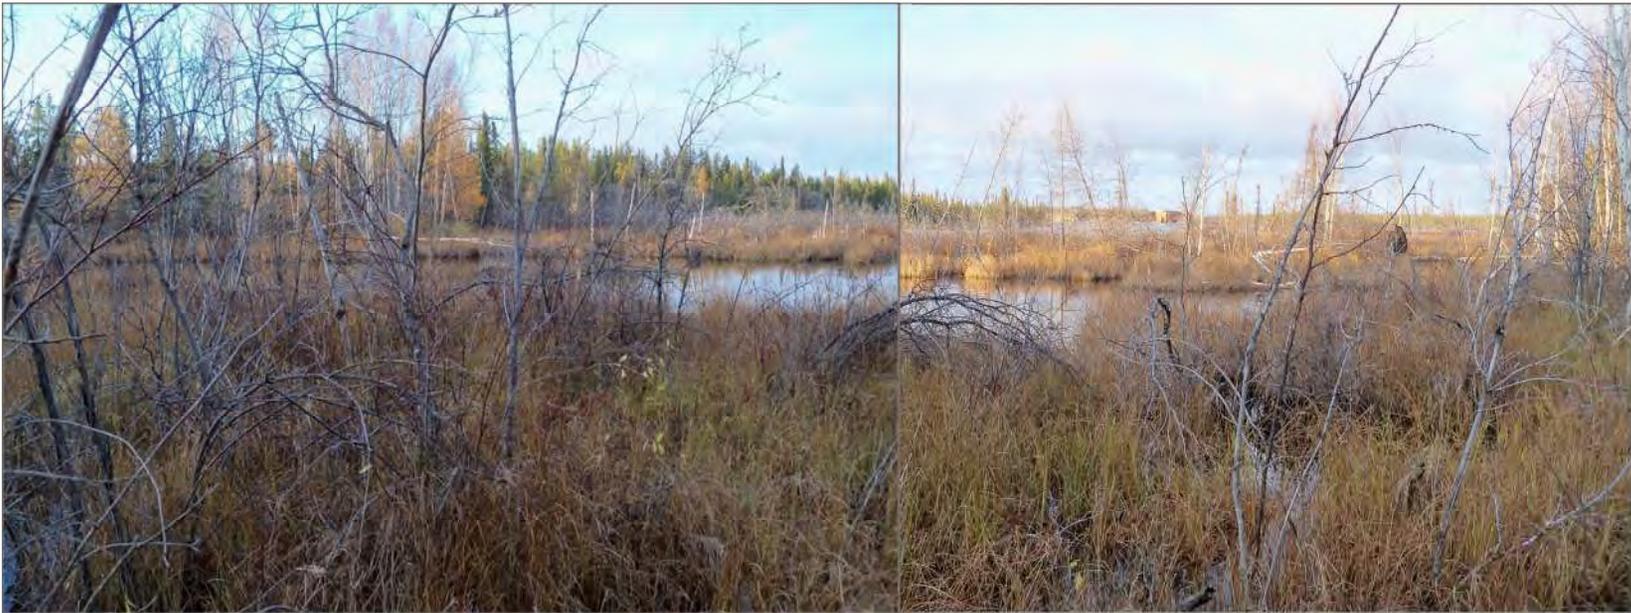
**Photo 21:** Looking upstream at Dyke 1 from marshy area downstream of south pond.

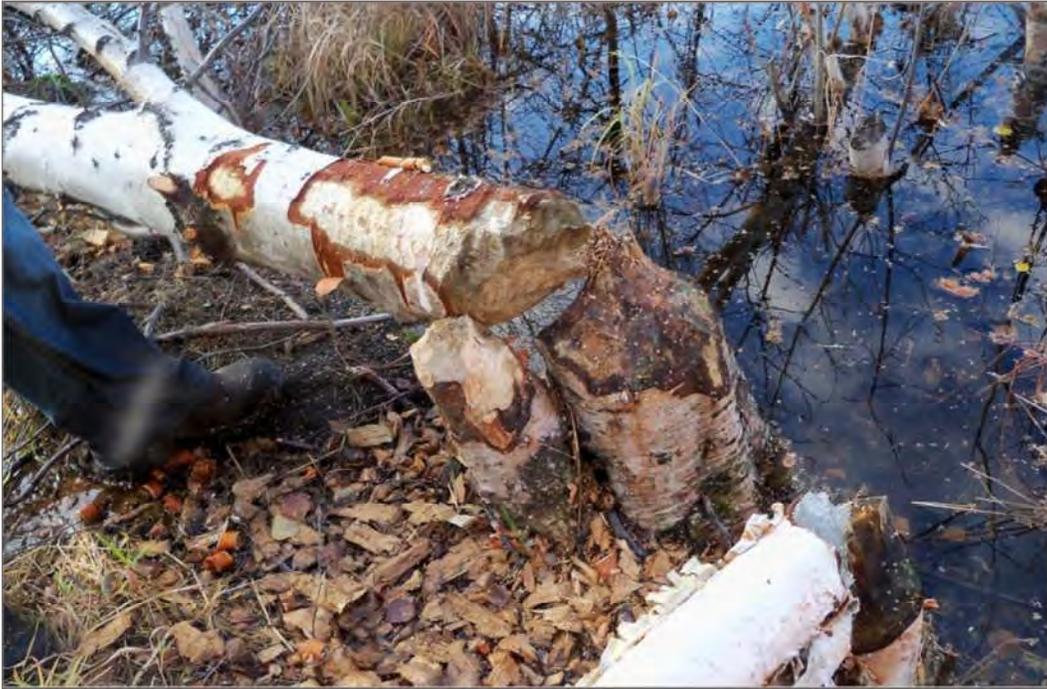
**Photo 22:** Beavers at work on Dyke 1.

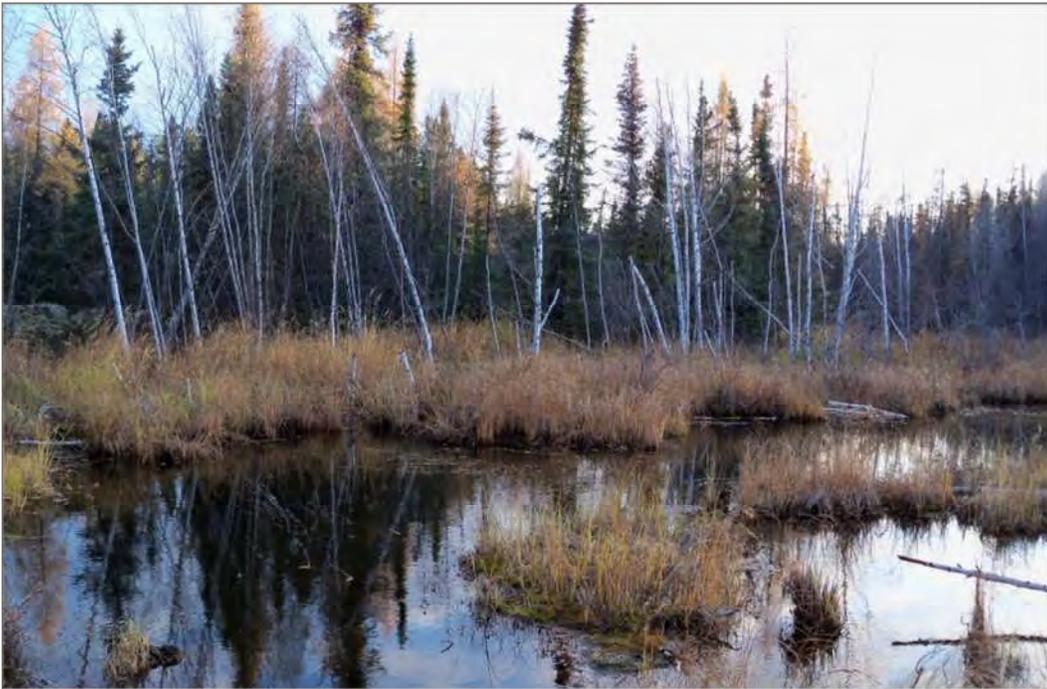
**Photo 23:** Looking downstream from Dyke 1. South pond flows south into Fiddler's Lake.

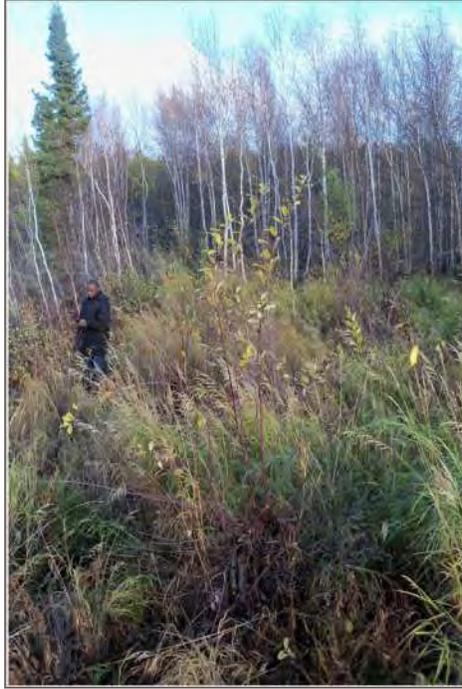
**Photo 24:** Looking east from west abutment of Dyke 2. Disturbed site indicators include grasses, birch and willow.

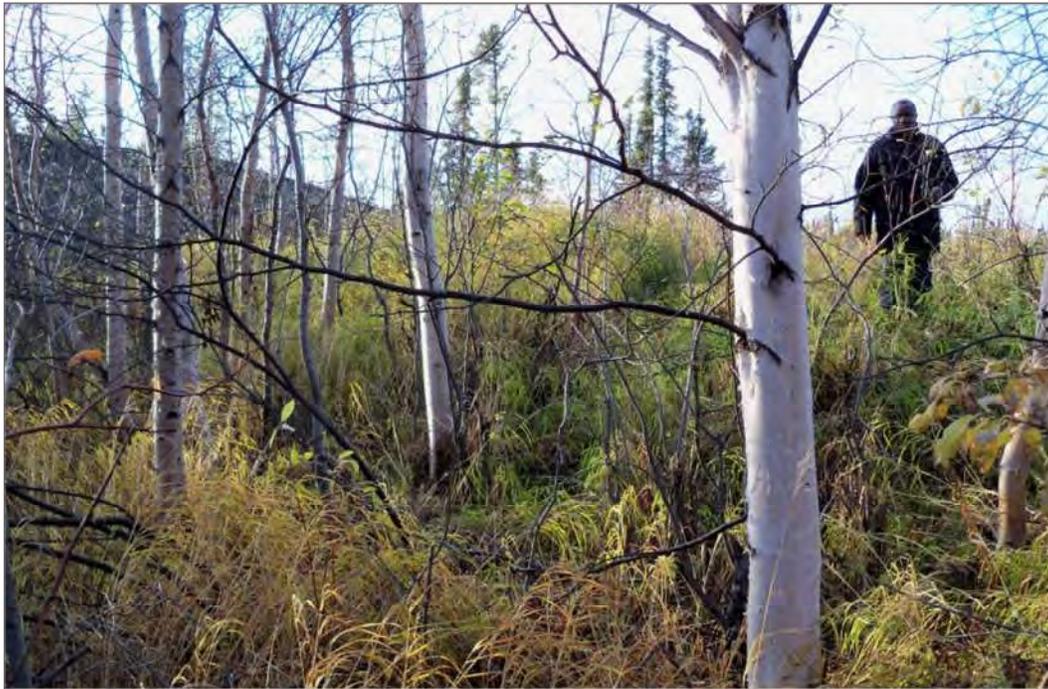
**Photo 25:** Looking upstream at well-vegetated downstream face of Dyke 2 near west end.

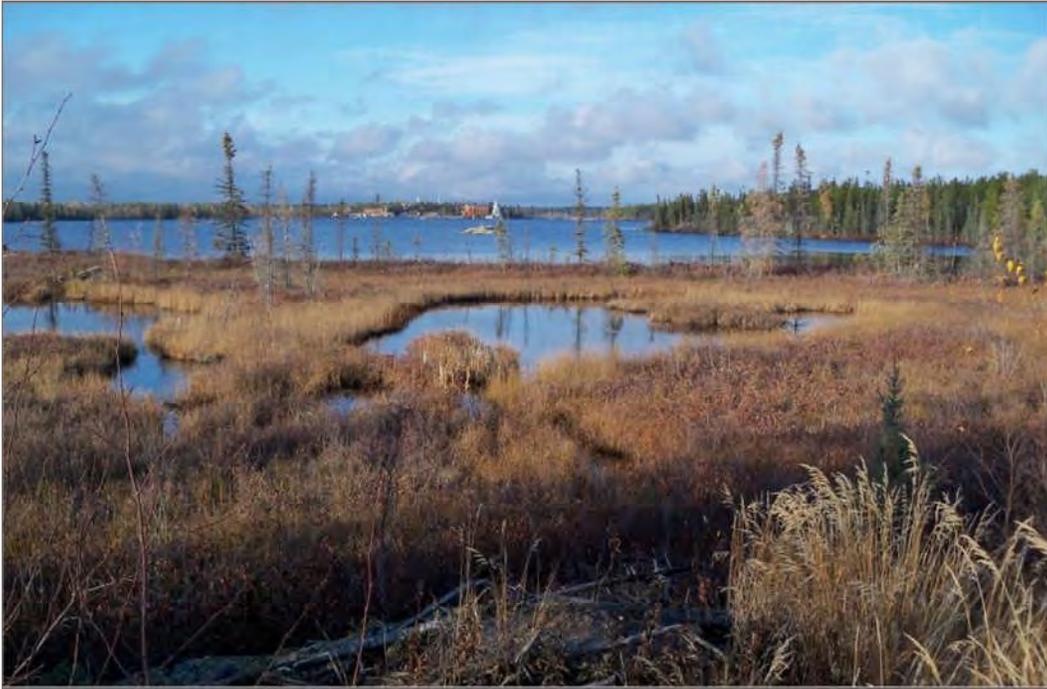
**Photo 26:** Looking upstream towards Trapper's Lake from near west end of Dyke 2. Small stream flows from lake through pond in marsh to dyke.

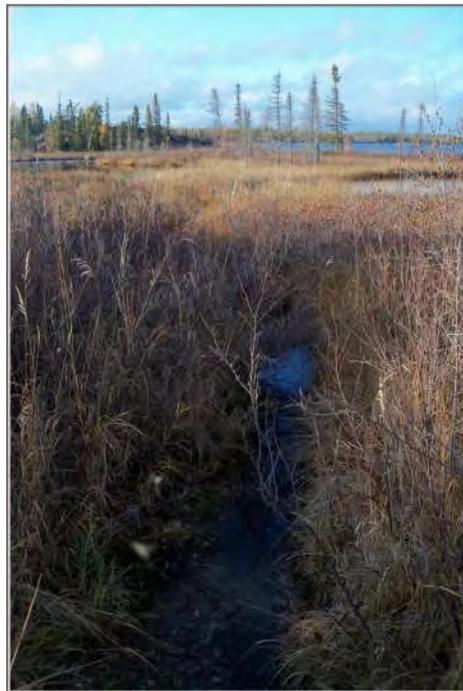
**Photo 27:** Looking upstream at small stream flowing towards Dyke 2.
